REF: 2006 Range Rover Sport HSE, VIN: SALSF25466A [REDACTED]

Front Differential Problems and Solutions (Range Rover III)

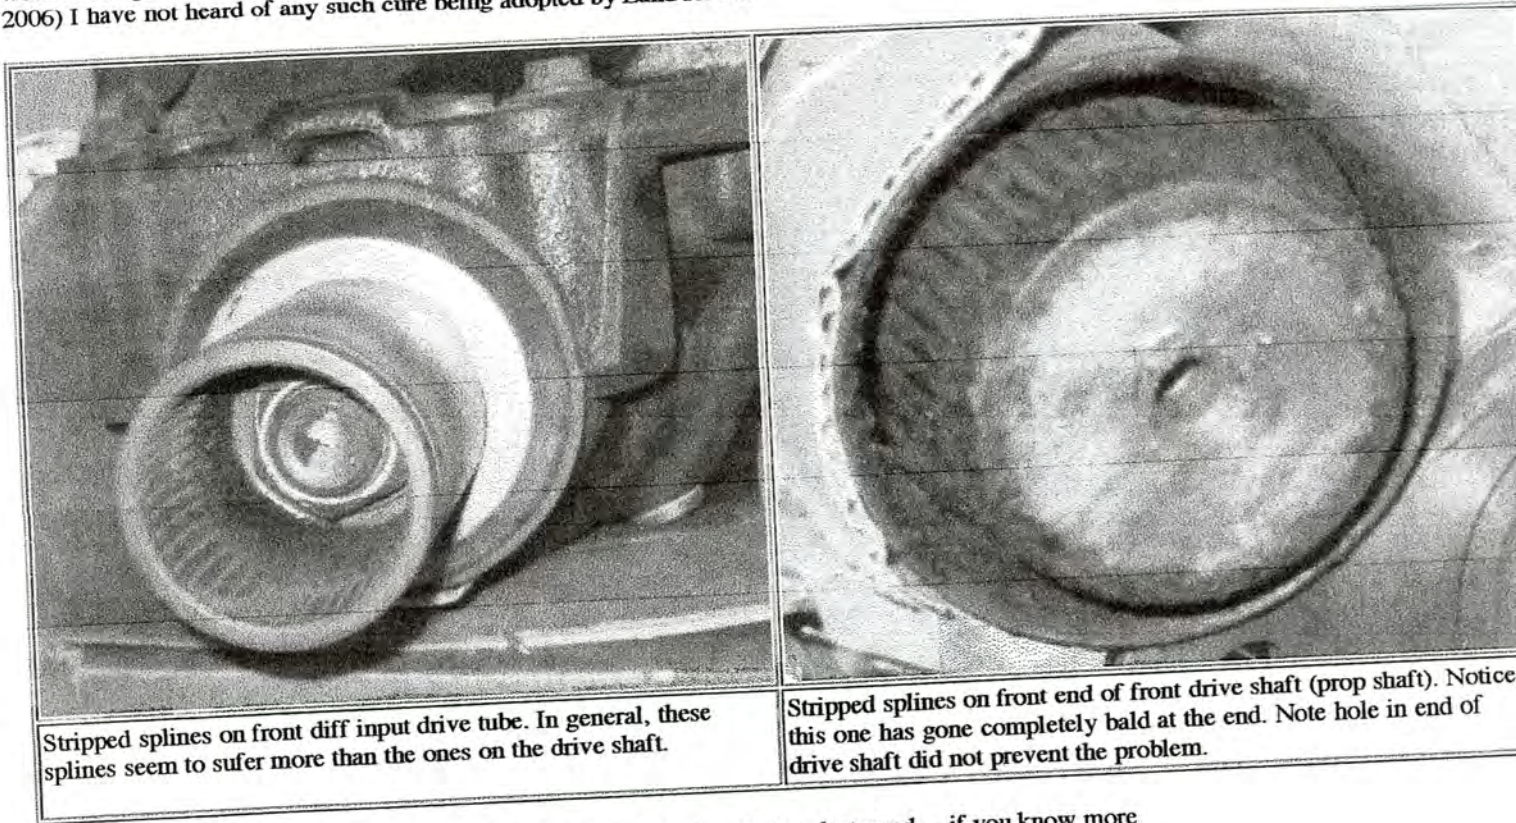
Accordingly, no problems have been reported at the transfer case end, but the connection to the front differential fails far more frequently than it should, often wrecking the entire diff with it. An obvious cure would be to provide some form of flexible coupling at the front end of the driveshaft, but to date (January 2006) I have not heard of any such cure being adopted by Land Rover.

One owner reported the internals of the diff rather than the splines being destroyed -- if you know more about this please [email me](#).

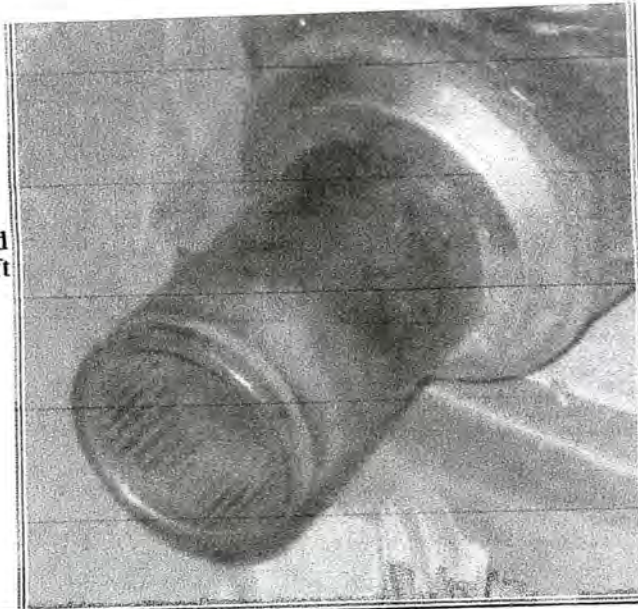
Top Right: Similar view but closer in (adapted from official Land Rover TSB) with driveshaft removed to see the the input splines of the front differential. Anti-sway bar at bottom.

Bottom Right: Closeup of failed splines on diff input tube.

If the spline wear on the inside of the diff input drive tube is excessive, the official procedure is to replace the entire differential assembly. According to the June 2003 service bulletin, the assembly includes a collapsible spacer that determines the bearing preload, and renewal of the drive tube only can apparently result in rapid failure of the differential bearings.

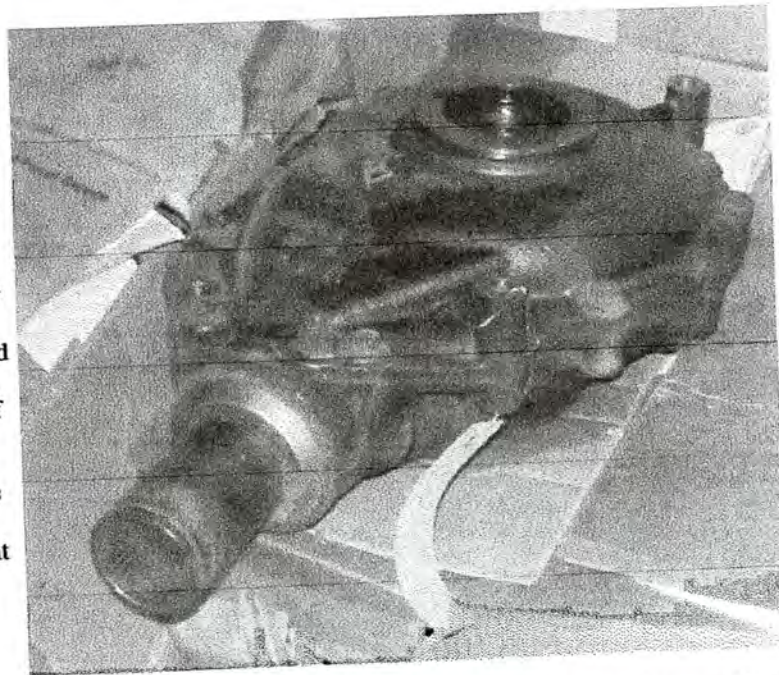
Photo at left (courtesy of Atlantic British): New replacement front differential unit with input drive at right side of picture.
