U.S. Department  
of Transportation  
**National Highway  
Traffic Safety  
Administration**

## ODI RESUME

**Subject:** STEERING INTERMEDIATE SHAFT BINDING

Sedona (GQ) Increased [Steering](#) Effort (Chassis -019)

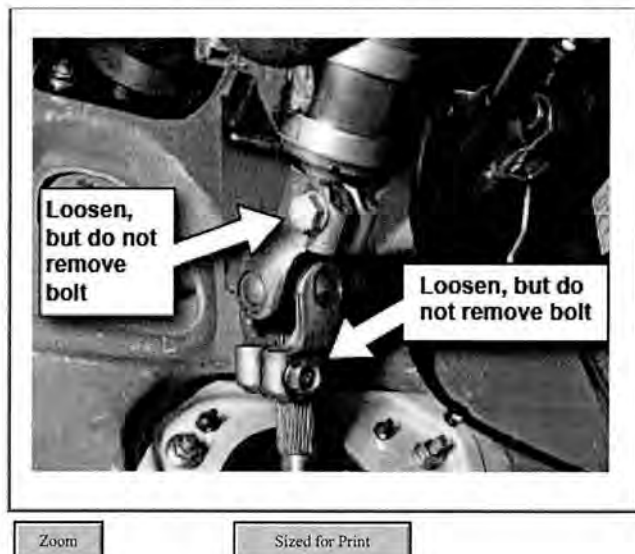
Underneath the dash, LOOSEN, BUT DO NOT REMOVE the two upper joint pinch bolts that attach to the steering column and intermediate shaft.

**\*NOTICE** The pinch bolts should still grasp the shaft tight enough that no play is felt.

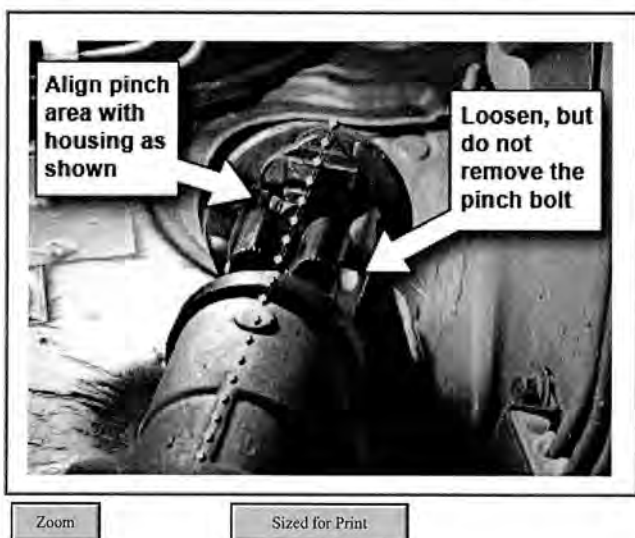
3. Raise the vehicle on a lift. LOOSEN, BUT DO NOT REMOVE the lower intermediate shaft pinch bolt.

With the wheels pointing straight ahead, center the pinch area of the lower intermediate shaft joint on the raised rib and/or circular reference point of the steering rack housing. You may need to clean and re-mark this area with a paint marker (as necessary) for reference.

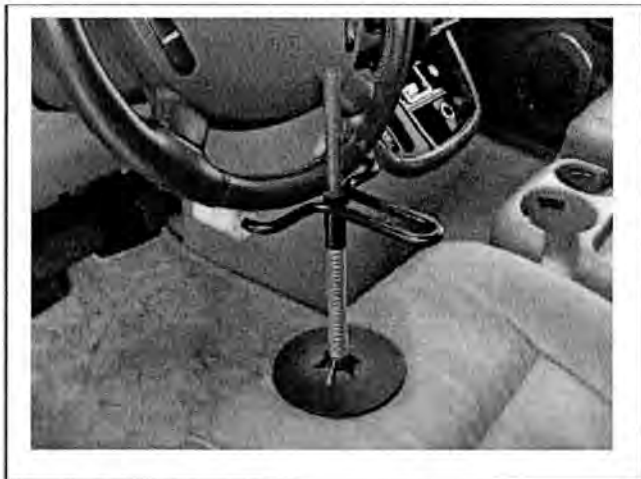
WITHOUT MOVING THE STEERING WHEEL, carefully install a commercially available steering wheel holding device, as shown in photo.

**\*NOTICE** For any number of reasons the steering wheel may no longer be centered once the lower intermediate shaft joint is aligned to the steering rack as outlined in step 3. The steering wheel must be locked in the position resulting from alignment of the lower intermediate shaft joint to the steering rack, and may not necessarily be centered.

**!WARNING** DO NOT ALLOW the steering wheel to spin freely while replacing the steering intermediate shaft. This may cause damage to the clock spring, and will effect centering of the steering wheel after the repair.

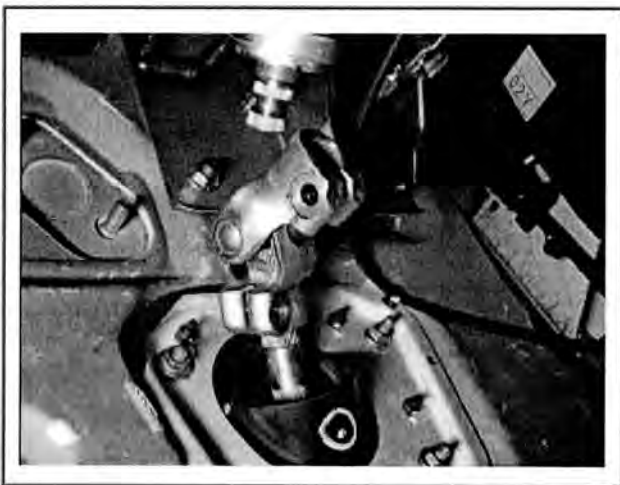
5. Completely remove the previously loosened upper intermediate shaft joint bolts. Slide the joint down onto the splines of the intermediate shaft, which will allow the joint to be removed from the bottom of the steering column shaft as shown.

**\*NOTICE** Do NOT allow either the steering wheel and/or intermediate shaft to turn.

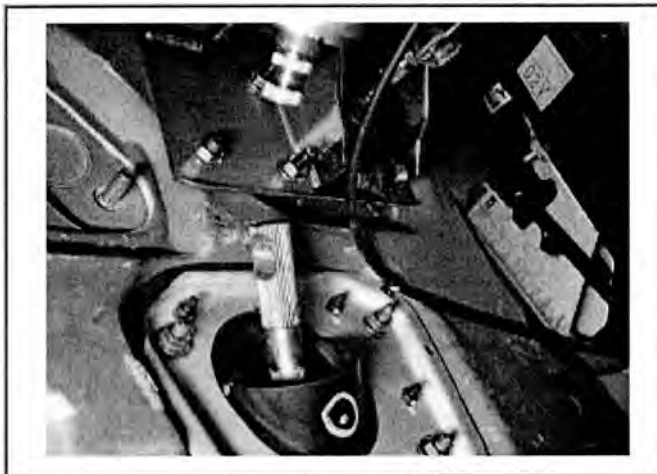
Remove the upper intermediate shaft joint from the intermediate shaft and set aside for later reinstallation.

**\*NOTICE** Do NOT allow either the steering wheel and or intermediate shaft to turn.

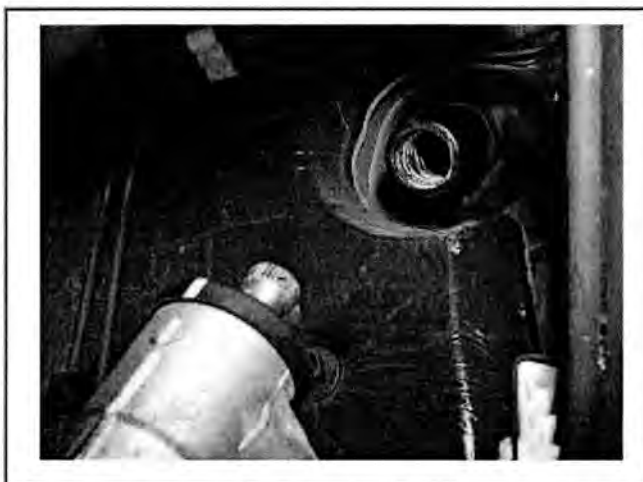
6. Raise the vehicle on the lift. Remove the previously loosened pinch bolt from the lower intermediate shaft joint, and then remove the intermediate shaft from the steering gear shaft as shown in the photo.

**\*NOTICE** Do NOT allow the joint to turn when removing the bolt and/or intermediate shaft.

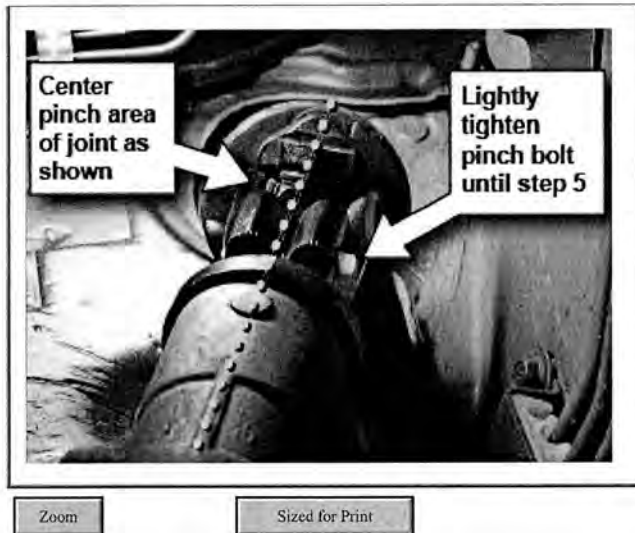
1. Install the new intermediate shaft, aligning the pinched area of the lower joint with the raised rib and/or circular reference point of the steering gear housing. Lightly tighten the pinch bolt making sure not to rotate the steering gear shaft.

**\*NOTICE** Do not fully tighten this pinch bolt until step 5 of the reinstallation procedure.

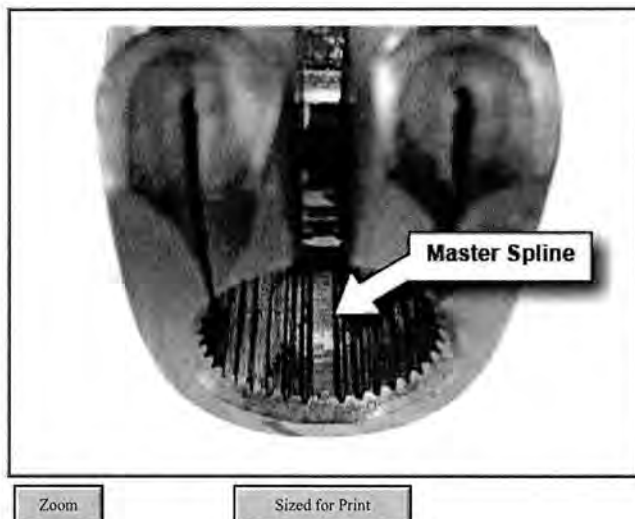
- 2a. **IMPORTANT:** The shaft's upper joint has a master spline on its lower joint section that assures proper phasing of the two joints of the intermediate shaft. Note that the upper section of the joint does not have a master spline.

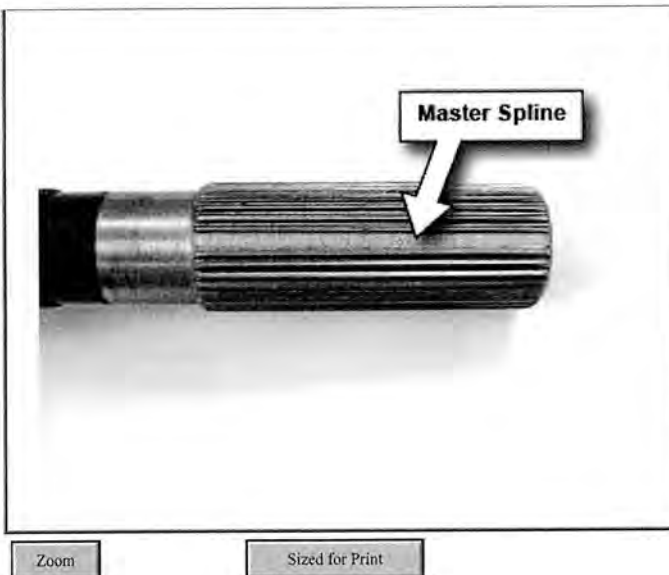
- 2b. **IMPORTANT:** The intermediate shaft has a master spline that assures proper phasing of the two joints of the intermediate shaft.

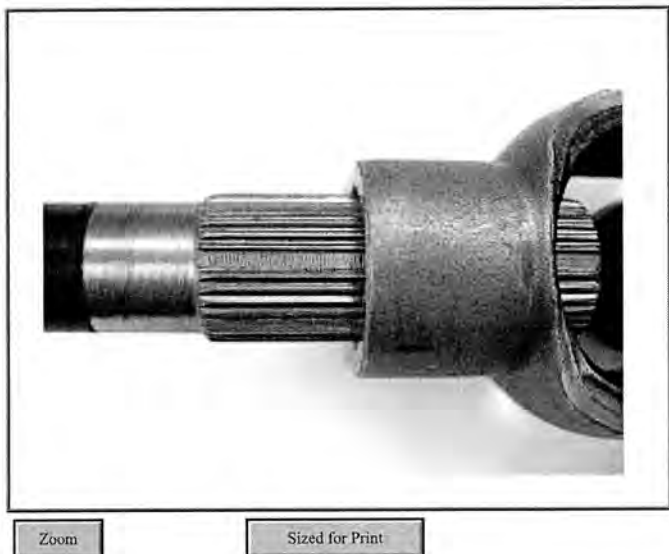
- 2c. **IMPORTANT:** The upper joint master spline must be aligned with intermediate shaft master spline as shown to assures proper phasing of the two joints of the intermediate shaft. Only the bottom section of the upper joint has a master spline.

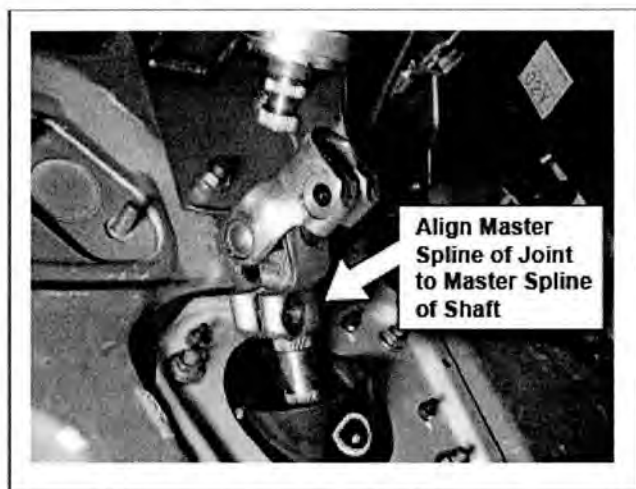
3. Under the dash, reinstall the previously removed intermediate shaft upper joint, paying close attention to the master spline alignment between the joints lower section and intermediate shaft.

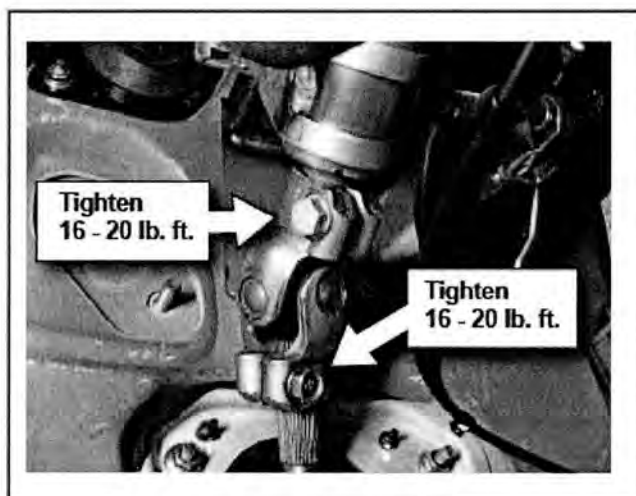
4. Fully install and tighten the upper intermediate shaft joint: 16 - 20 lb. ft.

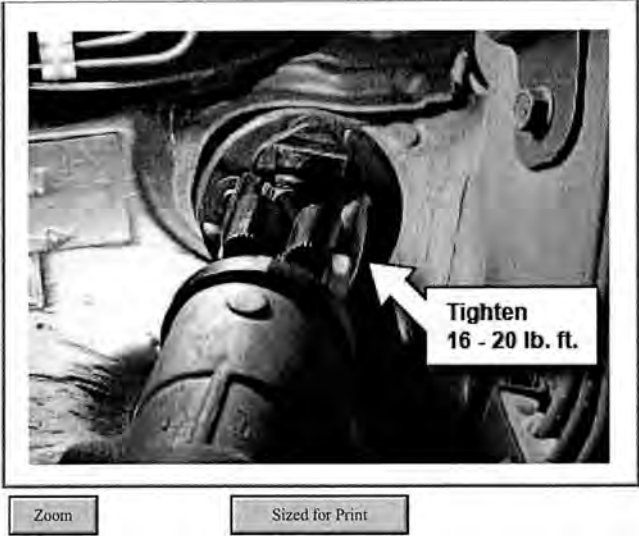
- 5. Raise the vehicle and fully tighten the joint at the steering gear shaft: 16 - 20 lb. ft.
- 6. Lower the vehicle and remove the steering wheel holding device. Road test the vehicle to assure the customer concern has been addressed.

Additionally check that the steering wheel is still aligned as before the intermediate shaft replacement.
