Vehicle Owner's Questionnaire
To Report Vehicle Safety Defects

10424476

Medtec® Type I Field Duty

Bench Seat also know as Squad Bench

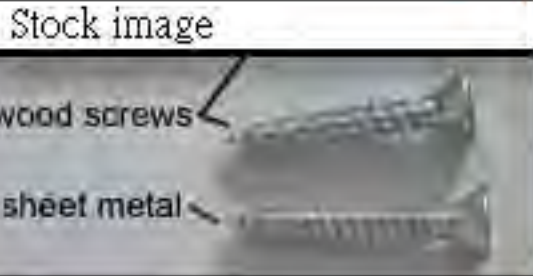
In the older models, the bench seat sits on top of the compartment. In the new MedTec models, the seat sits on only the front and back but not the sides.

We have had an expert look at the design. He said it was not sound. The expert's issue with the seat was that the hinge was sitting on top (instead of inbetween/under, as seen in the older models). When the hinge is on top, it acts like a crowbar on the screws. The screw we also small sheet metal screws. The screws are not designed for this use. Those types of screw also are not the best at load bearing and sustaining constant forces (the kind the hinge would be applying to them).

Bench seats are supposed to be able to support multiple medics at one time and we also use that seat to lay patients on (when on a spine board) flat across. The seat I was on broke, with just me on it, when hitting a small bump.

Medtec® Type I Field Duty built on a Ford F-450 chassis. While in transit, the seat broke off from it's hinges. The screws were wood/sheet metal screws that held the hinge in place (those screws were replaced with through and through nuts&bolts).
