From: [Wells, Cynthia CTR \(NHTSA\)](#)
To: [Fogle, Brenda CTR \(NHTSA\)](#)
Subject: FW: Gas hose stress crack
Date: Wednesday, November 09, 2011 3:47:12 PM
Attachments: [Propane Stress Crack1.jpg](#)
[Propane hose tear.jpg](#)
[Gas1a.jpg](#)
[gas2a.jpg](#)
[gas3.jpg](#)
[gas4.jpg](#)
[gas5.jpg](#)
[rwservlet.pdf](#)

Reference No.
10433994

Make
COACHMEN

Model
FREELANDER

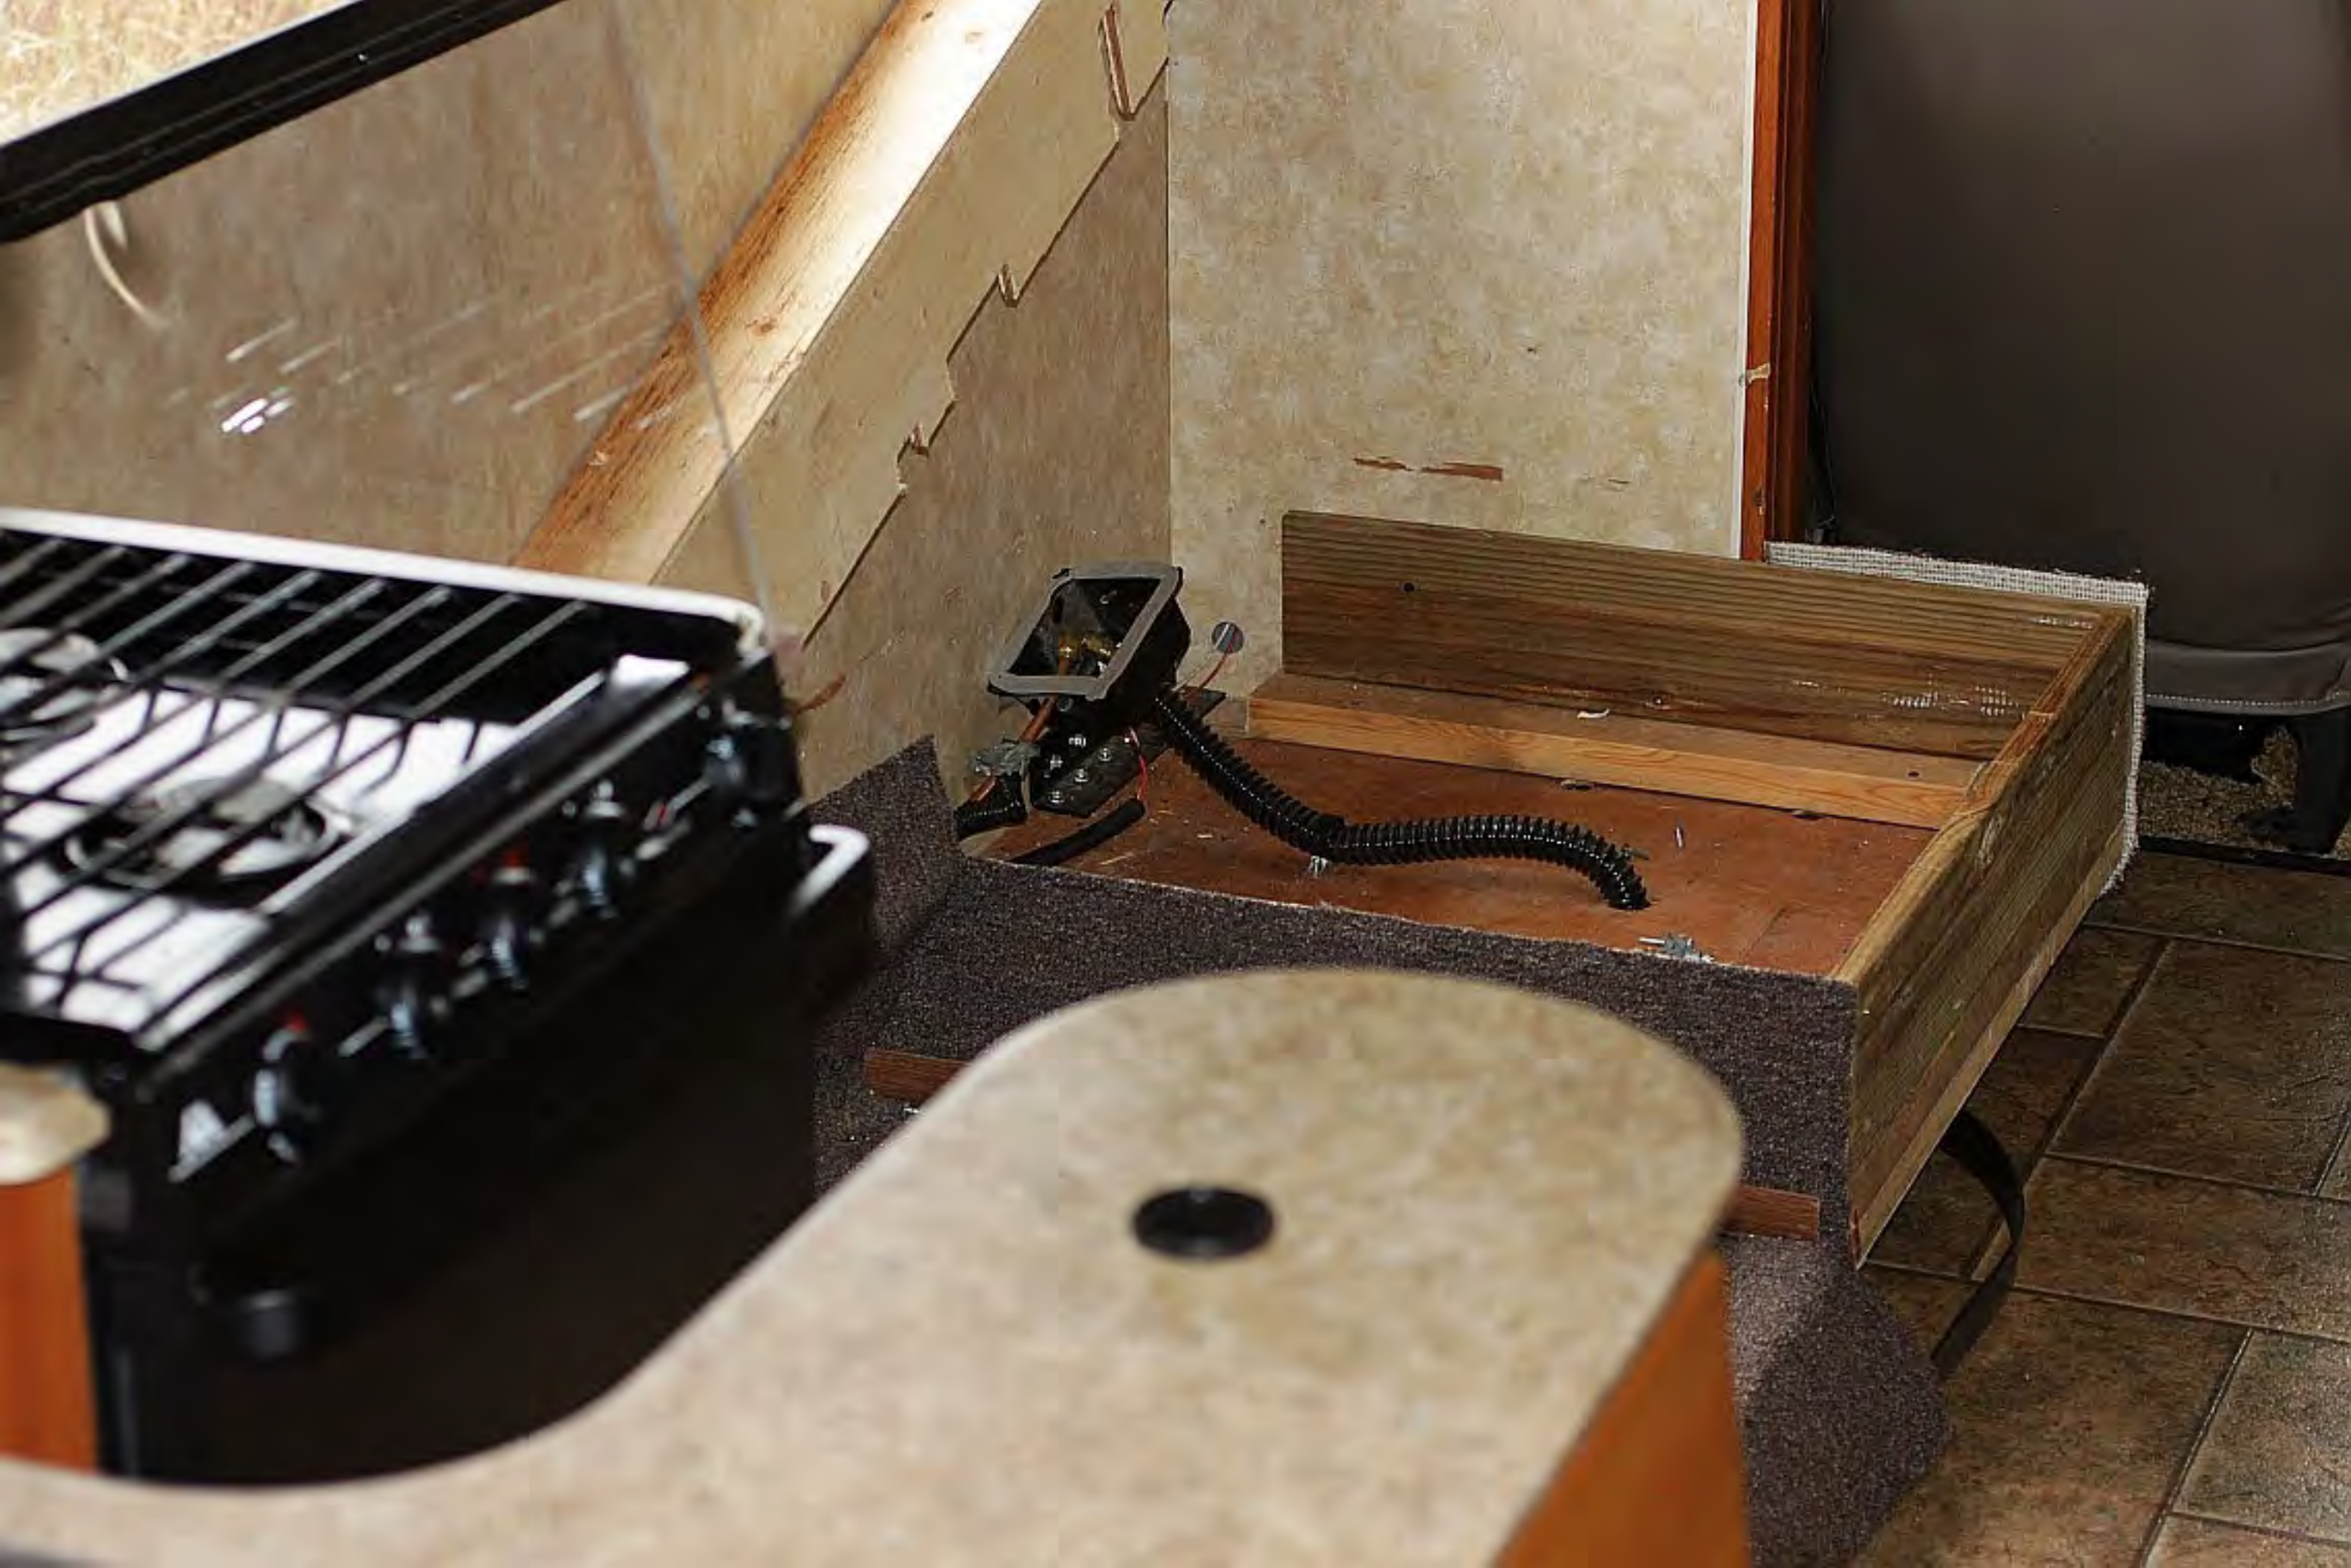
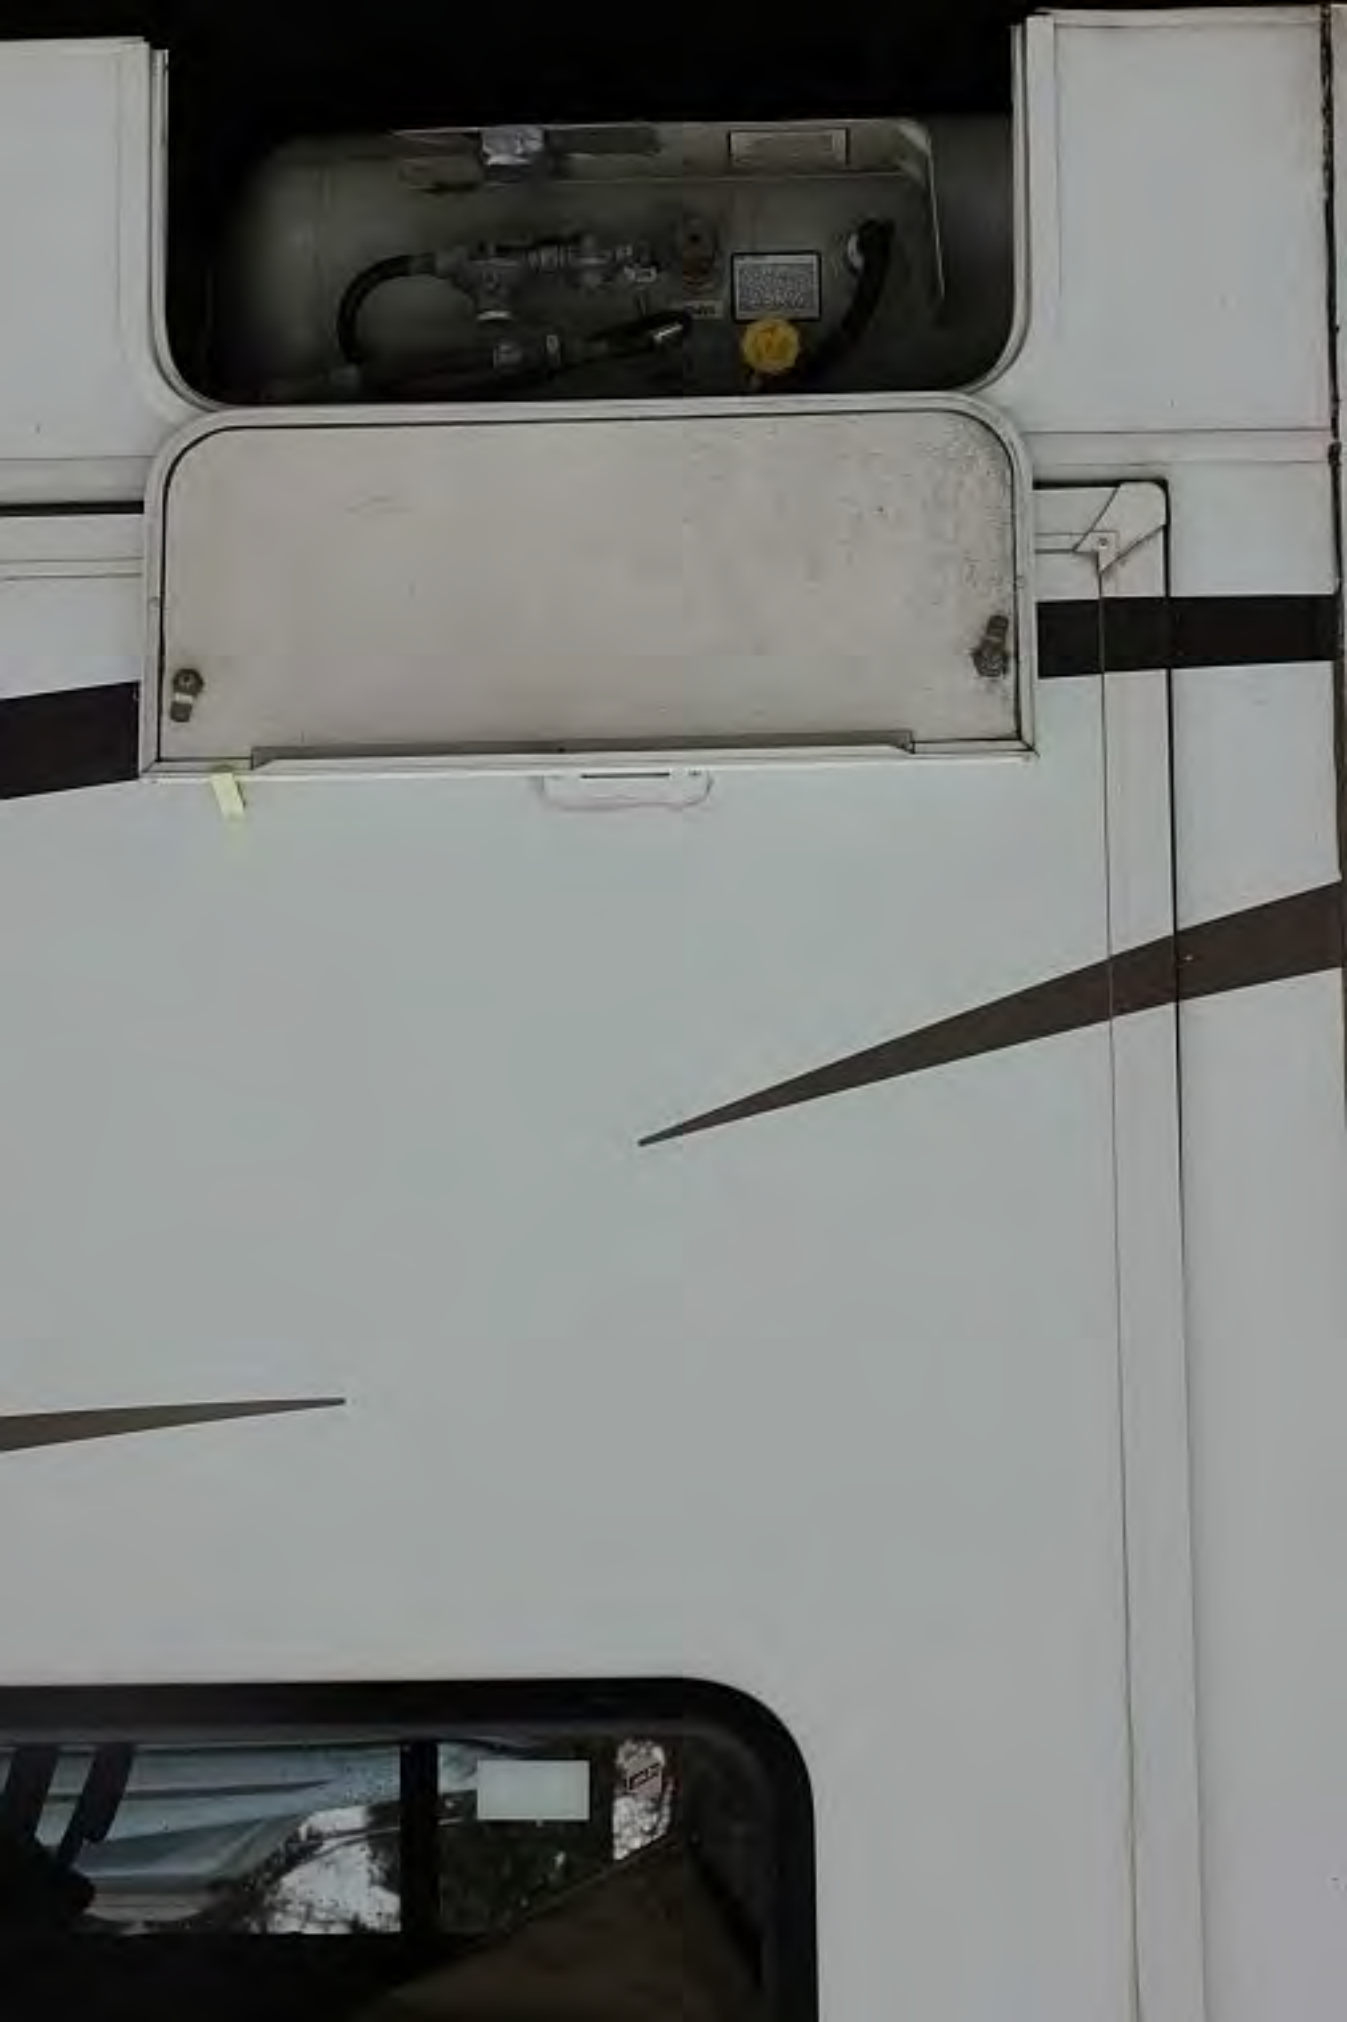
Please find attached 7 pictures of gas hose location and close up of stress cracking in the opened 180 degree fold-back.

THE HIGH PRESSURE PROPANE GAS LINE FROM THE PROPANE TANK TO THE STOVE HAS CRACKED. I JUST DISCOVERED THIS YESTERDAY NOV 1, 2011 WHILE LOOKING FOR THE REASON THE GAS TO THE STOVE WAS SHUTTING DOWN WHILE SLIDE WAS RETRACTED. WHAT I FOUND WAS THE GAS LINE PINCHED AT A 180 DEGREE ANGLE, FOLDED BACK ON ITSELF. WHEN THE SLIDE-OUT IS EXTENDED THE GAS LINE STRAIGHTENS ENOUGH TO ALLOW GAS TO FLOW. WHEN THE SLIDE-OUT IS DRAWN BACK IN TO MOVE THE MOTORHOME, THE GAS LINE IS FOLDED AND PINCHED CLOSED. I INSPECTED THE GAS LINE AT THE FOLD/PINCH POINT AND DISCOVERED A CRACK ON THE OUTSIDE OF THE HIGH PRESSURE RUBBER TUBING. THE SLIDE-OUT HAS BEEN MOVED, IN AND OUT, APPROXIMATELY 100 TIMES SINCE PURCHASING NEW IN SEPTEMBER 2002. THE SMALLEST HOLE IN THIS LINE WOULD PRODUCE A MAJOR LEAK RESULTING IN POSSIBLE EXPLOSION WITH SEVERE BODILY BURNS OR DEATH.

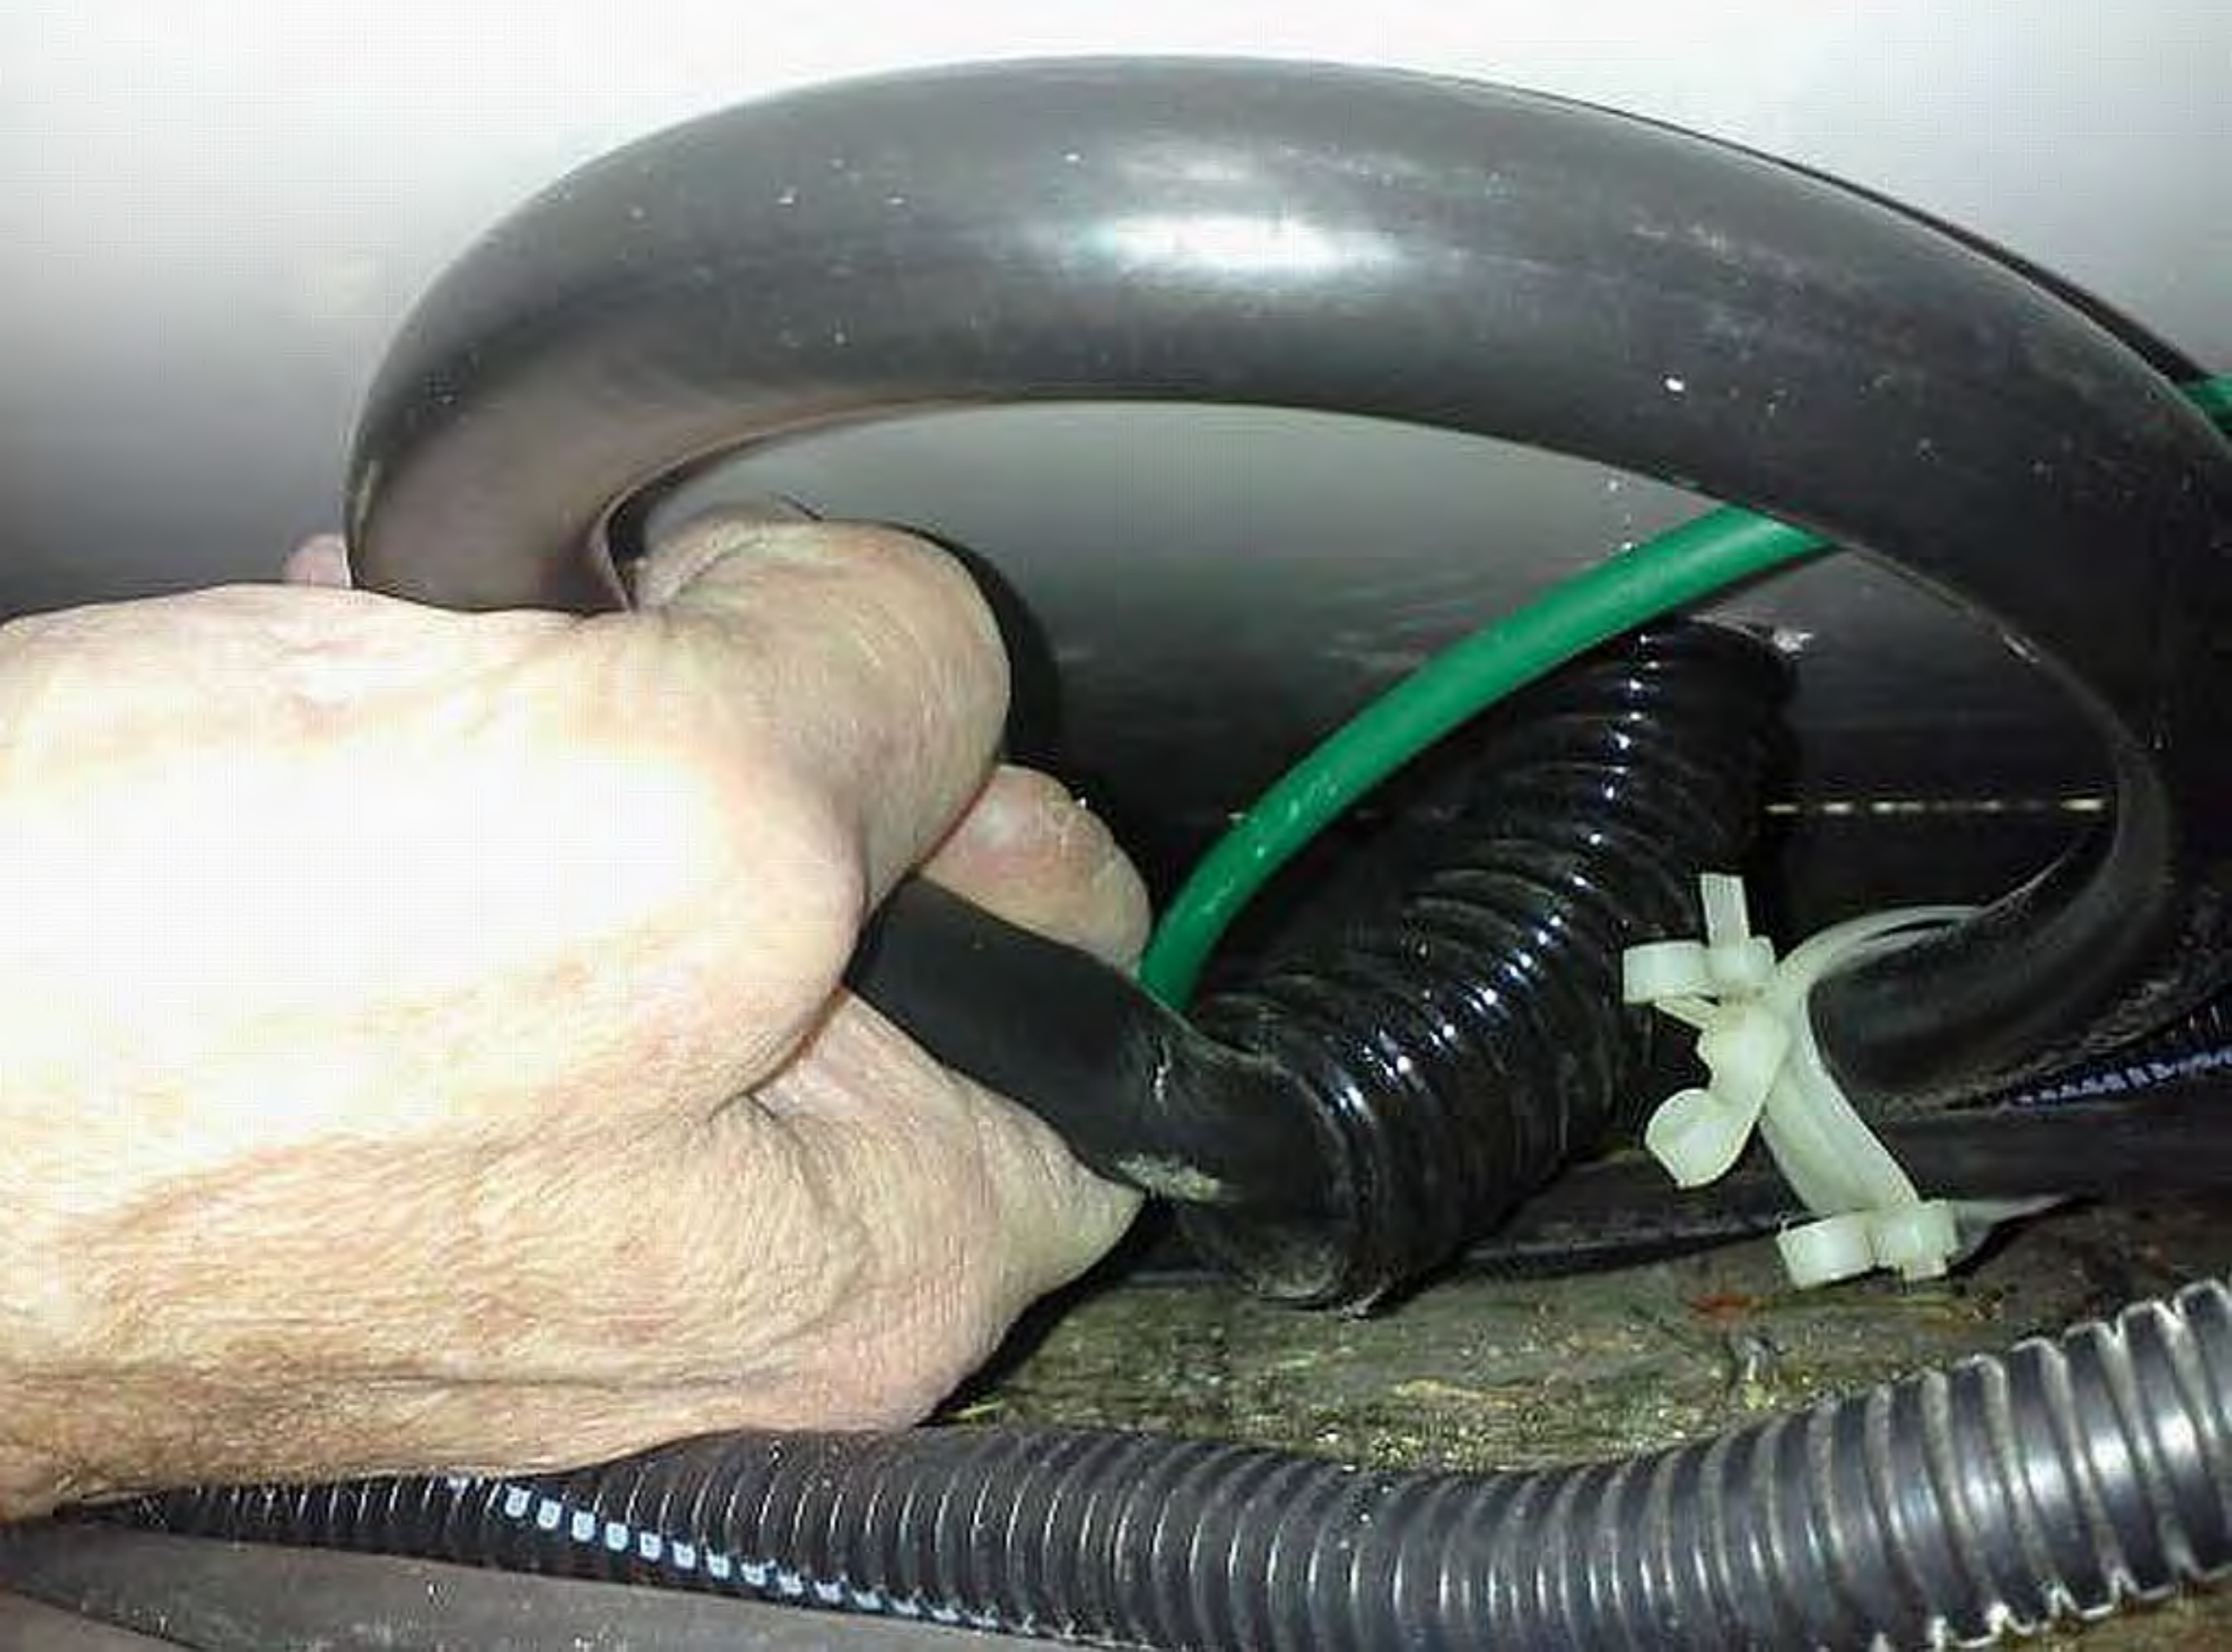
THIS PICTURE TAKEN BENEATH SLIDE-OUT FLOOR. CRACK IN HOSE IS WHERE THE 180 DEGREE FOLD FLEXES DURING SLIDE'S IN AND OUT ACTION OCCURS.
