Re: Toyota Prius Steering, Upper Intermediate Extension Shaft #2, Manufacturing Defect  
w/resp/to Recall 12V-537 (Lower Intermediate Extension Shaft #1, Manufacturing Defect)

Vehicle: [REDACTED] Subject Vehicle 2005 Toyota Prius  
VIN: JTDKB20U953 [REDACTED] MfgDt 10/04  
Issue: Alleged Steering Malfunction

05Prius  
Data & Analysis, Steering Failure

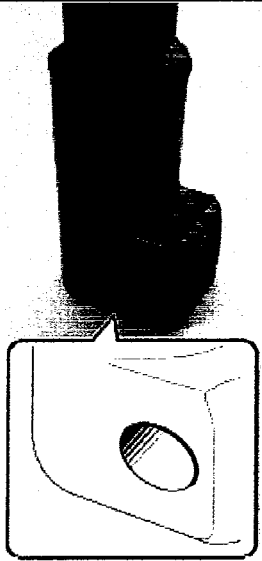
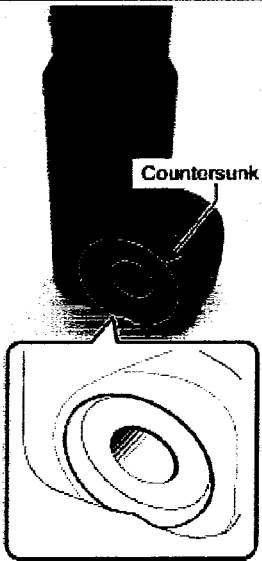
All extension shafts have a noncountersunk bolt hole if seen from the opposite side.  
Be sure to inspect from the side the bolt head seats to (no threads).

| | NO Countersunk | Countersunk |

| | NO Countersunk | Countersunk |
|---|---|---|
| Action Required | <b>OK</b><br>Replace the extension shaft bolt ONLY. Proceed to SECTION VII. EXTENSION SHAFT & BOLT REPLACEMENT. Complete STEPS 24-28 and 36-37. | <b>NG</b><br>Replace the extension shaft and 3 bolts. Proceed to SECTION VII. EXTENSION SHAFT & BOLT REPLACEMENT |

NOTE: The new shaft in the kit (04001-41212) is manufactured with a countersink. DO NOT mix the old and new shaft.

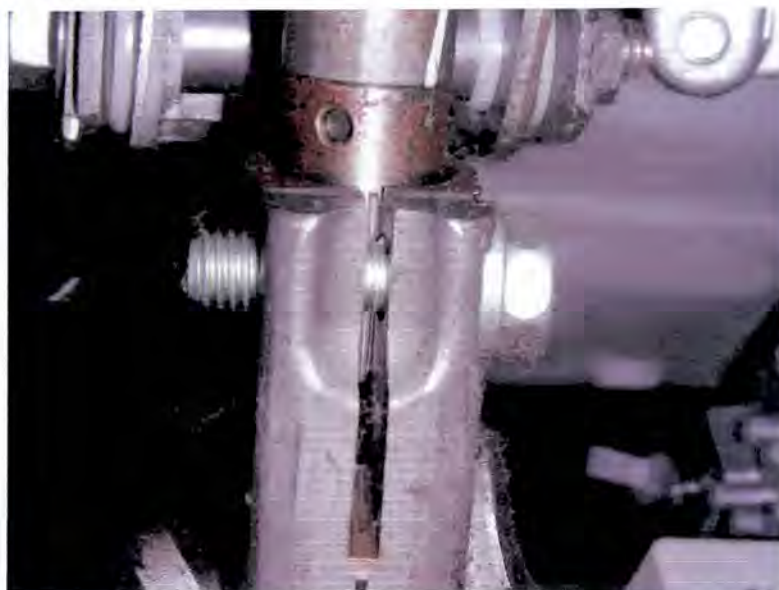
Exhibit 12 A photo sequence showing that exemplar vehicle and its upper intermediate steering shaft #2 assembly on the exemplar power assist exit spline annulus. These photos clearly show, with no ambiguity, that a proper installation includes the cinching bolt properly residing in the power assist exit spline annulus.
