**MULTIDISCIPLINARY ACCIDENT INVESTIGATION TEAM NARRATIVE/DIAGRAM**

**SL-42-12**

## MAIT SUPPLEMENTAL

This investigation was conducted by the California Highway Patrol (CHP) Southern Division Multidisciplinary Accident Investigation Team (MAIT).

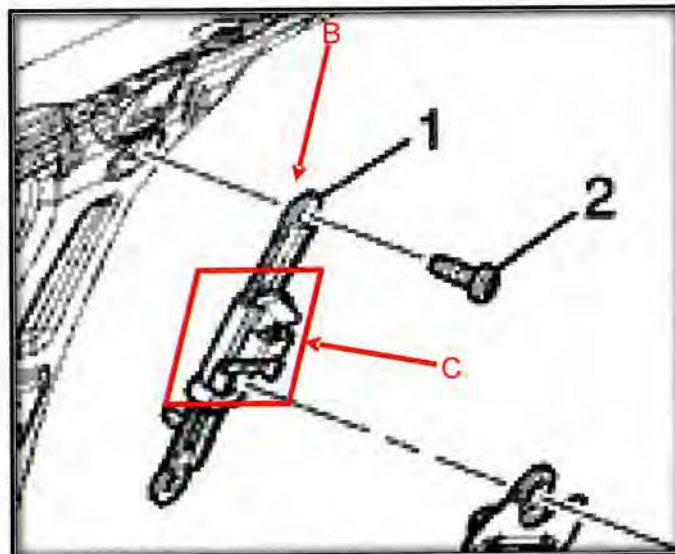
**Figure 2:** Parts diagram, close up

The parts diagram in Figure 1, describes Item 1 as an "Adjuster/shoulder belt/Guide." Item 1 consisted of a track section which was mounted to the B-pillar structure of the vehicle (Figure 2, Item B) and a locking mechanism which slid along the track section to allow adjustment of the guide loop height (Figure 2, Item C). For the purposes of this report, the track section (Figure 2, Item B) will be referred to as the Guide Loop Track. The component depicted in Figure 2, Item C will be referred to as the Guide Loop Adjustment Mechanism.
