**Vehicle Owner's Questionnaire**  
**To Report Vehicle Safety Defects**  
**1-888-DASH-2-DOT**  
**(1-888-327-4236)**  
**INTERNET: www.nhtsa.dot.gov/hotline**

3N1BC13E68L Make  
NISSANModel  
VERSAModel Year  
2008

**From:** [REDACTED]  
**To:** [Chan, Steve \(NHTSA\)](#)  
**Subject:** Re: Your report to NHTSA (ODI #10610795); Ref: 2008 Nissan Versa Airbag Inadvertent deployment  
**Date:** Wednesday, November 19, 2014 7:37:15 PM

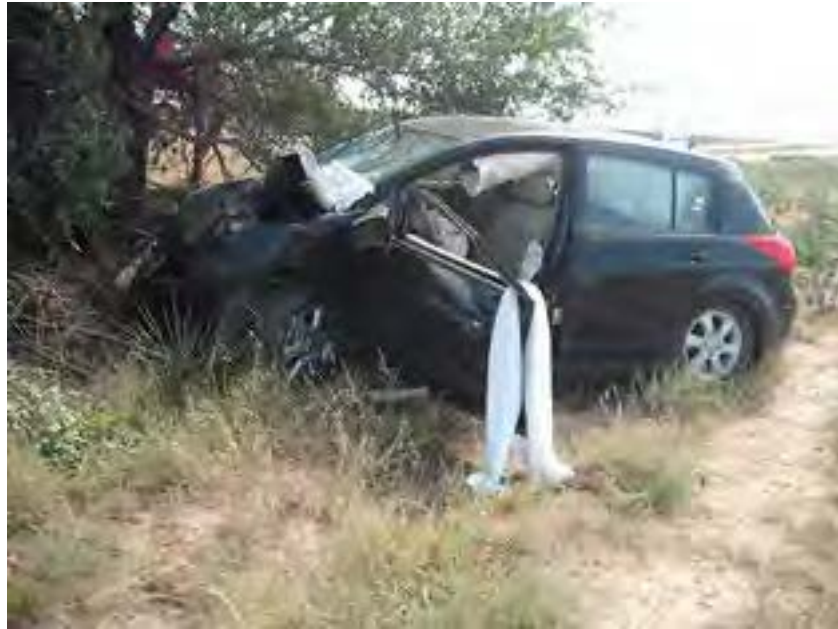
**PHOTO #1**

PHOTO DEPICTING UNIT 1'S LEFT SIDE

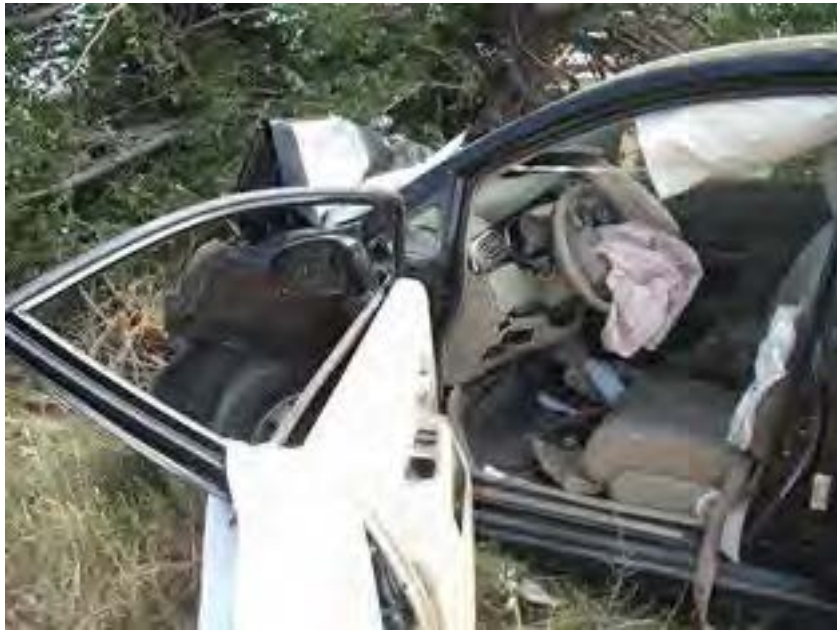
**PHOTO #11**

PHOTO OF UNIT 1 DEPICTING UNIT 1'S INTERIOR

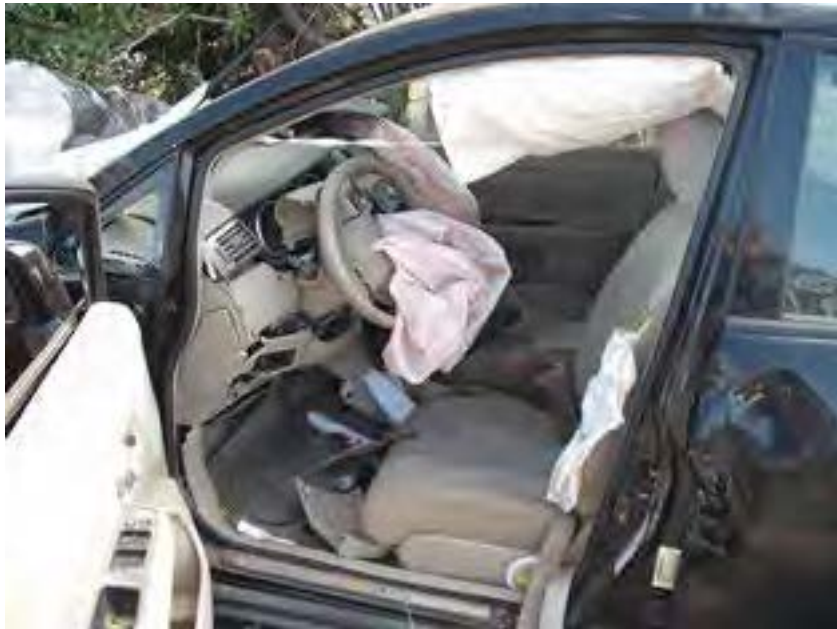
**PHOTO #13**

PHOTO OF UNIT 1 DEPICTING SIDE AIR BAG DEPLOYMENT & CUT SAFETY BELT

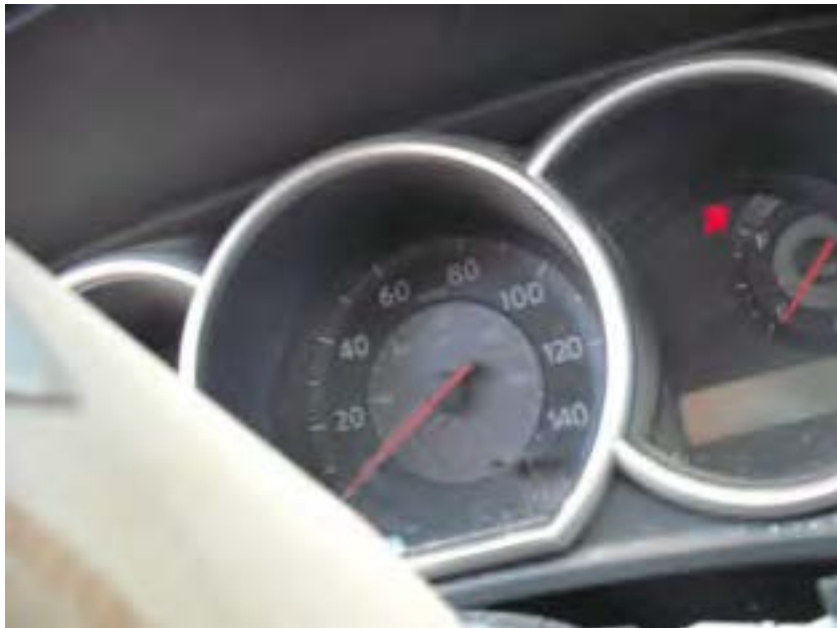
**PHOTO #18**

PHOTO OF UNIT 1'S INSTRUMENT PANEL DEPICTING NO POWER & LACK OF SPEED INDICATION

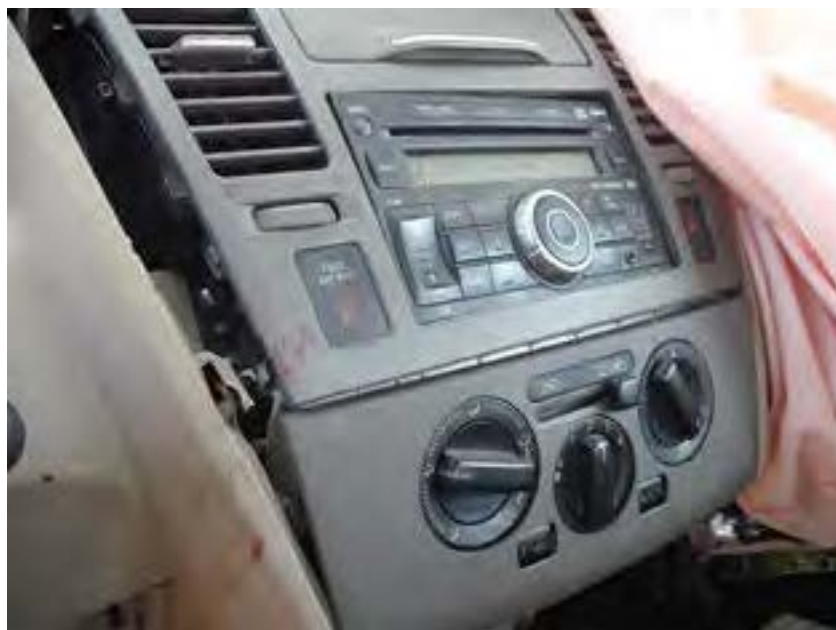
**PHOTO #19**

PHOTO OF UNIT 1'S RADIO / TEMPERATURE CONTROLS DEPICTING LOSS OF POWER & HEATING / COOLING LEVELS

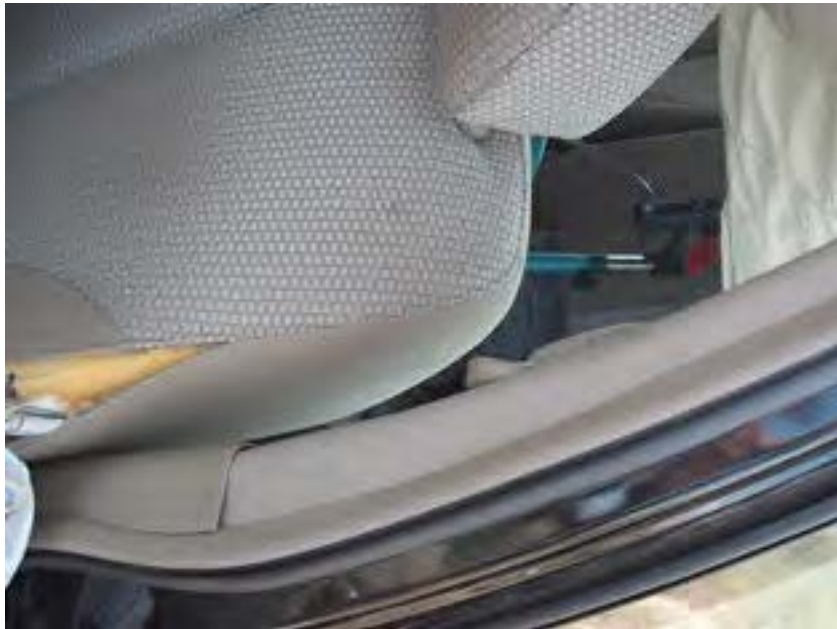
**PHOTO #23**

PHOTO OF UNIT 1'S DRIVER SIDE SEAT BELT ANCHOR

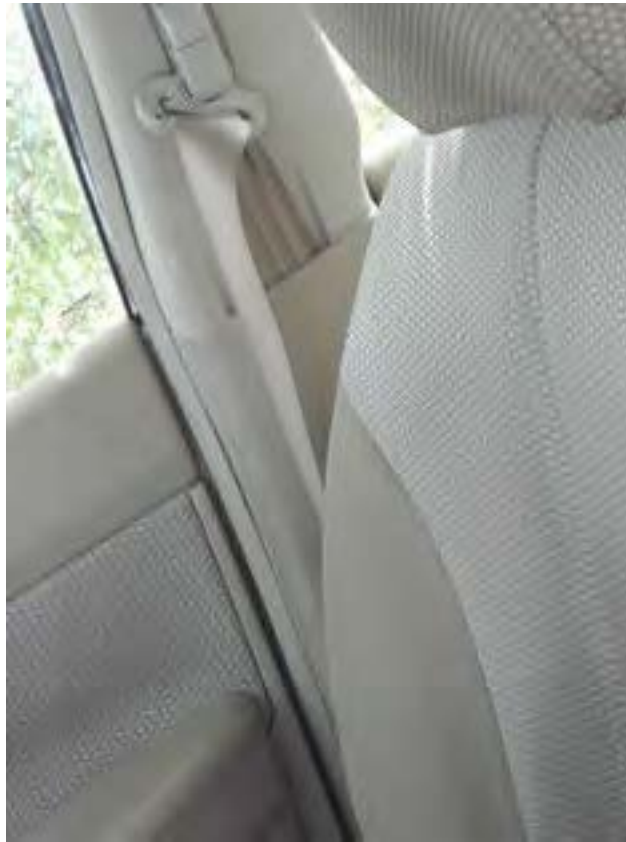
**PHOTO #25**

PHOTO OF UNIT 1'S PASSENGER SIDE SAFETY BELT & ANCHOR

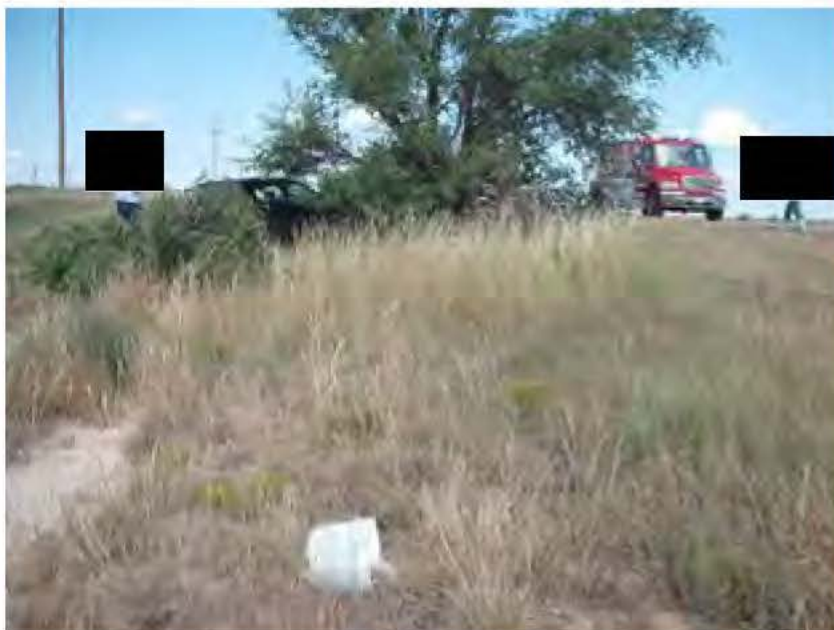
**PHOTO #36**

PHOTO OF UNIT 1'S WINDSHIELD WASHER SYSTEM RESERVOIR DEPICTING ITS PLACEMENT IN REFERENCE TO UNIT 1

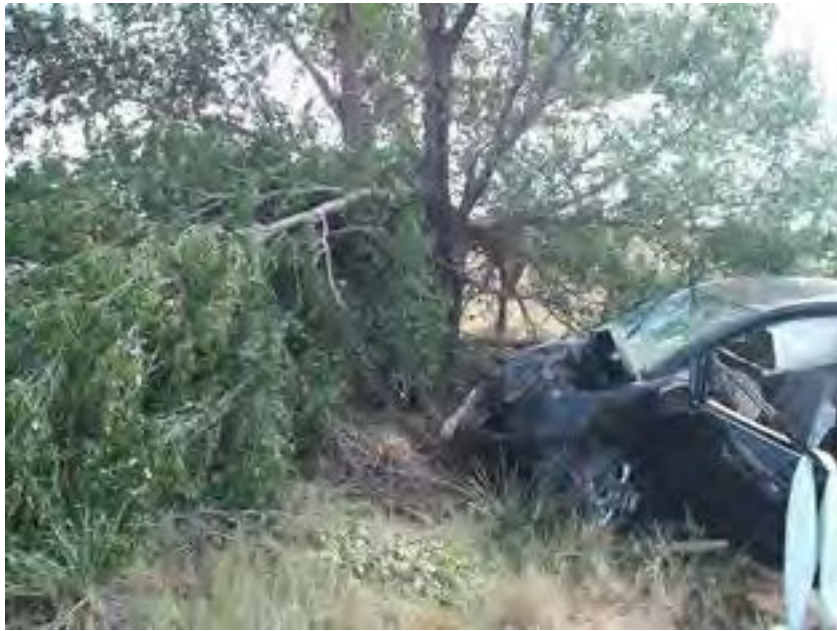
**PHOTO #37**

PHOTO OF UNIT 1 DEPICTING ITS POSITION IN RELATIONSHIP TO THE TREE IT STRUCK

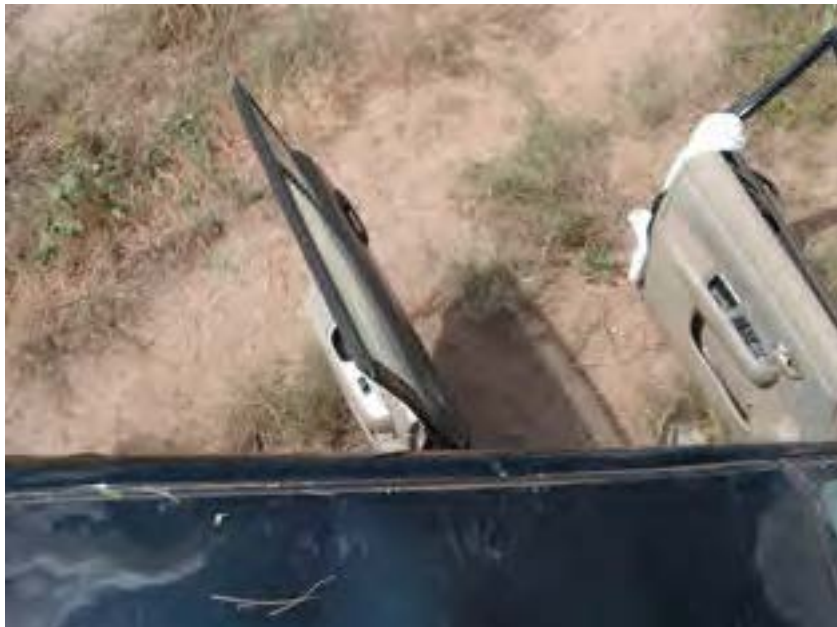
**PHOTO #44**

TOP VIEW OF UNIT 1'S DRIVER SIDE AREA

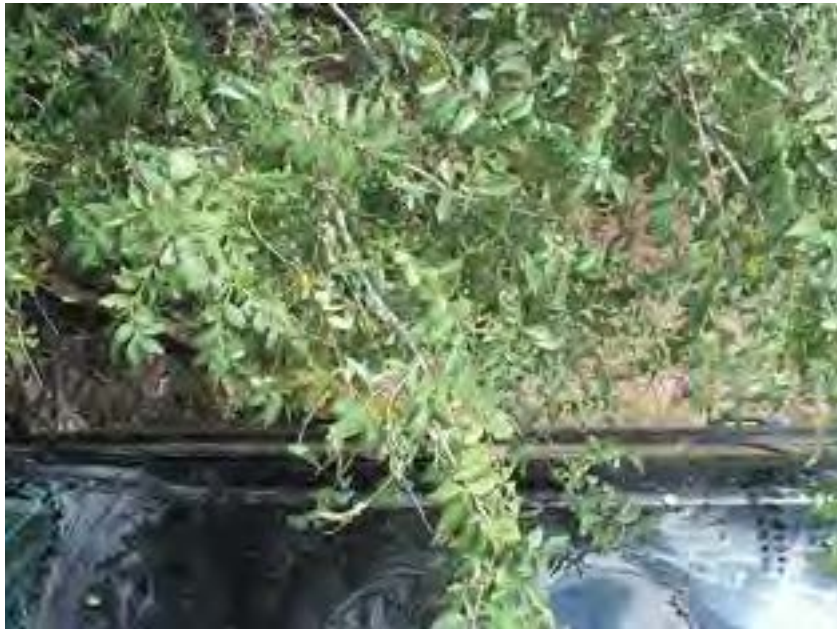
**PHOTO #45**

TOP VIEW OF UNIT 1'S PASSENGER SIDE AREA

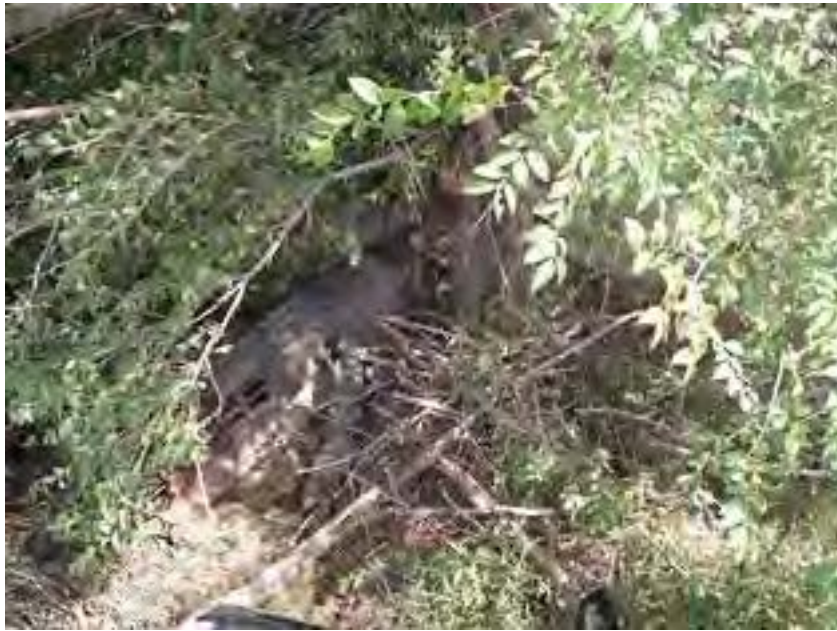
**PHOTO #49**

TOP VIEW OF UNIT 1 IN REFERENCE TO IT LOCATION TO THE TREE

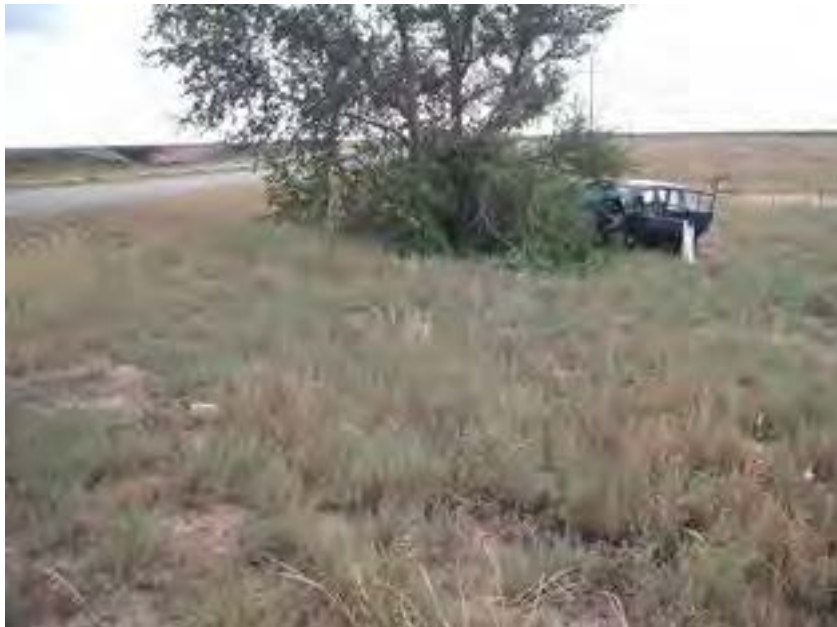
**PHOTO #64**

PHOTO OF UNIT 1, LOOKING EAST, DEPICTING AREA OF IMPACT AND EVIDENCE OF VEHICLE TRAVEL

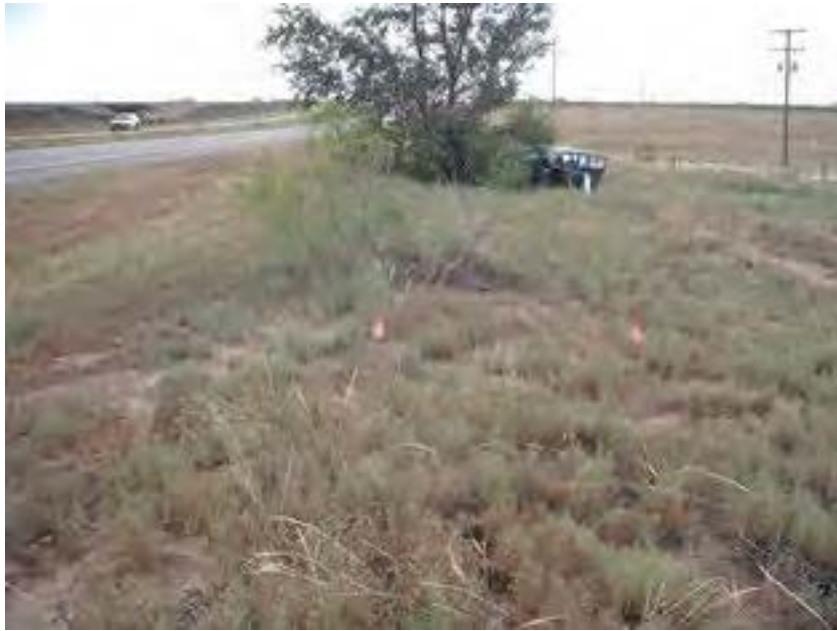
**PHOTO #65**

PHOTO OF UNIT 1, LOOKING EAST, DEPICTING PATH OF VEHICLE TRAVEL

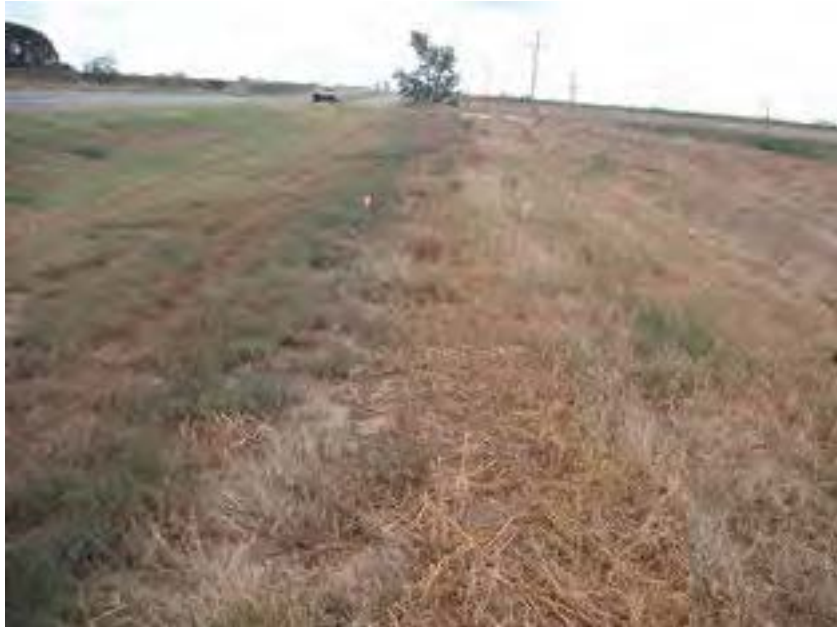
**PHOTO #69**

VIEW OF UNIT 1'S ROLLING TIRE INDICATION AND PATH OF VEHICLE

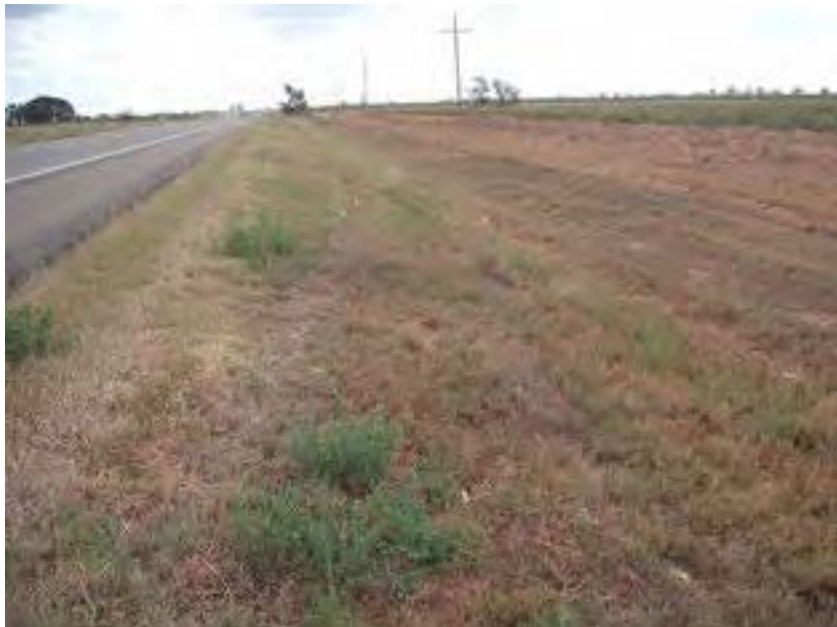
**PHOTO #76**

VIEW OF UNIT 1'S ROLLING TIRE INDICATION AS IT TRAVELS OFF OF THE ROADWAY AND INTO THE SOUTH DITCH OF U.S. HIGHWAY 84

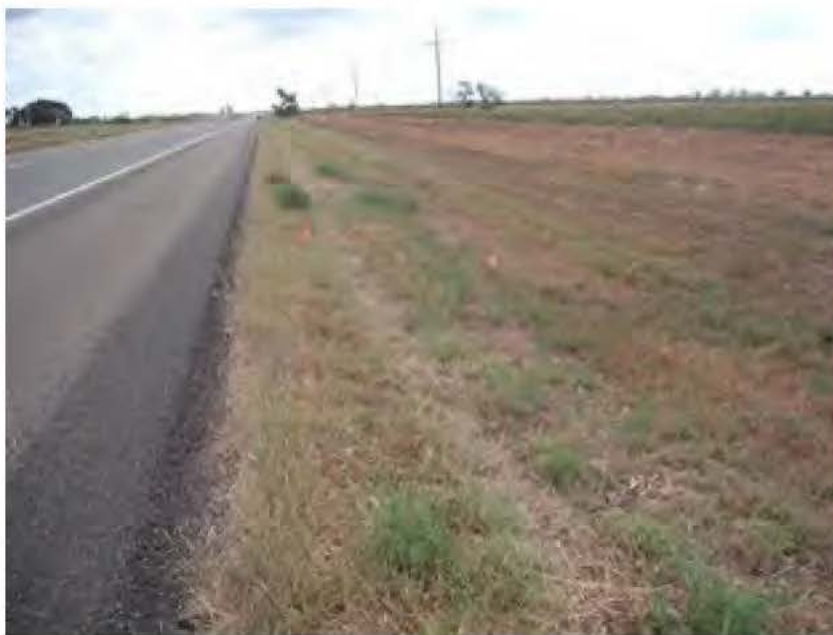
**PHOTO #77**

VIEW OF UNIT 1'S ROLLING TIRE INDICATION AS IT TRAVELS OFF OF THE ROADWAY AND INTO THE SOUTH DITCH OF U.S. HIGHWAY 84

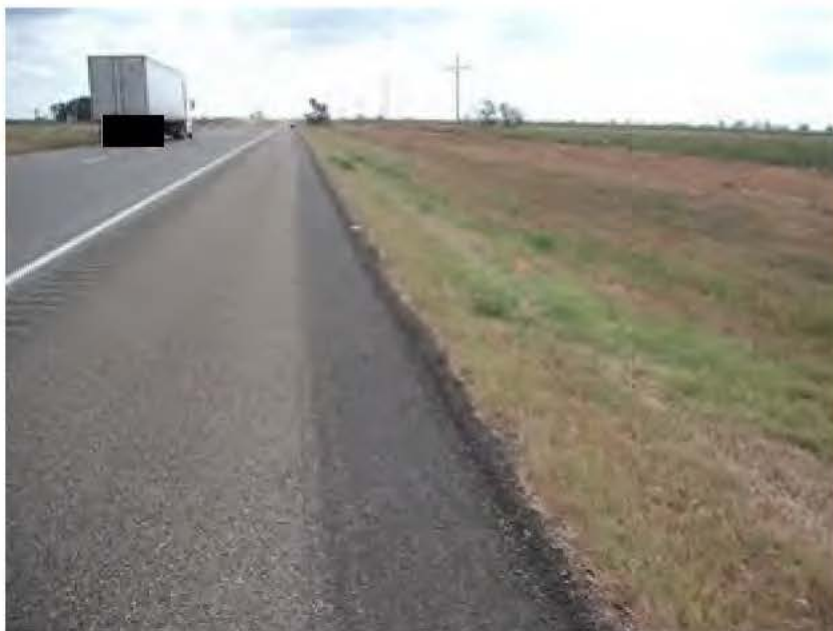
**PHOTO #78**

VIEW OF UNIT 1'S ROLLING TIRE INDICATION AS IT LEAVES THE ROADWAY
