**Vehicle Owner's Questionnaire**  
To Report Vehicle Safety Defects  
1-888-DASH-2-DOT  
(1-888-327-4236)  
INTERNET: www.nhtsa.dot.gov/hotline

# Trust's 2015 Salem Villa

## Another Problem

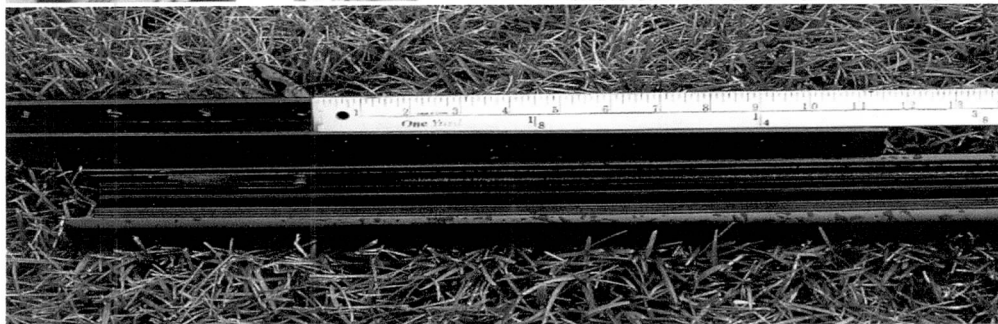
**A "grip rail" runs along the top of the trailer on the door side and holds the awning and canister via the mounting bracket shown below in picture 3. The end of the tarp (awning) is secured to it as well; the canister rolls out as extended.**

**Due to mechanical defect, related herein, TerryTown RV will repair the awning under the extended warranty by getting replacement parts, putting fill in existing holes and drilling new ones. While we are grateful for this, we do not feel safe using it or attaching a sun screen to block the afternoon sun.**
