**Re: status of NHTSA Safety Issue 11012912**

Manufacturer: Forest River, Coachmen

Model: Clipper 9.0 Express. Serial No. 2344

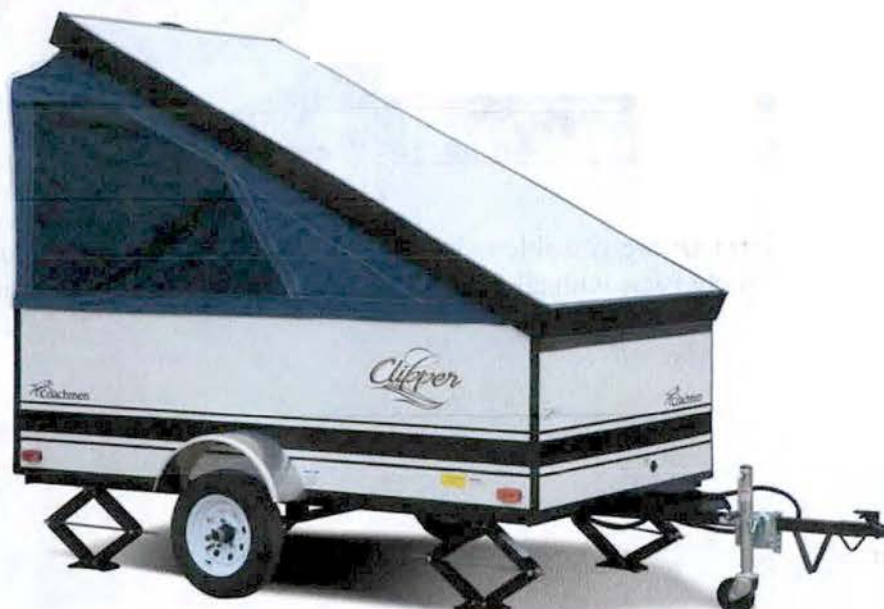
**One of several defects reported to the supplier after delivery late April 2017:**

Following a 5-mile drive to our home along major highways it was noted that a small gauge wood screw at the front right corner, used to attach the upper body to the angle iron chassis, was only partially fastened. Further back two more screws were also not fully in place but to a lesser extent. It was also found that there were no screws across the front of the trailer although a series of holes had been provided for some in the chassis. By hand, the body could easily be lifted clearway from the chassis. **This hazardous condition of vibration so easily loosening from the body from the chassis during operation was promptly reported to the dealer.**

Early May, following contact with the manufacturer, the dealer replaced each small gauge Robertson screw with more substantial hex head stainless steel wood screws and also installed the same where fasteners had been omitted across the front. This seemed to be a logical fix. However, after several miles of travel over rough road works along North Dakota Highway 1804 east of Williston, the replacement chassis-to-body fastening screws also worked loose. In order to maintain adequate road worthiness needed to continue our journey, I removed all loose fasteners – the entire front row and behind these 3 down each side in front of the axle – then replaced them securely after jamming several hard wood slivers into each hole. The screws have since remained in place, but I consider this to be a band-aid solution and not one that all owners can be expected to be aware of or know how to perform during their own travels.

This condition and temporary fix was reported to the dealer June 25, 2017 with the following recommendation: **these trailers need to be recalled and corrected sufficiently to satisfy highway safety codes.**
