DOT Auto Safety Hotline
Vehicle Owner's Questionnaire
To Report Vehicle Safety Defects
1-888-DASH-2-DOT
(1-888-327-4236)
INTERNET: www.nhtsa.dot.gov/hotline

17 digit Vehicle Identification Number Located at bottom of windshield on driver's side: SUXFE435X8[REDACTED]
Make: BMW Model: X5 Model Year: 2008
Date Purchased: 8/23/16 Dealer's Name and Telephone Number: Excellence Auto Direct 214-584-6969 Engine: No: Cylinders: 6 Fuel Type: Premium
Original Owner: Dealer's City: Addison State: TX Zip Code: 75001
Transmission Type: Auto Antilock Brakes Cruise Control Powertrain: V6 3.0L AWD Multiple Failure: Failed engine Incident Date(s): 02-DEC-2017

Vehicle Component Code: 060000 ENGINE (PWS) Failure Mileage: 111778 Failure Speed: 60

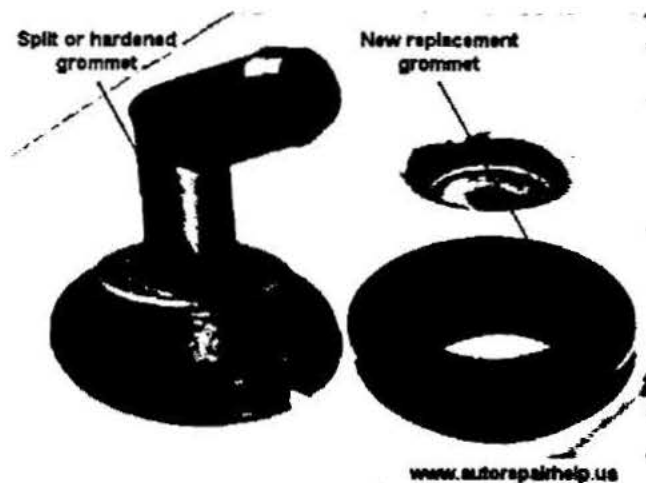
Many problems in the PCV Valve system originate from the hoses and mounting components, rather than the valve itself. A PCV valve attaches to the engine in many ways, depending on the design. Manufacturers often use rubber grommets, inserted into a hole in the valve cover. The pliable rubber grommet seals the valve to the cover and holds it in place. On other designs, the valve may screw in or twist-in and seal with an O-ring. The PCV valve must be completely sealed for maximum benefit, very important! Any leak will cause problems, so always inspect the positive crankcase system closely.

REPLACING THE PCV GROMMET WITH THE VALVE PREVENTS PROBLEMS:

Rubber grommets and O-ring seals get hard over time and cause problems. Grommets sometimes crack and split, creating an oil leak and allowing dirt into the engine. Replacing the grommet or O-ring with the valve prevents many problems. Grommets come in a variety of designs, depending on the engine design. Original equipment manufacturer (OEM) grommets work and fit best. If the PCV valve mounts with a grommet, purchase a new one with the valve.

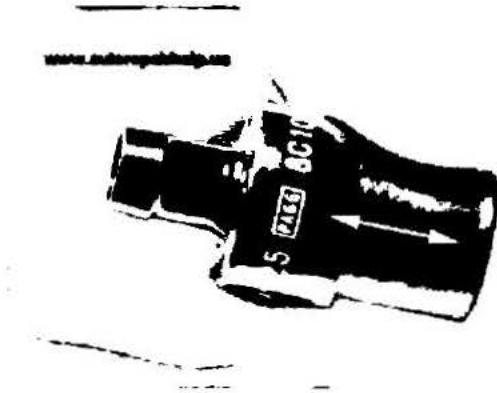
THE RATTLE TEST GIVES AN INDICATION BUT IS NOT CONCLUSIVE:

Because PCV valves fail in different ways, no test will show all the possible problems. For instance, the old test of shaking the valve and listening for a rattle is only partially helpful. No rattle may show a stuck valve, on many designs, but the valve could rattle freely and still be bad. Use Best Practices and change the valve. This little cheap part, if not changed in time, will cost thousands of dollars in engine repairs if not changed at the recommended interval.

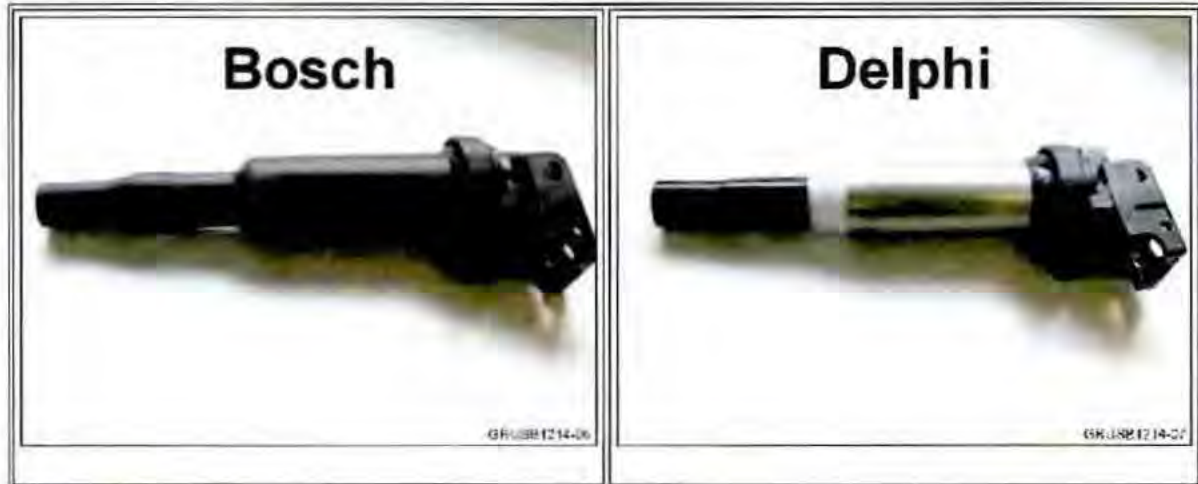
Ignition Coil Identification

- At the first service visit with for an ignition coil failure
- Alternator failure (see [SI B12 12 13](#))
- DME replacement due to a failed Bit Serial Data (BSD) interface circuit

Part Number	Description	Quantity
12 13 8 616 153	Delphi coil	Up to 6
