I am writing to create an awareness of possible safety defects in design and/or construction of a MOTORHOME (also called an "RV" for brevity).

2017 Fleetwood Pace Arrow  
Model 33D  
VIN 4UZAAJDT9HC [REDACTED]  
Purchased NEW, April 2017 from a local authorized dealer

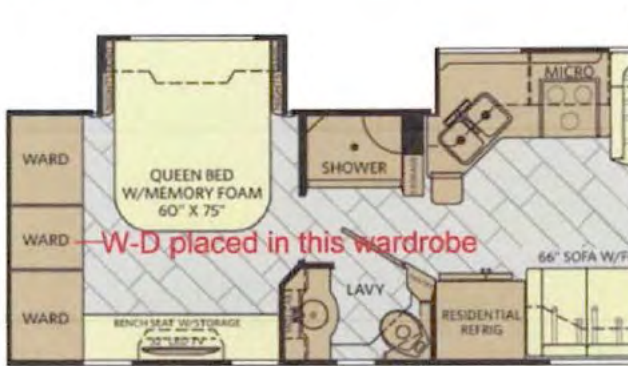
The WD sat on a shelf over 2 feet above the floor in the very back of the RV. The "shelf" is the bottom of the center "wardrobe" cabinet. Please see a copy of the manufacture's sales brochure included here as photo FP-1 (floor plan - 1). I discovered 2 issues.
