Reference #: 11206504.

2014-mercedes-benz C350W - Column Mounted - Controls

PHOTOGRAPHS - SERIES 3:

INTERIOR OF MERCEDES-BENZ C300W - 2019-MODEL-YEAR.

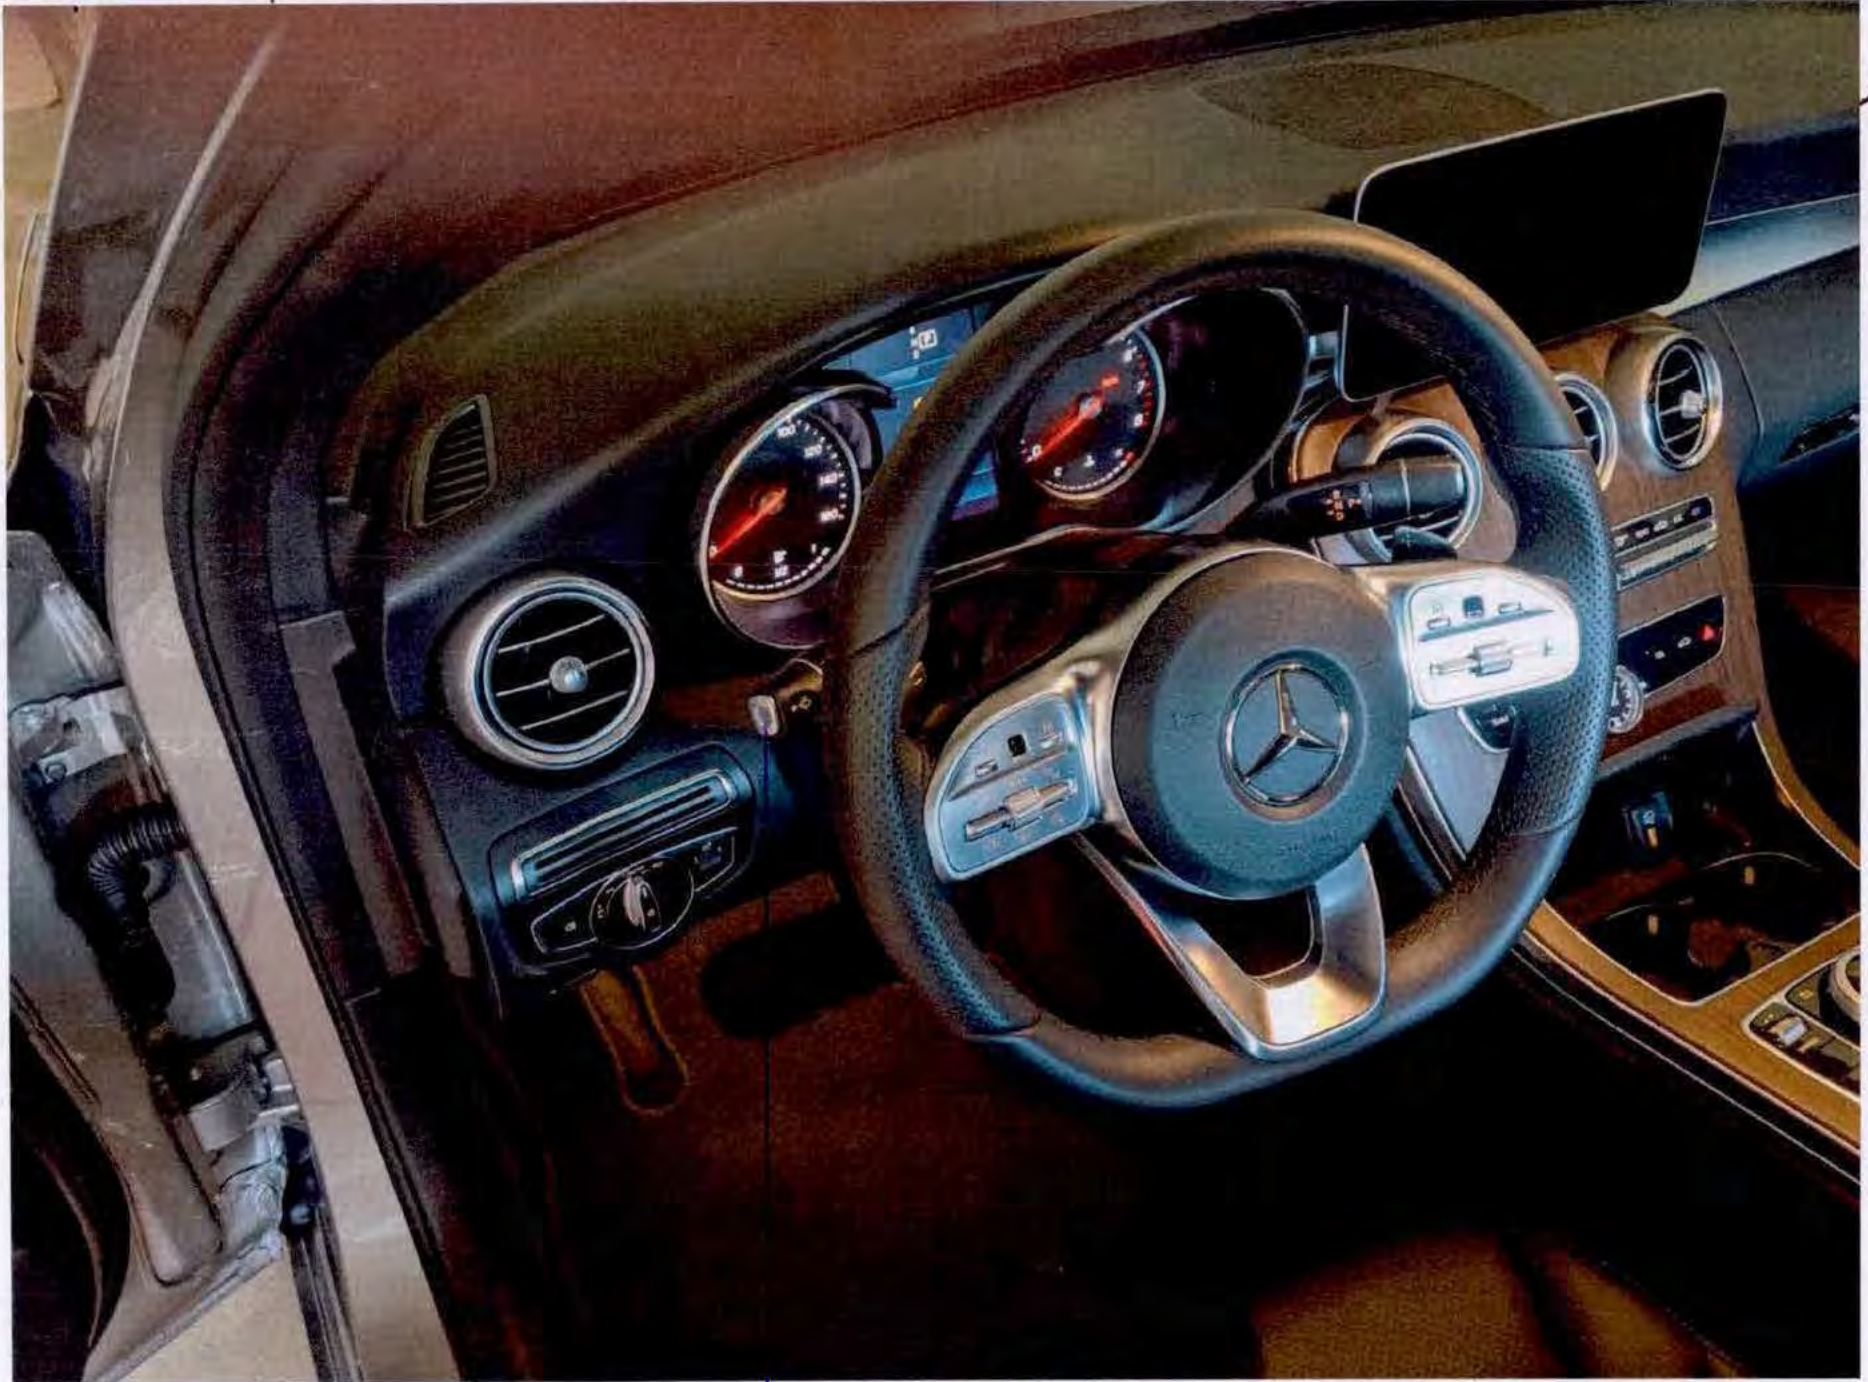
Depicted: 2019-Mercedes-Benz C300W

COCKPIT FROM LEFT ANGLE OF DRIVER'S SEAT.

Just one lever.

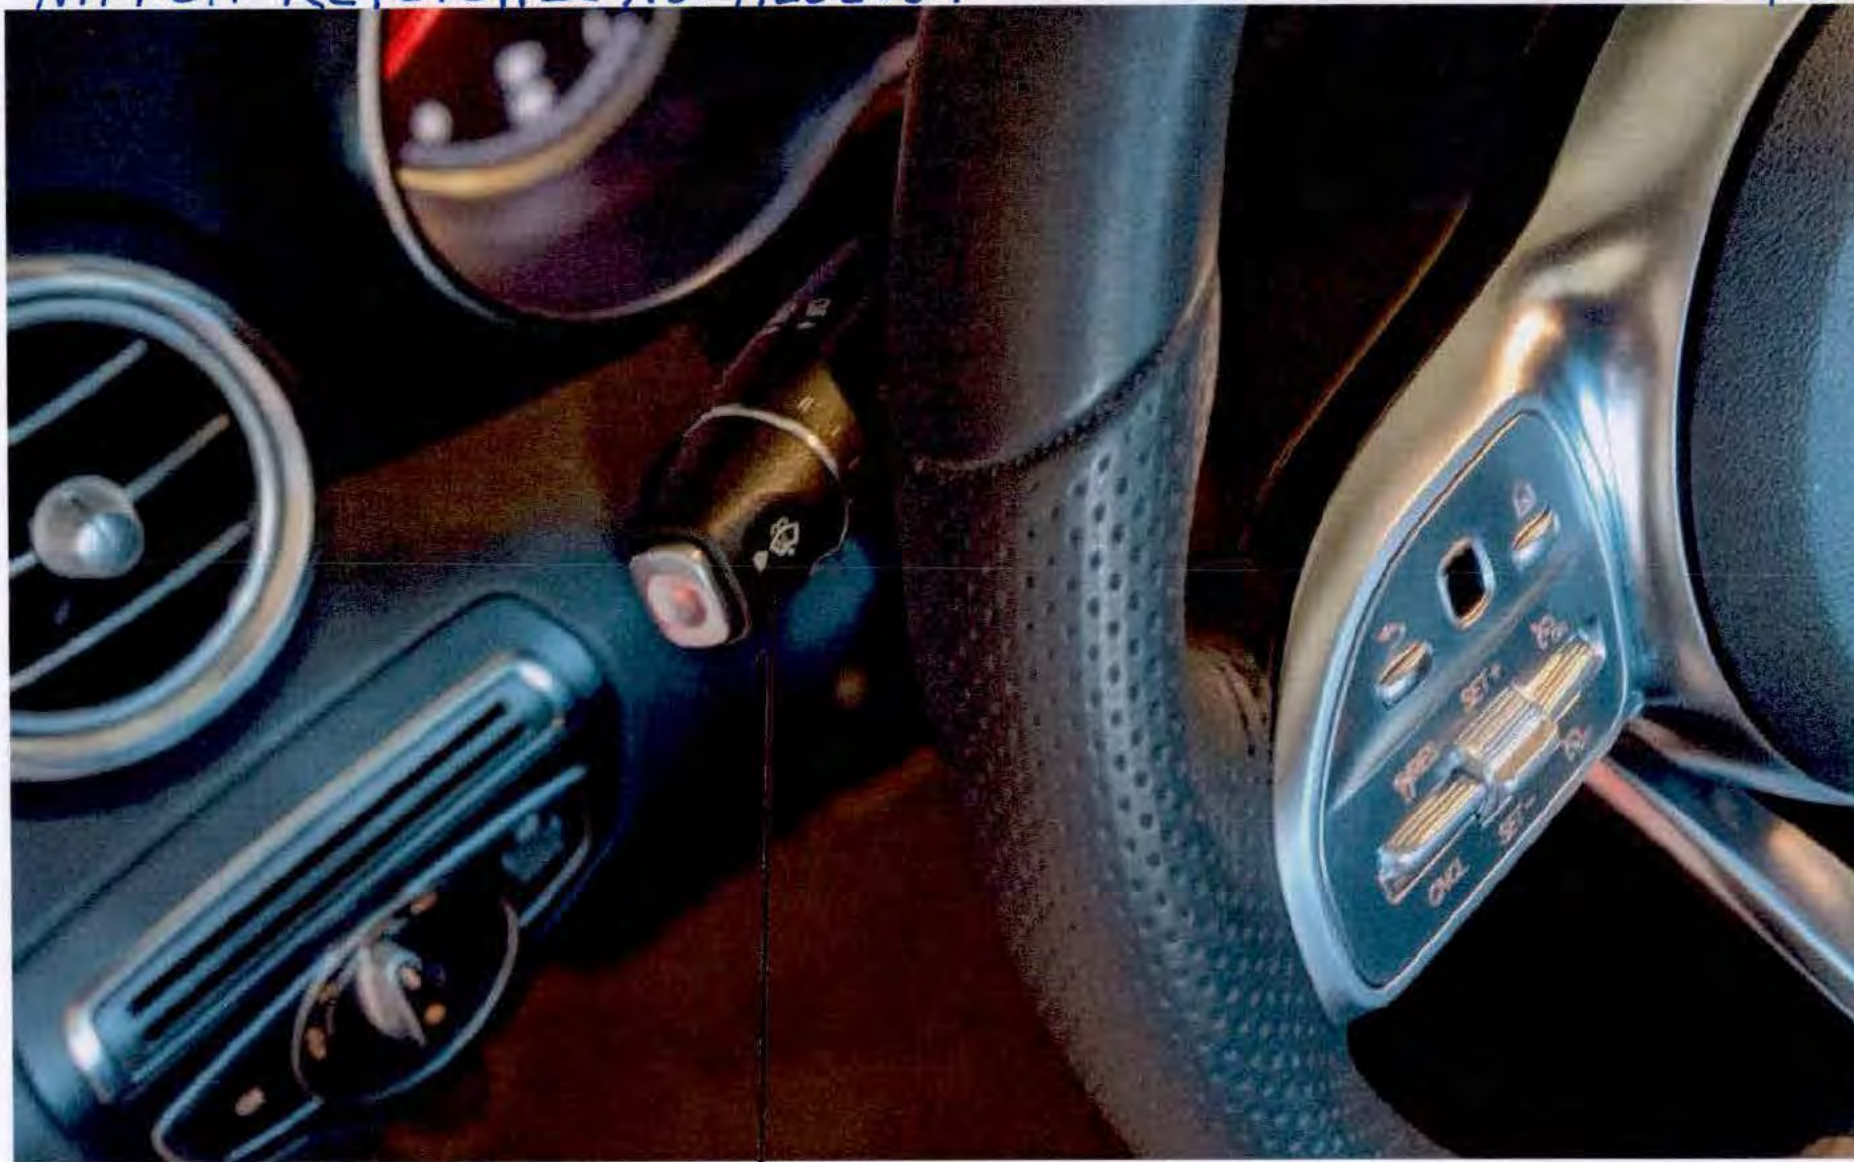
Depicted: 2019-C Class (Compact) M-B

C  
O  
N  
T  
R  
A  
S  
T  
T  
O  
2  
0  
1  
4  
D  
E  
S  
I  
G  
N.

Literally, one lever. "Lever-Confusion: Impossible."

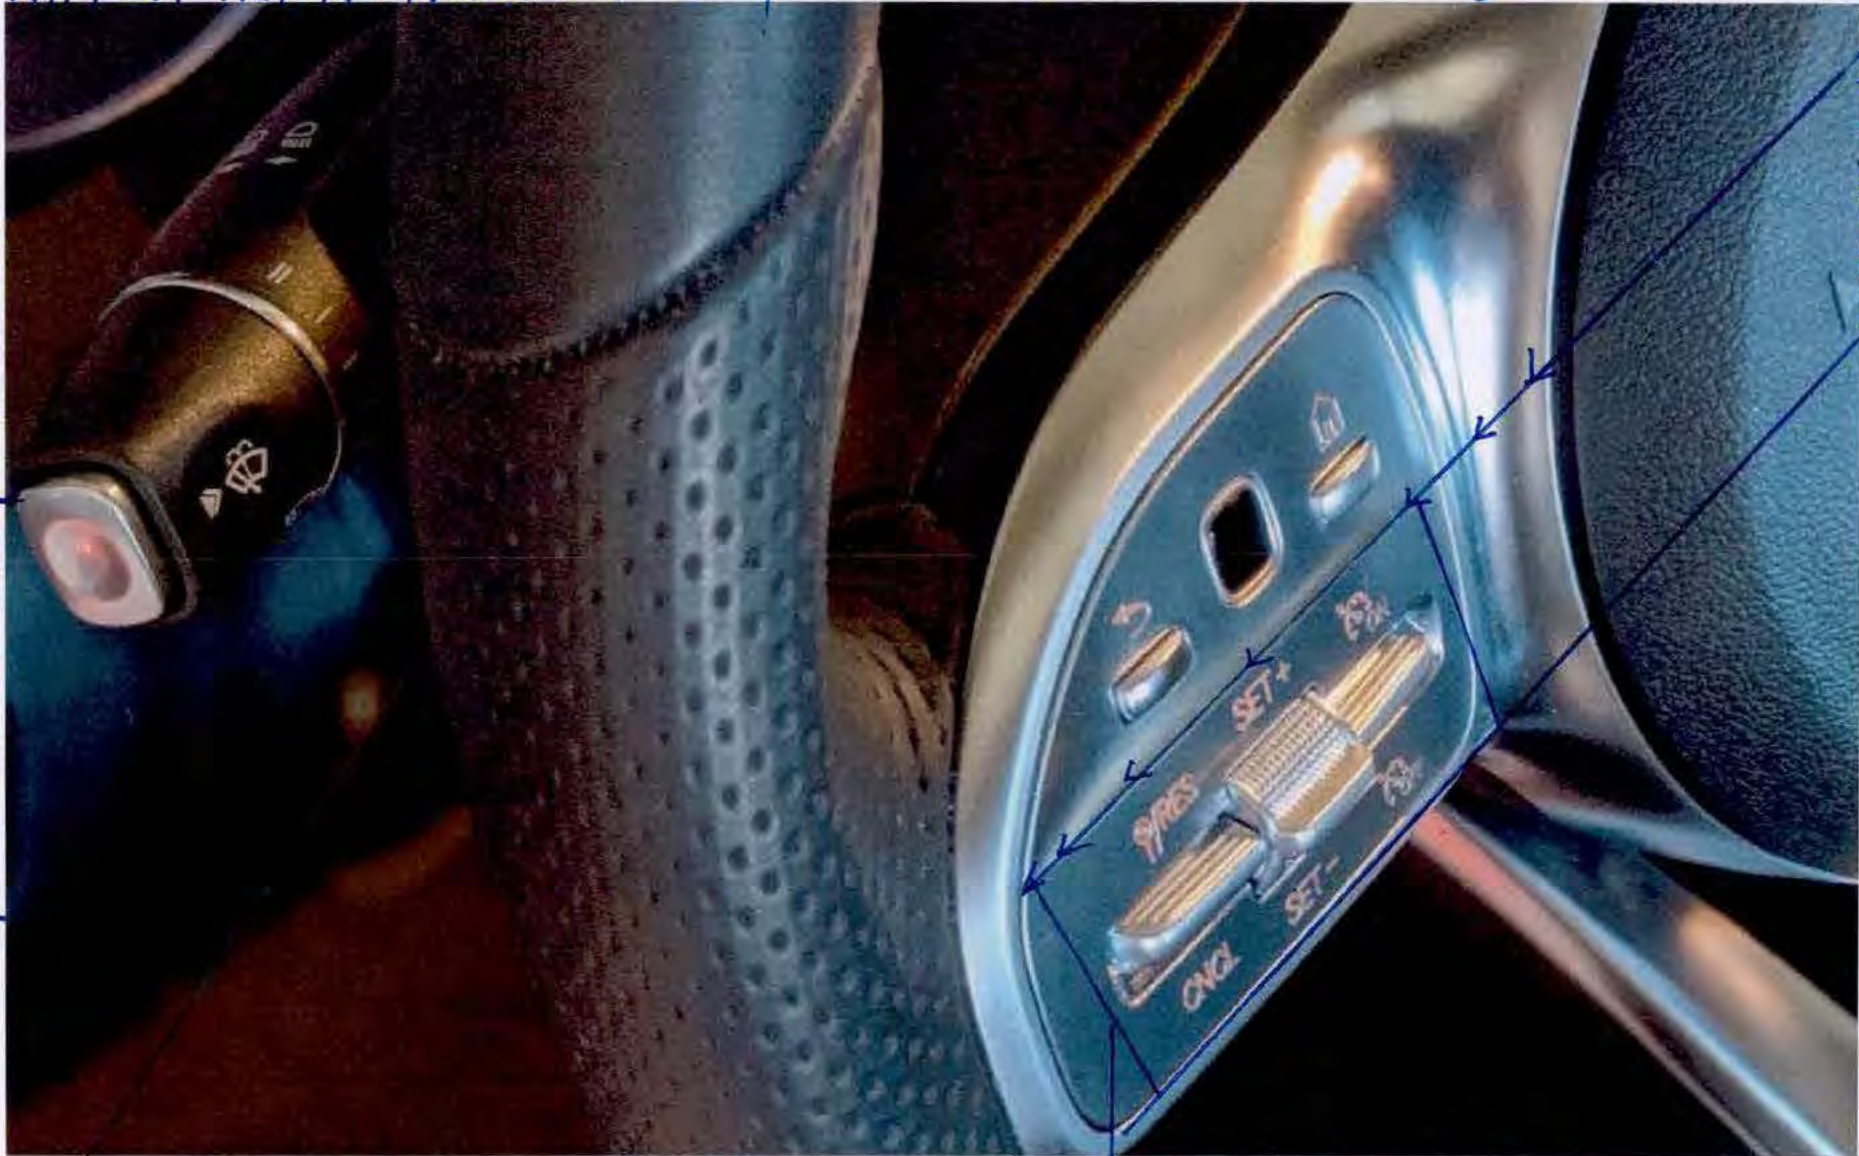
NHTSA-Ref. No. 11206504. Depicted: M-B-C300W-Steering Wheel, & Associated Control switches.

Directional Signal; wipers; Low-high beam lever  
Squirter of water on to windshield

CRUISE-CONTROL  
Switches.

No Cruise-Control lever here. Design ameliorating potential for:

"Lever-Confusion."

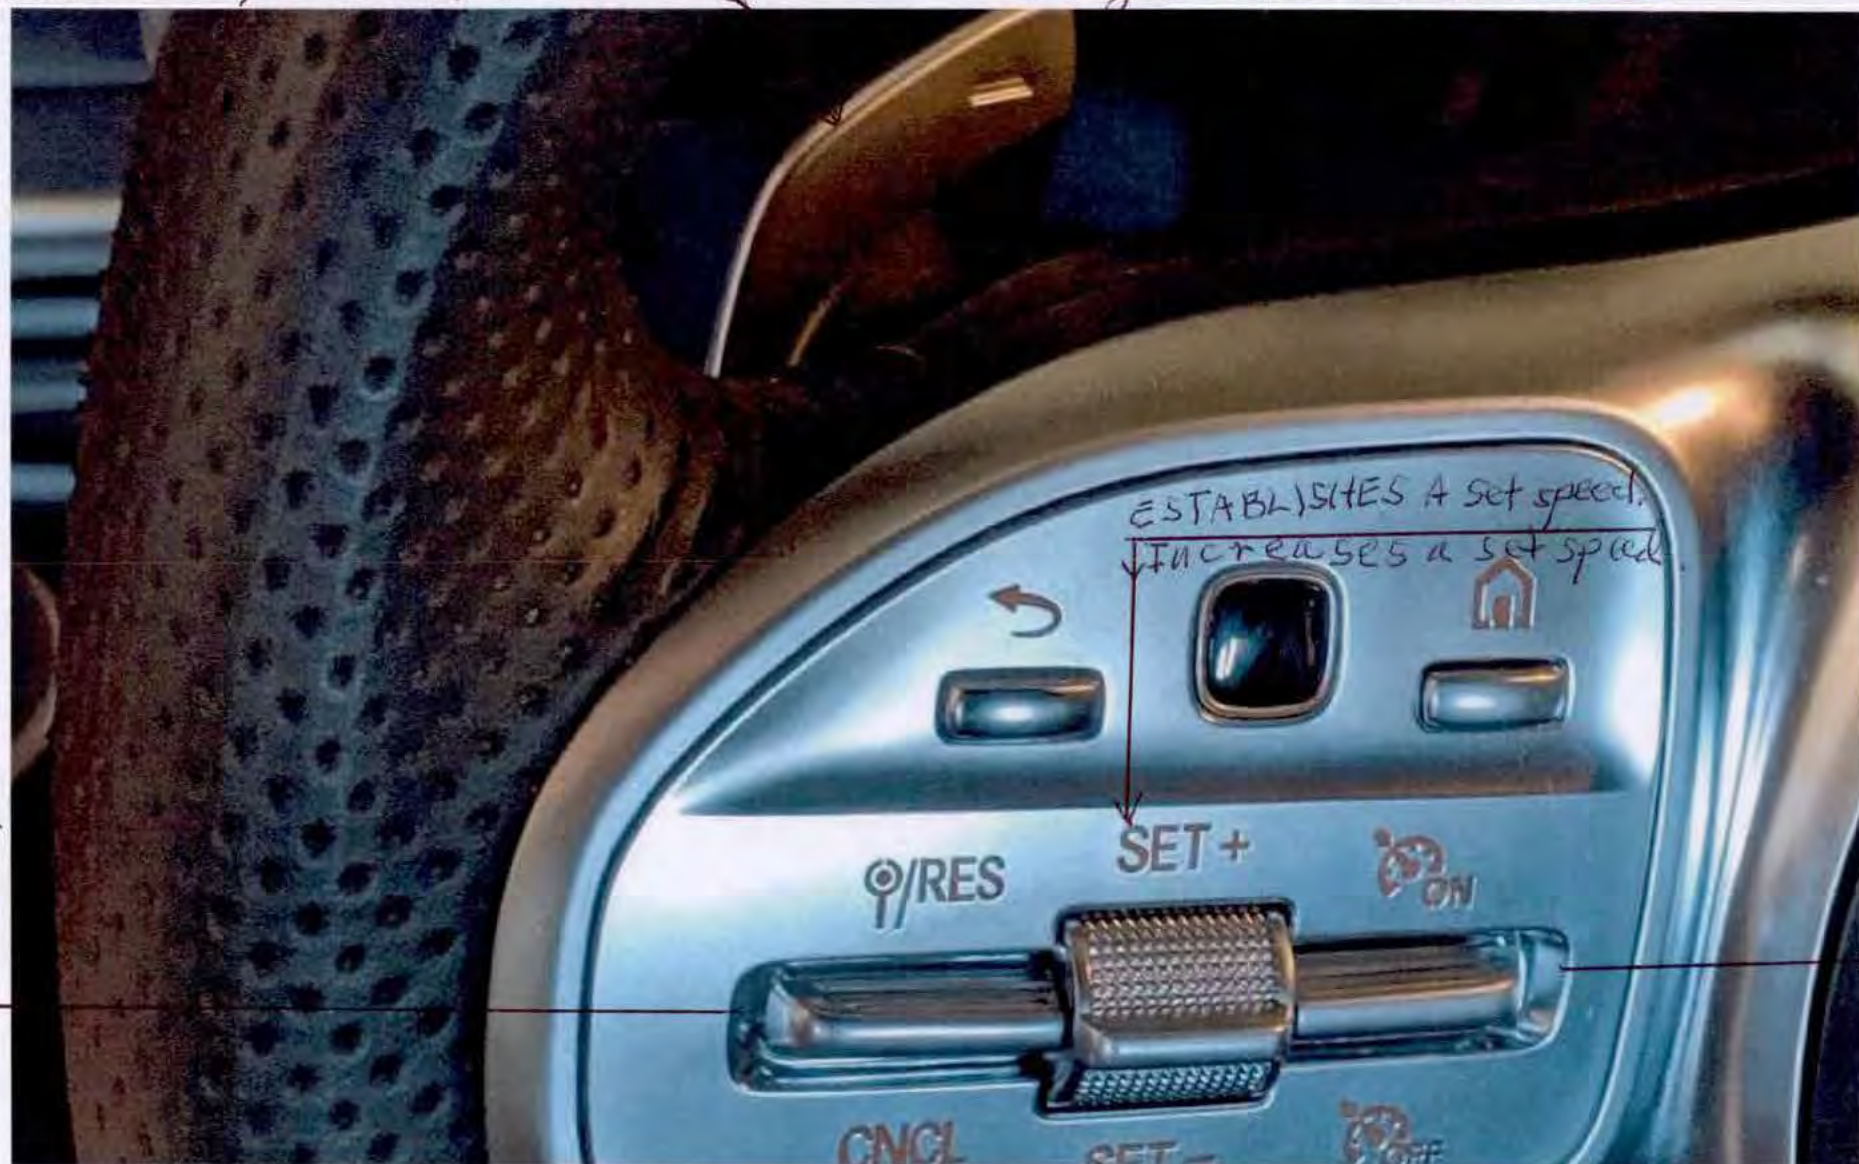
(Zimko road) Turns Cruise-Control "On" (Up-Push) and "Off" (Down-Push); Enables other switches.

Depicted: Blow-up of C300W-Steering wheel-Left Side; Note position of cruise-control buttons. 3 Switches control six function (Driver's "Selections," or, "choices regarding cruise control. When compared with 2011-2016-Year-Models, "lever confusion is impossible.

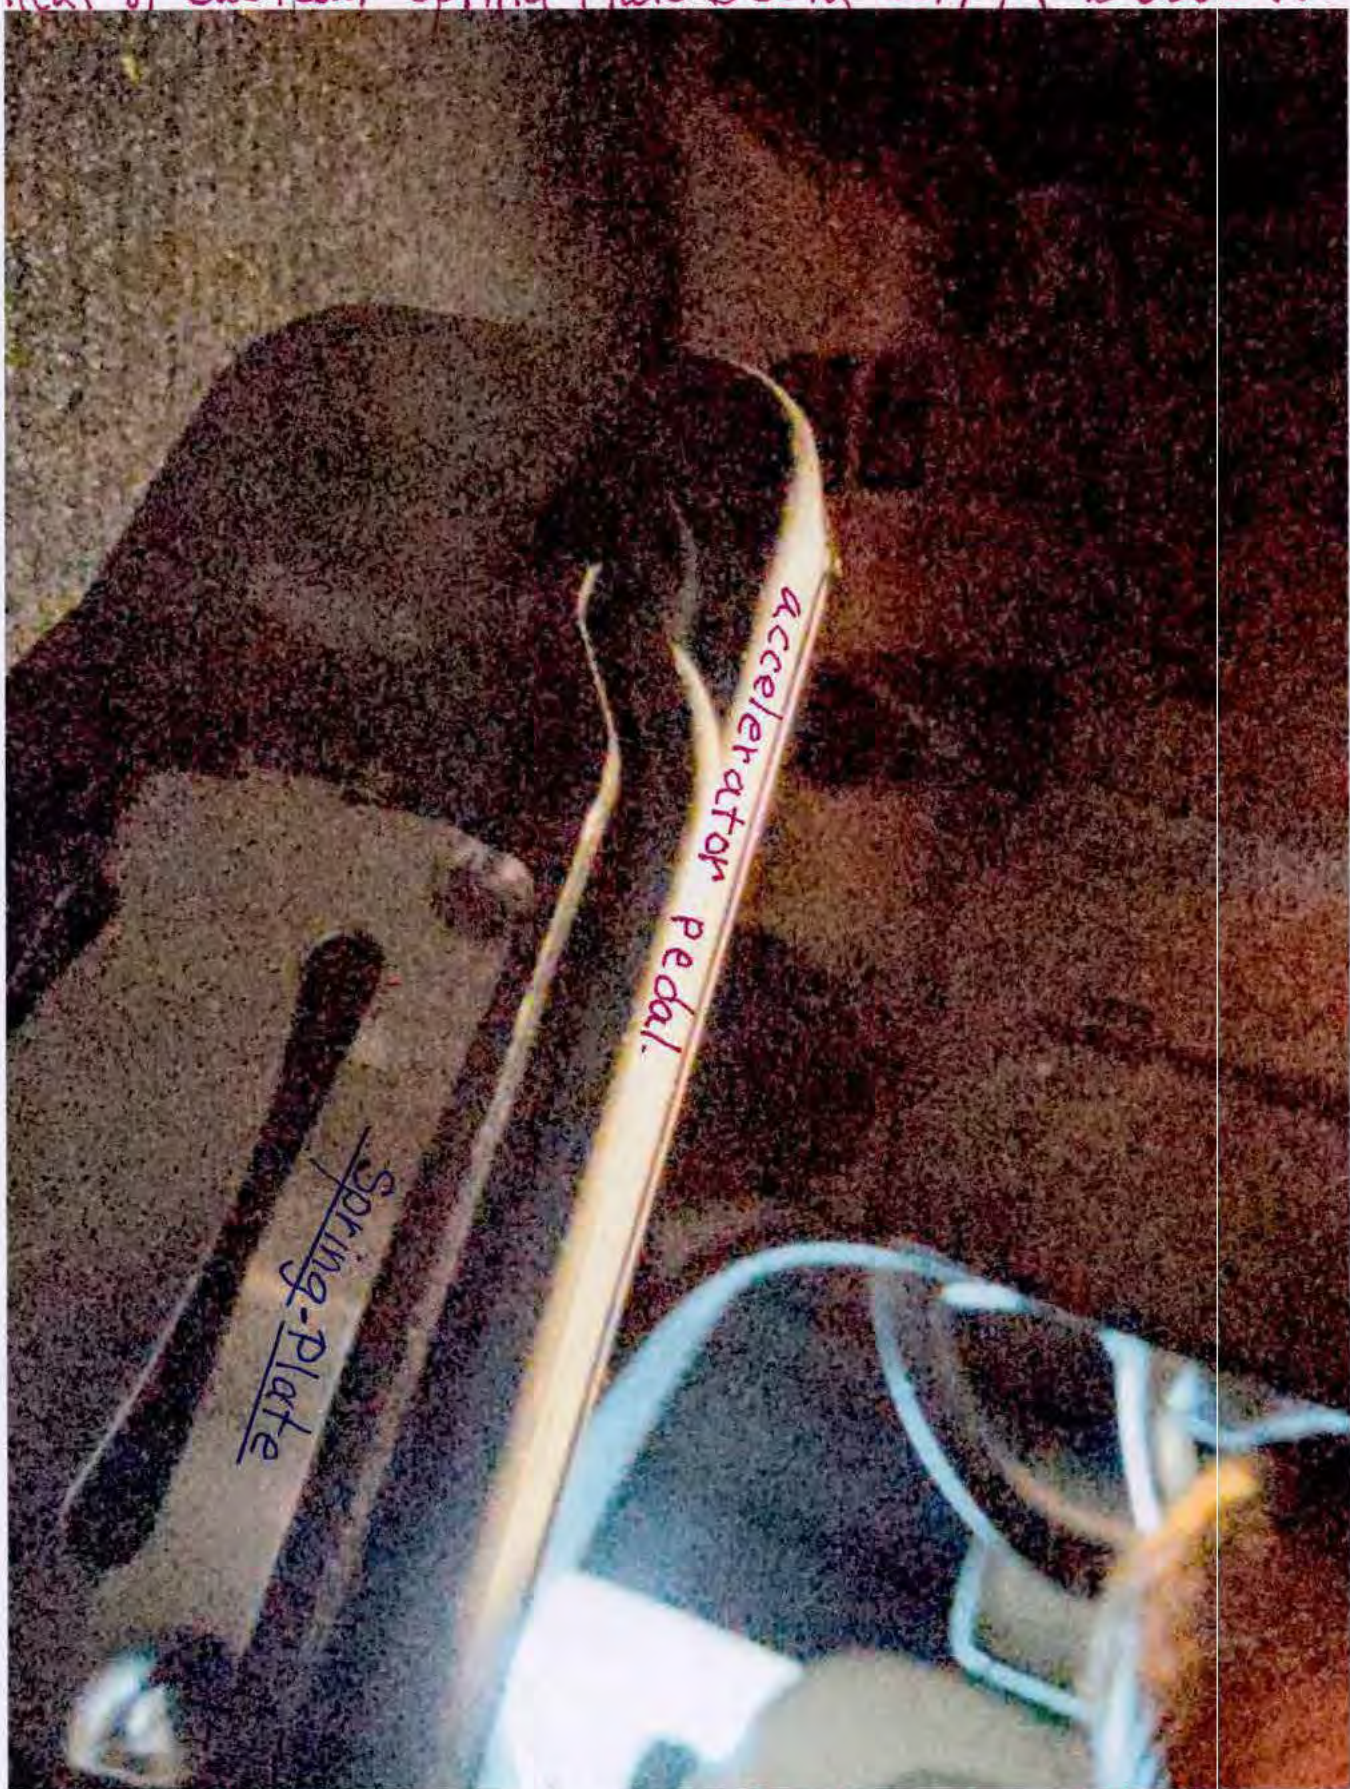
Rear of Gas Pedal-Spring Plate Desia-2019-M-B-C300 W.

DESIGN CHANGE: RESISTANCE TO PIN FOOT.

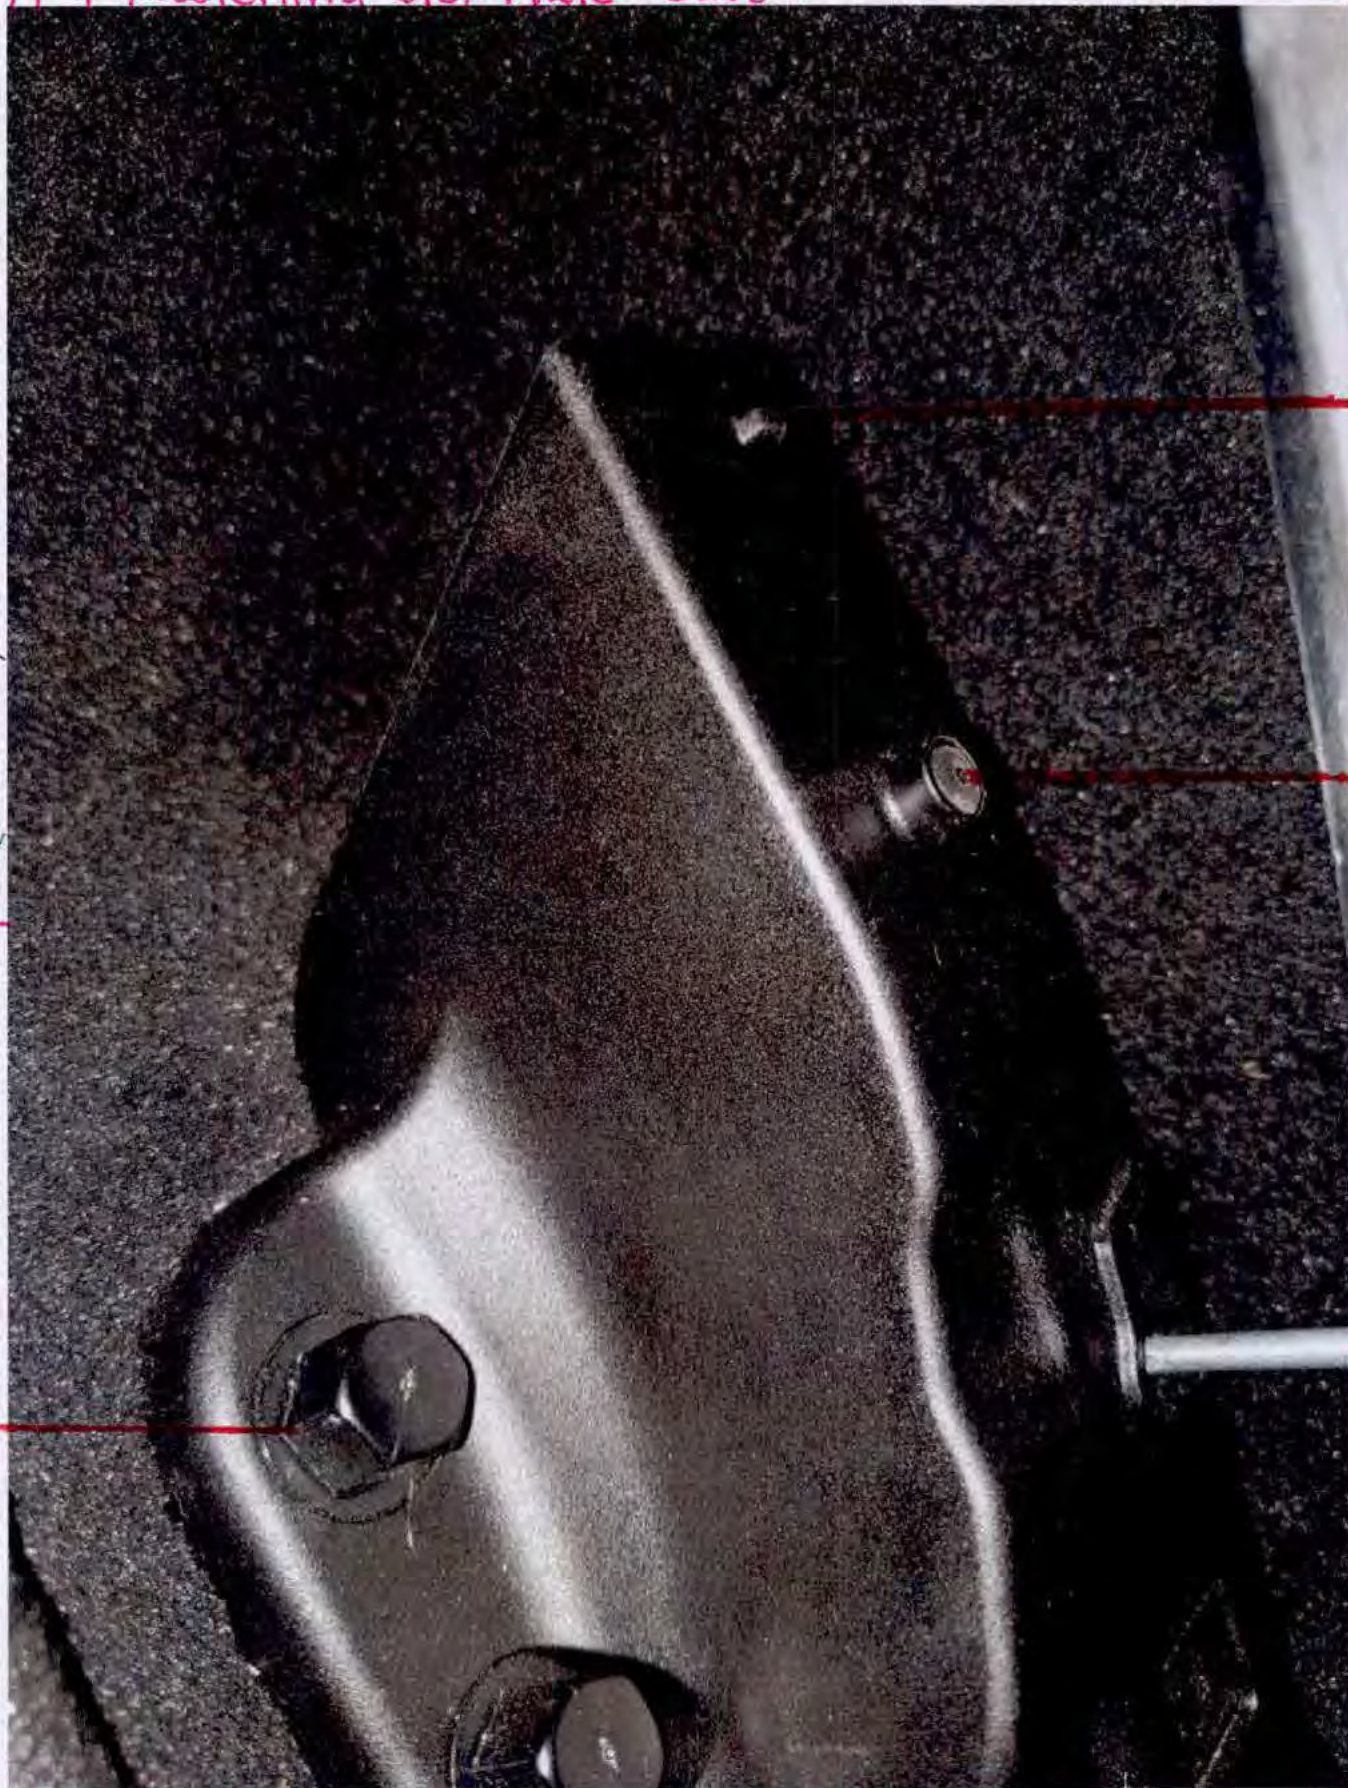
Depicted: floorboard area  
2019 Model Year M-B - C300 W.

High Grade Fastening Bolt

Alignment and accelerator-pedal-stop protrusion.

Accelerator-Pedal-Spring-Plate-Contact-stop.

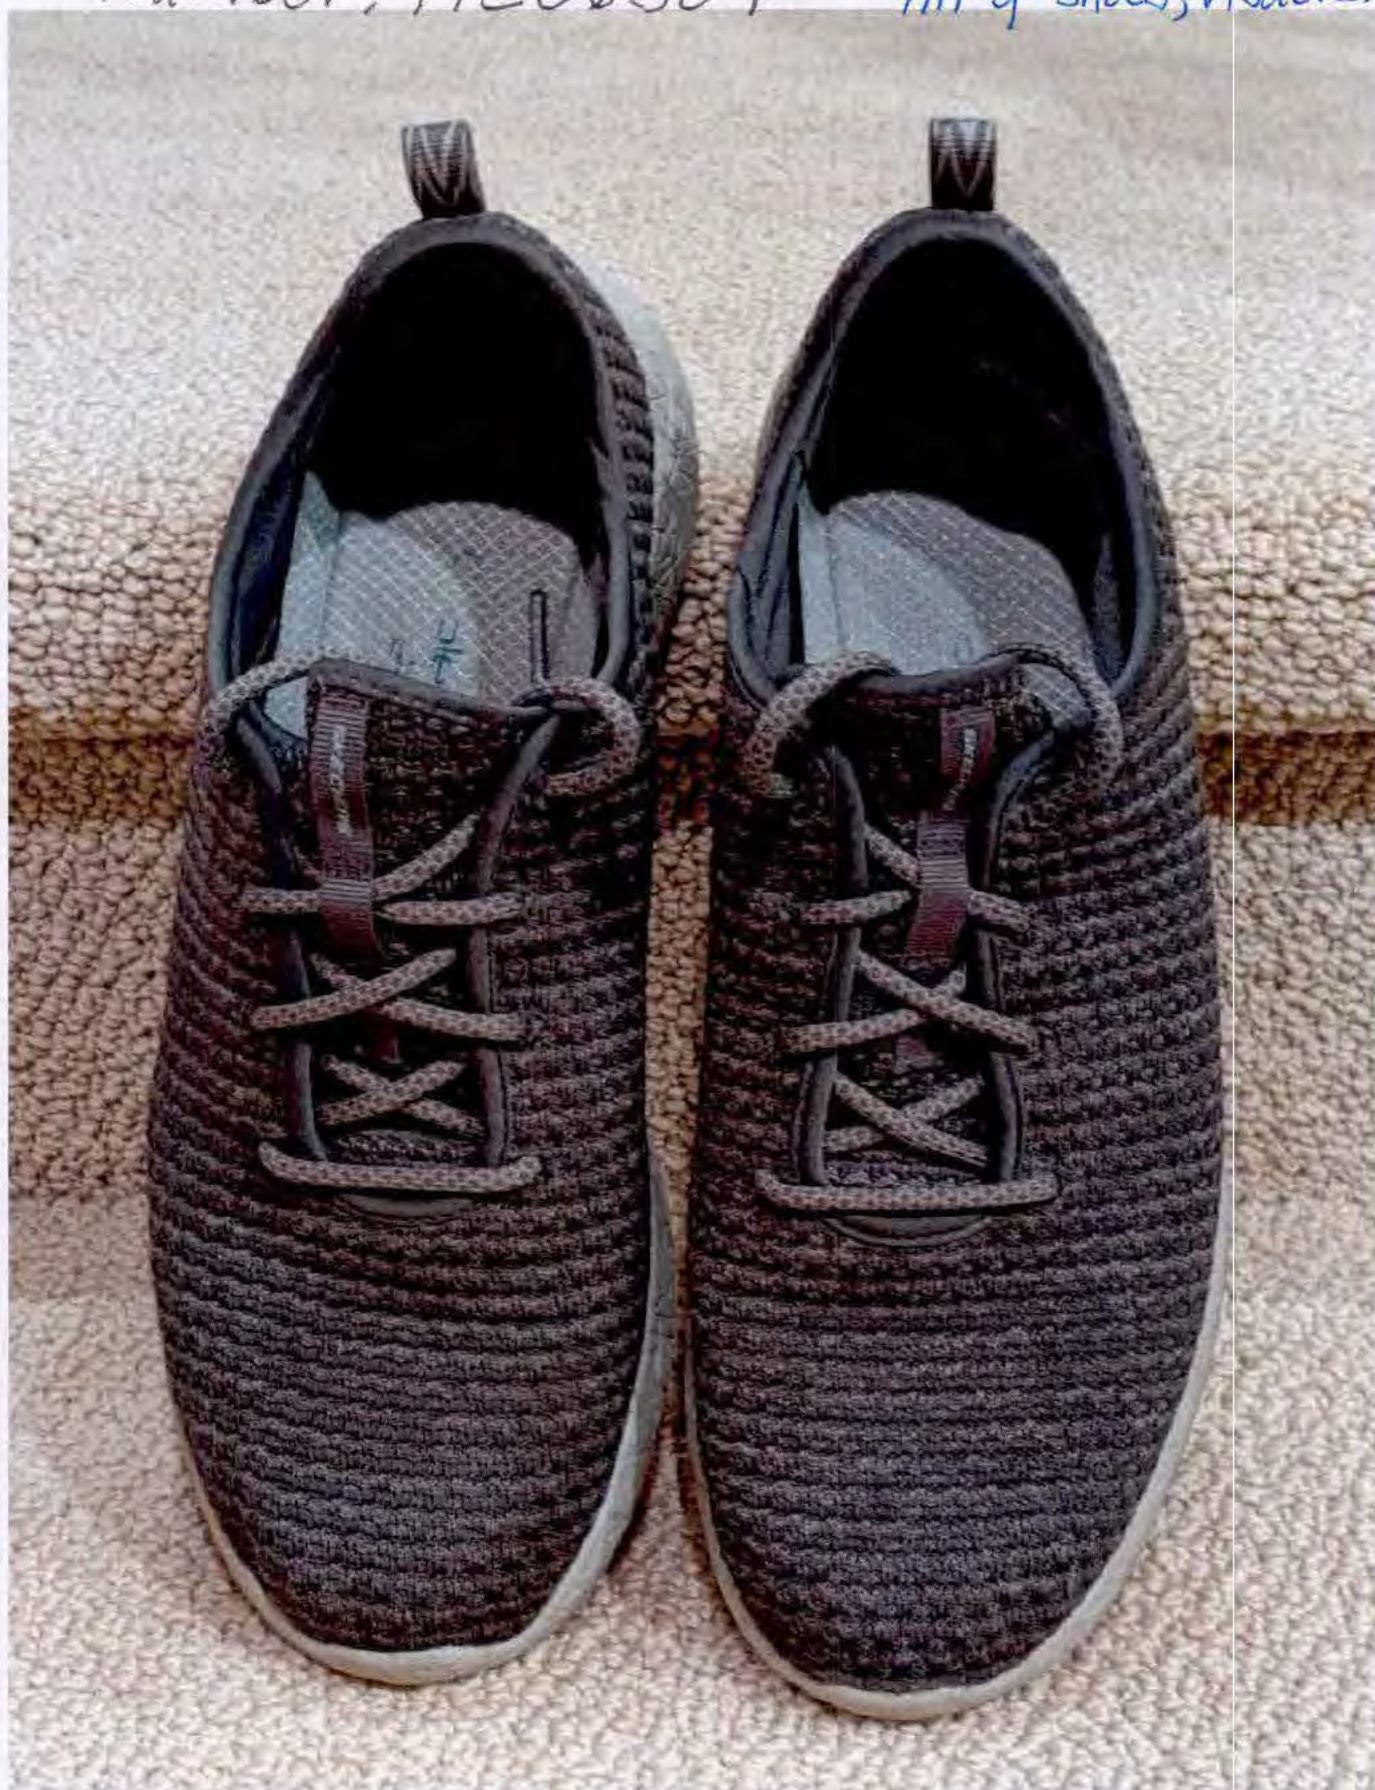
All of shoes, visible.

Worn while driving - FABRIC Soft Rubber

Worn by Driver on date of accident, 2/23/19 (See Over)
