**COMPLAINT # 11343867**

Re: Recall on 1985 Mercedes 380SL Sub-Frame  
VIN Number: WDBBA45C7FA [REDACTED]

Vehicle Component Codes: 020000 SUSPENSION, 161100 STRUCTURE: FRAME AND MEMBERS: UNDERBODY SHIELDS

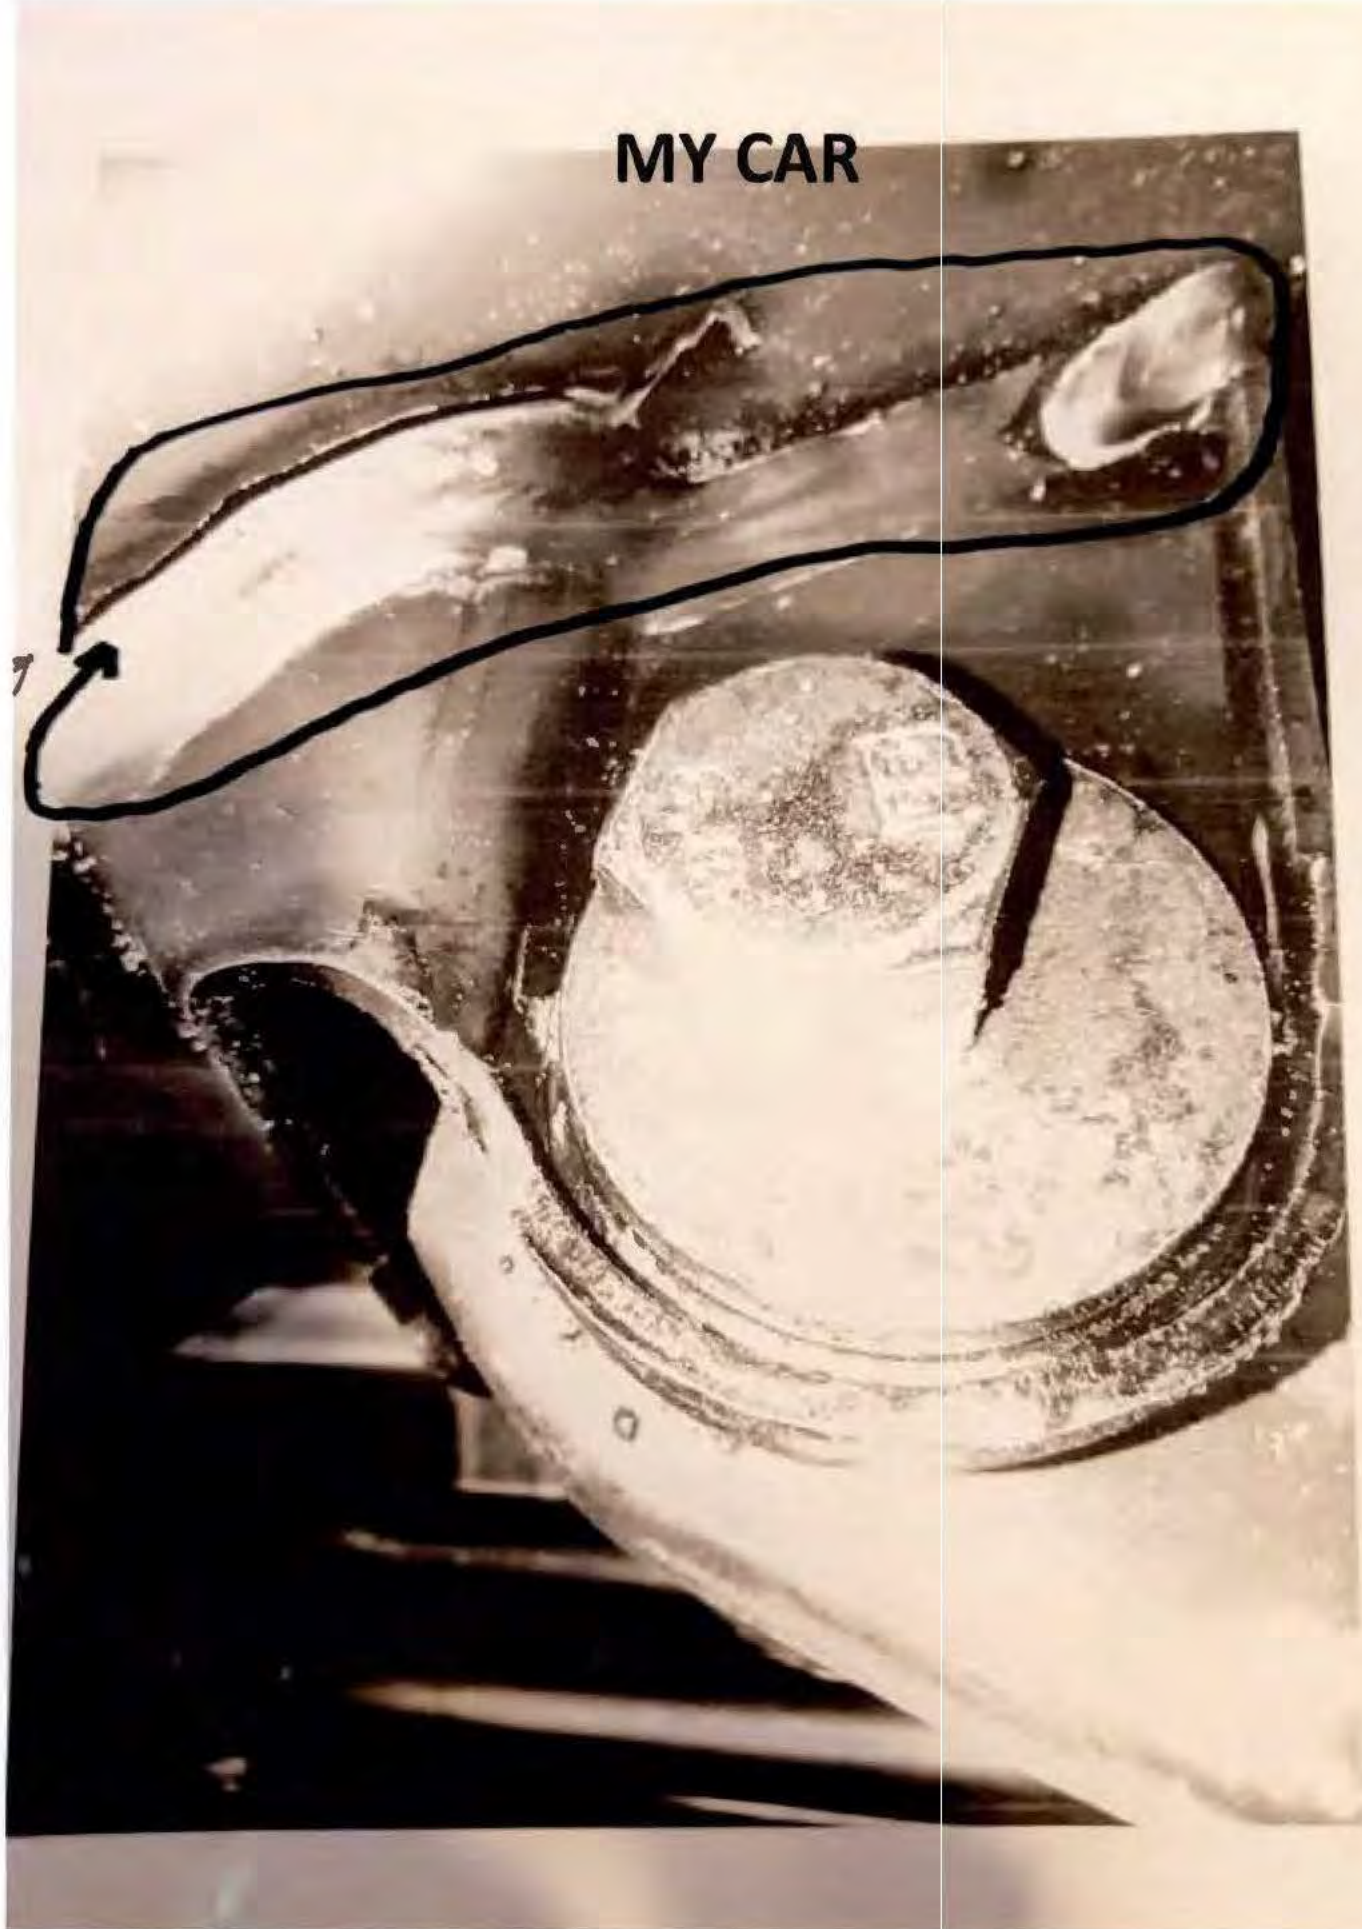
**MY CAR**

As I said when I first reported this problem I had my 1985 Mercedes 380SL at Roy's Auto Service in La Habra CA 90631. Phone number 562-697-3106. As Roy was doing an Oil Change, he noticed that the Sub Frame was broken in two different places. He notified me about this problem and that it was very dangerous to drive the car.

TL\* THE CONTACT OWNS A 1985 MERCEDES BENZ 380 SL. THE CONTACT STATED THAT THE SUBFRAME UNDER THE FRONT OF THE VEHICLE WAS FRACTURED. AN INDEPENDENT MECHANIC DISCOVERED THE CRACK OF THE SUBFRAME WHILE PERFORMING AN OIL CHANGE. THE SUBFRAME WAS CRACKED IN TWO PLACES ON THE DRIVER'S SIDE. THE WELD WAS CRACKED AND COMPLETELY SEPARATED FROM THE SUBFRAME. THE CONTACT CALLED THE HOUSE OF IMPORTS (6862 AUTO CENTER DRIVE, BUENA PARK, CA 90621, 714-627-5553) AND THEY STATED THAT THE WARRANTY HAD EXPIRED AND THERE WAS NO RECALL ON THE VEHICLE AND QUOTED A REPAIR COST OF \$3,000. THEY ALSO STATED THAT THE VEHICLE WAS UNSAFE TO DRIVE. THE MANUFACTURER CONFIRMED THAT THE WARRANTY WAS EXPIRED WITH NO RECALLS. THE CONTACT HAD HIS MECHANIC REPLACE THE DAMAGED SUBFRAME WITH A USED ONE. THE FAILURE MILEAGE WAS 200,000.

| OPER. NO. | REPAIR ORDER - LABOR INSTRUCTION - AT CUSTOMER'S REQUEST: | INTERNAL |
|---|---|---|
| | Replace Front Sub Frame | |
