**From:** [DataQuality, DataQuality \(NHTSA\)](#)  
**To:** [EVOO \(NHTSA\)](#)  
**Subject:** FW: Case #11425477 requested additional information  
**Date:** Monday, September 13, 2021 10:17:40 AM  
**Attachments:** [REDACTED]

Please find the additional requested information attached as a PDF file regarding the faulty Vanos bolts failure of my 2011 BMW 328i e91 wagon.

2011 BMW 328i e91 Sports Wagon  
Broken and Faulty Vanos bolts in N52k Engine  
VIN: WBAUT9C59BA [REDACTED]  
(Exhaust Cam Vanos)

**Recall Campaign 14V-176: N51, N52K and N52T Engine – Replace VANOS Gear Bolts**

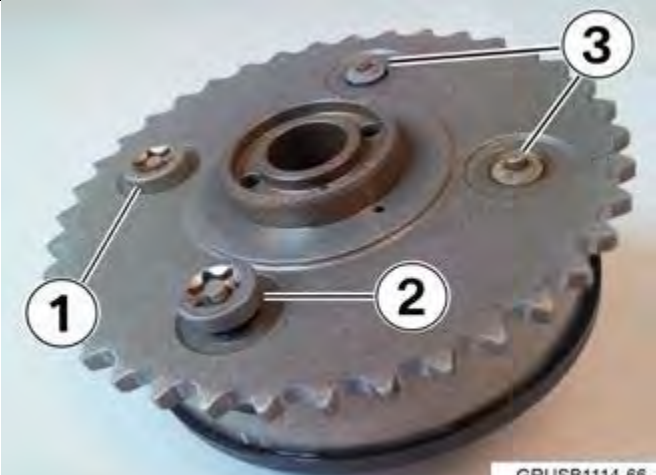
| <p>GRUSB1114-66</p> | <p>3. Evaluation of bolt:</p> <p>If any of the bolts were loose or broken during this procedure, the VANOS assembly will need to be replaced. Refer to step 14.</p> <p>VANOS bolt is tight (1)</p> <p>VANOS bolt is loose (2)</p> <p>VANOS bolt heads have sheared off (3)</p> <p>Note: VANOS gear assembly removed from engine for clarity. Do not remove VANOS Gear Assembly</p> |

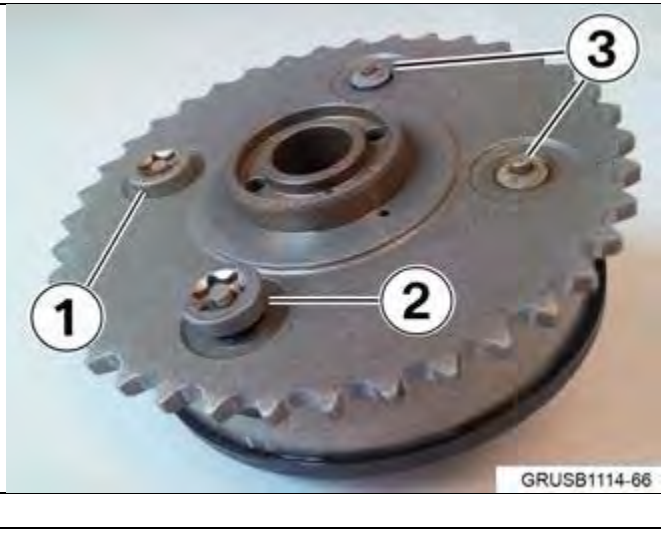
| | <p><b>10.</b> Evaluation of bolt:</p> <p>If any of the bolts were loose or broken during this procedure, the VANOS assembly will need to be replaced. Refer to step 16.</p> <p>VANOS bolt is tight (1)</p> <p>VANOS bolt is loose (2)</p> <p>VANOS bolt heads have sheared off (3)</p> <p>Note: VANOS gear assembly removed from engine for clarity. Do not remove VANOS Gear Assembly</p> |

| <p>17. If any of the VANOS bolts were found loose or broken, that VANOS unit will need to be replaced. Refer to Repair Instruction 11 36 046, “Removing and installing or replacing intake and exhaust camshaft adjusters.”</p> | |
