MAKE  
MAZDA

Model  
MAZDA6

Model Year  
2010

### ODI Complaint 11426631

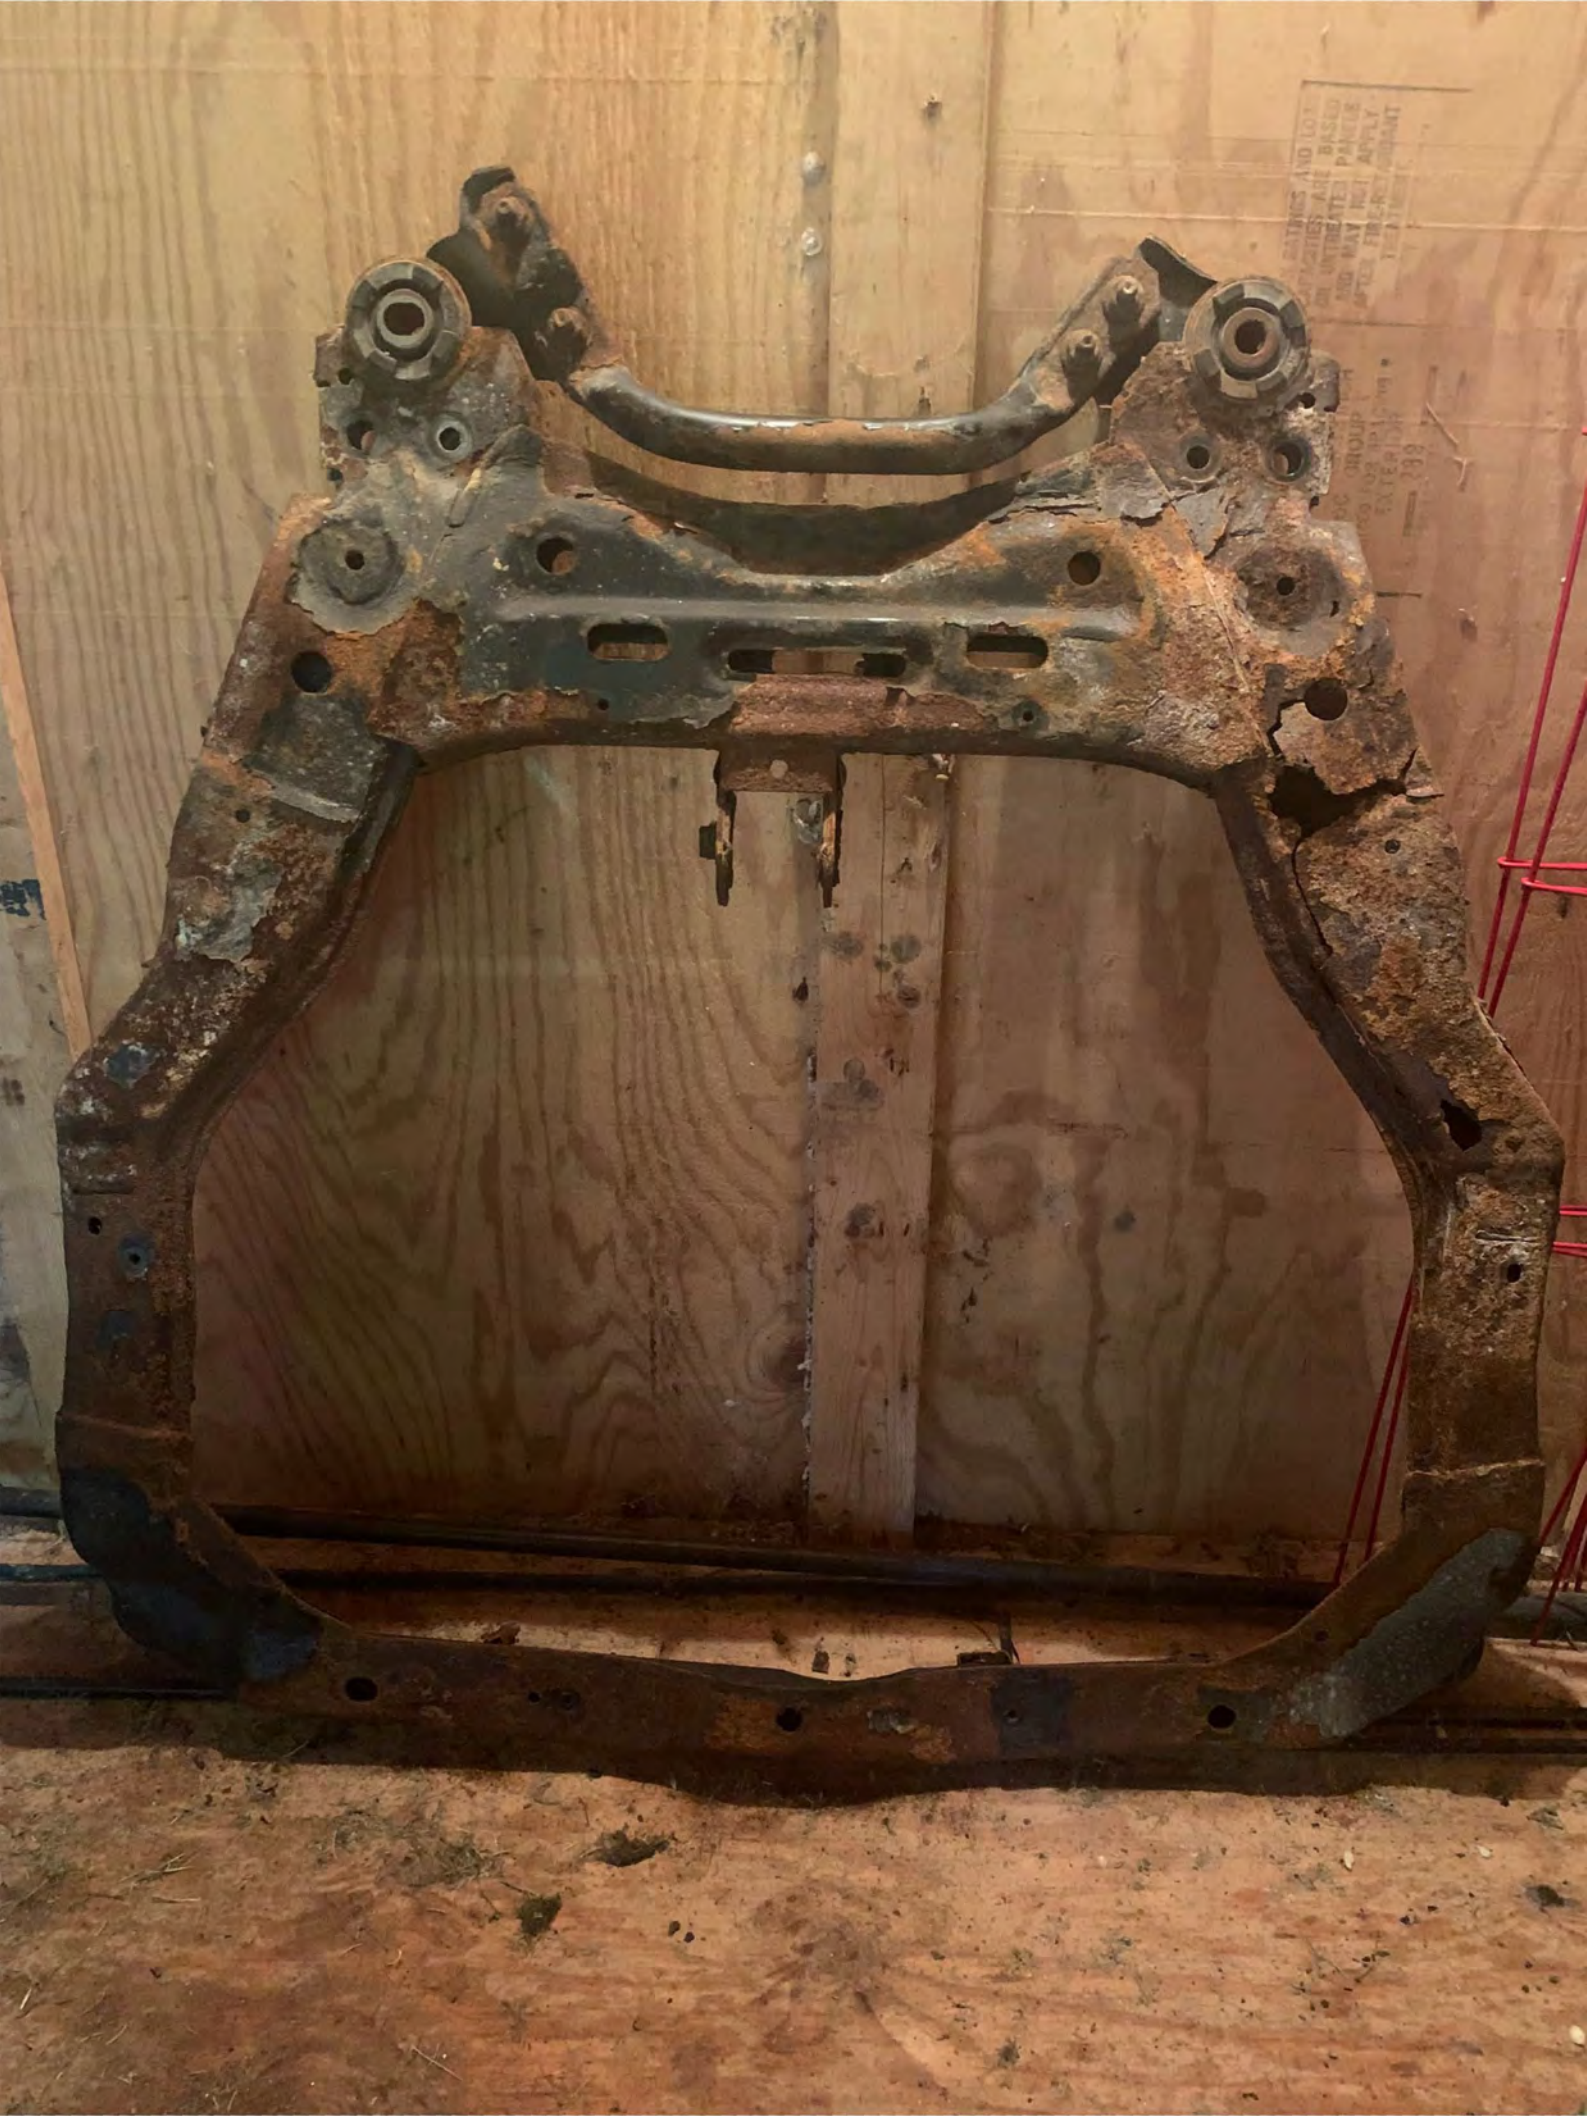
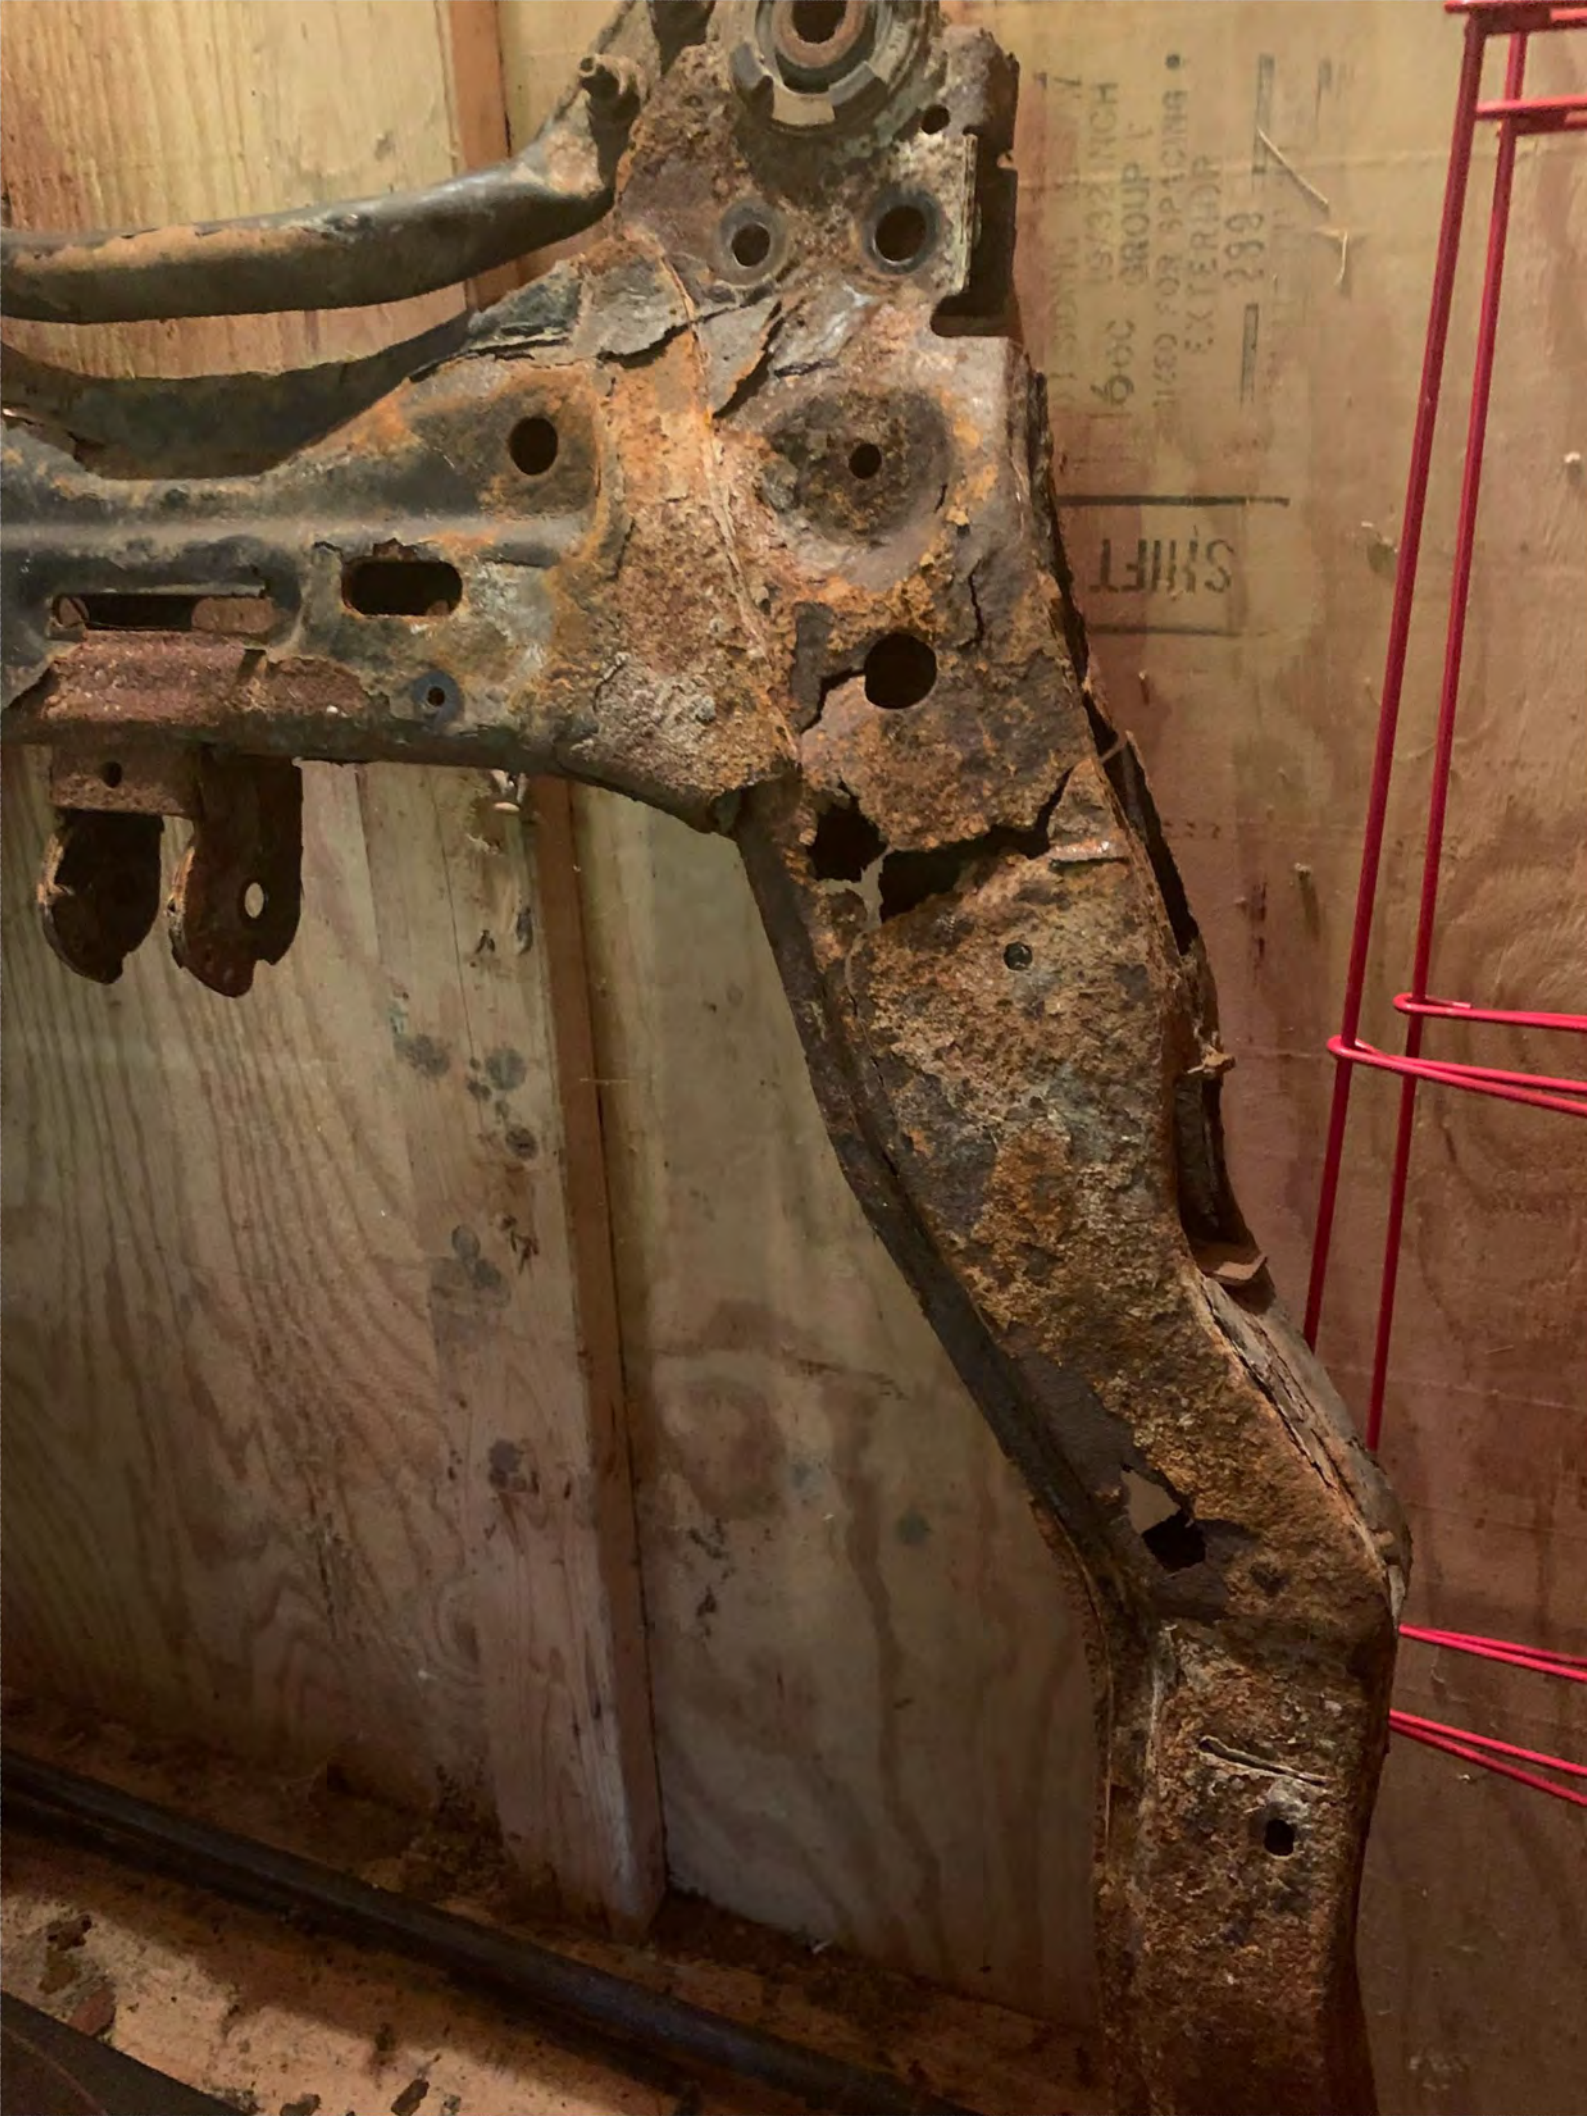
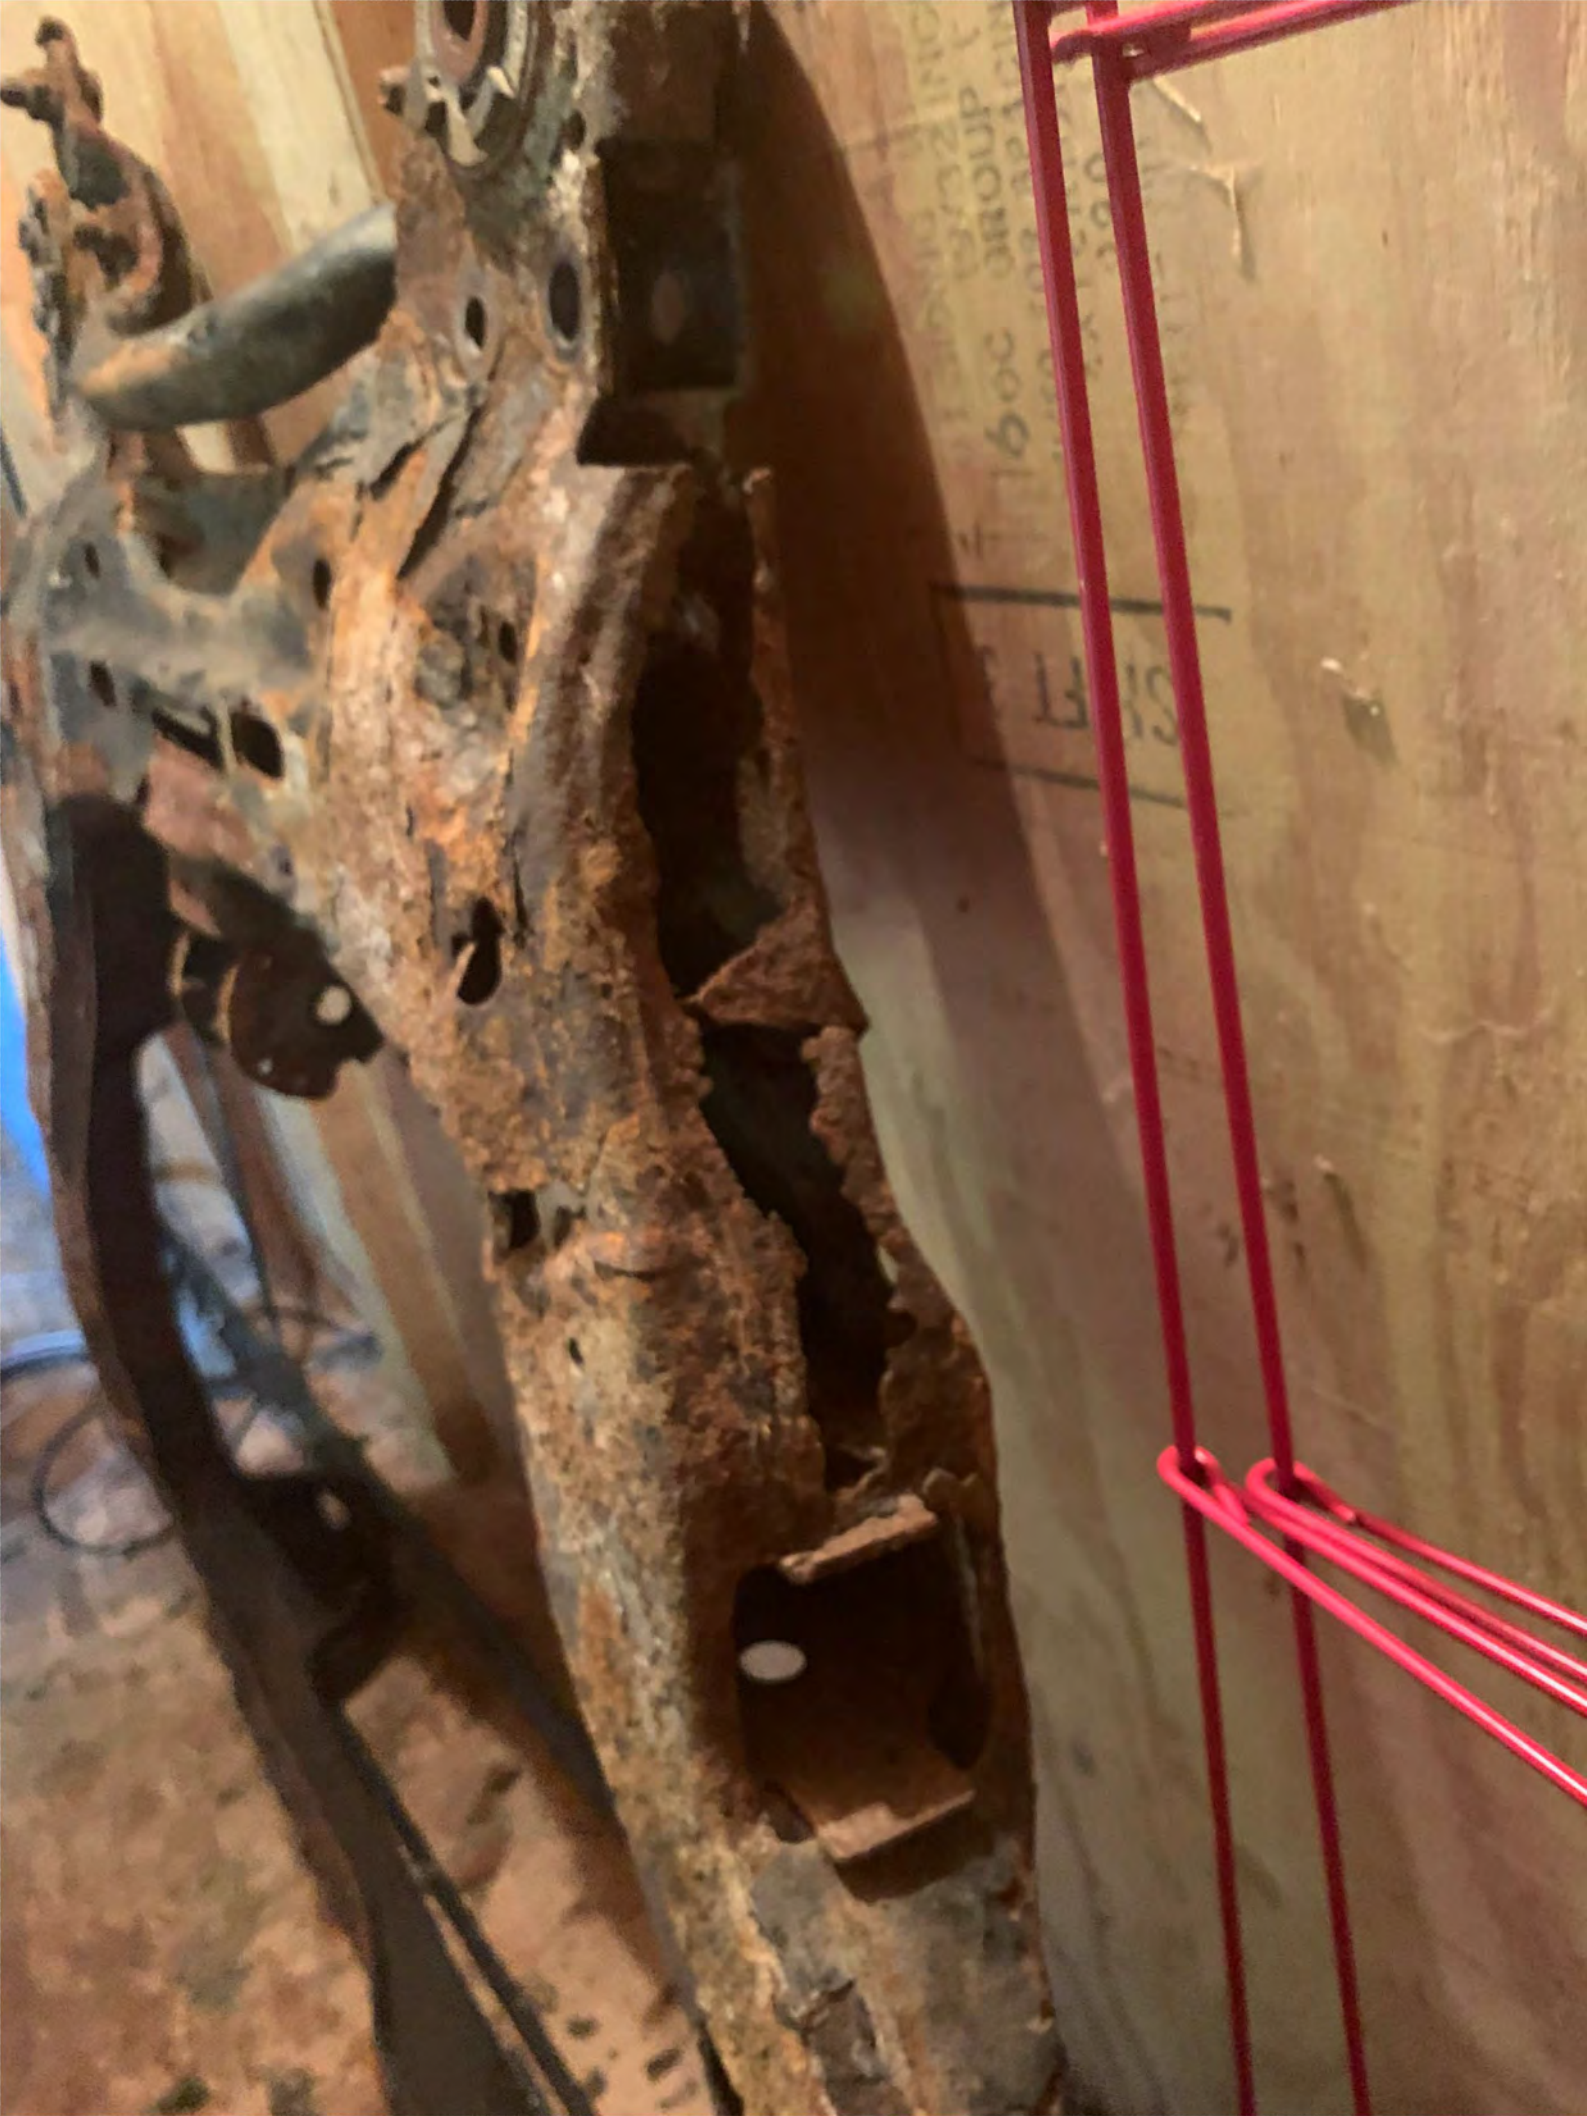
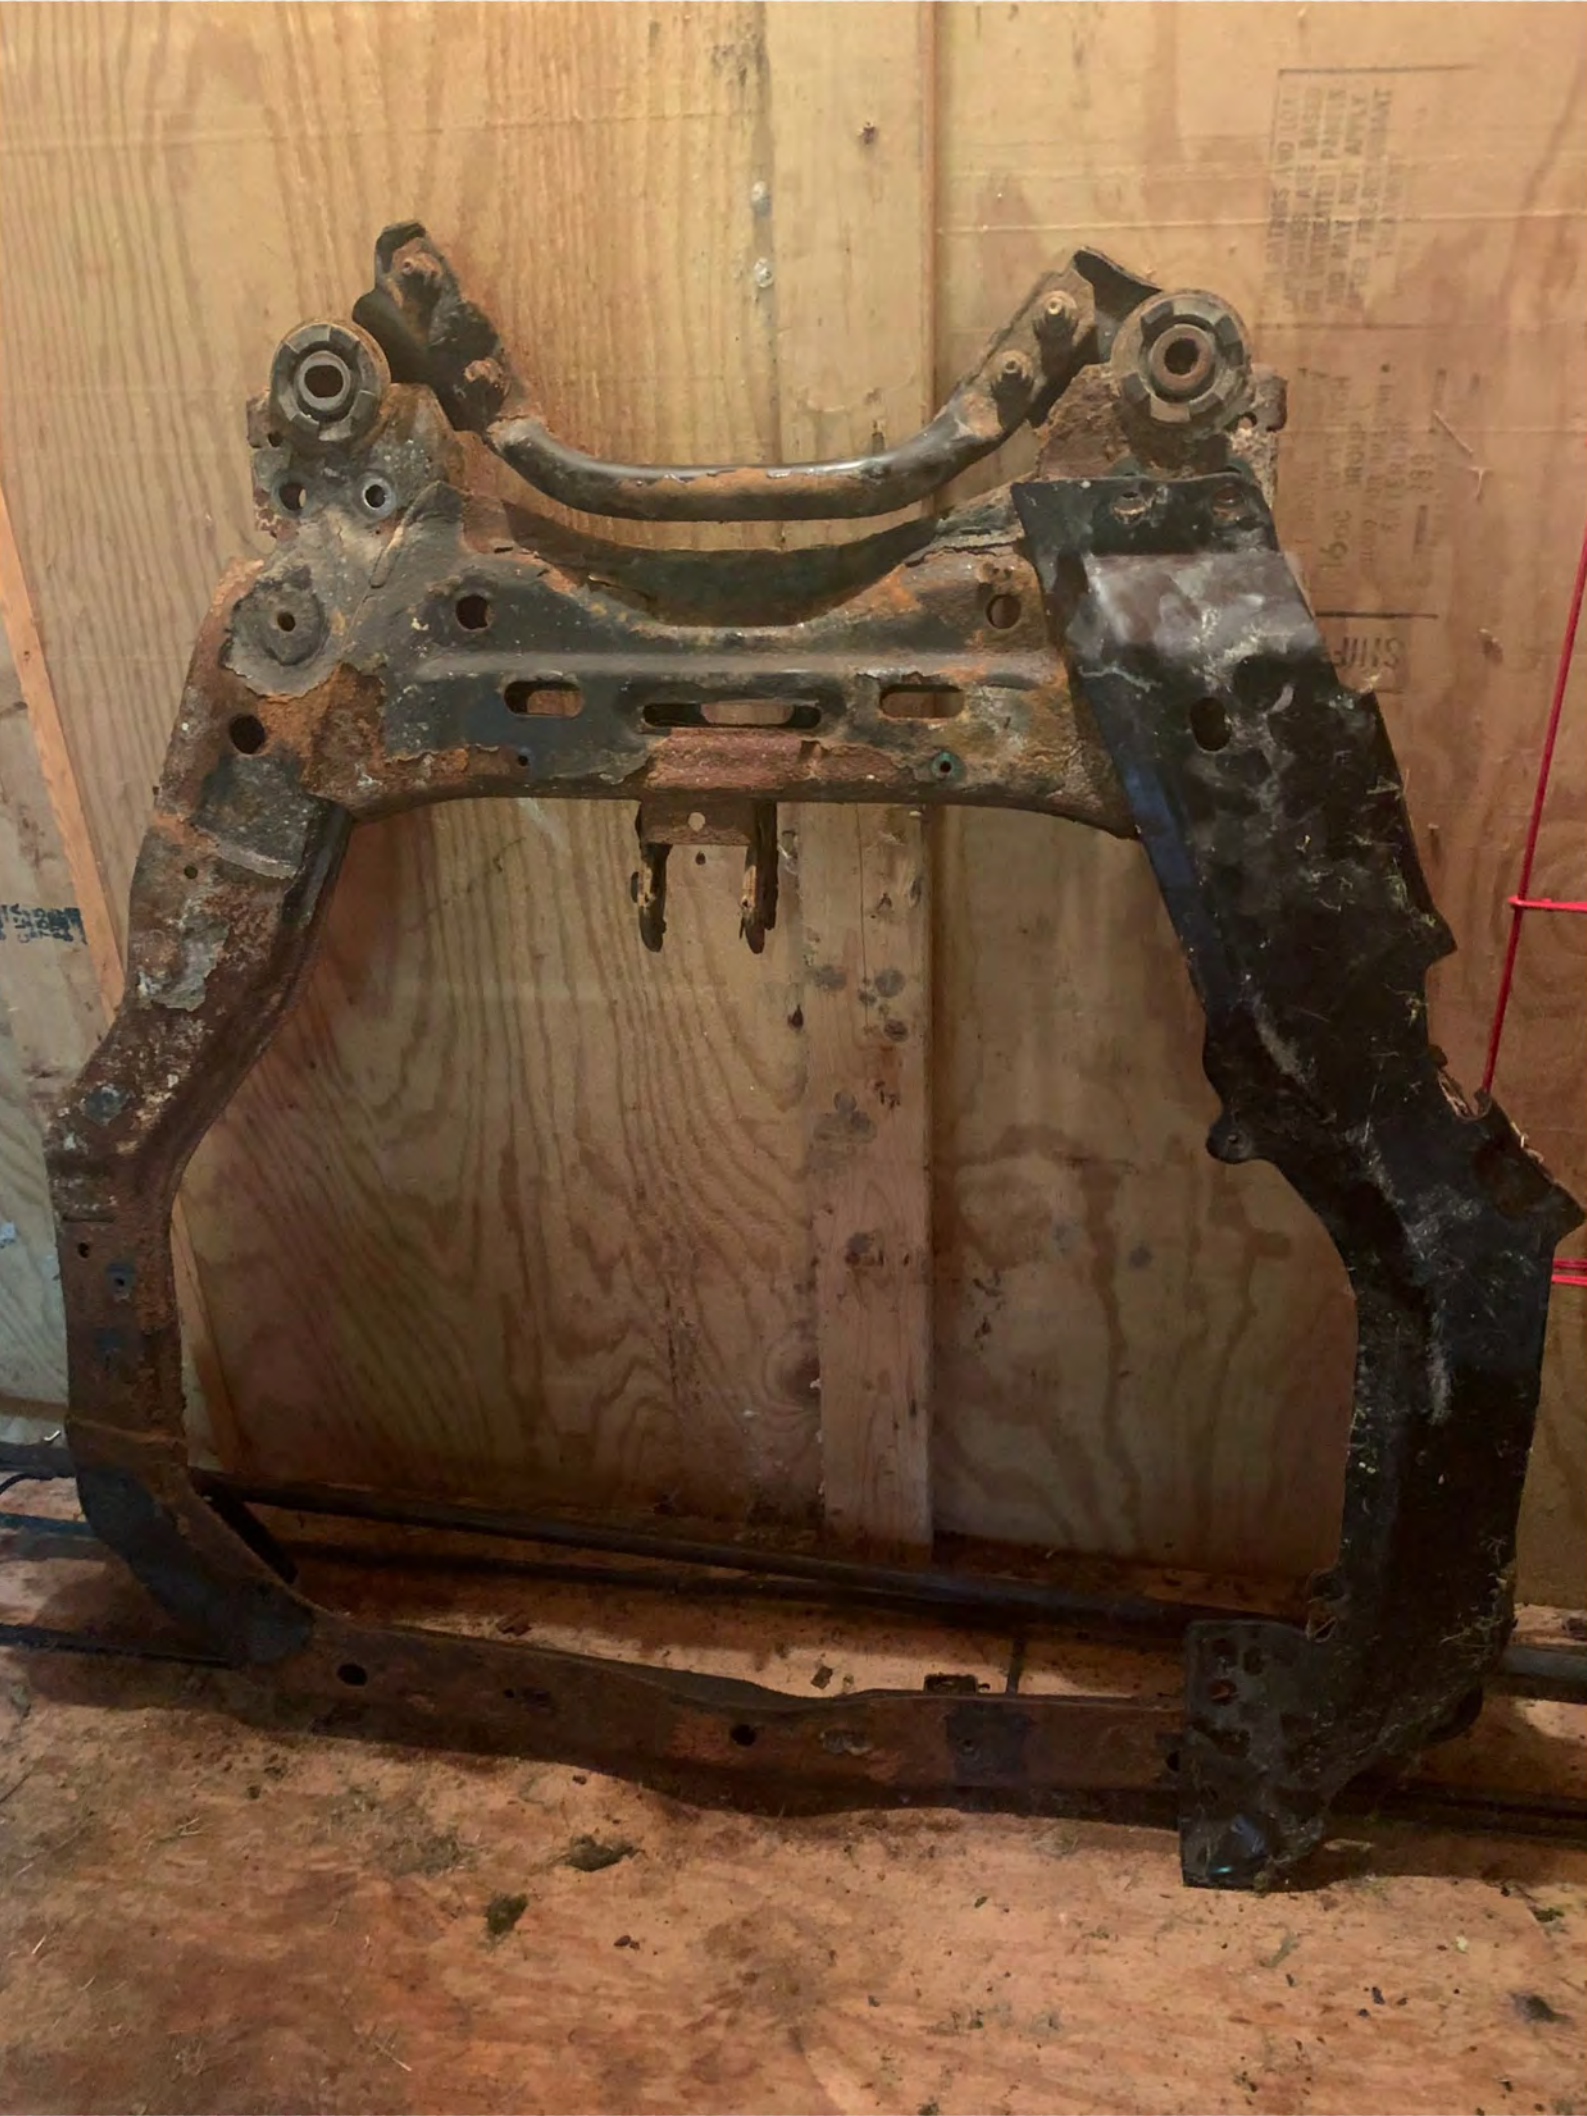
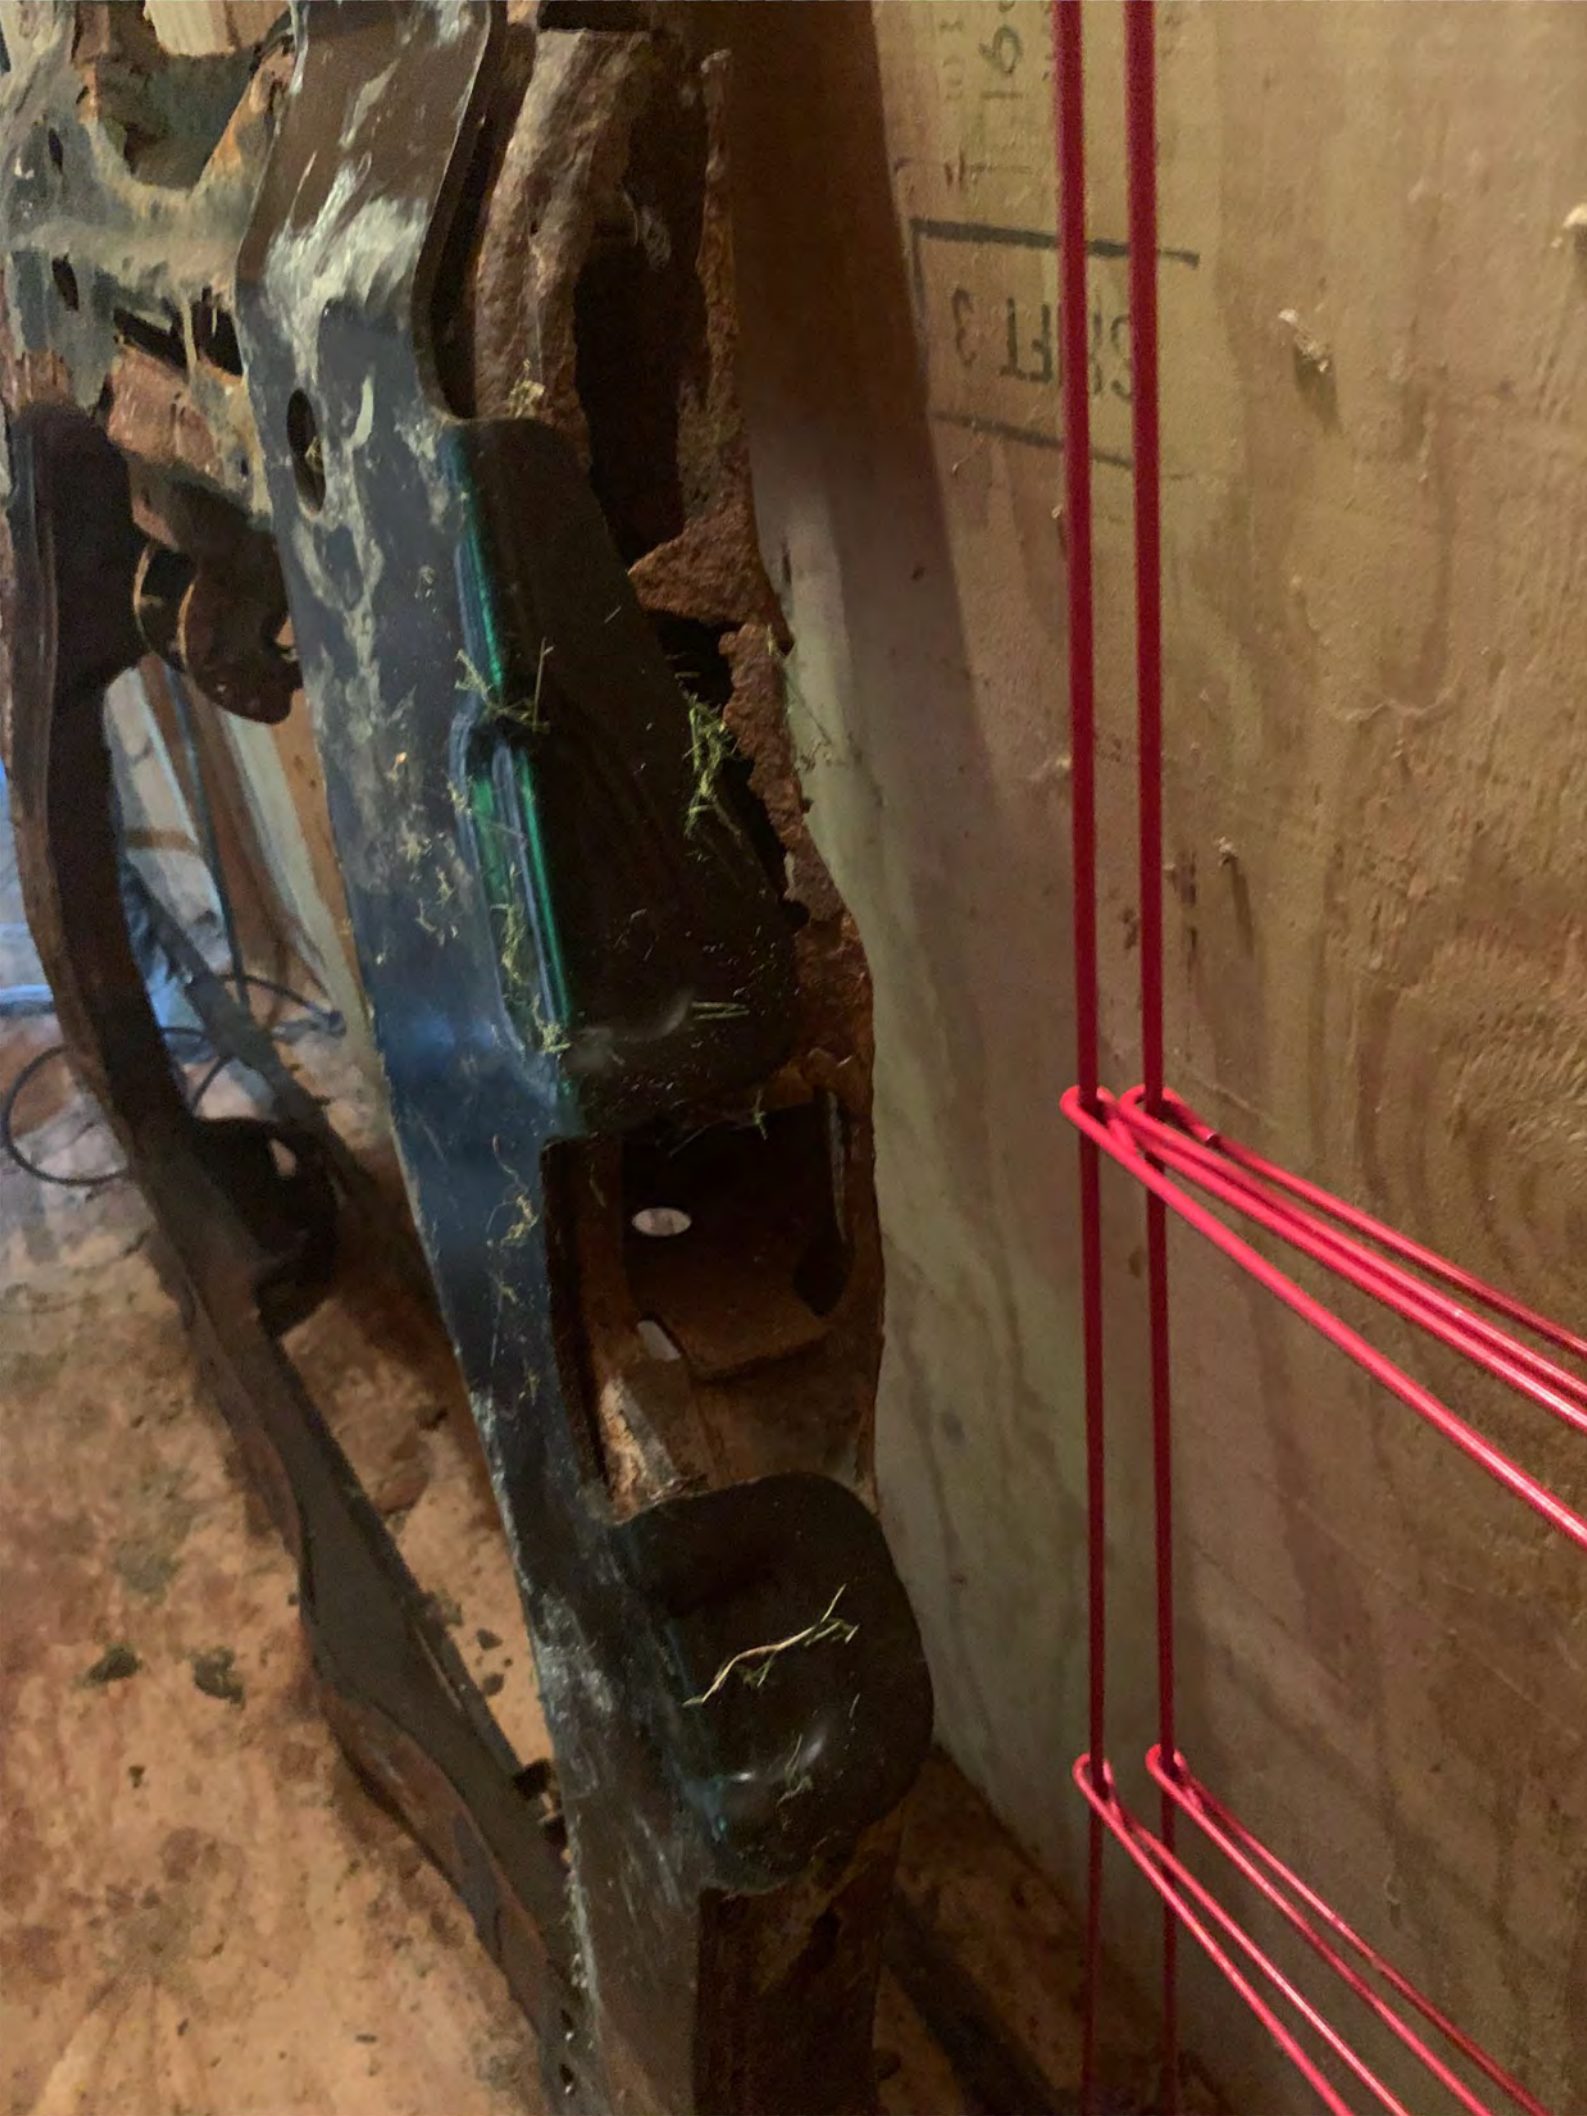
The contact owns a 2010 Mazda Mazda6. The contact stated that the steering wheel was pulling without warning. There was rust on the frame. The vehicle was taken to an independent mechanic and the contact was informed that the vehicle was not safe to drive. The local dealer was contacted. The vehicle was not diagnosed nor repaired. The contact stated that the vehicle was previously repaired under NHTSA Campaign number 18V631000 (Suspension, structure). The manufacturer was not contacted. The failure mileage was 151,000.

This issue resulted from a poorly repaired recall (NHSTA campaign ID: 18V-631000) initiated on September 18, 2018. The safety risk from Mazda's website specifically states *"Continued use of the vehicle with such condition may allow the perforation to progress, and the support of the right lower control arm front bushing to decrease. This may result in a change of the right front wheel alignment. The driver may experience a heavy pull to the right, and in some cases, it is possible that the steering control may become difficult."* The solution Mazda used DID NOT solve this dangerous issue, specifically with the right lower control arm. Rust was significantly worse on the right versus left side of the frame and especially where the control arm attaches. My mechanic noted that Mazda's recall repair only served to keep the car from splitting apart, but it in no way resolved the control arm issue. As a result my car was unexpectedly swerving all over the road and was difficult to control. That was with the control arm still somewhat attached, though extremely loose. I can only imagine how bad this could've been if this had completely loose. There's a good chance I'd be injured, dead or have injured someone else.

The Mazda recall also notes *"In severe cases the front cross member will be replaced along with the A/C drain hose instead of the side member."* Perhaps the dealer didn't adequately assess the corrosion on my vehicle and instead went the cheaper route of repair; however, this left me eventually driving a dangerous vehicle and it cost me approximately \$1,200 to fix what should've been fixed for free a few years ago. The last two photos are shown with the replacement part from the recall, which held the frame together but didn't address the real problem.
