On Aug. 5, Saturday, my husband and I, along with our two sons who are [REDACTED] years old and [REDACTED] years old, were driving on [REDACTED] at 75 miles per hour at approximately 5 pm when we heard and felt a whoosh sound, and the air dam fell off completely, rolled under our vehicle, and beneath several vehicles behind us, including semis that ran over the air dam because they could not swerve around it. This is a congested two-lane highway between Oklahoma and Texas. When it ripped off, it sounded like it first came from the front drivers side, which is reinforced by other complaints posted onto [REDACTED]

2020 highlander air dam fell off

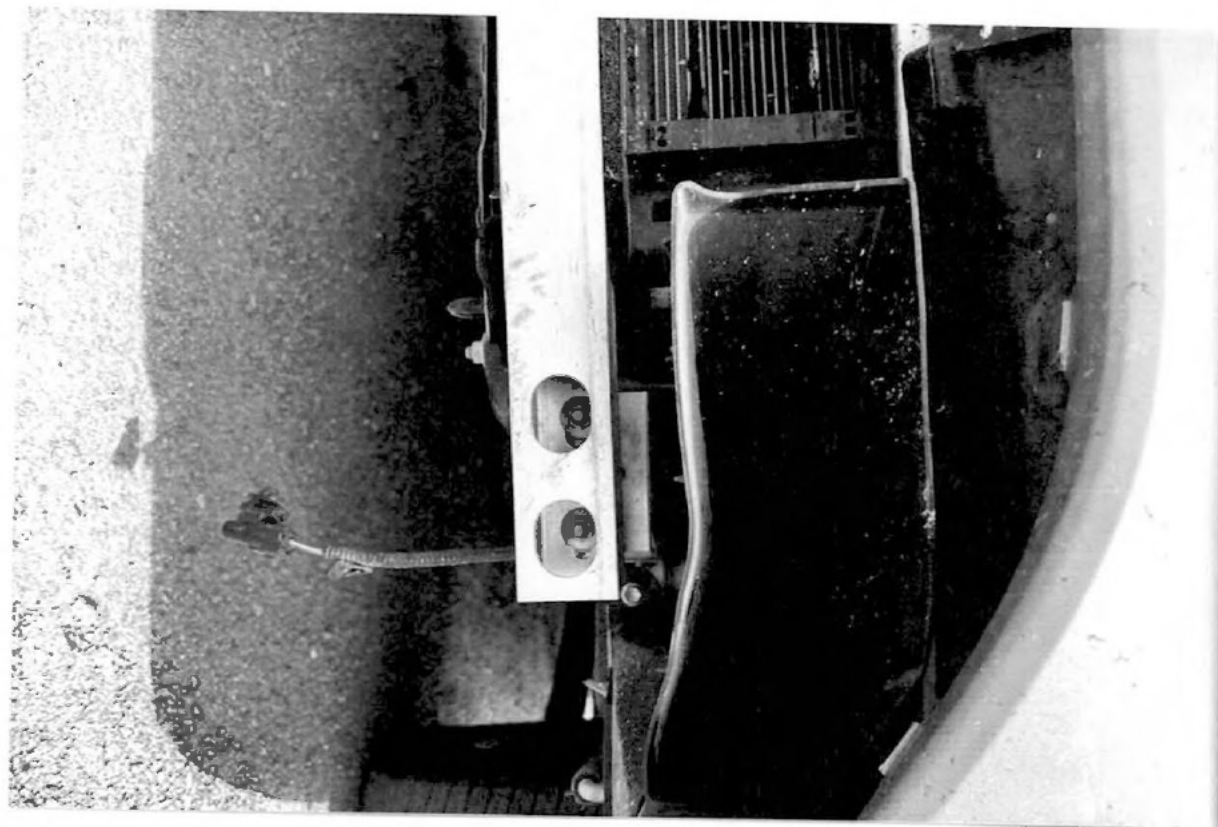
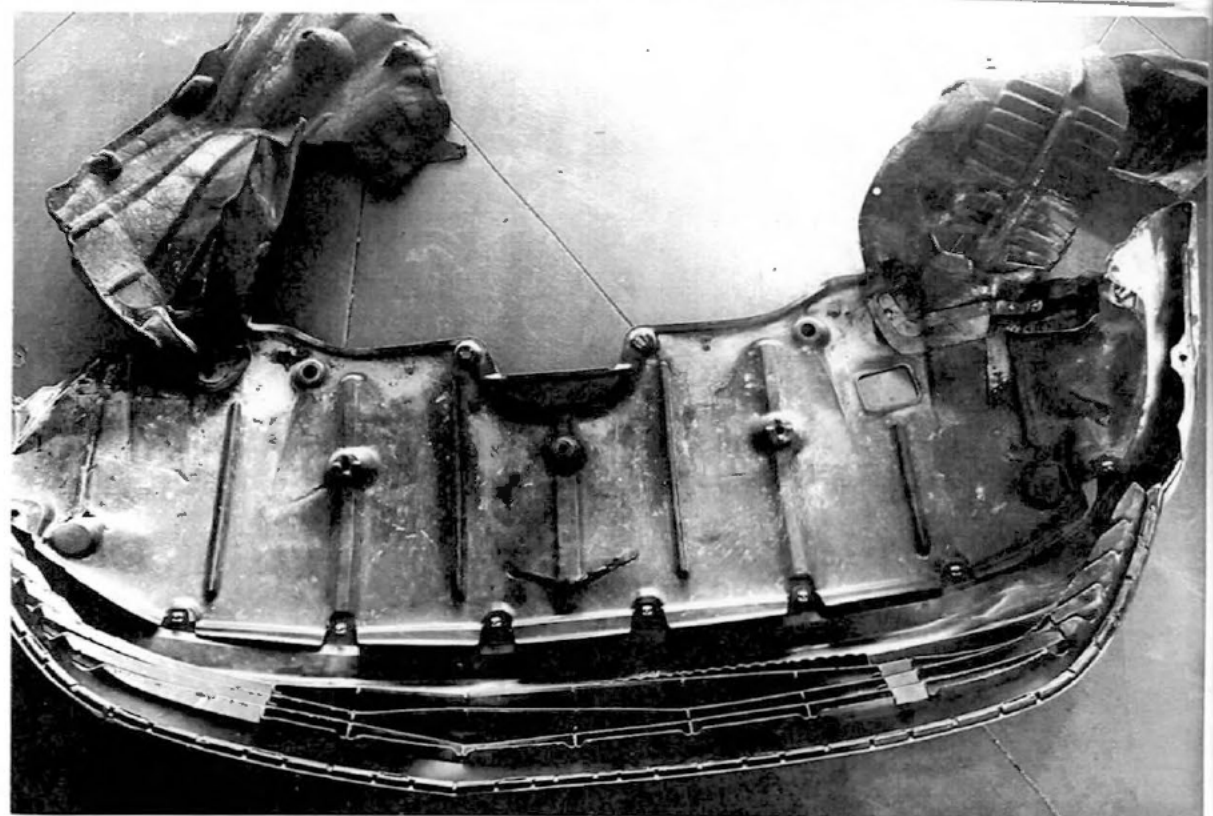
We were driving to work. All of a sudden we hear scrapping coming from the front of the car. I stopped and found this. I did not hit anything. What exactly is this called?
