VEHICLE OWNER'S QUESTIONNAIRE

DODGE

D360

Subject: DODGE MODEL-350 1993 YEAR FRONT SUSPENSION

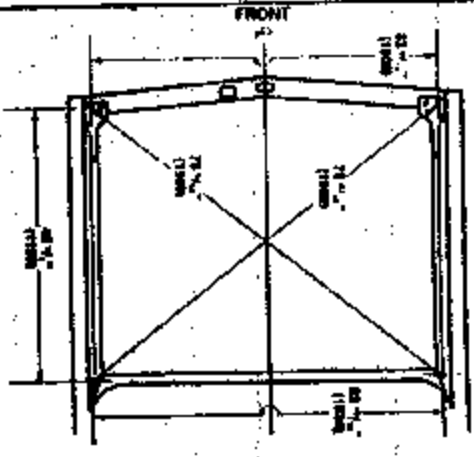
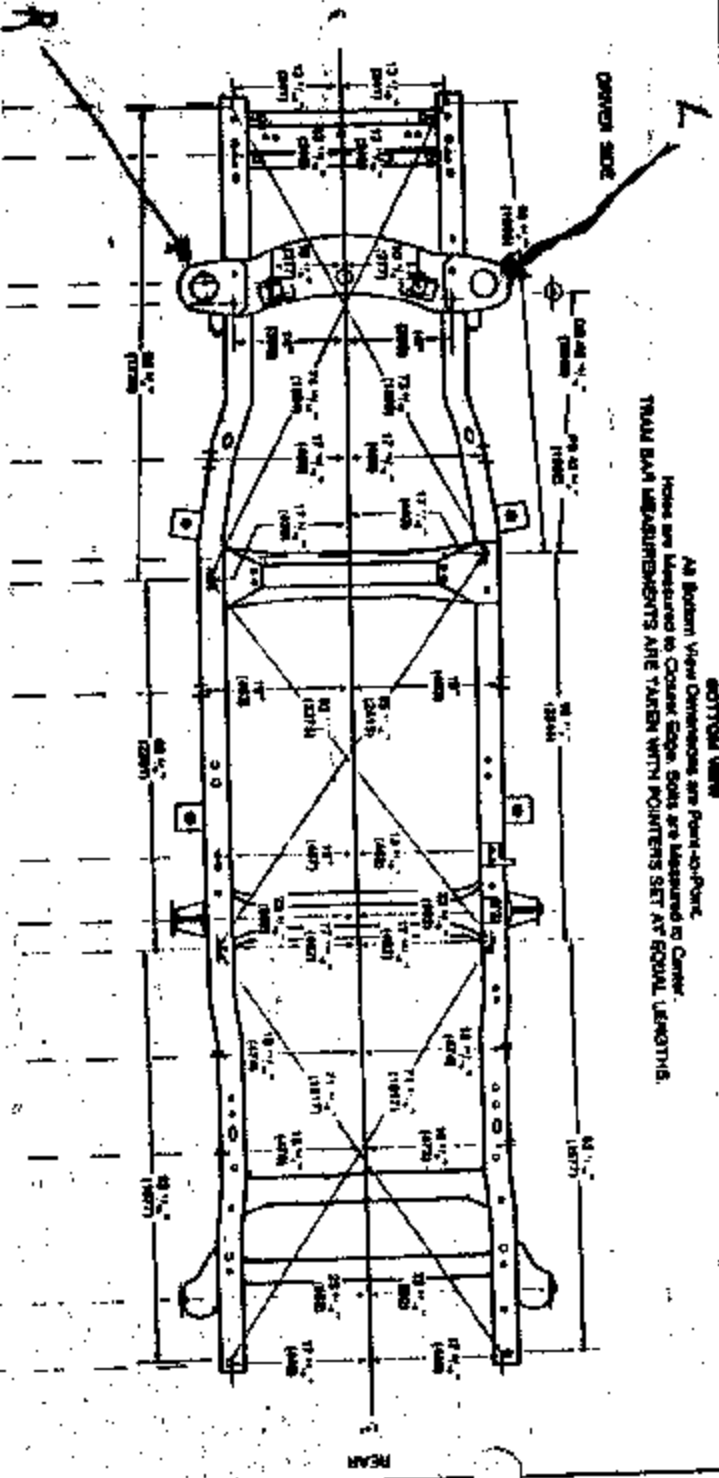
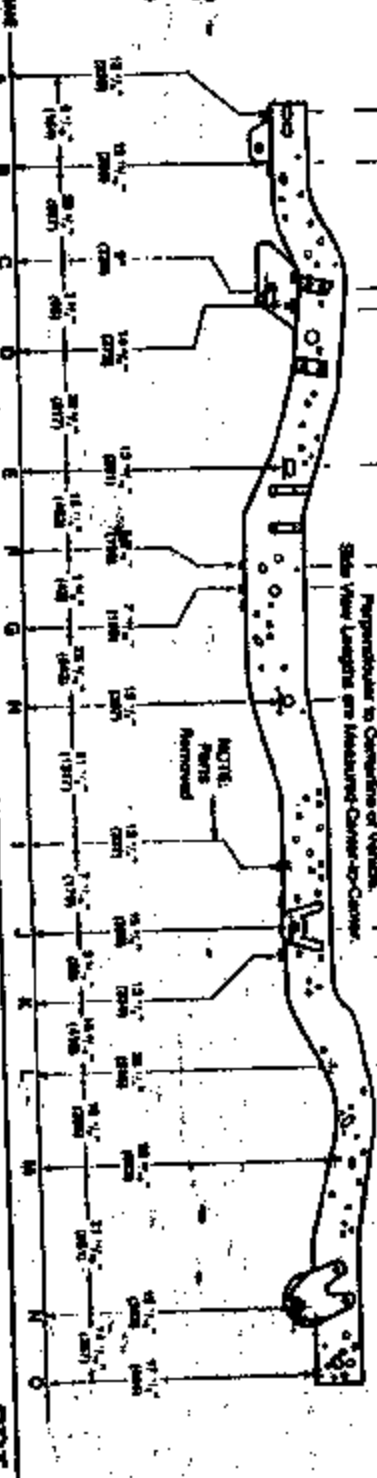
- A. UPPER TOWER CAP WELDS ARE CRACKING
- B. MAIN SUPPORT CROSS MEMBER
- 1,2,3. WELD SUPPORTS LOCATIONS ARE CRACKING 80%

*Welds
L/R location of broken*
