## NHTSA Investigation

## Toyota Response

## NHTSA Concerns (EA Resume)

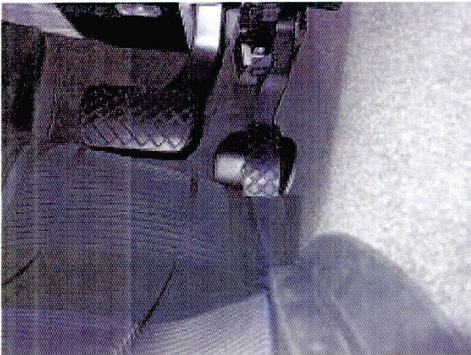
- Any floor mat can interfere with the accelerator pedal in any vehicle
  - Transport Canada issued a **general** advisory in March 2007 ([click here](#))
    - If you have installed aftermarket floor mats in your vehicle, make certain they cannot move while driving.
    - If you are going to install rubber mats in the winter months, when doing so, be sure that you remove the originally equipped factory floor mats.
    - Use only one set of mats and make certain that the mats do not interfere with the gas or brake pedal before driving the vehicle.
    - If the vehicle is equipped with a floor mat retaining pin or clip, make certain that the mat is installed as per the vehicle manufacturer's instructions.
