To: All Toyota Dealer Principals, Service Managers, Parts Managers

Subject: Safety Recall – 90L
Certain 2007 – 2010 Model Year Camry and Camry Hybrid Vehicles
Potential Floor Mat Interference with Accelerator Pedal (January, 2010)
Phase 1 – Vehicles Equipped with Accelerator Pedals manufactured by Denso Corporation

TECHNICAL INSTRUCTIONS
FOR
SAFETY RECALL 90L
DENSO ACCELERATOR PEDAL MODIFICATION
2007 – 2010 MODEL YEAR CAMRY

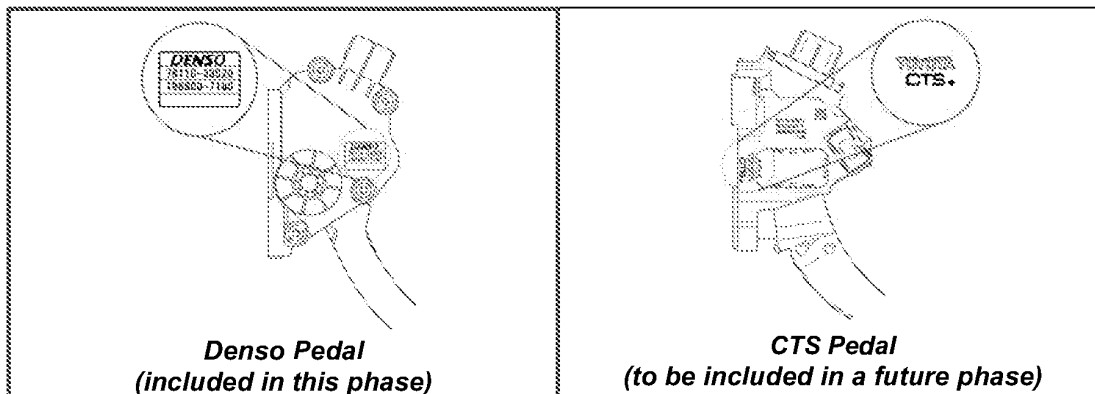
Note:

- **The name of the pedal manufacturer is printed (Denso) or embossed (CTS) on the upper sensor housing on the brake pedal side.**
- **This condition is separate from the Defect Information Report (DIR) filed on 1/21/2010 in reference to the possibility that certain CTS accelerator pedal mechanisms may, in rare instances, mechanically stick in a partially depressed position or return slowly to the idle position.**

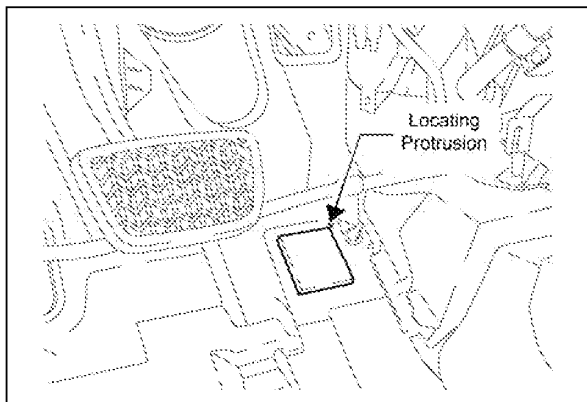
- a) Inspect the rubber pad application area for sound deadening material.
 - If OK (no sound deadening material in pad application area), proceed to step "b" below.
 - If NG (sound deadening material found in application area), please refer to APPENDIX "C" for "REMOVE THE SOUND DEADENING MATERIAL".

- b) Clean and degrease the rubber pad application area.
- c) Peel the double sided tape cover off the **NEW** rubber pad.
- d) Apply the rubber pad to the floor pan. The upper right corner of the rubber pad needs to be positioned next to the locating protrusion.
