ENGINEERING ANALYSIS CLOSING REPORT

SUBJECT: Speed Control Deactivation Switch Fires.

EA No: EA02-025

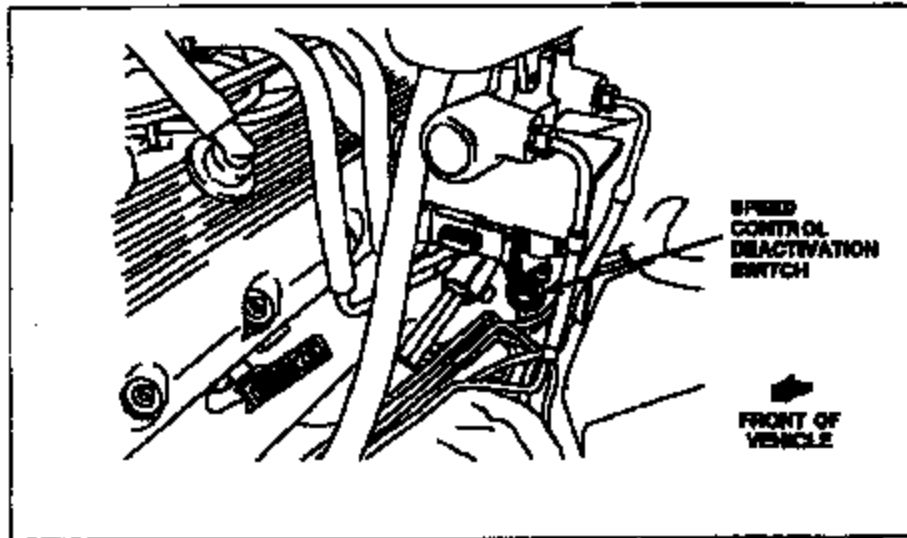
SUBJECT SWITCH DESCRIPTION: The subject components are hydraulic pressure switches that function as redundant safety switches to interrupt power to the speed control servo during brake application.² The normally closed switch opens at brake system pressures produced by approximately 5-10 lbs of pedal force, breaking the circuit to the speed control servo and causing speed control to disengage. The deactivation switch is mounted on the brake proportioning valve, which is located on the rear bulkhead on the left (driver's) side of the engine compartment beneath the brake master cylinder (Figure 2). Texas Instruments (TI) manufactured the switches.

Figure 2. Speed Control Deactivation Switch Location.

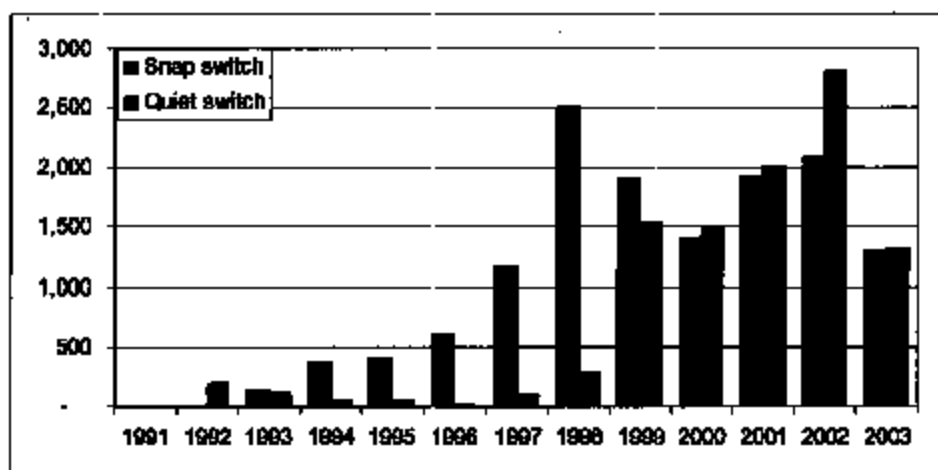
Figure 4. Service part sales of subject switches by switch and sales year (through July 2003).

Figure 4 shows the annual sales of the “snap” and “quiet” switches. Ford also sold the recall kit, which consisted of a “snap” switch and a switch electrical connector, as a service part in non-recall vehicles. In 1999 and 2000, sales of the recall kit were higher than sales of the “snap” and “quiet” switches in subject vehicles. Figure 5 shows the annual combined sales of the switches and kits by model. Annual sales peaked at over 15,000 units in 1999, when Ford initiated recall 99V-124. Since 1999 sales have been relatively constant at about 7,000 units per year.

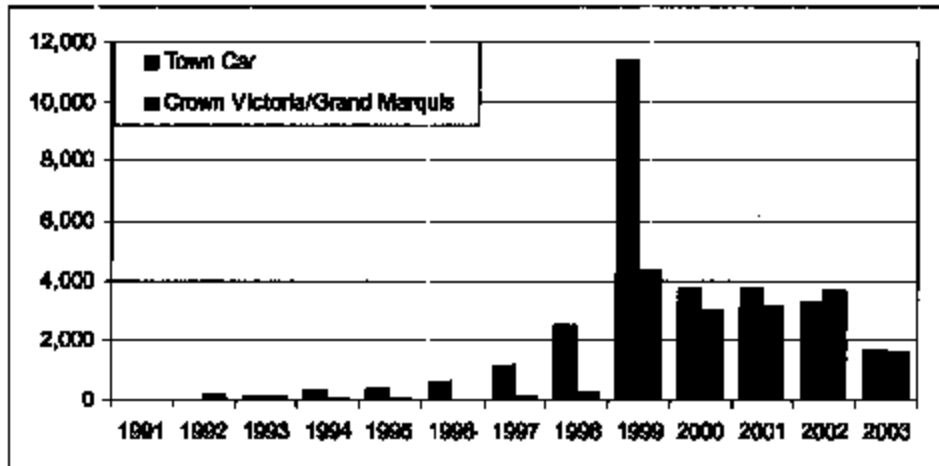
Figure 5. Combined service part sales of switches and kit by model and sales year (through July 2003).

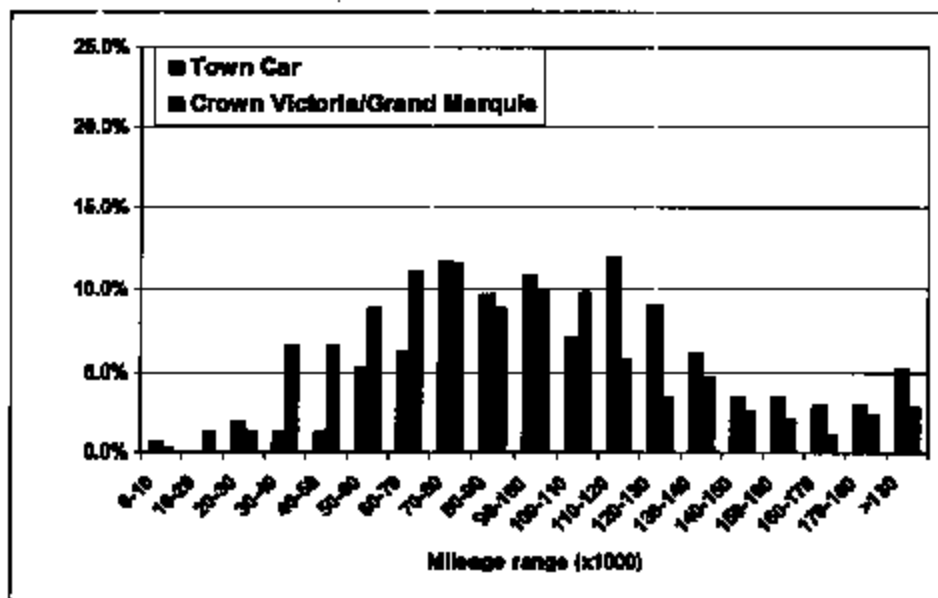
Figure 6. Distribution of SCDS part sales UDB data by model and mileage.

Figure 6 shows the mileage distribution of Ford's UDB data for the subject switches in MY 1993 through 1995 Town Car, Crown Victoria, and Grand Marquis vehicles. The Town Car has about the same percentage of sales as the Crown Victoria and Grand Marquis vehicles from 70,000 to 100,000 miles. The Crown Victoria and Grand Marquis have a greater percentage of sales than Town Car at less than 70,000 miles and the Town Car has a greater percentage at greater than 100,000 miles. A breakdown of UDB data by failure mode/symptom is provided in Table 9.

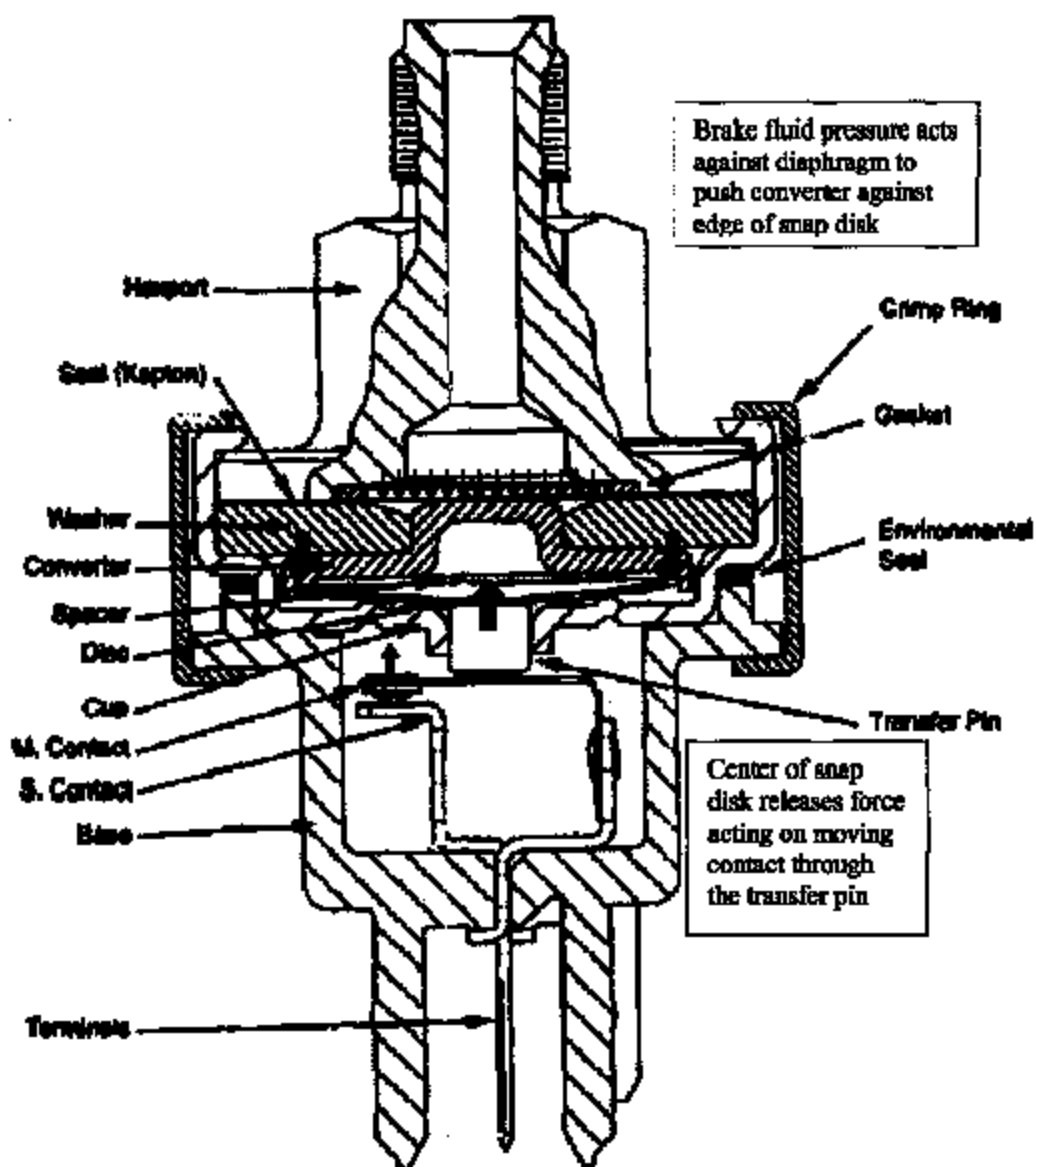
Brake fluid pressure acts against the switch converter through the Kapton diaphragm to actuate the switch snap disk during brake application (Figure 9). Actuation of the snap disk allows the sprung arm of the switch movable contact to lift off the stationary contact, breaking the speed

Figure 9. Speed Control Deactivation Switch.

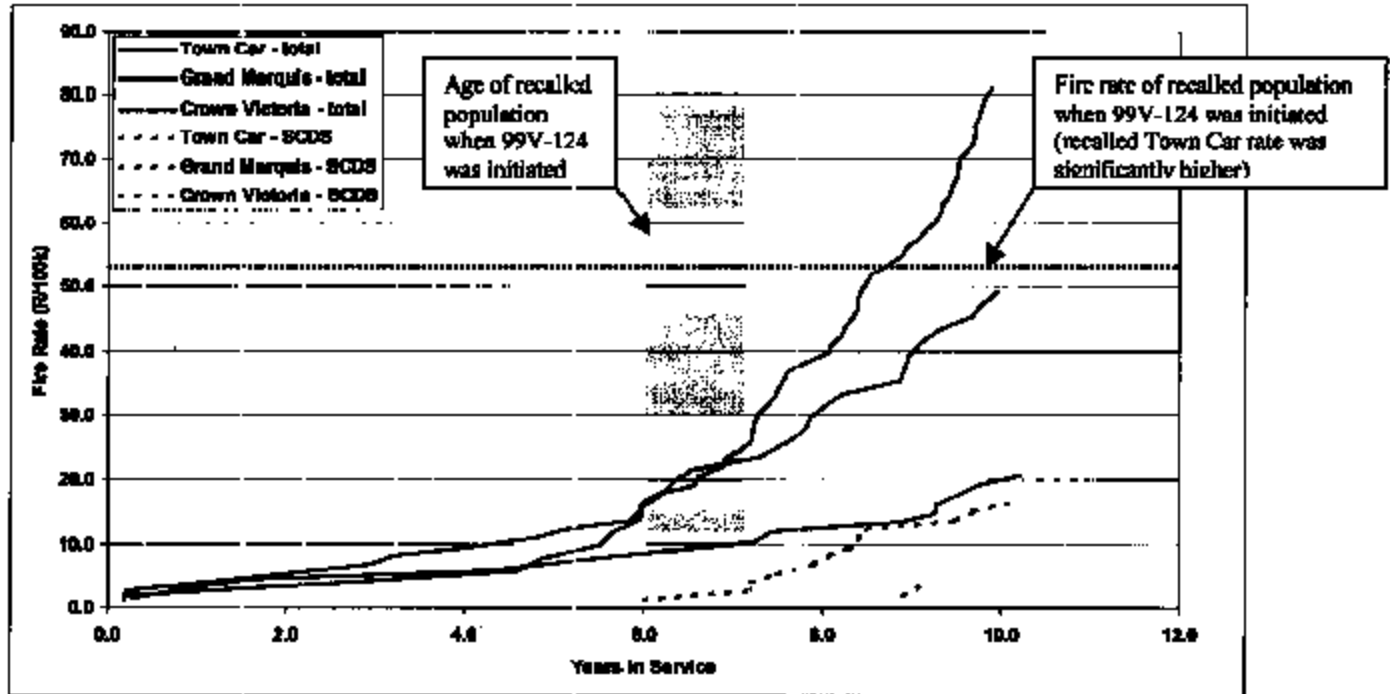
Figure 14. MY 1993 (post-recall production) cumulative fire rates, all underhood fires⁹ and SCDS fires (ODI & Ford data).

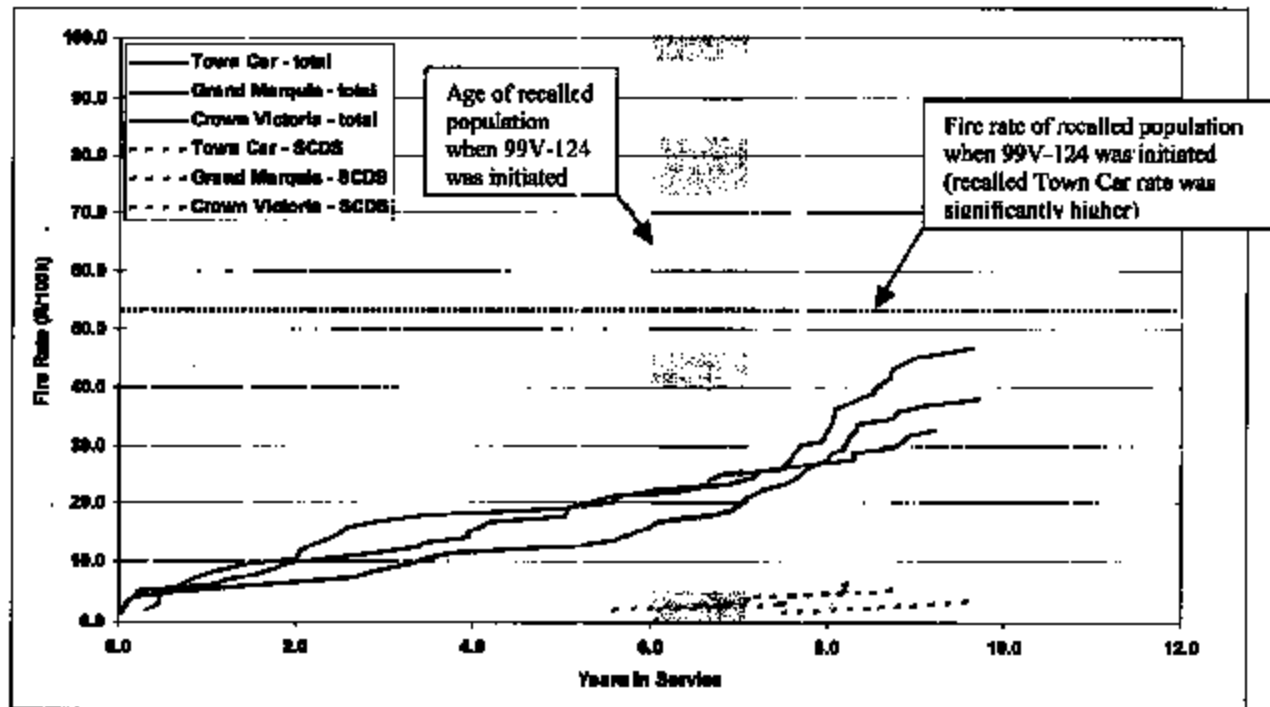
Figure 15. MY 1994 cumulative fire rates, all underhood fires⁹ and SCDS fires (ODI & Ford data).

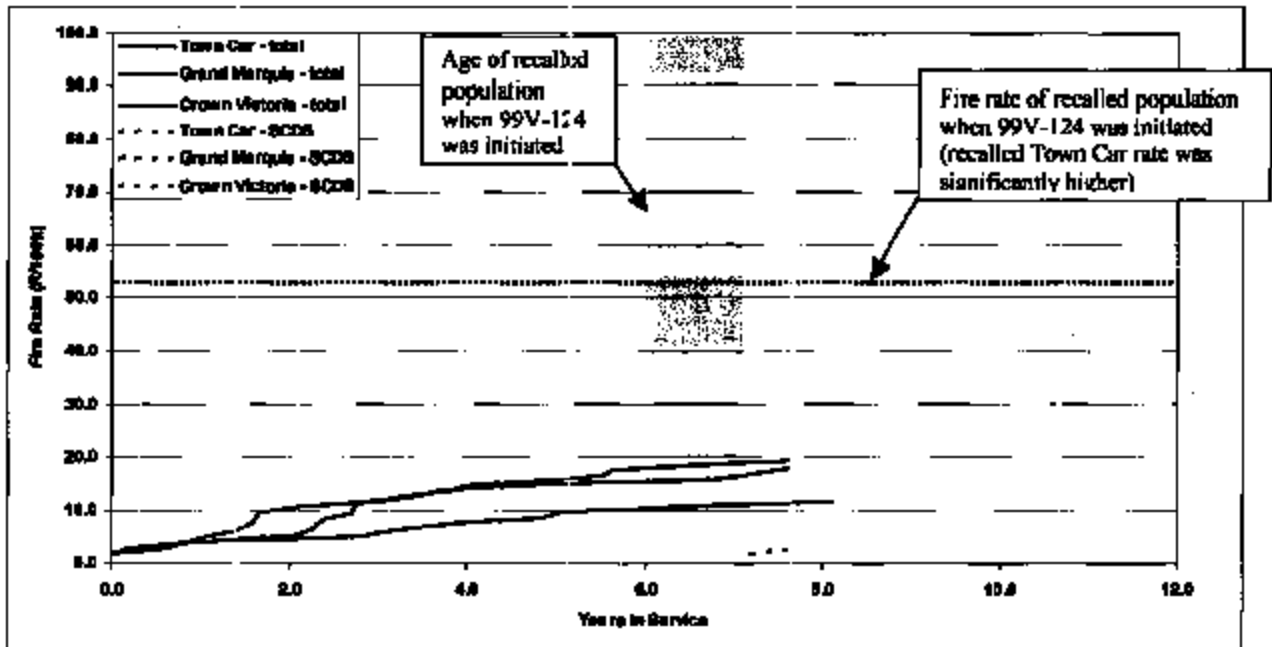
Figure 16. MY 1995 Cumulative Fire Rates, all underhood fires⁹ and SCDS fires (ODI & Ford data).

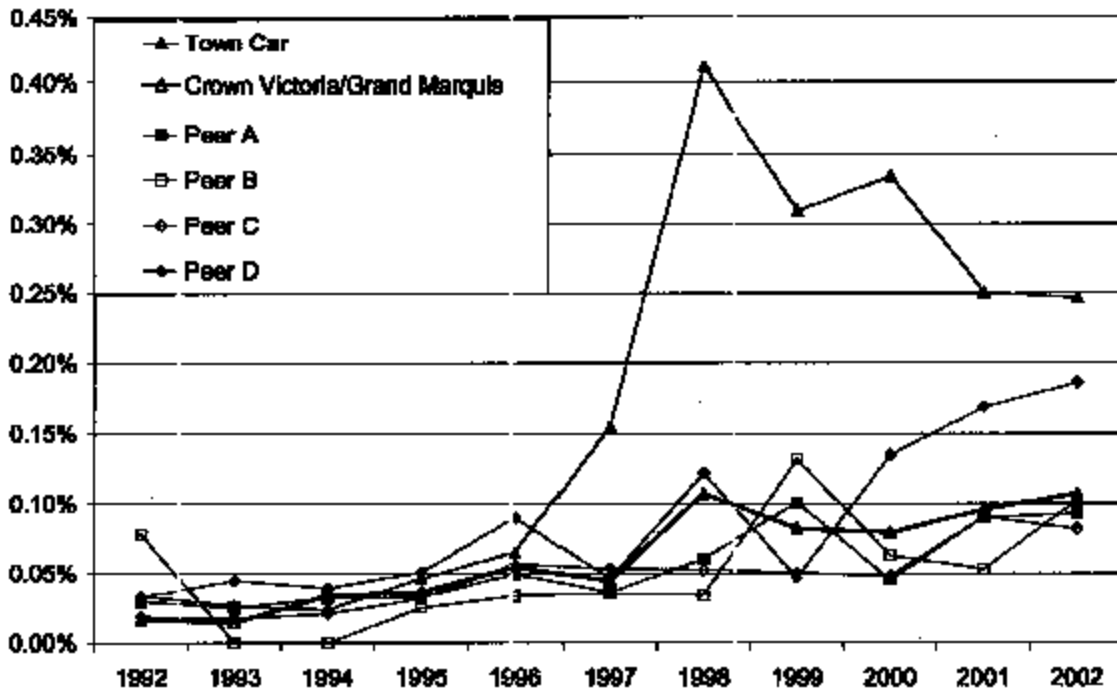
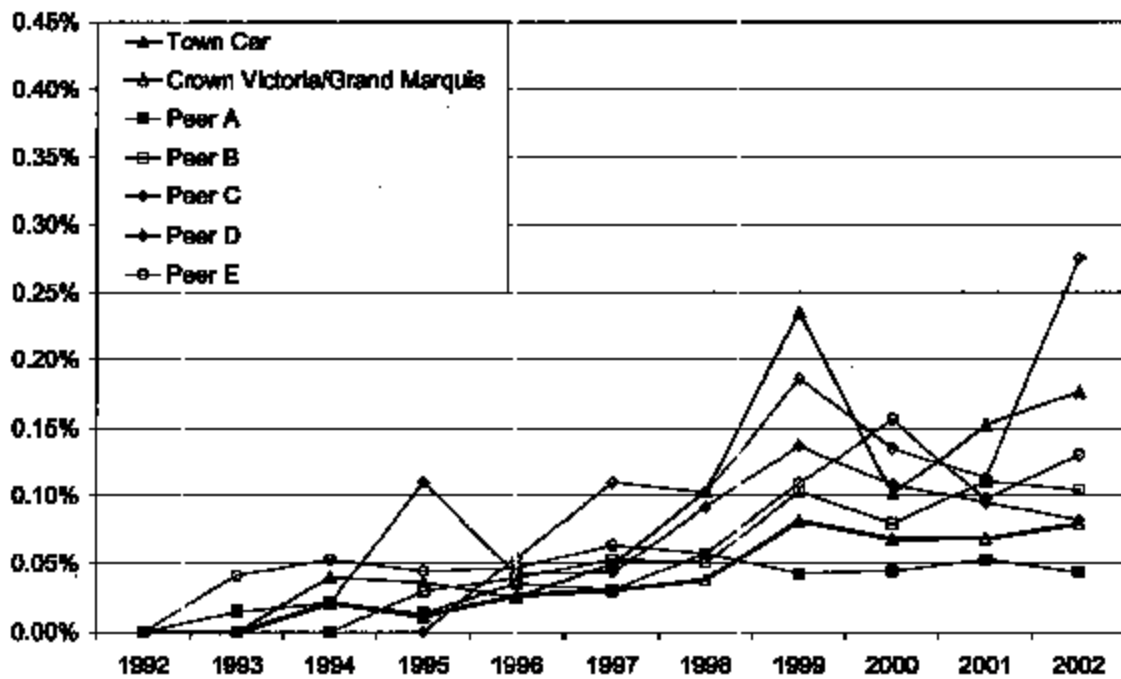
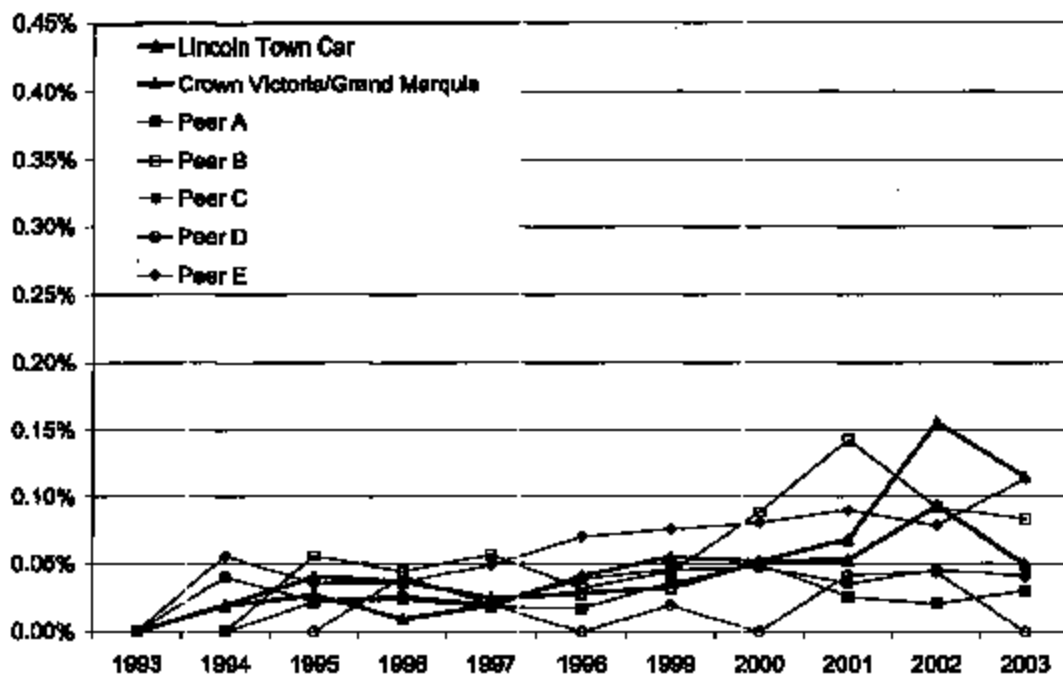
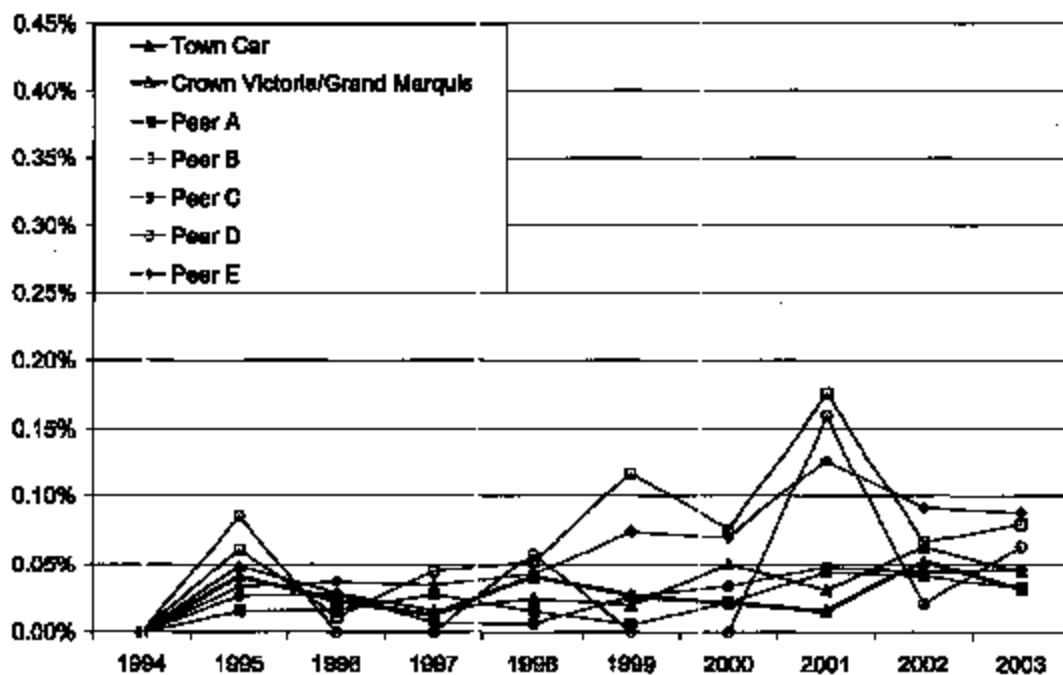
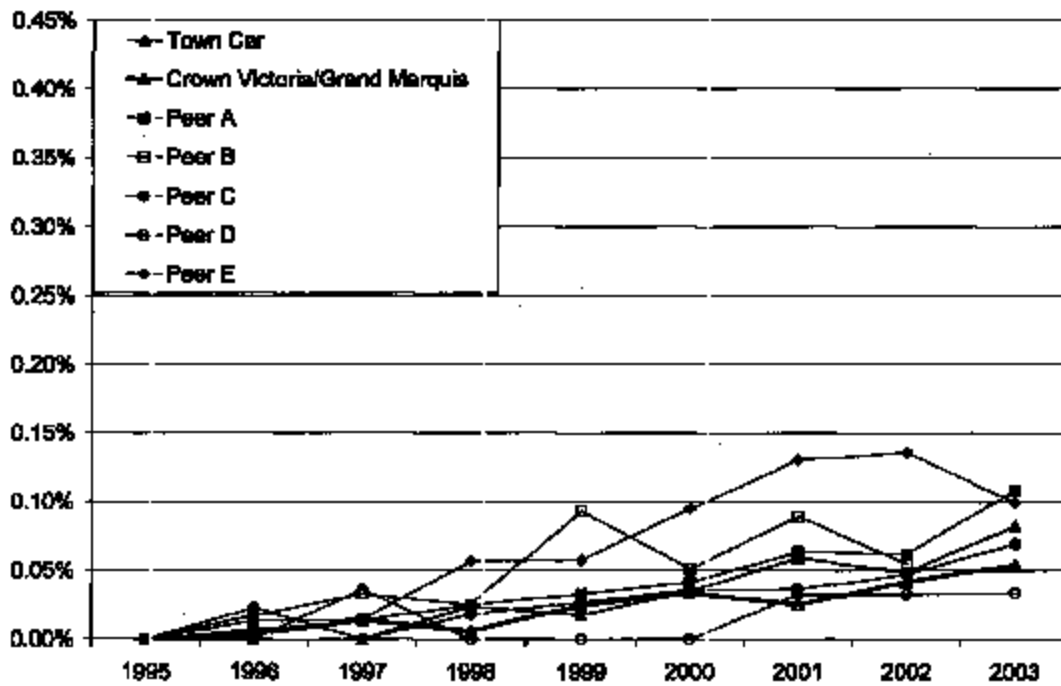
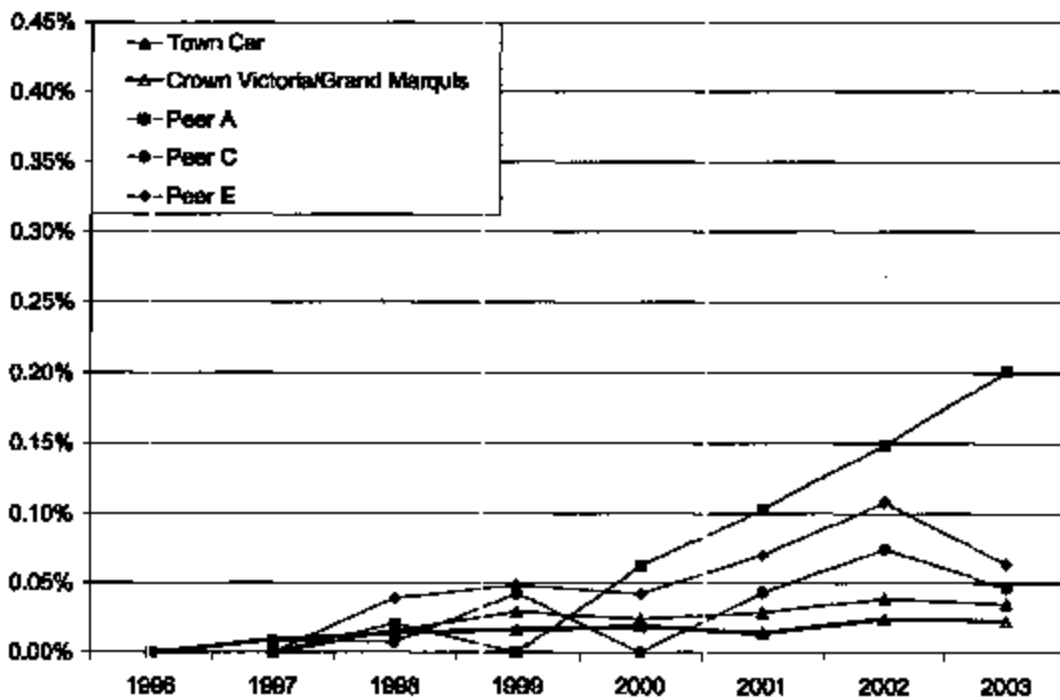
Figures 17 through 22 show the insurance fire claim rate trends of the subject vehicles and select peers for each model year. The MY 1993 data includes both recalled and non-recalled vehicles. Figure 23 shows the combined trends for MY 1994-97 subject vehicles by years of exposure. This analysis shows a moderate increase over time in the subject vehicles, particularly in the Town Car vehicles after 7 years in service. The insurance data is of limited use in evaluating a specific defect condition, since it is not limited to a specific location or cause. In addition, the insurance data could not be analyzed by key position or geographic trends.

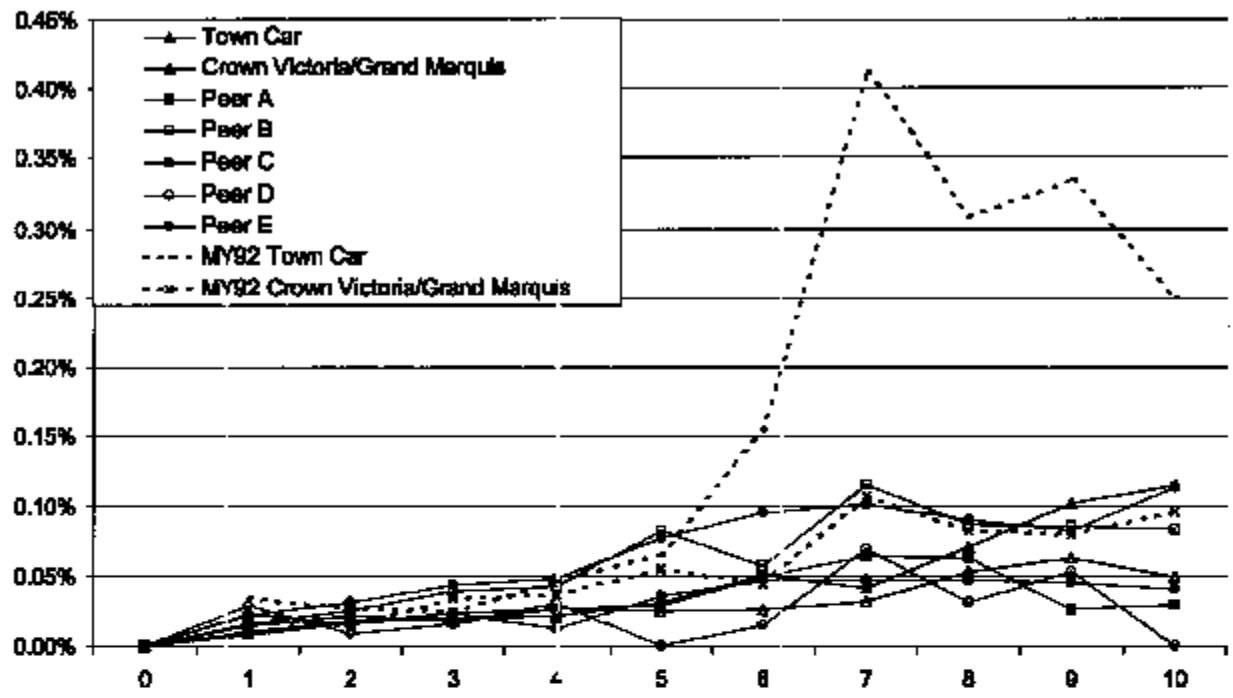
Figure 23. Insurance Claim Rates for Non-Crash Fires by Model and Exposure Years, MY 1994-97.
