**FORD 10/28/03
LETTER TO ODI**

VEHICLE AND GARAGE FIRE

CLAIM NO.: 565DP07941

P.A.C.E. PROJECT NO. I-2006A

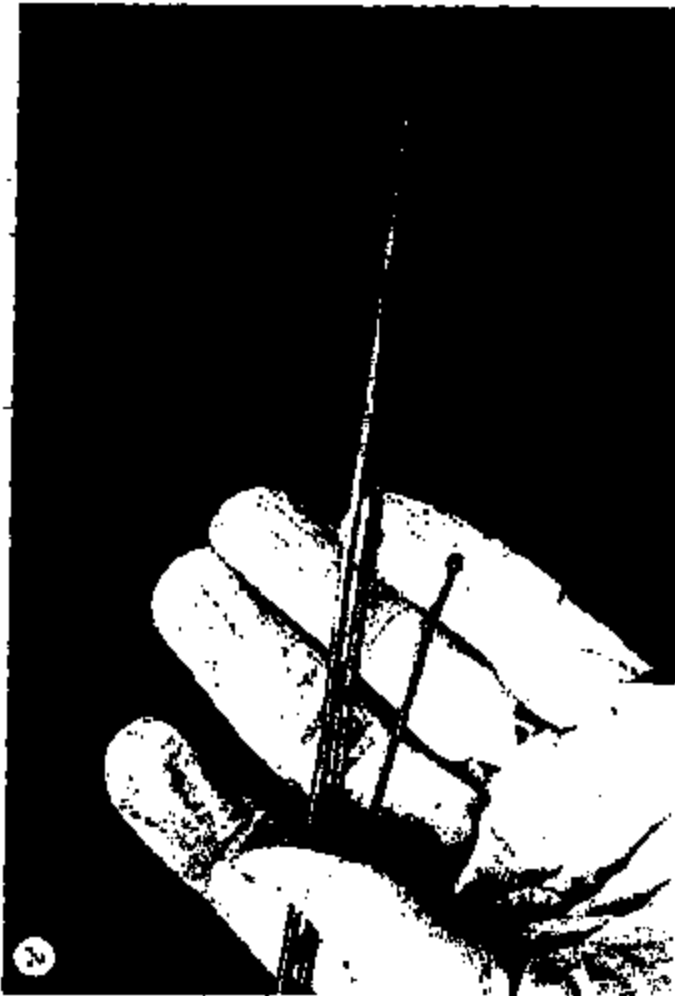
FIGURE 25

Figure 25 is a view of the remains of a romex-type cable which had traveled through the ceiling area above the automobile at the time of the fire. Figure 26 is a close view of the ends of this cable. The melted copper suggests that short circuit arcing may have occurred in this cable at some point in time, in my opinion.

VIEW OF ROMEX CABLE REMAINS

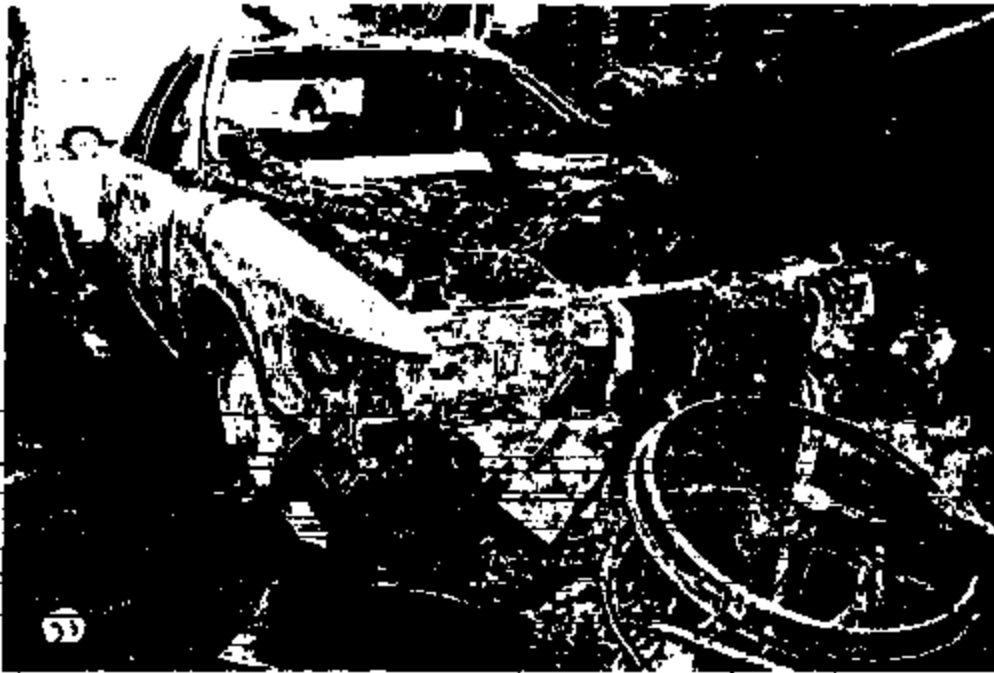
FIGURE 33

At the middle of Figure 2 a "clean area" may be observed on the block wall. This "clean area" is an area of very intense heating. This area was approximately in line with the right, front corner of the Mercury, which is where I believe the fire originated. Figure 33 is a view of this right, front

corner of the Mercury, and Figure 34 is another view. Figure 35 is a closer view of the wiring harness remains shown in Figures 33 and 34. I believe a vehicle short circuit arc in this area is what caused this fire.

FRONT VIEW OF MERCURY

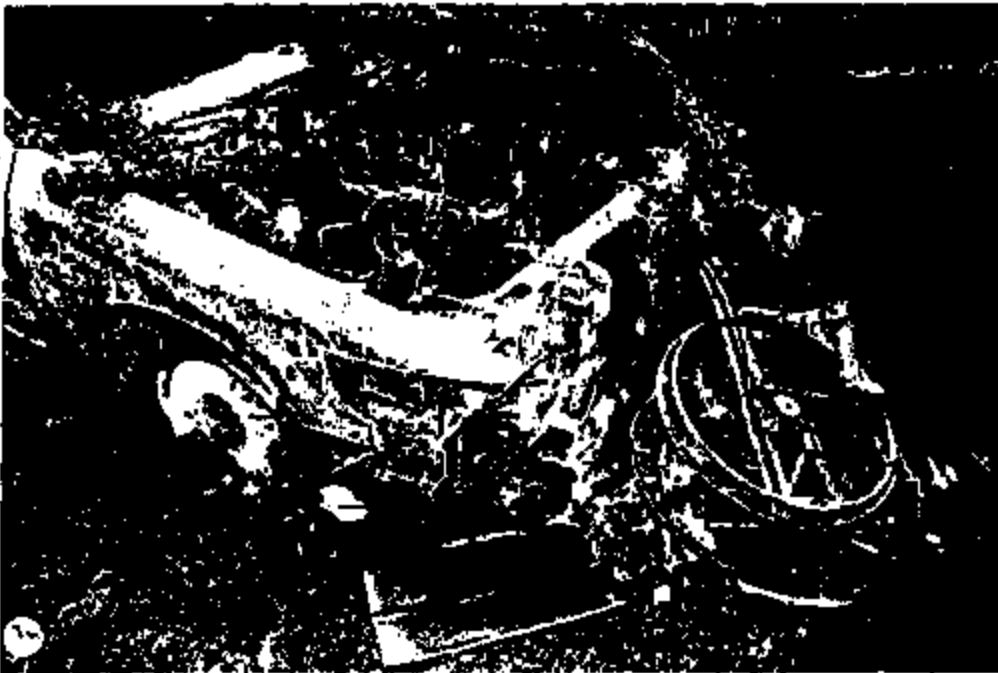
FIGURE 34

VIEW OF RIGHT FRONT CORNER OF MERCURY

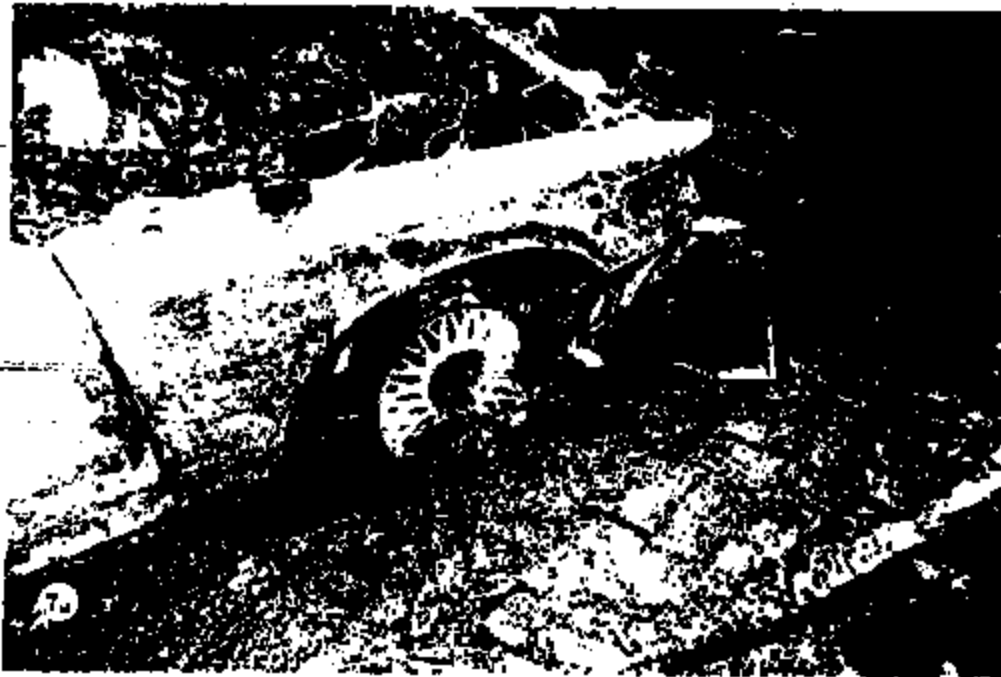
FIGURE 36

Figure 36 is another view of the partially melted right, front wheel. This wheel was much more intensely damaged than the other three wheels on the Mercury, which are shown in Figures 37, 38, and 39, in my opinion.

VIEW OF RIGHT FRONT WHEEL

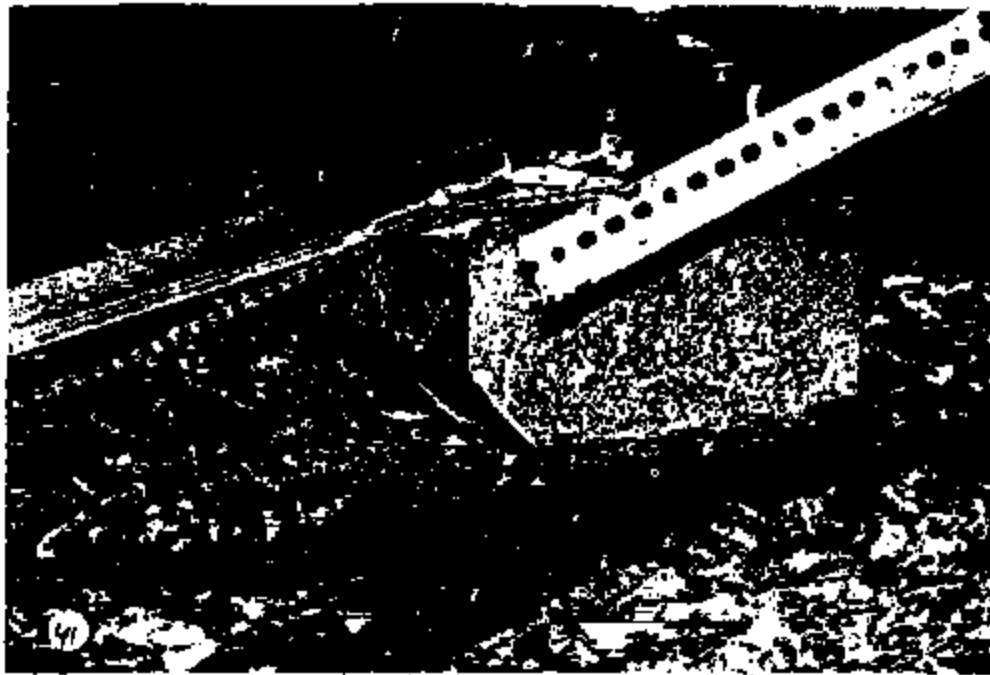
Figures 40, 41, and 42 are views of the garage door opener which has fallen onto the roof of the Mercury. I could find no holes in its metal cover. In my opinion, any short circuit arc inside the garage door opener would have to create a hole in the metal cover before flying copper globules could exit to cause a fire.

VIEW OF GARAGE DOOR OPENER REMAINS

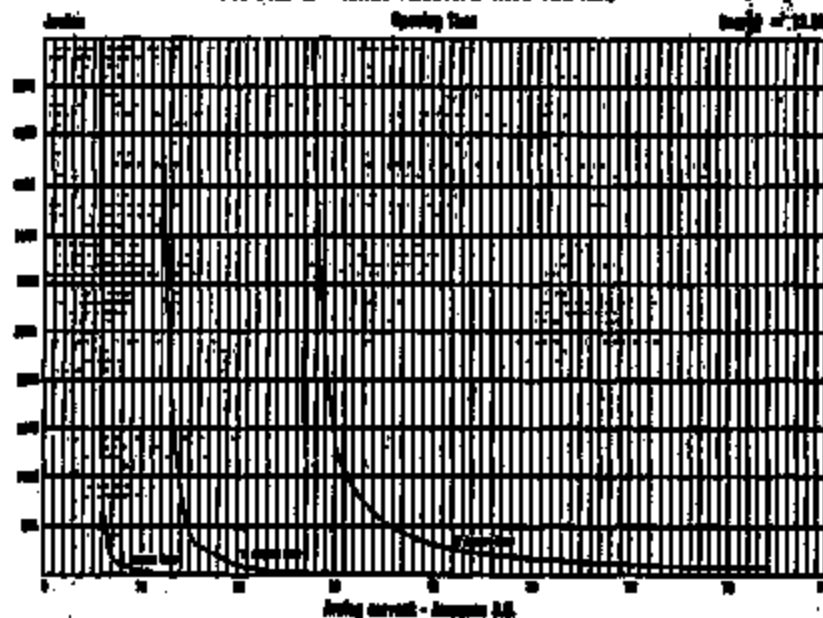
FIGURE 2 ENERGY ALLOWED INTO THE ARC

The heating energy delivered to the arc is proportional to the opening time of the fuse. Figure 2 shows the energy allowed into an arc by each size before it pops, as a function of the current that the short circuit arc draws. Between 15 and 25 amperes of arcing current, a 20-ampere fuse allows hundreds of times more heating energy into an arc than a 10-ampere fuse. Likewise, a 30-ampere fuse allows hundreds of times more energy into an arc between 7 and 15 amperes than a 5-ampere fuse.
