EA02-025

**FORD 10/27/03
LETTER TO ODI**

BOOK 6 OF 22

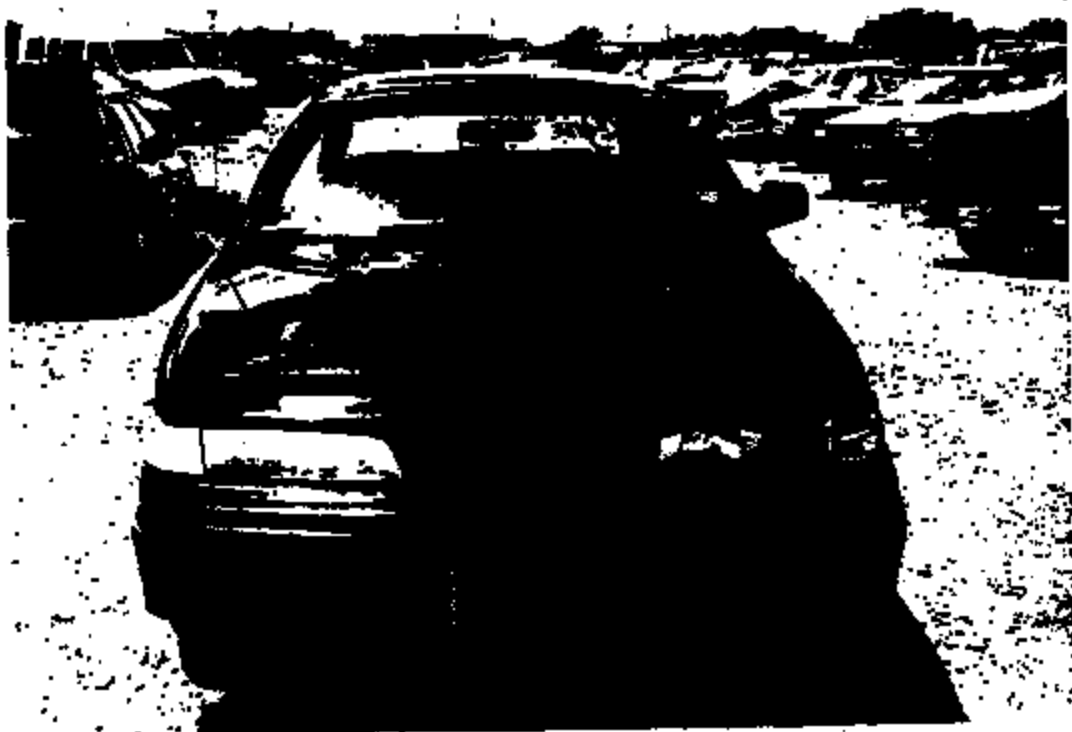
No. 1

1. Front of fire damaged 1992 Ford Crown Victoria.
2. Right front corner of involved vehicle.
3. Right rear corner of involved vehicle.
4. Left rear corner of involved vehicle.

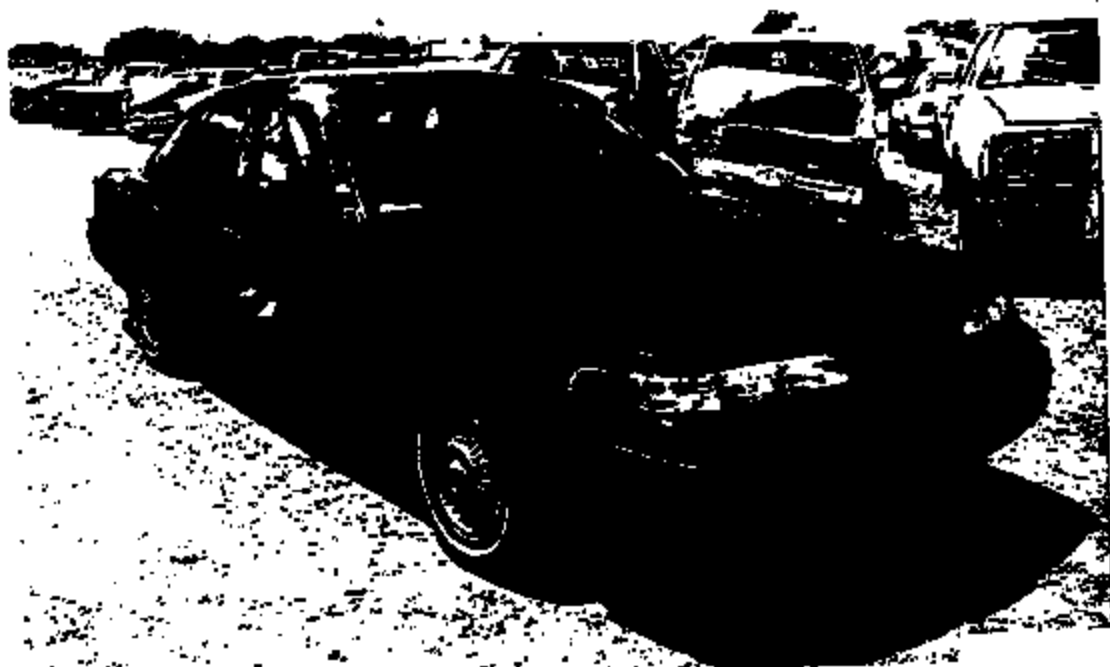
No. 2

1. Front of fire damaged 1992 Ford Crown Victoria.
2. Right front corner of involved vehicle.
3. Right rear corner of involved vehicle.
4. Left rear corner of involved vehicle.

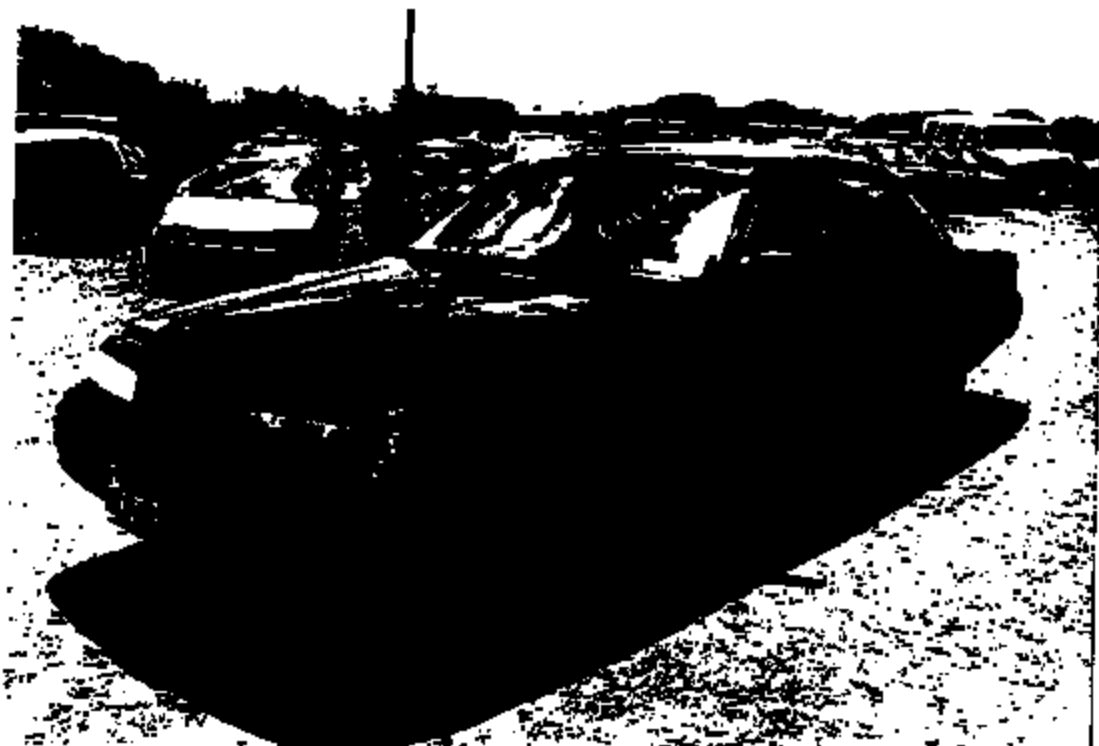
No. 5

5. Left front corner of involved vehicle.
6. Undamaged paint on exterior surface of the hood.
7. Minor damage and heat stress on right front corner of hood.
