**EA02-025**

**APPENDIX N**

PE Opening Reports (PE98-055)  
 1992 Lincoln Town Car Engine Fires

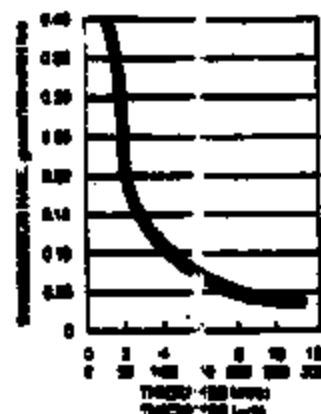
Figure 13. Water Vapor Transmission Rate of DuPont FEP Film at -4°C (24°F) as ASTM E-96 (Modified)

Many gases and vapors permeate FEP films at a much lower rate than for other thermoplastics (see Figure 13). In general, permeation increases with temperature, pressure, and surface contact area and decreases with increased film thickness. Table 6 lists rates at which various gases are transmitted through DuPont FEP fluorocarbon film, while Table 7 lists rates of vapor permeability for some representative substances. Note that the pressure for each material is its vapor pressure at the indicated temperature.
