**EA02-025**

**APPENDIX N**

# PE98-055 1992-1993 Lincoln Town Car

14D Number:	14D Title:	92-93 Town Car F2VC-9FB24-A Brake Pressure Switch		
Plant/Activity:	Open Date:	12/15/1998	Close Date:	Status: Open
<b>D1. PROBLEM DESCRIPTION:</b>				
NHTSA letter PELB-055 identifies "...21 reports of engine compartment fires in 1992 and 1993 Lincoln Town Cars." One of the insurance reports included with the letter states "...that the fire originated in the area of the brake system pressure switch located below the master cylinder..."				
<b>D2. DEFINE ROOT CAUSE:</b>				
<b>D3. PROBLEM INVESTIGATION/VERIFICATION DATA:</b>				
One sensor which exhibited a melted cavity was analyzed by Texas Instruments (the supplier) showing corrosion in the switch cavity. All three layers of the 'topper' membrane were blistered and perforated.				
Two sensors from suspected incidents were analyzed by Ford's Central Laboratory. The plastic housing and switch mechanism were gone and the other components damaged too greatly to identify a leak path.

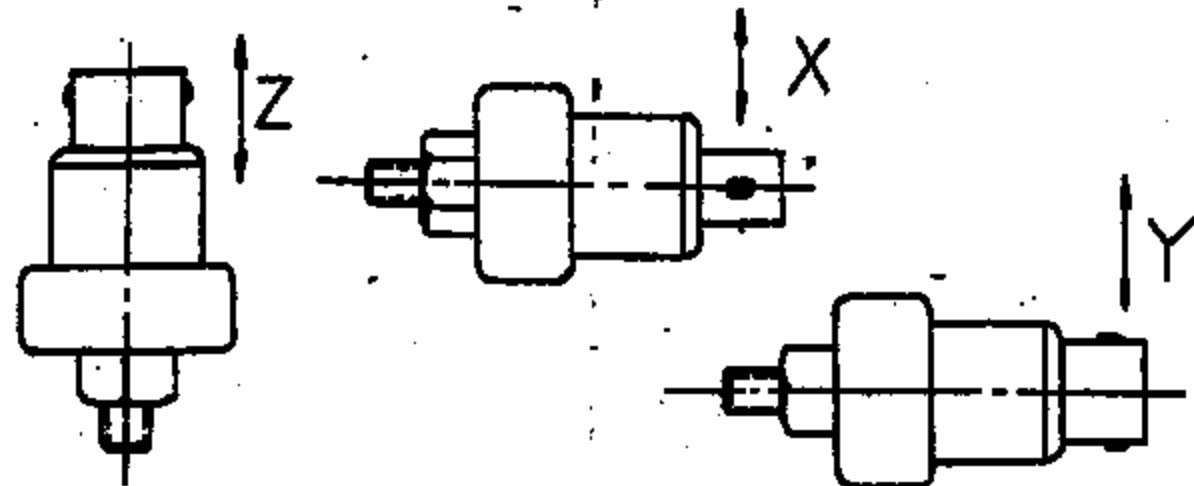
**FIGURE 1.**

- a. Mount the switch in the test port and attach the currently released rating electrical connector before start of test.
- b. Switches are to be vibrated in all 3 planes with electrical continuity being monitored during the entire test. See Figure 1 for switch orientation in the 3 planes. Vibration tests are to be conducted at room temperature using brake fluid, ambient air, or equivalent as the pressure medium.

**VIBRATION TEST - SWITCH ORIENTATION**

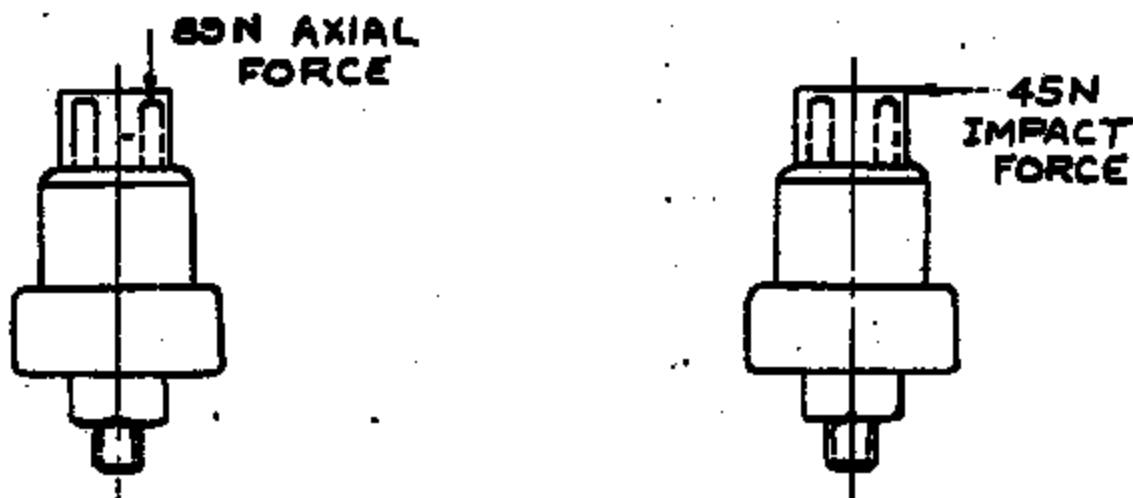
**FIGURE 2.**

- a. Mount the switch in the test port.
  - (1) Apply a  $89 \pm 9$  N axial force to each terminal.
  - (2) With a pendulum apply a  $43 \pm 5$  N impact force to the switch housing at the connector end, perpendicular to the centerline axis of the switch. See Figure 2 for force application point and direction.

**TERMINAL STRENGTH - LOAD ORIENTATION**

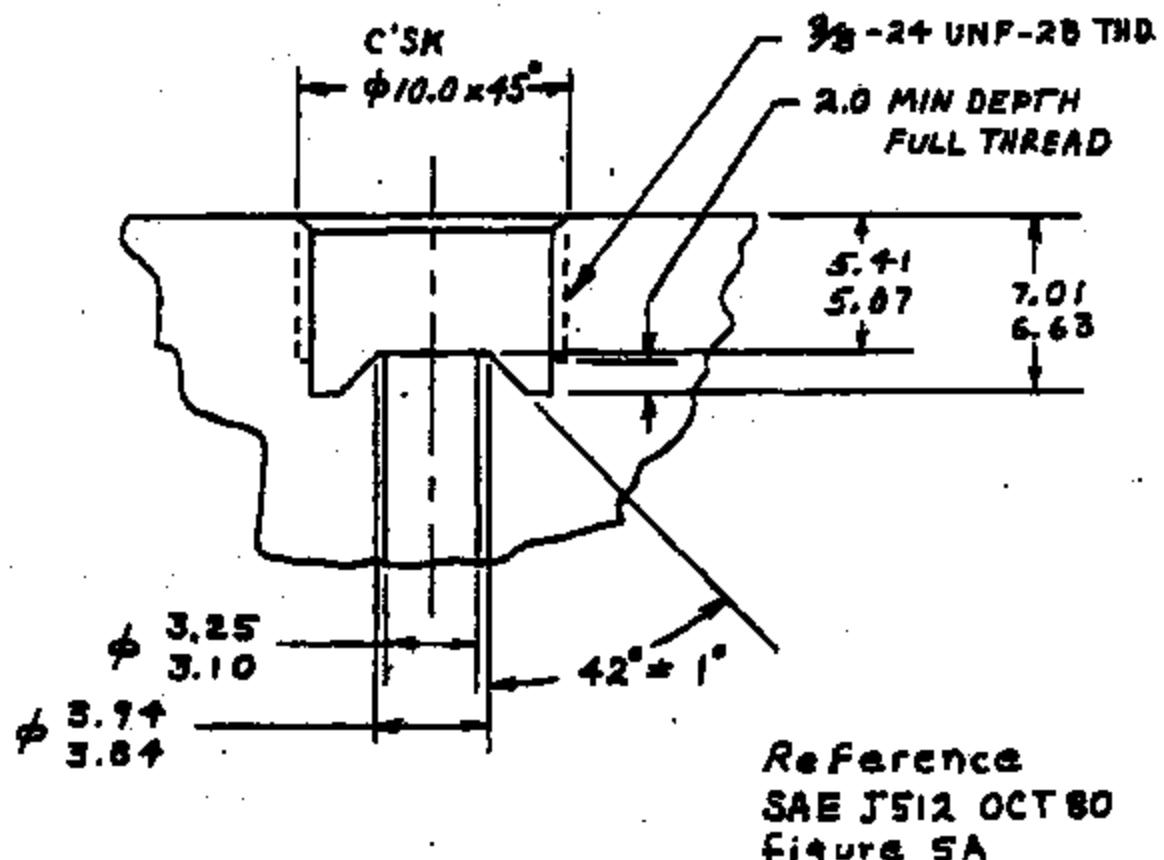
FIGURE 3

Test port configuration is shown in Figure 3.

TEST FIXTURE PORT CONFIGURATION
