**EA02-025**

**FORD 10/27/03**

**APPENDIX N**

# Parade of 92/93 Town Car Underhood Fire Allegations With Engine On/Off/Unknown

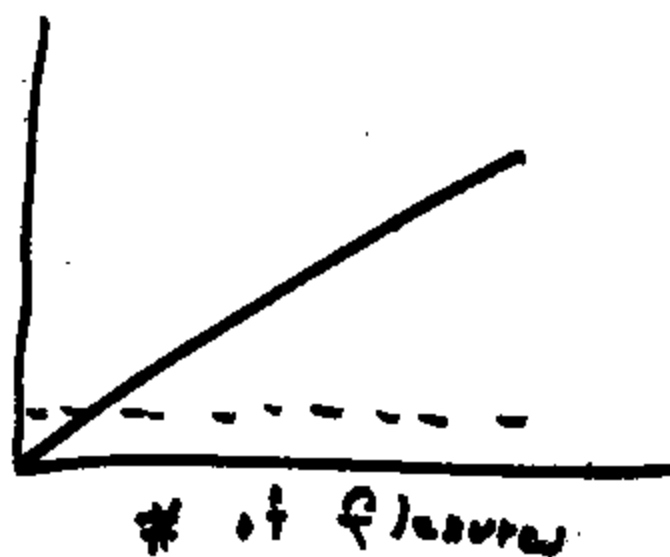
Seal deterioration, Amount of current, Length of path from term. to ground

Ray's  
defect

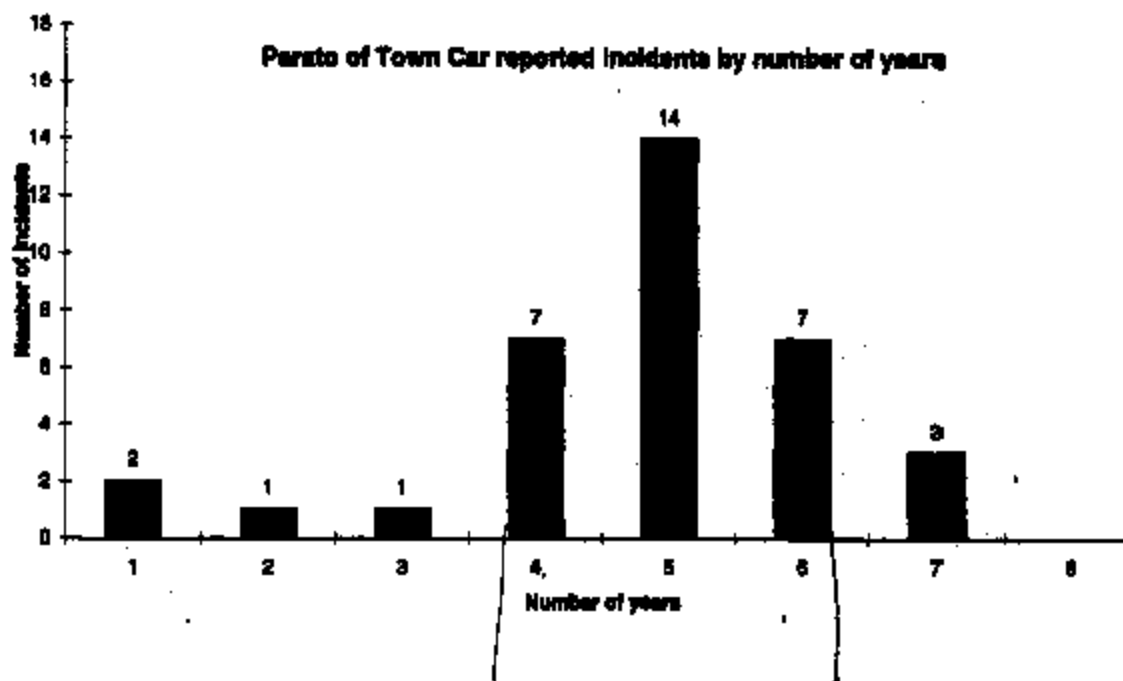
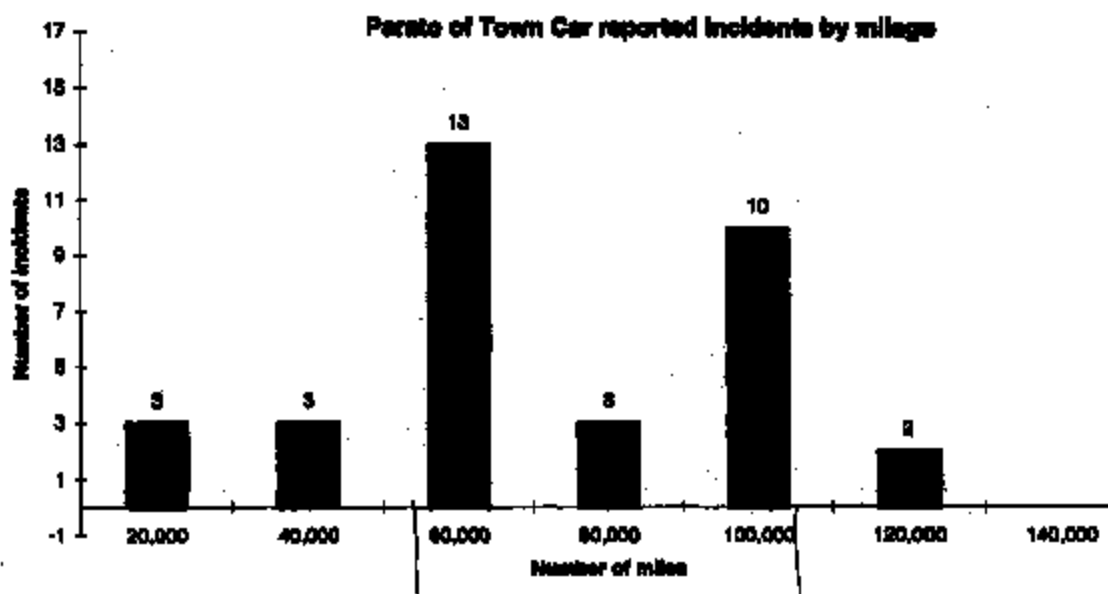
## 92 Lincoln Town Car Reported Incidents Of 40 Vehicles with Engine Off/Unknown

There were 5 vehicles with unknown vms, therefore, years in service were undetermined.  
There were 8 vehicles with unknown miles.
