**EA02-025**

**APPENDIX N**

# RECALL

**SUBJECT:** Safety Recall 99S15: Certain 1992 and 1993 Crown Victoria, Grand Marquis, and Lincoln Town Cars with Speed Control - Speed Control Deactivation Switch

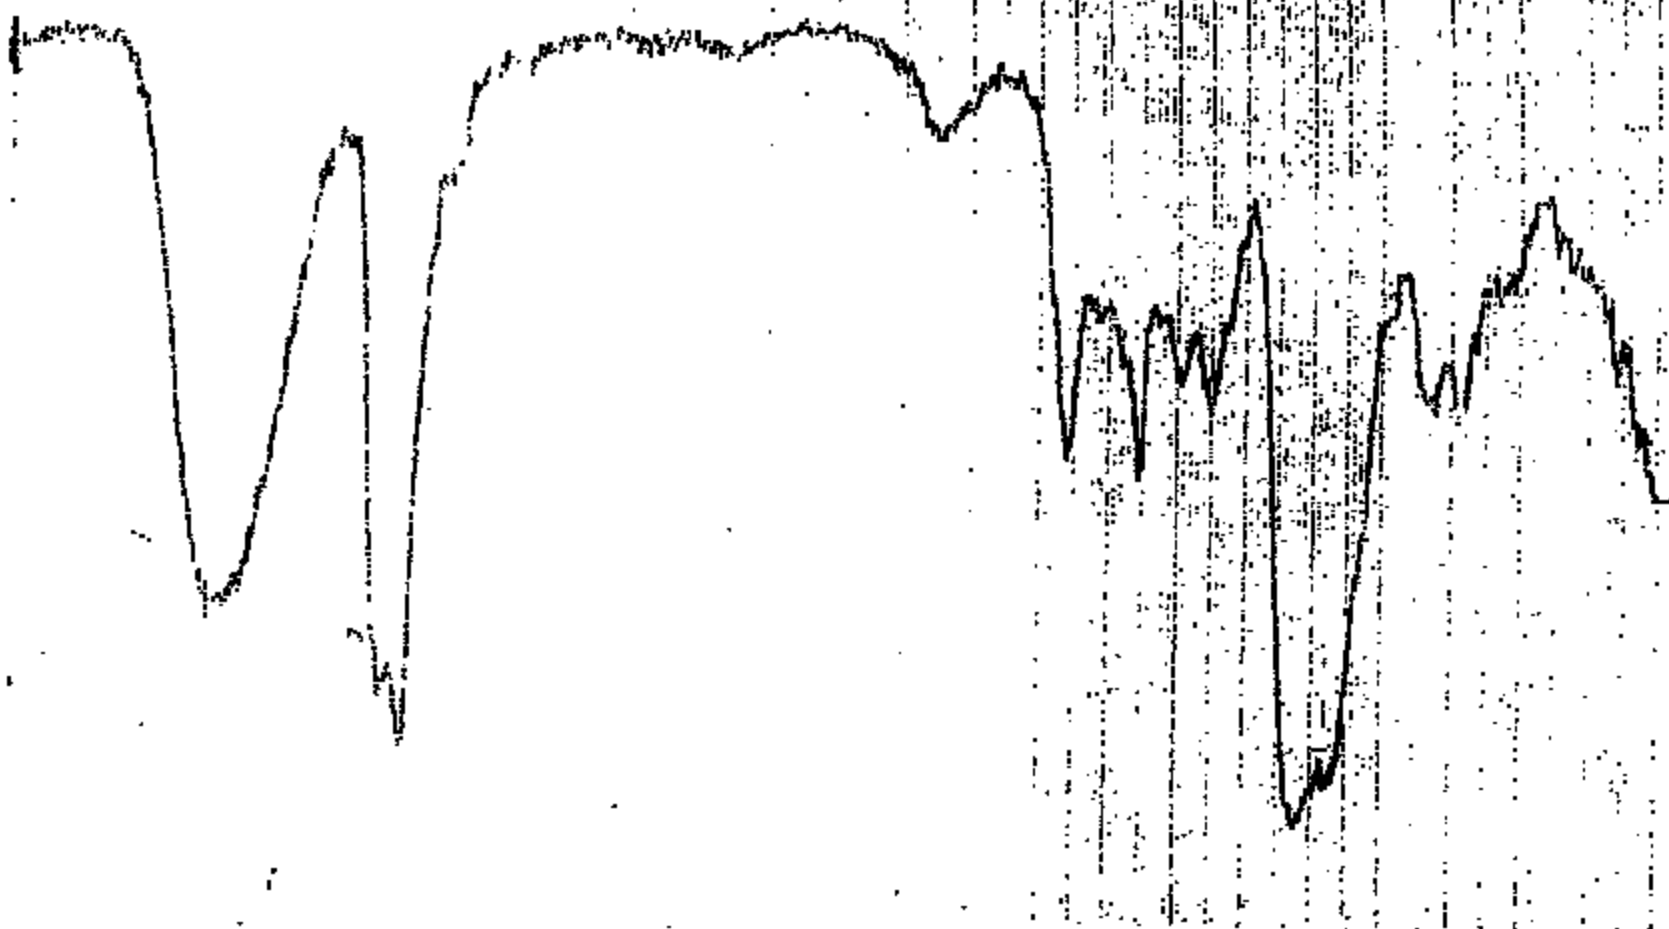
6.1000  
 CHCl<sub>3</sub>  
 14-00  
 TL

Only some were evaluated for chemical analysis. Number 4, 6, 7 and 8 were extracted for brake fluid using the common solvent, chloroform. All of these showed significant amounts of DOT-3 brake fluid. Number 2 was extracted but there was no visible wet (possible brake fluid) extract found.
