**FORD 12/12/03 LETTER
TO ODI 4 BOOKS**

ATTACHMENT L

**PART 4 OF 4
BOOK 2 OF 4**

Purpose: To Define Root Cause of Stop Lamp Switches that fall after the original switch was replaced on FSA 01808.

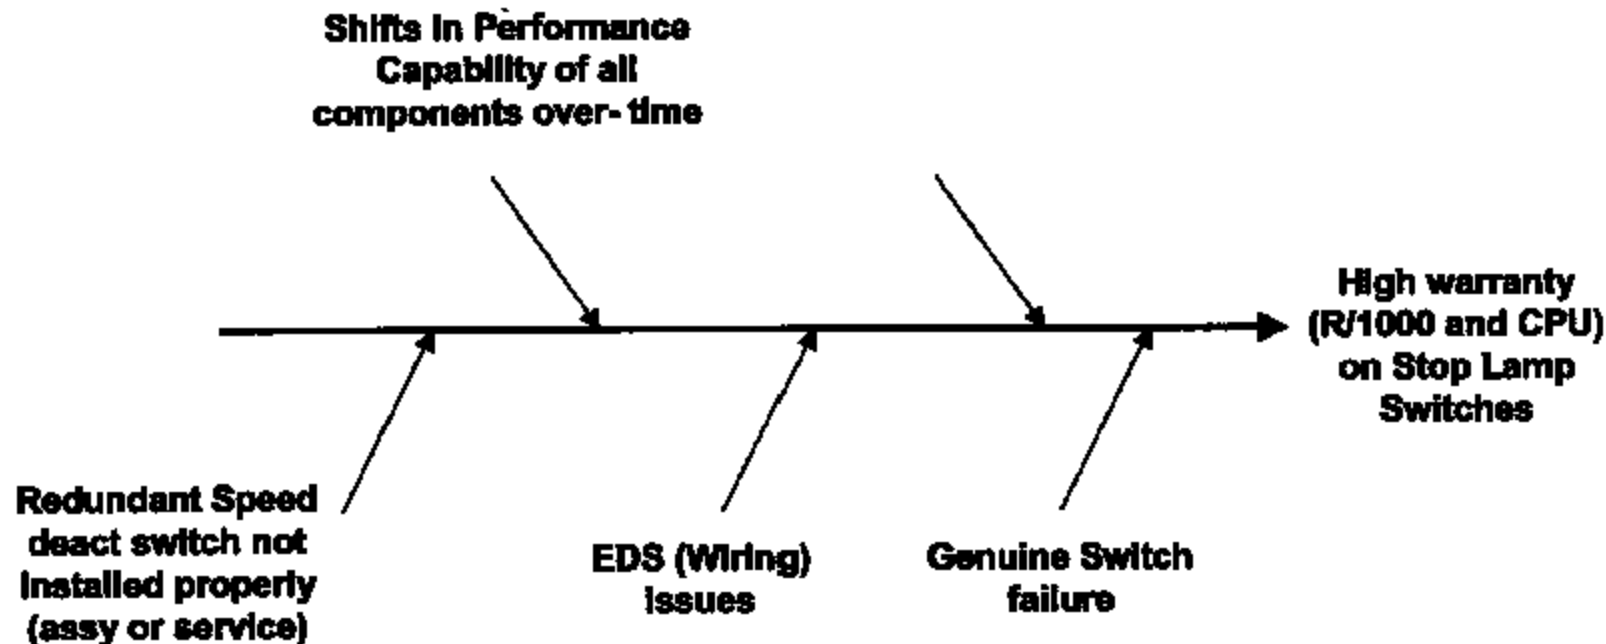
Cause & Effect Fish Bone Diagram: High Warranty (R/1000 and CPU)

A permanent corrective action is being investigated for feasibility

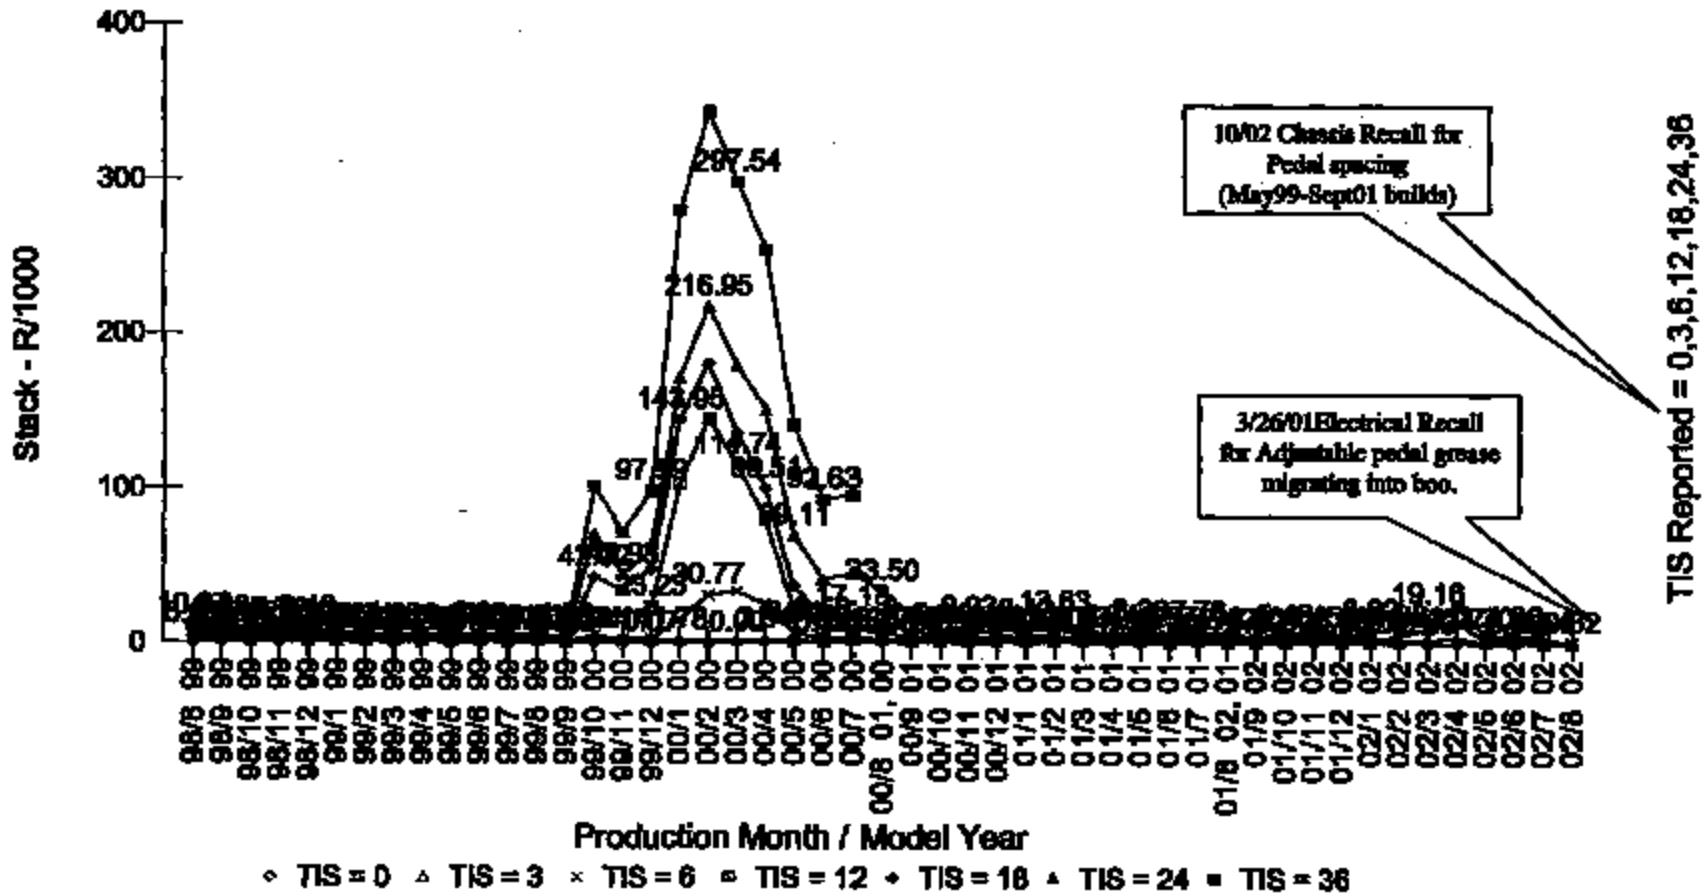
D186 Total BOO

Pollak 2 Terminal Switch	Customer /Tech	Field Analysis	Switch Design Changes	System Changes
D186	Lts On & Park Shift Interlock	- Field returns show no problem found - Pedal box lash & wiring issues	-Change the <u>switch actuation range</u> (upwards) to compensate for system interaction. (C11470585; ETA NOV 03) *- Change to stronger spring within switch to counter pedal weight (Testing req'd: DPG Vehicle testing, component testing, and fleet testing (accelerated life); ETA Jan04cy).	-Hi flex wire adopted to prevent wiring breakage. -Chassis & Switches developing System FMEA: cascade SC's to all suppliers
W126/ V229	Lts On	- Field returns show no problem found - W126 rod is major contributor to lts on	See above	- V229 improved robust pedal box & booster rod changed. - Wiring TBD (New supplier) - Chassis & Switches developing System FMEA: cascade SC's to all suppliers
U152	Lts On & Park Shift Interlock	-IVD vehicles predominantly. -Also 03MY not trending like 02MY.	See above	- Wiring sheathing on 03MY and takeout length reqs revision- identified . - Redundant Speed deact switch changes @ J1 to address adj IVD vehicle problem with Lts on. - Chassis & Switches developing System FMEA: cascade SC's to all suppliers
