Petition

**A Petition of Investigation
Office Of Defects Investigation C/O
National Highway Traffic Safety Administration
Room 5319 , NVS-215
400 7th Street SW
Washington , D C 20590**

For public safety and to perform a citizen's duty , I Robert Galanty hereby petition the National Highway Traffic Safety Administration for the following reasons pertaining to the 1992-1997 Chrysler LHS family of vehicles namely initiating with VIN number 2R3HD56F3TH306742 which exploded on July 2,1996 with 250 miles on the odometer (Note: This vehicle is believed as per Chrysler / U S Customs records to have been a Canadian gray Market vehicle) to conduct an investigation into the left and right fuel rail subject to Chrysler recall number 790 , ABS brakes subject to earlier recall number unknown at this time and the frame construction / allignment.

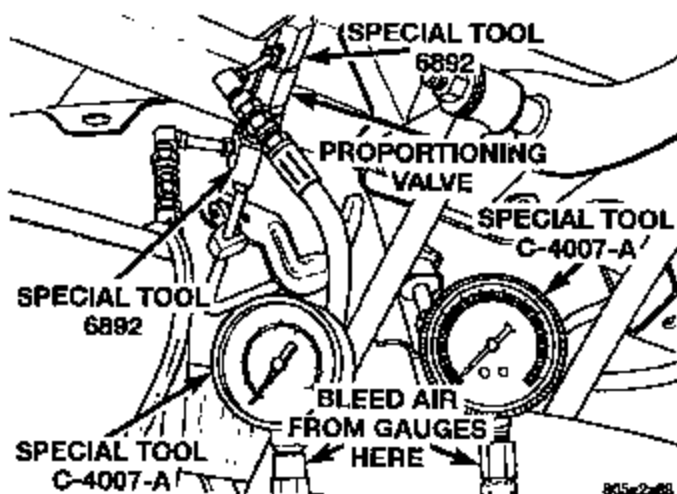
Fig. 23 Pressure Gauges Installed

outlet pressure does not agree with value shown on the following chart, when inlet pressure shown on chart is obtained, replace the proportioning valve. If proportioning valve is within pressure specifications do not replace proportioning valve.
