DP04-006

Attachment #Q6

Safety Recall: Ignition Switch Key Interlock

(Supersedes 03-088, dated January 8, 2004)

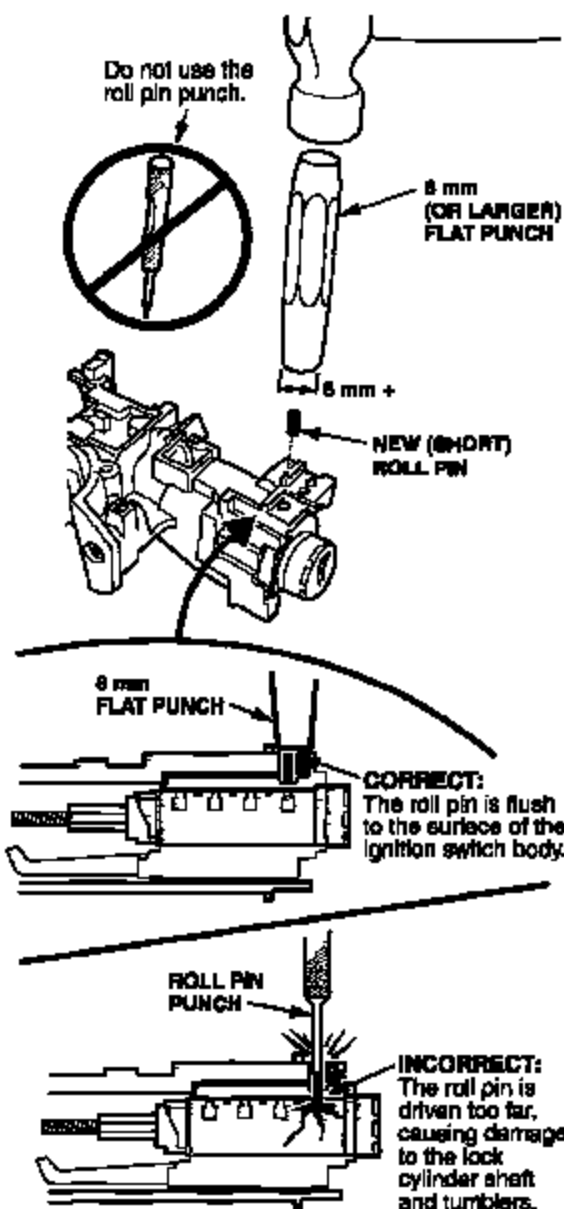
NOTE: The new roll pin is about 1/2 mm longer than the original one. Do not install the original roll pin; it cannot be fully seated in the new lock cylinder body.

19. Install a new (short) roll pin in the hole on the lock cylinder body with a 6 mm (or larger diameter) flat punch and a small hammer. **Do not use the roll pin punch to drive the new roll pin.** When correctly installed, the top of the roll pin is flush with the lock cylinder body.

To avoid damaging the lock cylinder shaft and its tumblers, do not drive the roll pin past its flush position on the lock cylinder body.

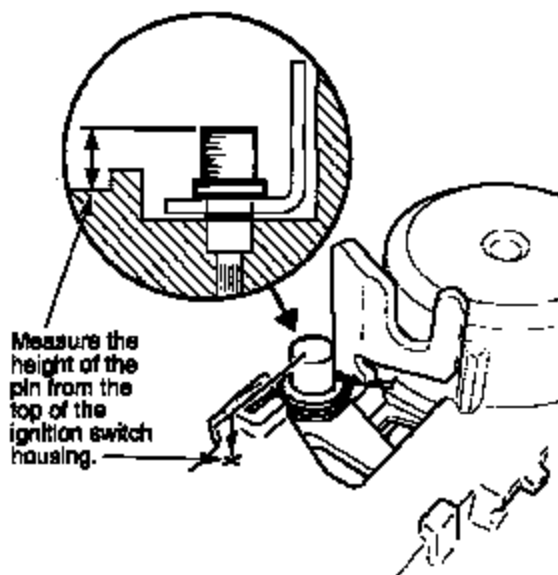
NOTE: It's normal for the interlock lever to be loose, even when the pin is fully seated.

22. Use vernier calipers to measure the installed height of the lever pin. The height should be close to the measurement you made in step 5 of the inspection procedure. If the height is more than 5.3 mm, the pin is not seated. If needed, reattach the slide hammer, and seat the pin.

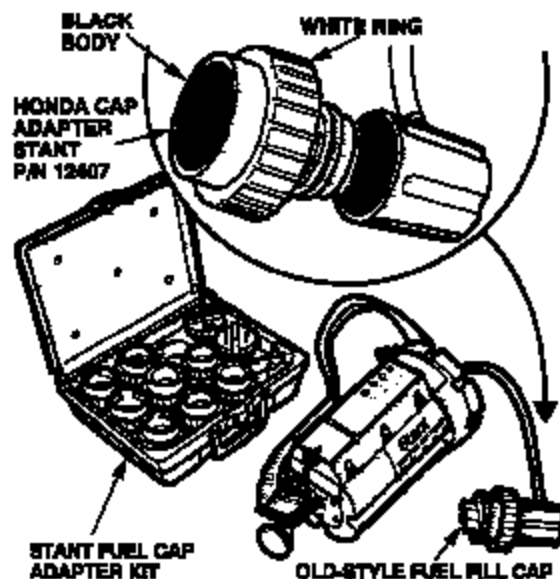
Tech Line has been getting calls from our dealers about customer's vehicles failing a state I/M (Inspection/Maintenance) program test (smog check) because of defective fuel fill caps, only for those vehicles to fail the test *again* after the dealer replaced the cap with a new one.

The problem might not be the fuel fill cap, but instead the equipment used for testing. If the smog check station is using a Stant fuel cap adapter kit, and the wrong adapter is used, the fuel fill cap *won't* fit properly, and it *will* fail the leak test.

The right adapter for testing these fuel fill caps is Stant P/N 12407 (it's black with a white ring). If your dealership is a state-certified smog check station, and you're *not* using this adapter, contact Stant Corporation at 765-825-3121 and order the adapter. If customers coming into your dealership failed the test at other smog check stations, as a customer courtesy, contact those stations, and tell them about this adapter.

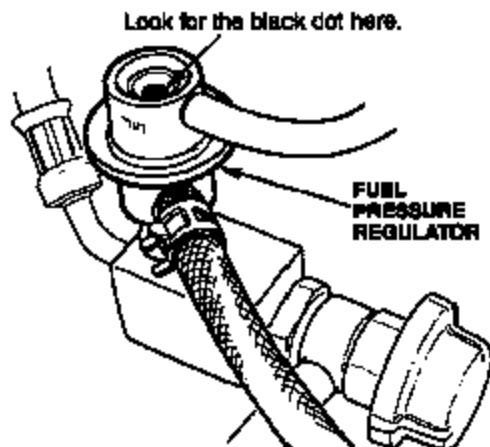
During the '00 model year, the factory changed the fuel pressure regulator and the PCM in '00 Accord V6 4-door models (from VIN YA[redacted] and 2-door models (from VIN YA[redacted] to improve engine starting after hot soak. The new fuel pressure regulator is set to a range of **48 to 54 psi** instead of **41 to 48 psi**, and is marked with a black dot so it's easy to identify. The new PCM mounts with three bolts instead of two.

The PCM and fuel pressure regulator must be matched to each other; otherwise, performance drops over time and the MIL eventually comes on. When ordering a replacement PCM, make sure you're ordering the unit that's matched to the fuel pressure regulator installed in the vehicle.

To keep things straight, check the fuel pressure regulator for a black dot. If you see a black dot, order PCM P/N 37820-P8C-A55, H/C 6828479. If you don't see a black dot, then order P/N 37820-P8C-A53, H/C 6358469.

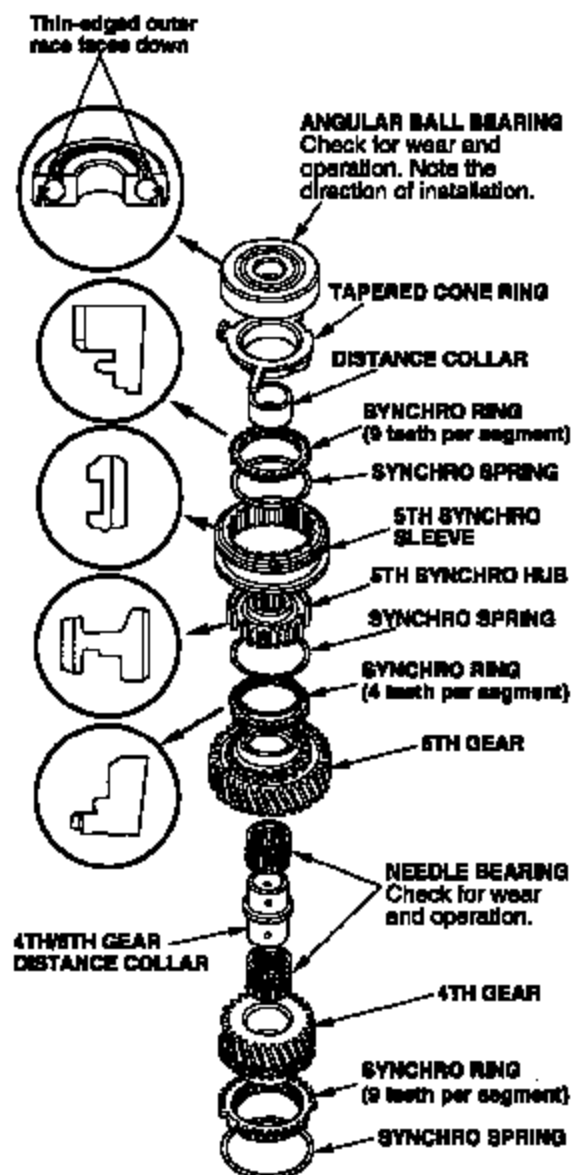
Our thanks go to **William Shaughnessy** of Metro Honda in Johnson, RI, for pointing out an error in the 2001-04 Civic S/M. The synchro ring order for 5th gear is wrong in the Exploded View on page 13-28. It shows the synchro ring with nine teeth per segment mating to 5th gear and the synchro ring with four teeth per segment mating to the tapered cone ring. If you install the synchro rings in this order, the M/T locks up in 5th gear.

To ensure proper reassembly of 5th gear, refer to this exploded view.

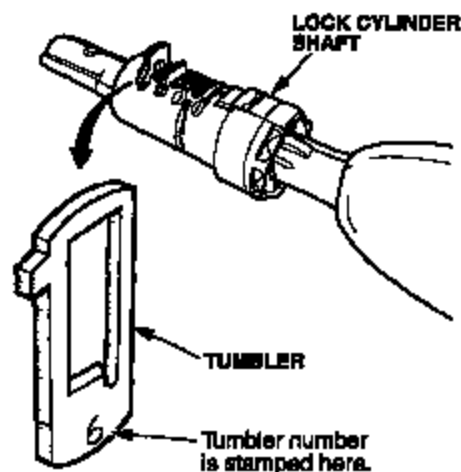
- When you're instructed to turn the ignition switch to LOCK (0), whether you're doing the **INSPECTION PROCEDURE** or **REPAIR PROCEDURE A** or **REPAIR PROCEDURE B**, make sure you push the ignition key in while you turn the switch to LOCK (0).
- In step 16 of **REPAIR PROCEDURE B**, if you can't turn the ignition key 90 degrees clockwise as instructed, check the ignition key for excessive wear. If the key is worn, cut a new one using the vehicle's key code. If you still can't turn the switch with the new key or the switch feels stiff, one or more of the tumblers may be worn. Remove the lock cylinder shaft, and replace the worn tumbler(s).

- If your parts department doesn't have the replacement tumbler(s) you need, Honda parts stock carries a complete tumbler kit as well as individual tumblers in packs of 25. Refer to this table when ordering:

- If you've done all the steps in **REPAIR PROCEDURE A** or **REPAIR PROCEDURE B**, and the ignition key still comes out of the switch with the shift lever in gear, then do this: Remove the key interlock solenoid cover, insert the key, and turn the ignition switch to ACCESSORY (1). Watch the interlock solenoid plunger as you push in on the ignition switch with the key.
 - If the plunger moves in toward the solenoid, then install Key Interlock Repair Kit B (if you've installed Key Interlock Repair Kit A). If you've already installed Key Interlock Repair Kit B, then order another kit, and install it, carefully following the steps in **REPAIR PROCEDURE B**.
 - If the plunger doesn't move in toward the solenoid, refer to the circuit schematics in the Switch Interlock section of the appropriate ETM for assistance in troubleshooting.

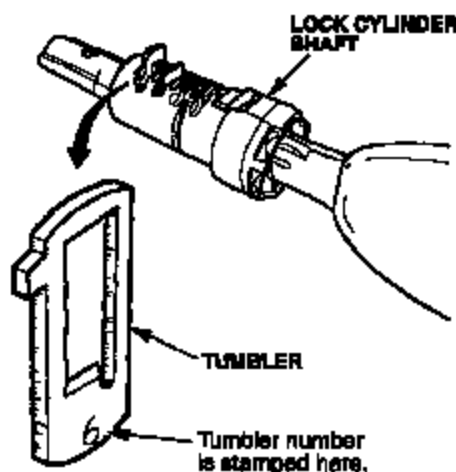
- When you're instructed to turn the ignition switch to LOCK (0), whether you're doing the **INSPECTION PROCEDURE** or **REPAIR PROCEDURE A** or **REPAIR PROCEDURE B**, make sure you push the ignition key in while you turn the switch to LOCK (0).
- In step 16 of **REPAIR PROCEDURE B**, if you can't turn the ignition key 90 degrees clockwise as instructed, check the ignition key for excessive wear. If the key is worn, cut a new one using the vehicle's key code. If you still can't turn the switch with the new key or the switch feels stiff, one or more of the tumblers may be worn. Remove the lock cylinder shaft, and replace the worn tumbler(s).

- If your parts department doesn't have the replacement tumbler(s) you need, Honda parts stock carries a complete tumbler kit as well as individual tumblers in packs of 25. Refer to this table when ordering:

- If you've done all the steps in **REPAIR PROCEDURE A** or **REPAIR PROCEDURE B**, and the ignition key still comes out of the switch with the shift lever in gear, then do this: Remove the key interlock solenoid cover, insert the key, and turn the ignition switch to ACCESSORY (1). Watch the interlock solenoid plunger as you push in on the ignition switch with the key.
 - If the plunger moves in toward the solenoid, then install Key Interlock Repair Kit B (if you've installed Key Interlock Repair Kit A). If you've already installed Key Interlock Repair Kit B, then order another kit, and install it, carefully following the steps in **REPAIR PROCEDURE B**.
 - If the plunger doesn't move in toward the solenoid, refer to the circuit schematics in the Switch Interlock section of the appropriate ETM for assistance in troubleshooting.
