**PE04-078**  
**FORD**  
**1/28/2005**  
**BOOK 3 OF 12**  
**ATTACHMENT F**  
**PART 1 OF 6**

**B. PHOTOGRAPHS**

# Interscience, Inc.

Re: Our Project No: L0500-02  
Insured: [REDACTED]  
Claim No: [REDACTED]  
Date of Loss: April 27, 2004  
Date of Notification: May 4, 2004  
Date of Inspection: May 11, 2004

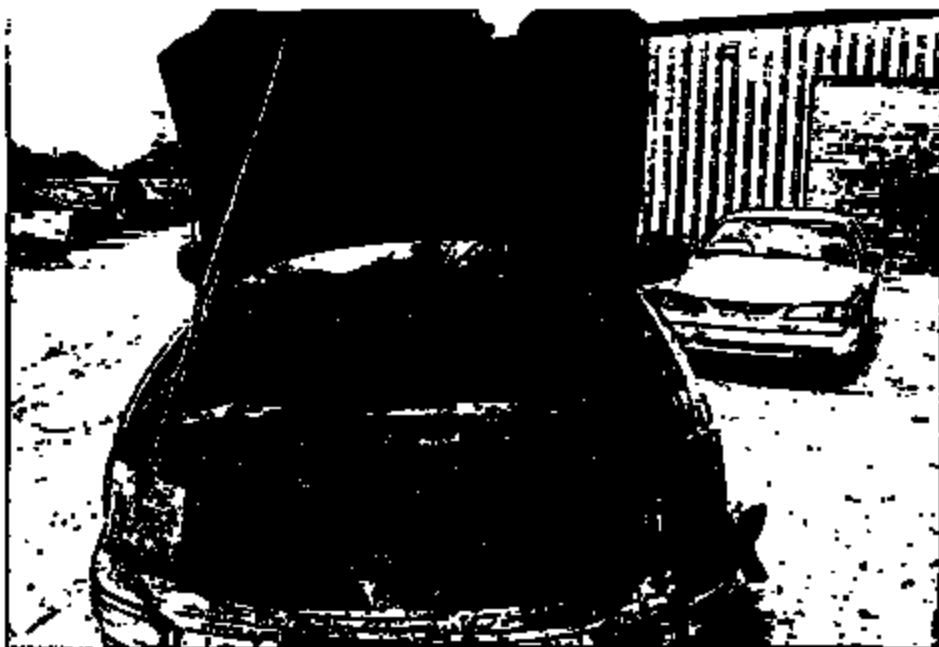
The engine compartment was systematically and thoroughly inspected and photo documented. The area of fire origin was determined to be located within the engine compartment on the driver's side of the vehicle which had sustained significant flame and heat damage. The fire damage was intense and localized on the driver side of the engine compartment. The fire consumed most readily combustible materials in this localized area.

24. Overall view of the engine compartment.
