PE04-078

FORD

ARBITRATIONS & INSPECTIONS

The purpose of this assignment was to determine the origin and cause of a fire in the below referenced 2001 Ford Expedition, hereafter referred to as the subject vehicle, that reportedly occurred shortly after the vehicle had been parked.

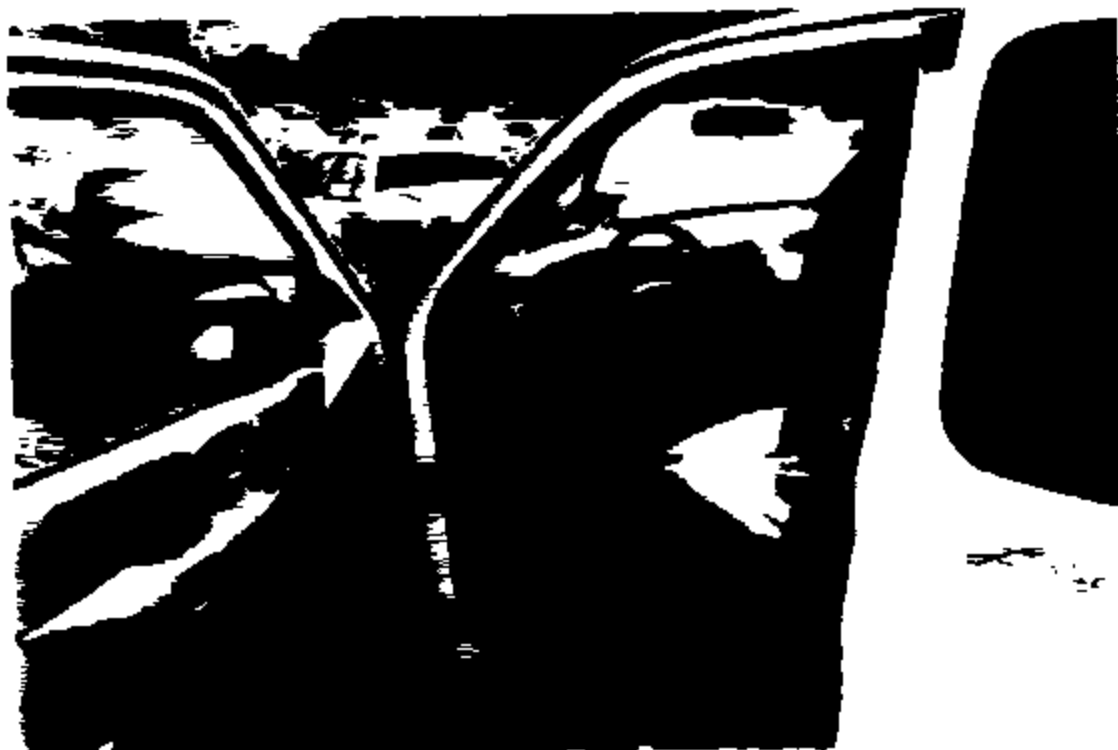
#11 - Interior as viewed through the driver's door opening
