RQ04-011
FORD
APRIL 26, 2005
REQUEST 8
PART 2 OF 4
BOOKS 30 OF 43

GLOBAL BUCKLES WARRANTIES

SEAT BELT BUCKLE INSPECTION AND/OR REPLACEMENT PROCEDURE

Subject: 2001 Expedition/Navigator Front Seat Belt Replaced After Recall

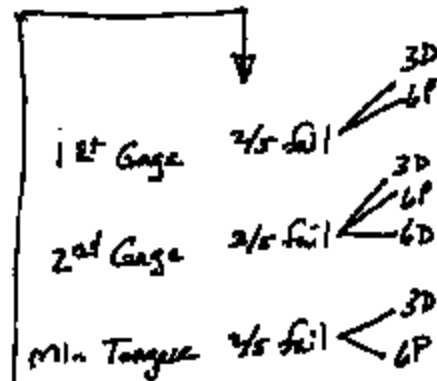
1st gen. gage
3/21 Fail

5/21 Push Button
not Return

6P	One Precycle would have Caught
3D	Pass-fail-pass Good BUCKLE
6D	Good Beta ERROR

Hand Min Tongue
- CAN FOOL BUCKLE Due to Latch/Rough Surface interaction

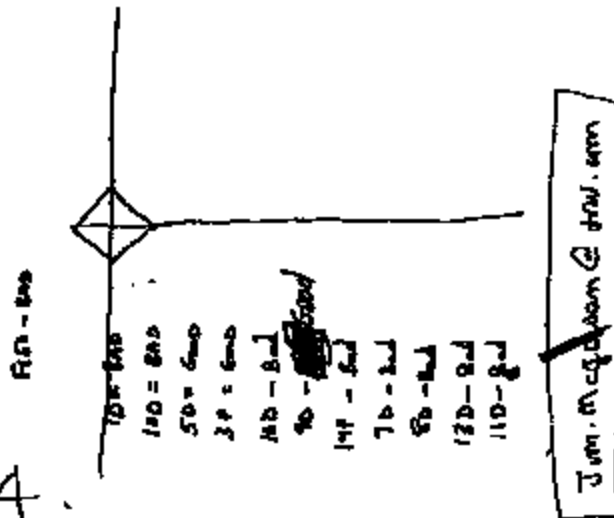
2FM2AS1462BA00004
 2FMDA58432BA00008

10 fail
00 pass

bottom
things
below

is info sound all button down (spring returned) Call of own tongue propel by inducted		
⑭ B71717	00000 / 11011	00000 / 11111	00000 / 11111	00000 / 10111
⑮ B71725	00000 / 00000	00000 / 00000	00000 / 00000	00000 / 00000
⑯ A00004	11111 / 00001	00000 / 00001 + initial (not fail)	11111 / 00000	11111 / 00000
⑰ A00008	00000 / 11111 with-pass	00000 / 11011	00000 / 11111	00000 / 11111
18 B71004	11111 / 00000	01111 / 00000	01101 / 00000	10111 / 00000

Marked the status of each vehicle on the Rotation label. For the ones identified as bad, you will have to replace them with new ones. If you know of any other 2001 Windstars that I may not have checked, please let me know.
