U.S. Department  
of Transportation  
**National Highway  
Traffic Safety  
Administration**

Investigation: EA 05-005  
Prompted By: PE04-078  
Date Opened: 03/22/2005 Date Closed: 08/02/2006  
Principal Investigator: Bruce York-B  
Subject: Engine Compartment Fires

## ENGINEERING ANALYSIS CLOSING REPORT

**SUBJECT:** Speed Control Deactivation Switch Fires.

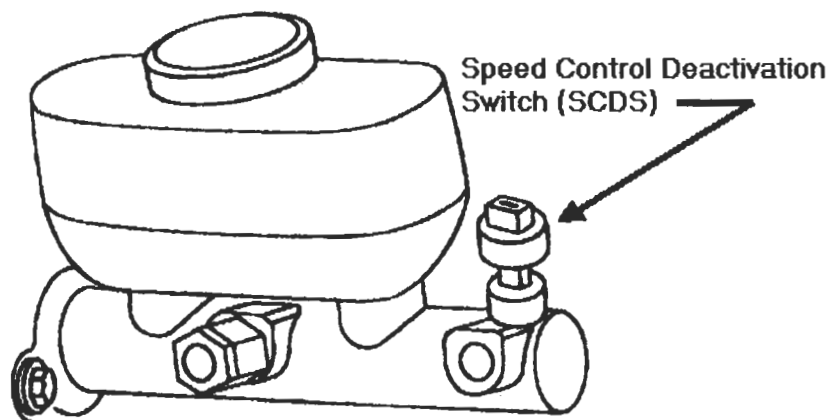
Figure 3. Speed Control Deactivation Switch Location.

**SUBJECT SWITCH DESCRIPTION:** The subject component is a hydraulic pressure switch, manufactured by Texas Instruments (TI), which functions as a redundant safety switch to interrupt power to the speed control servo during brake applications. The normally closed switch opens at brake system pressures produced by approximately 5-10 lbs of pedal force, breaking the circuit to the speed control servo and causing the speed control to disengage. The deactivation switch is mounted on the brake master cylinder, which is located at the rear bulkhead on the left (driver's) side of the engine compartment (Figure 3.). The SCDS may be oriented so that it mounts in the Master Cylinder in a vertically up, vertically down, or angled down position.

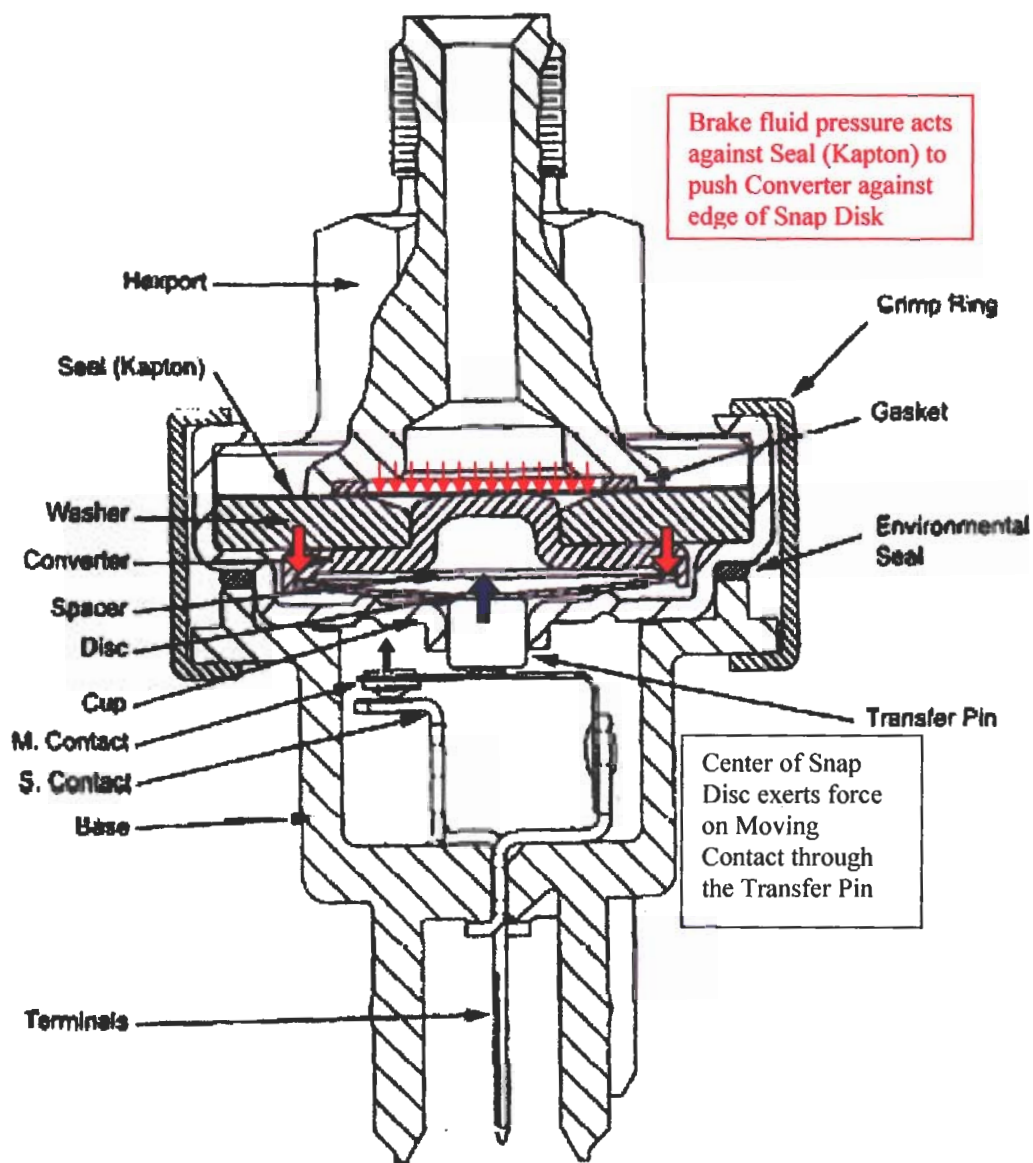
Figure 12. Speed Control Deactivation Switch.

hydraulic brake fluid, and a “dry” side that interfaces with the electrical wiring to the cruise control servo and contains electrical contacts that open and close disengaging the cruise control when the brakes are applied. A multi-layer diaphragm and gasket seal the interface between the hydraulic and electrical sides of the switch (Figure 12.). The diaphragm consists of three layers of Kapton 500FN131 (Kapton sandwich), a high performance polyimide polymer film supplied by DuPont. Each Kapton FN layer is a composite structure consisting of a 3 mil (76.2  $\mu\text{m}$ ) core of Kapton HN film with 1 mil (25.4  $\mu\text{m}$ ) laminates of Teflon FEP on each side. TI used three layers of Teflon-coated Kapton to enhance the durability of the switch. The Kapton sandwich (hexport seal, middle seal, and washer seal) is clamped between the hexport cup and the washer with a gasket on the hexport side (Figure 12.).

In operation, brake fluid pressure acts against the switch converter through the Kapton diaphragm and actuates a switch snap disk. Actuation of the snap disk allows the sprung arm of the switch movable contact to lift off the stationary contact (Figure 12.), breaking the speed control circuit to the servo clutch. When brake pressure fluid drops, the snap disk is released, forcing the contacts back together through a transfer pin resetting the switch and resuming speed control function.

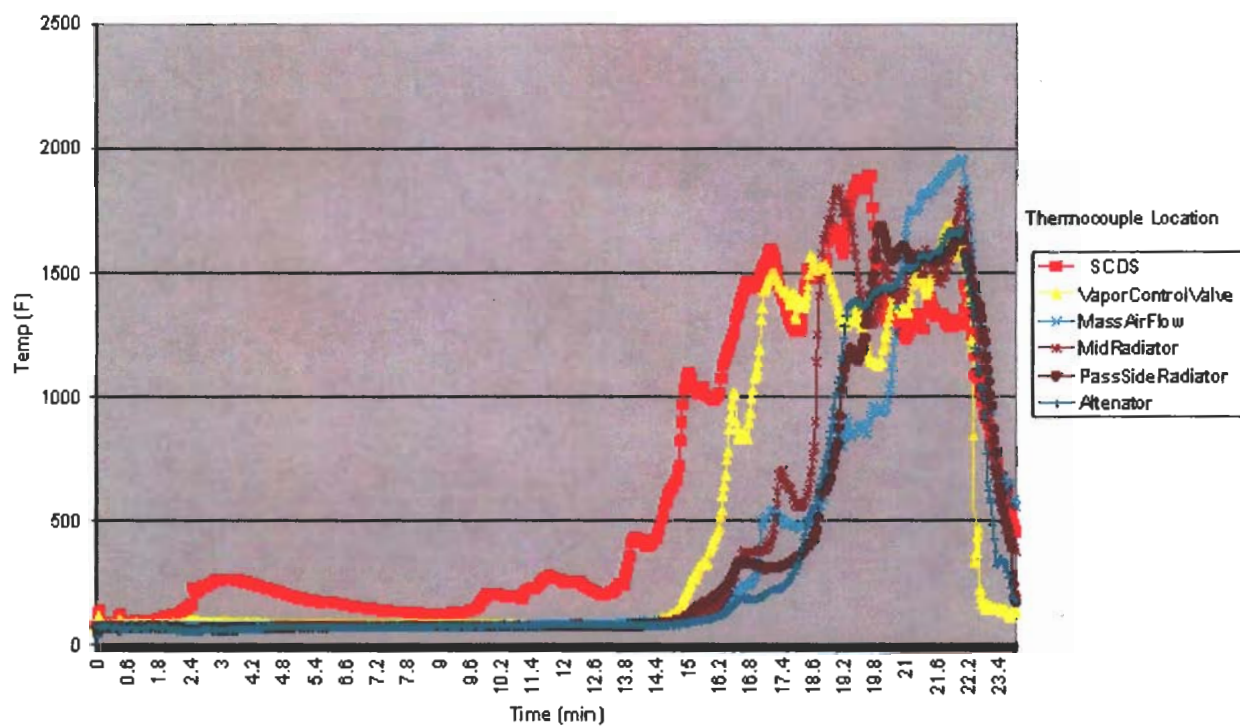
Figure 18. Thermocouple Data From Live Burn Test Vehicle.

ODI observed four live vehicle burn tests to assist in determining if a fire reported to the agency was likely caused by the SCDS, and to prove that a SCDS could start a fire that could spread to the rest of the vehicle. The live burn tests were started by using a defective SCDS that was on the verge of catching fire. The vehicles were instrumented with under-hood cameras and 6 thermocouples located throughout the engine compartment. The vehicle fires were also video recorded from the exterior. The data and burn patterns collected from this series of live burns showed that a defective SCDS could catch fire and the fire could then spread to the remainder of the vehicle. The under-hood cameras and thermocouples documented how the fire spread, how hot certain areas got and how long it took for certain areas of the engine compartment to get involved in the fire (Figure 18.). This data, along with the burn patterns that were documented

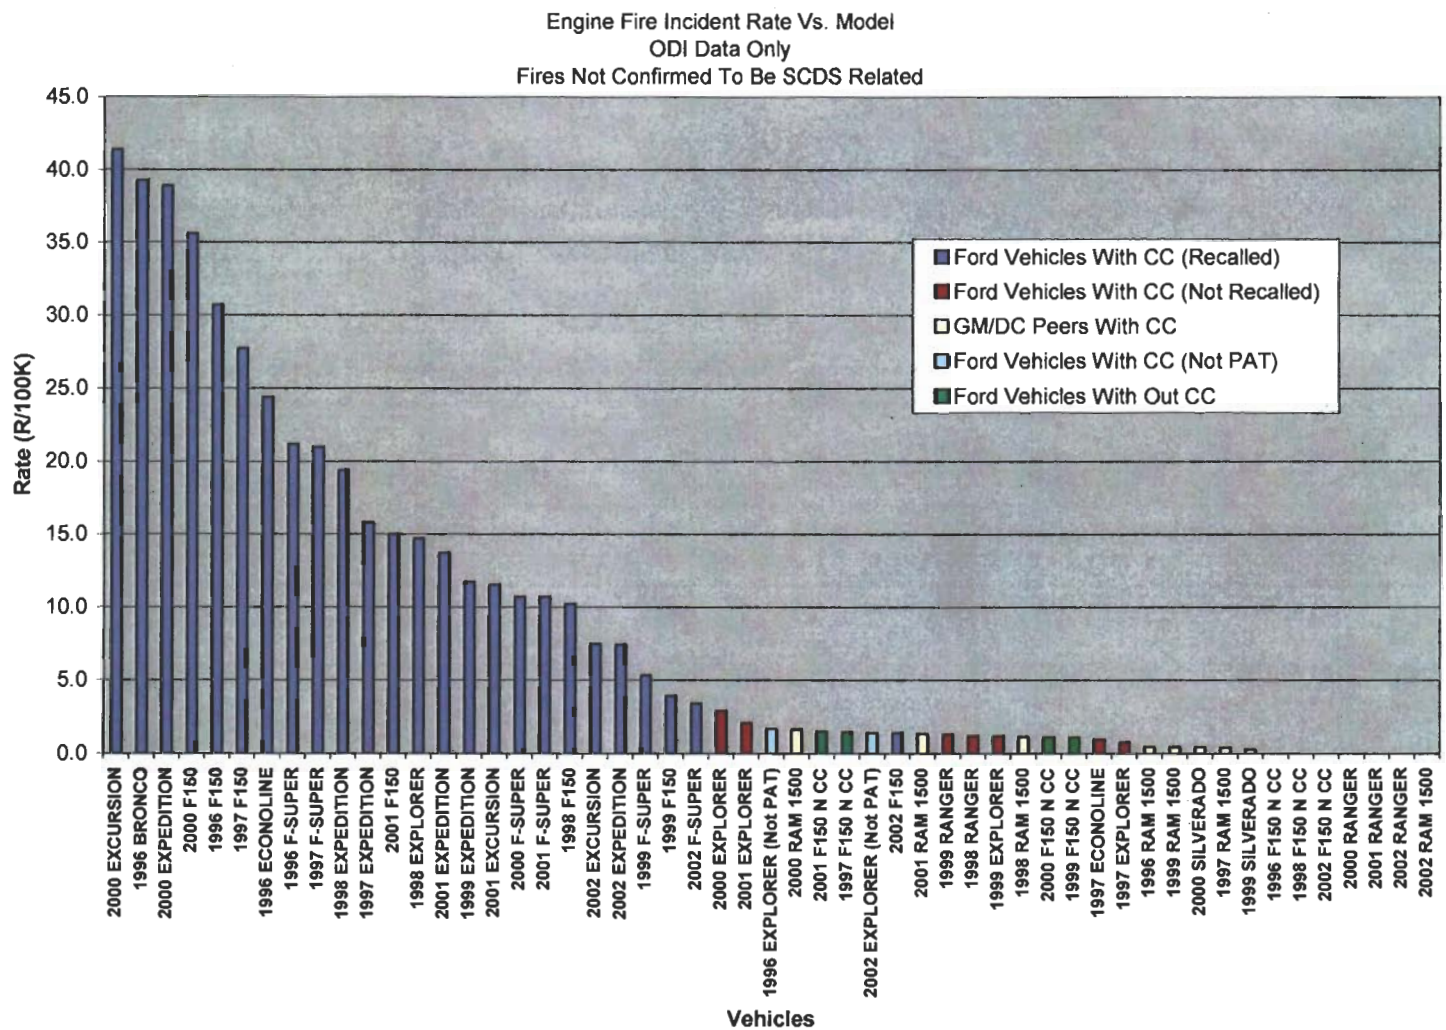
Figure 20. Key Off Engine Compartment Fire Complaint Rate Data.

In order to better understand if the SCDS was the true cause of the fires in the Ford model vehicles equipped with cruise control, ODI determined the key off engine compartment fire failure rates on some peer Ford models manufactured without cruise control. ODI also determined the key off engine compartment fire failure rates for some peer Ford models that were manufactured with cruise control but where the SCDS was not PAT. A third group of peers that ODI collected complaint information on and determined complaint rates for were General Motors CK 1500 trucks and Daimler Chrysler Ram 1500 trucks. A comparison of these failure rates is shown in Figure 20.

In comparing the Ford models that have a high rate of key off, engine compartment fire (Figure 20.) to the models that exhibit the three factors identified as the primary factors in causing SCDS related fires (Table 1.), it can be seen that the models exhibiting these factors are also the models with the highest rate of fire. This correlation provides support for the position that these three factors: (1) The SCDS is contained in a PAT circuit; (2) The SCDS is mounted in a vertically up or angled down orientation; (3) The brake system produces vacuum levels that cause the Kapton diaphragms within the SCDS to flip orientation; are the likely root cause for the fire related failures of the SCDS.
