FIELD TECHNICAL REPORT

TQCN DOC# FTR-JR1116141		Affiliate TMS	Dept. QA-Chassis	Source FTS	Location REG-CIN	Ref 20787-1	Date 6/14/2004
Problem Area Base Vehicle	Primary Model Tundra	Model Year 2003	Production Date 11-2002	Odometer 19492 mi	VIN (confirm 17 characters): 5TBBT441 [REDACTED]		
Condition Title LEFT FRONT WHEEL BALL JOINT

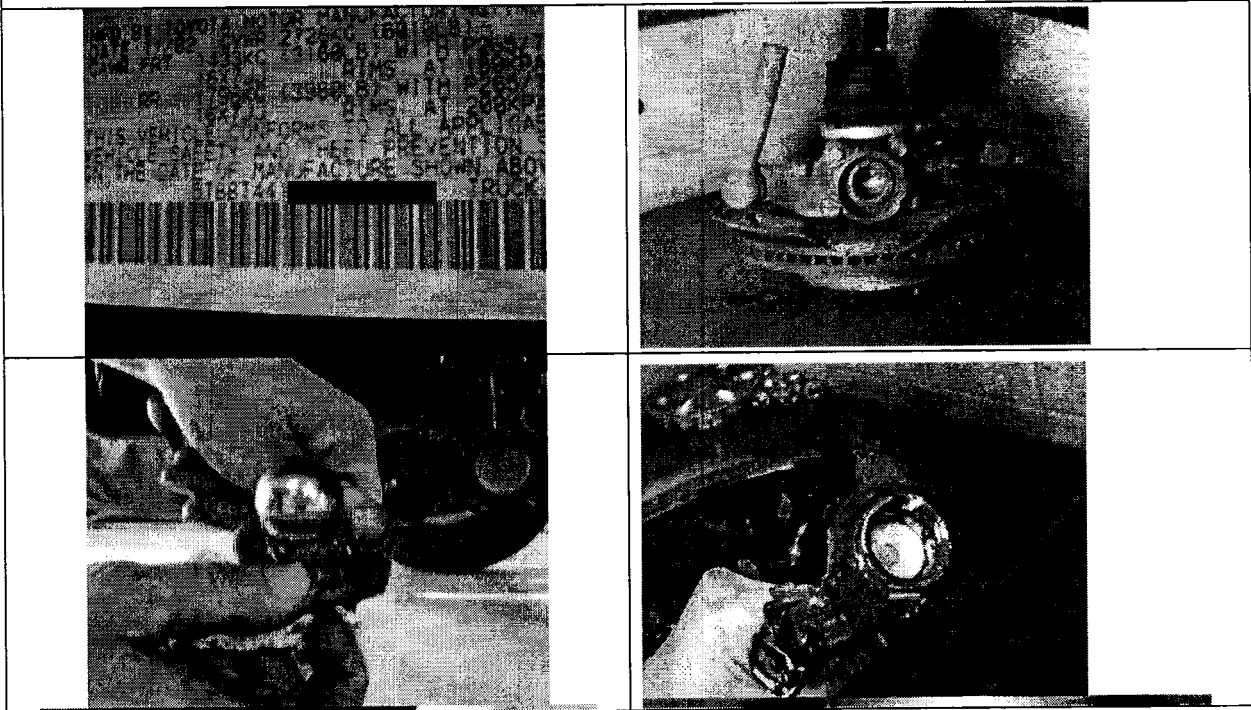
Customer states while driving the left front wheel came loose and skidded to a stop. Left front wheel assembly appears to have separated from suspension at the upper and lower ball joint sockets.

Dealership and D.S.P.M. indicate there is no indication of off road use such as mud, unusual amounts of dirt or bent or scrapped components under vehicle. It appears the upper and lower control arm ball joints separated ball from socket. Unable to determine which separated first.

Lower and upper ball joints and associated and damaged parts replaced with new components.
