REPORT OF ANALYSIS

EA05-005

I. Problem Statement

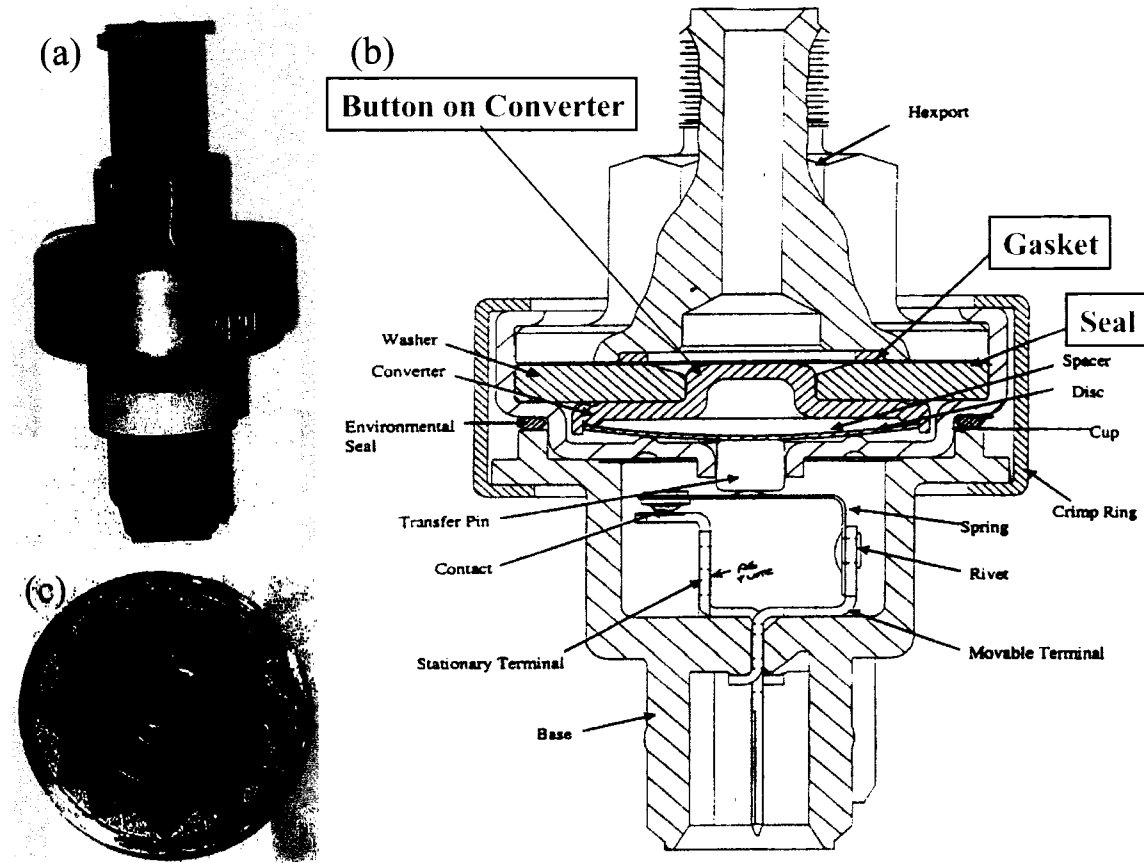
Figure 1. Speed Control Deactivation Switch (SCDS) (a) Assembled (b) Assembly Cross-Section Drawing And Component Labels, and (c) Kapton Seal arrangement.

SCDS failure has been linked to the failure of the Kapton[#] seal (labeled Seals in Figure 1b). As shown in Figure 1c, this seal is composed of three layers of 19.05 mm (0.75 in) square Kapton laminate film that is 5 mil (0.125 mm) thick. The Kapton film (DuPont Kapton 500FN131L) is a composite construction consisting of a polyimide film 3 mil (0.075 mm) thickness sandwiched between 1 mil (0.025 mm) thick films of fluorinated ethylene propylene copolymer (FEP). The seal is held in place by a rubber gasket (see Figure 1b).

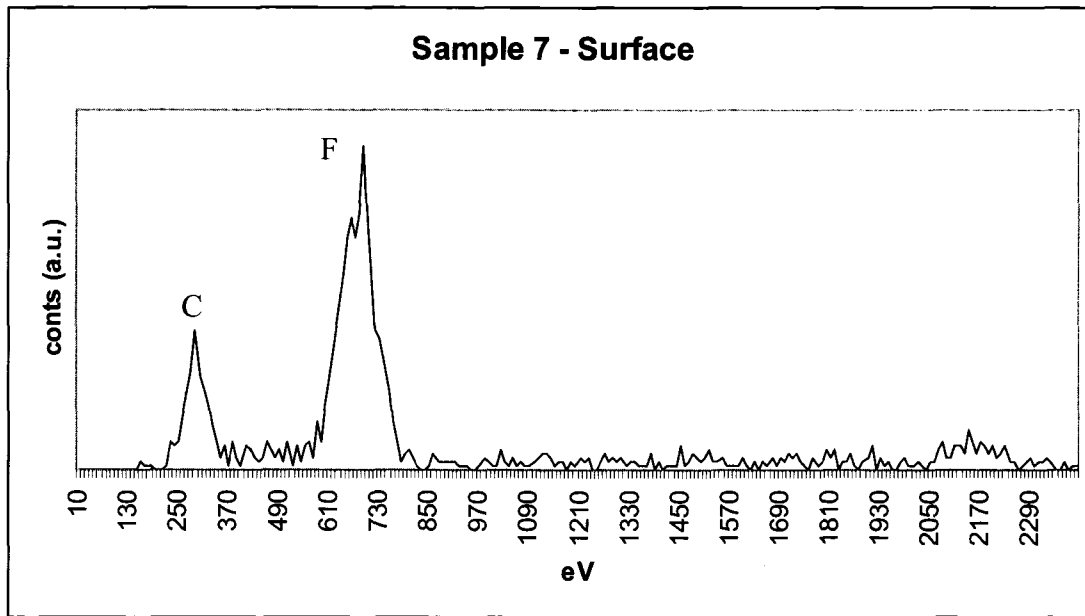
Figure 17. X-ray microanalysis of SCDS #7, Surface

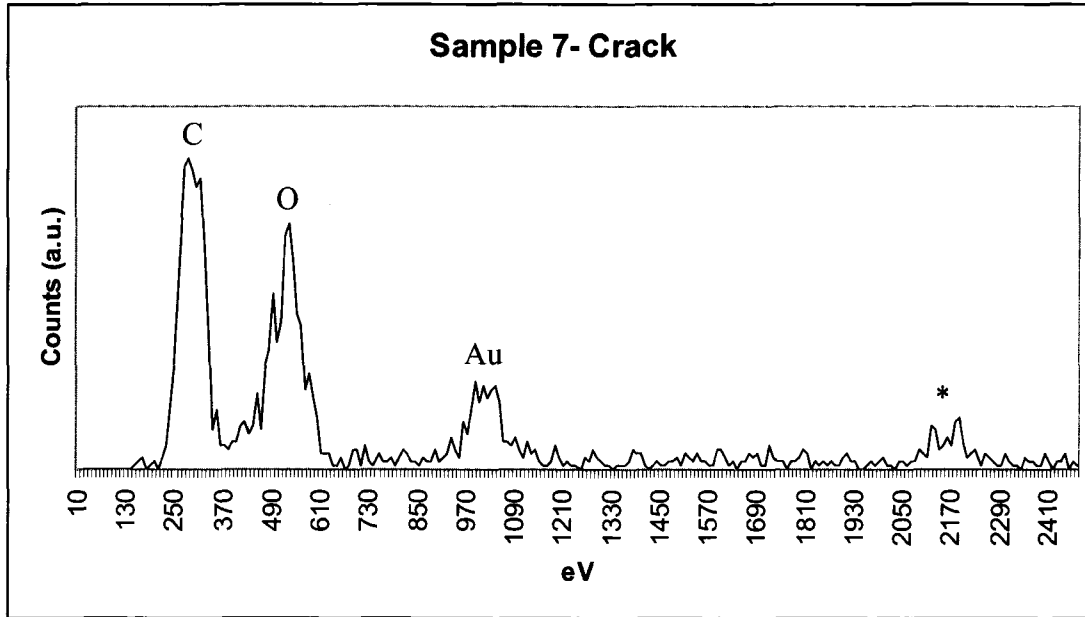
Figure 18. X-ray microanalysis of SCDS #7, Crack, * This peak was not expected, possibly a contaminant, possible matches are Na, Cu, Zn

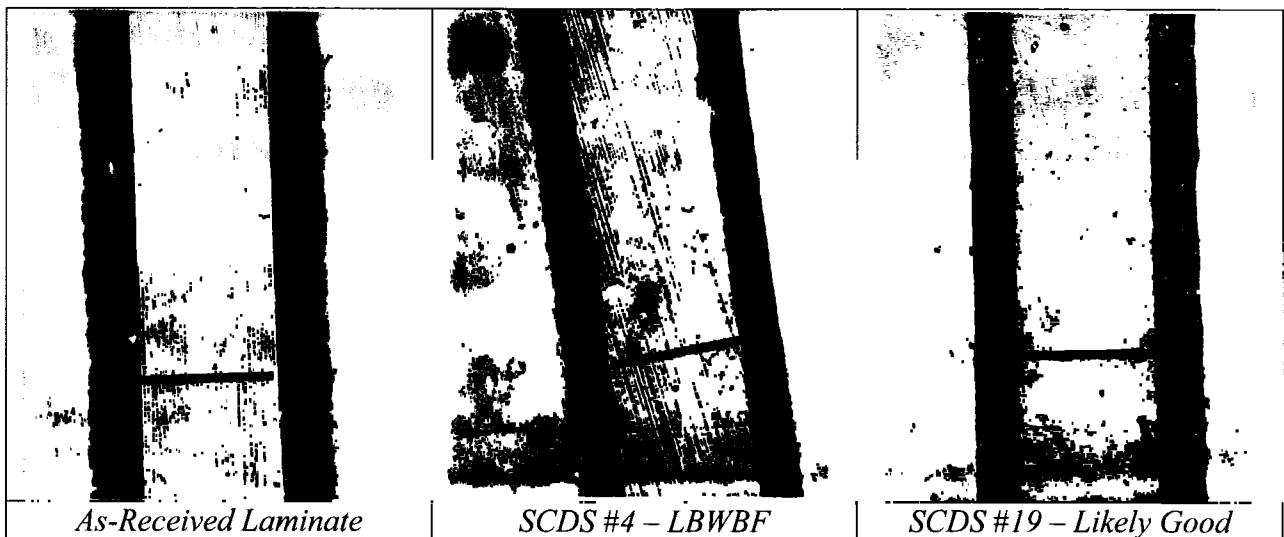
(2) *Laminate Layer Thickness Verification.* Figure 19 shows the cross section images of the as-received Kapton laminate, a LBWBF SCDS, and a Likely Good SCDS. The dark bars are the FEP and the region between them is the Kapton. Within the resolution of the technique, there is no apparent difference in the layer thicknesses.

Figure 19. Comparison of FEP (Blue Line) and Kapton (Red Line) Layer Thicknesses Between Samples. Note that the red and blue lines are the same size in each image.

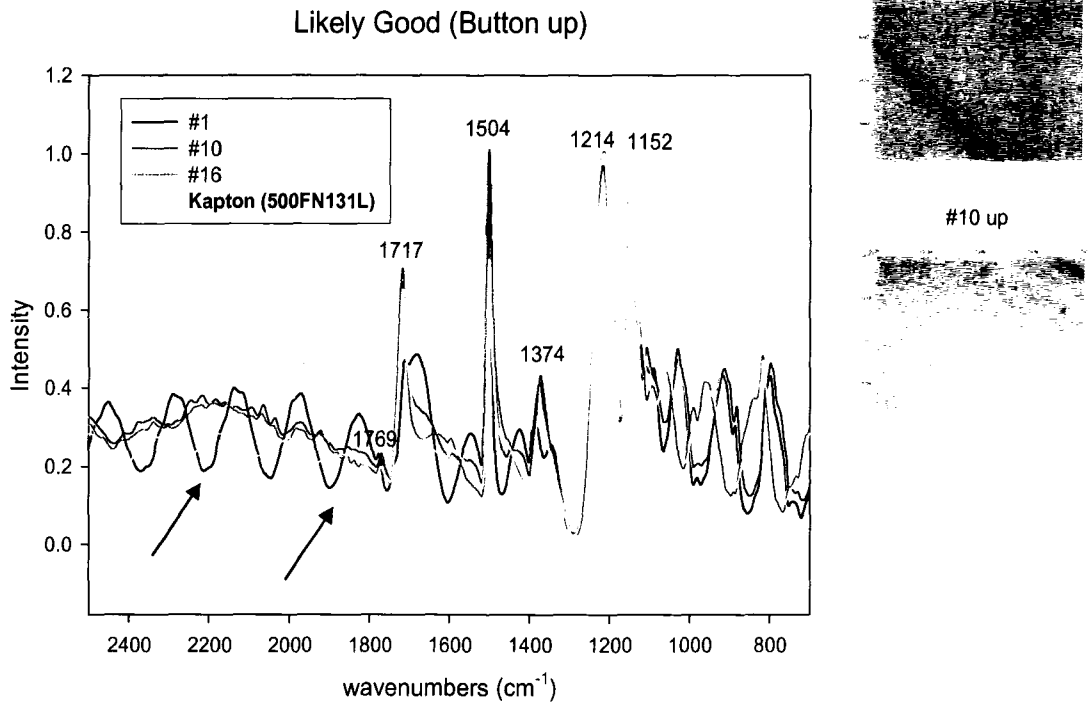
Figure 20 shows the reflectance spectra of the “likely good” Kapton film. Arrows indicate the interference fringes in the baseline, which only grow stronger as wavenumbers decrease and affect the intensity of the absorption peaks. Any differences in intensity of the Kapton peaks among the films in Figure 21 cannot be attributed to differences in the amount of Kapton for the reason discussed above. The same can be concluded for Figure 22 and Figure 23. An image of visible damage is shown optically (bottom image) in Figure 24 for a likely good film sandwich. There are no conclusive chemical differences between the spectrum damaged area and the undamaged Kapton reference film. Figure 25 addresses inspecting damaged and undamaged areas within the same optical image. The Kapton peaks from Area 2 are substantially lower than Area 1 or the Kapton reference film. This is the only instance where we have detected removal of the Kapton with confidence. We also took spectra of the “button down” side of the sandwich films. Figure 26 and Figure 27 have IR spectra from the same sandwich films as previously discussed. Because of the interference fringes mentioned above, we could not distinguish any chemical differences between likely good, likely bad, and likely bad with brake fluid using this technique.

Figure 20: FT-IR reflectance spectra of “likely good” film sandwich and Kapton reference film and associated optical images

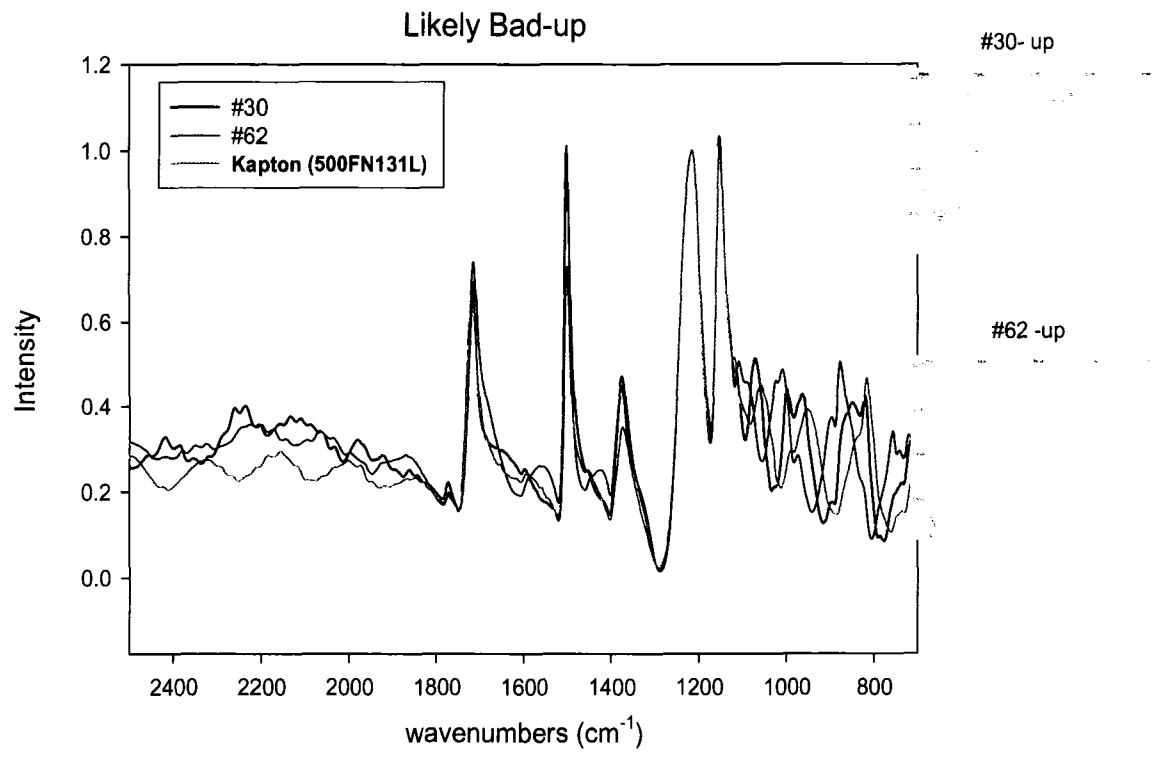
Figure 21: FT-IR reflectance spectra of likely bad film sandwiches and Kapton reference film and associated optical images.

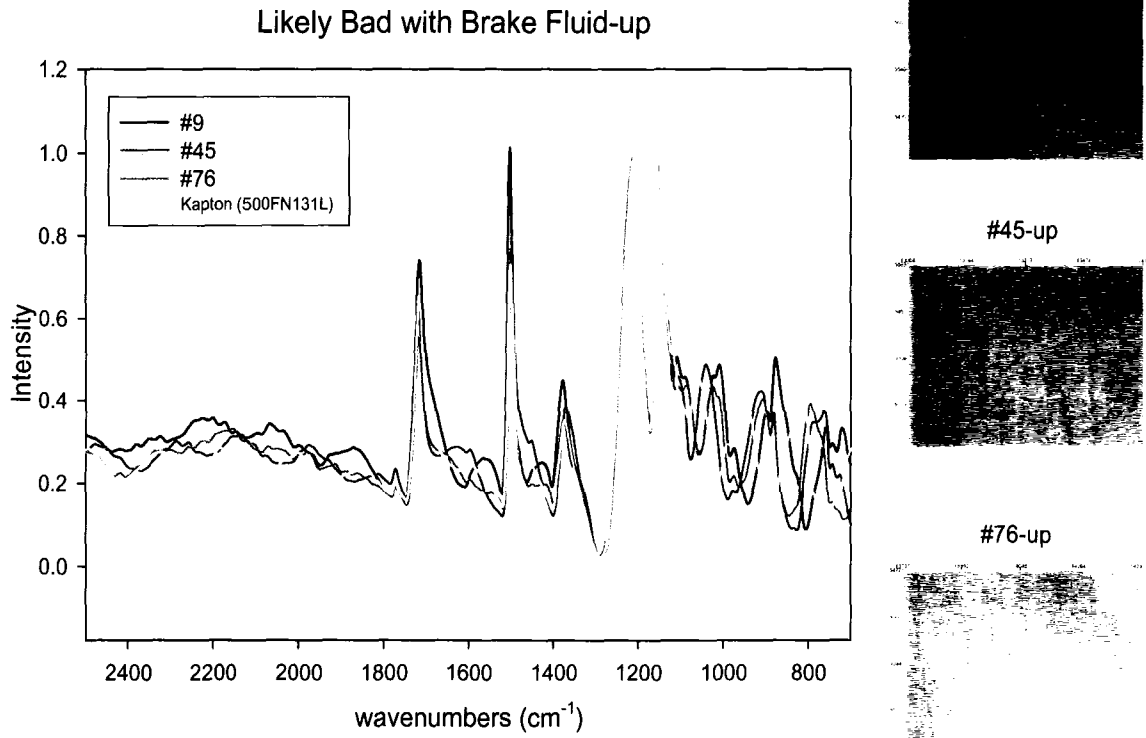
Figure 22: FT-IR reflectance spectra of likely bad with brake fluid film sandwich and Kapton reference film and associated optical images.

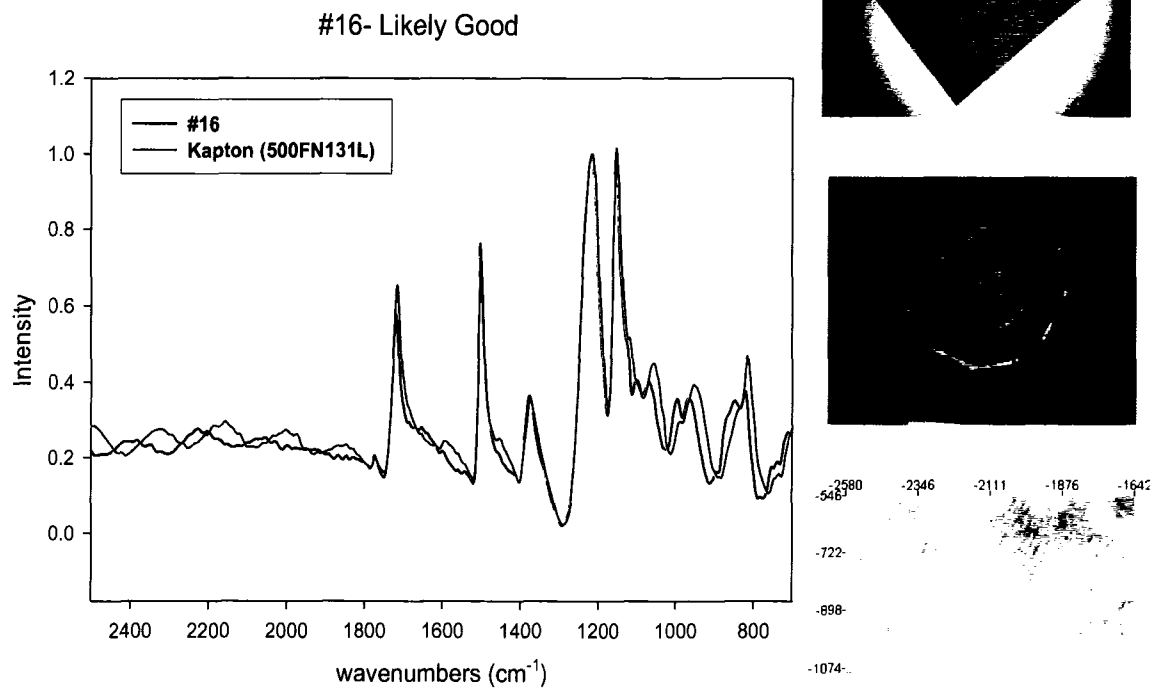
Figure 23: FT-IR reflectance spectra of likely good film sandwich and reference Kapton film and associated optical images.

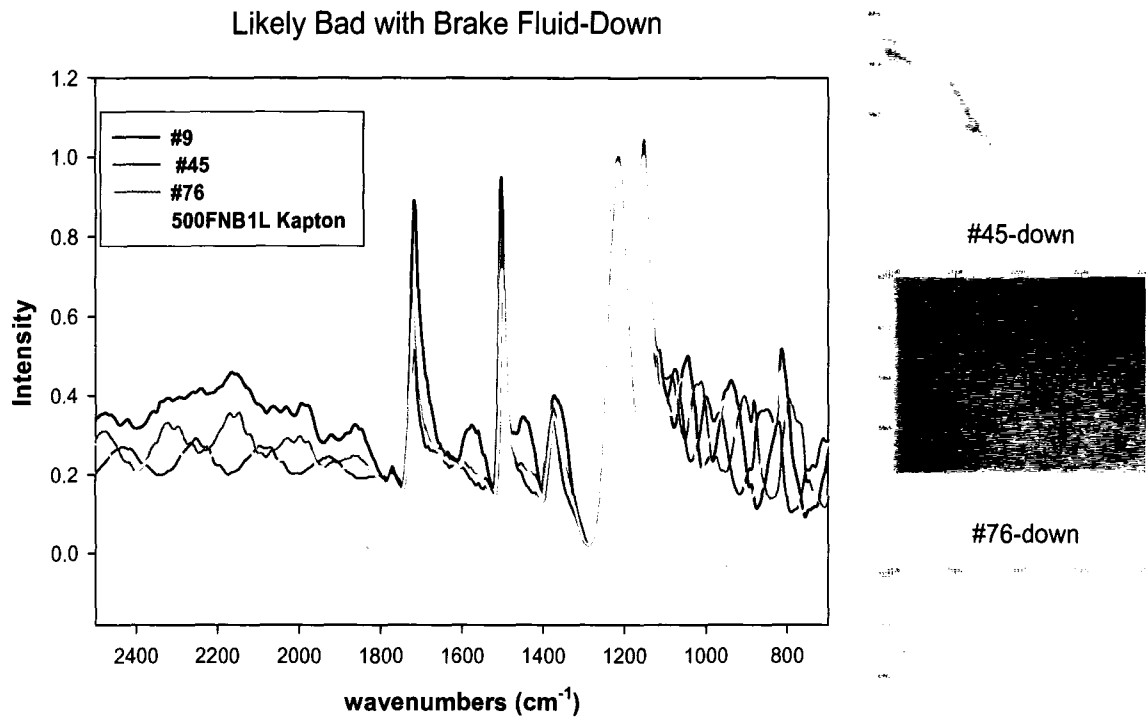
Figure 26: FT-IR reflectance spectra of likely bad with brake fluid sandwich films with associated optical images.

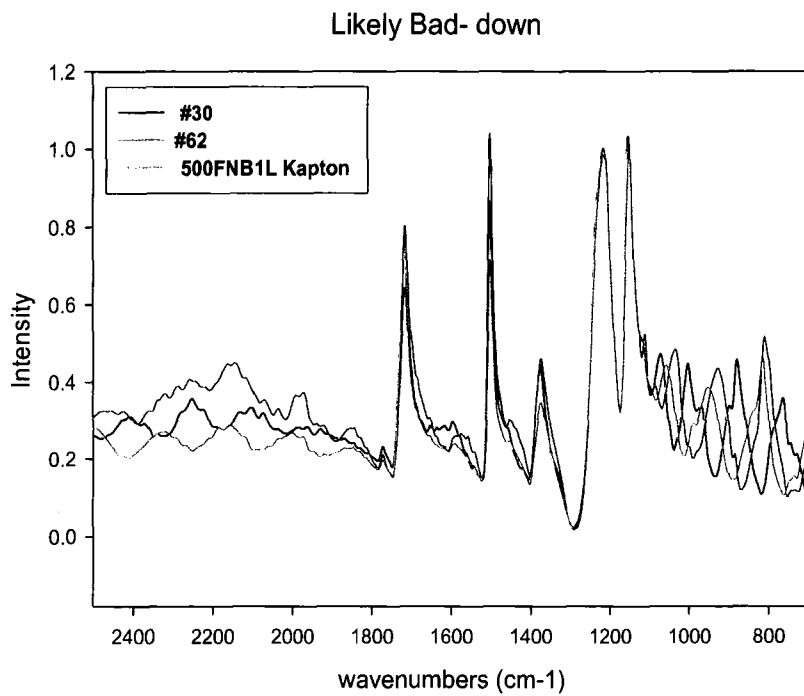
Figure 27: FT-IR reflectance spectra of likely bad sandwich films with associated images.

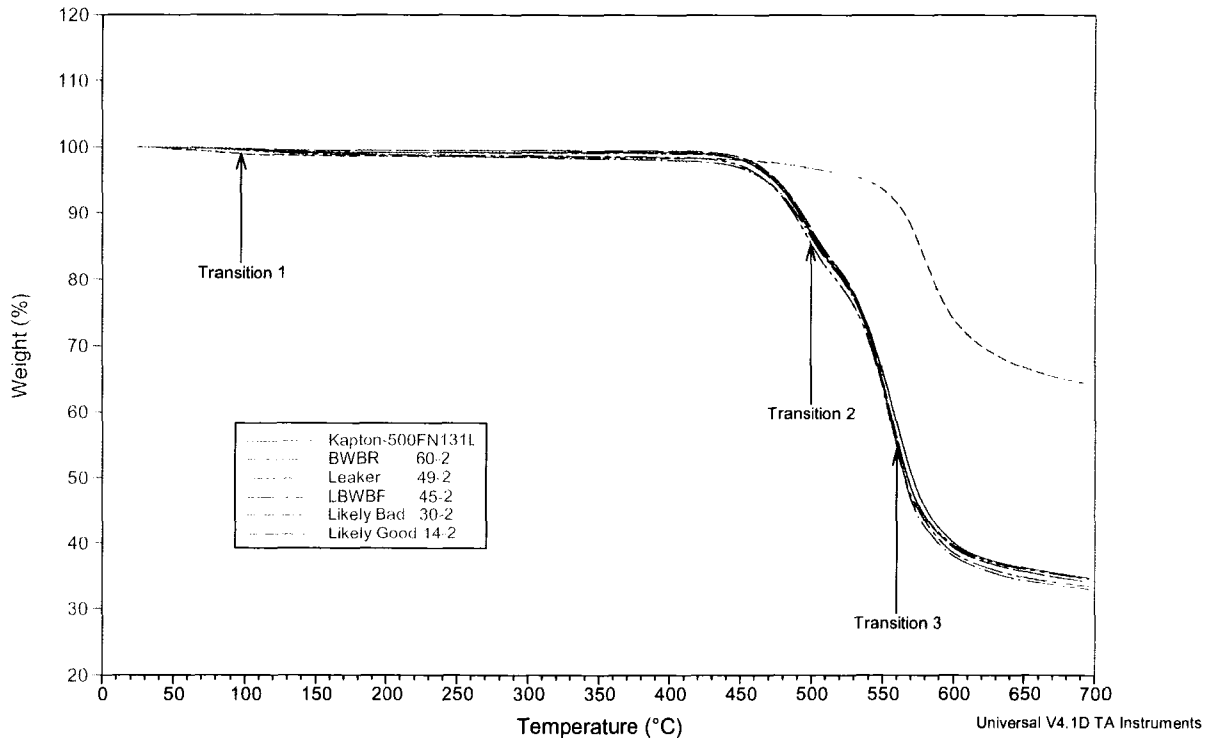
(1) *Thermogravimetric Analysis (TGA)*. A typical TGA scan is shown in Figure 28. Because the BWBR samples were clearly degraded, as can be seen in Figure 28, they have been excluded from the analysis of correlations between the other 4 categories. ANOVA analyses between the curves indicated only Transition 1 displays a statistically significant difference between the

Figure 28. Sample TGA curves for all five categories of switches, plus an as-received Kapton-500FN laminate film.

four category of switches. Because of the temperature range and the known thermal stabilities of both Kapton and FEP, Transition 1 has been attributed to water loss. As can be seen in Table 20 below, the Leaker and LBWBF have a statistically significant higher content of moisture than

the Likely Good, whereas the Likely Bad has a lower moisture content. It is impossible to determine whether this slightly higher moisture content in the failed films is due to ingress of the moisture after failure of the FEP layer or whether it is related to FEP failure. The low moisture content of the Likely Bad switches might suggest the former; however, no definitive statement can be made at this point.

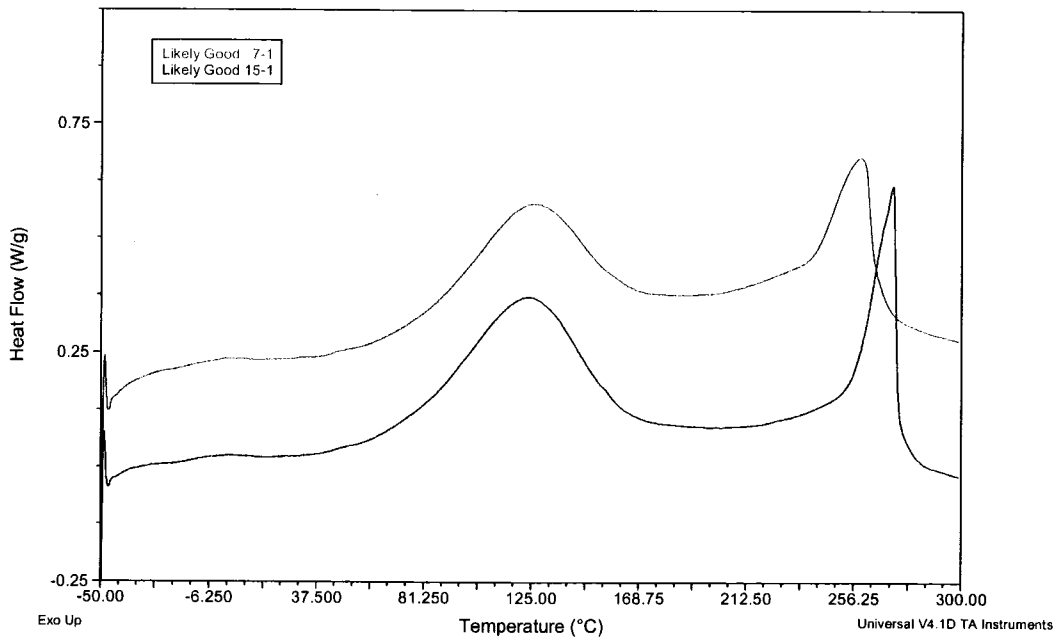
(2) *Differential Scanning Calorimetry*. Two primary endotherms (peaks in the DSC scan) were identified in all the classes of SCDSs. One peak is located around 115 °C and another around 250 °C. The lower peak is attributable to the glass transition of FEP and the upper endotherm the melting of crystals in the FEP layer. The glass transition had a large enthalpic relaxation component, i.e., instead of the step change in the heat flow typically observed with “clean” glass transitions, there was also a large enthalpic relaxation component, i.e., the peak on top of the step change. Because of the curvature in the baseline above and below the transition, the peak position of the enthalpic relaxation was examined rather than applying a typical glass transition analysis. No trend was detectable for the glass transition: 87 % of the 147 layers examined fell within the range of (124 ± 3) °C, and out of the remaining 13 % of the layers, 68 % were BWBR SCDSs. Because the glass transition overlaps the melting transition, no realistic estimates could be made regarding the heat of melting for the upper endotherm, however, analyses were performed on the peak positions. As can be seen in Figure 29 and Figure 30, there is a definite variation in the melting temperature, and as Figure 29 demonstrates, this even occurs within the Likely Good category.

Figure 29. Typical DSC scans of two likely good switch components.

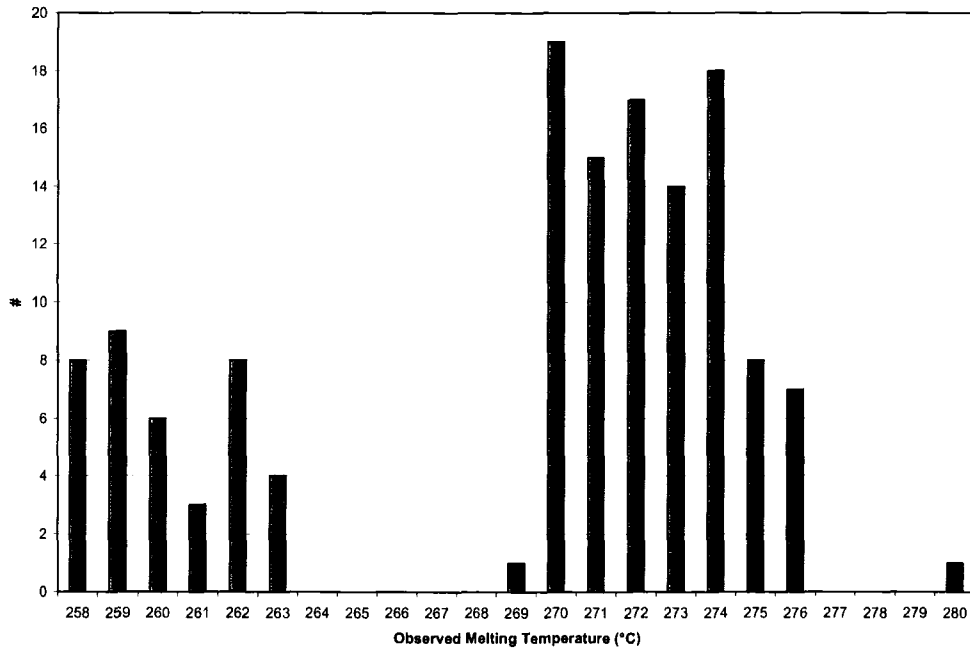
Figure 31. Number of layers with a given FEP melting temperature as a function of melting temperature.
