EA05-005

**US DEPARTMENT OF
COMMERCE 3/1/2005**

REPORT OF ANALYSIS

PART 2 OF 2

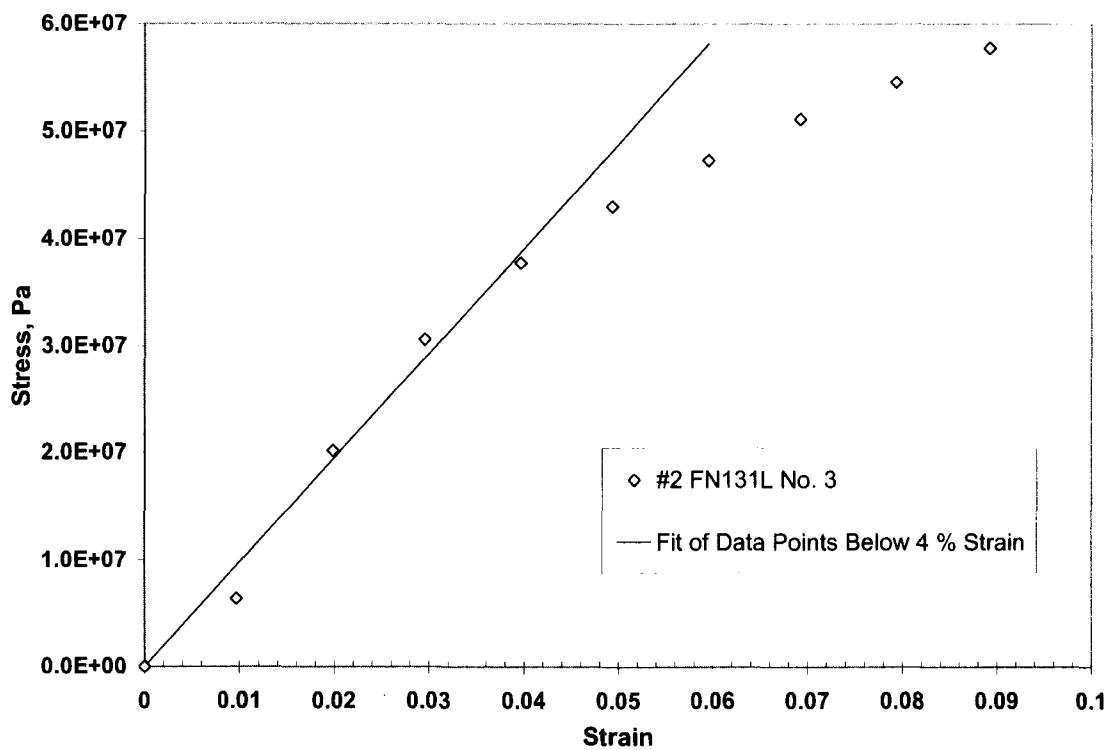
Figure 32. Typical stress-strain response of Type FN Kapton below 10 % strain.

Modulus Test Results. Eight reference samples of FN131L material were tested to provide the expected secant modulus at 4 % strain that should be obtained for FN type Kapton Film using this approach (see Figure 32). For these reference samples, an average value of (0.789 ± 0.093) GPa was obtained (see Table 21).

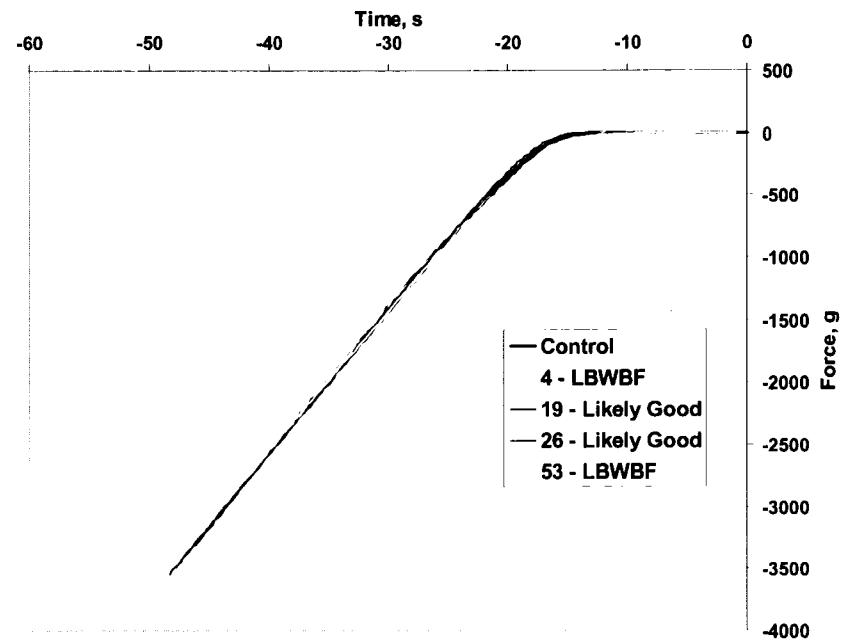
Figure 33. Compressive Response of Gaskets from SCDS No. 4, 19, 26, and 53 relative to control gasket taken from an unused SCDS.

Test Results on Gaskets. To determine the compressive stiffness, the RSA III instrument was equipped with two 12.5 mm parallel plates. Each gasket was placed between the plates and deformed at a rate of 0.01 mm/s. Using this approach, eleven samples (6 - Likely Good and 5 - LBWBF) samples were compared to a control gasket taken from an unused speed control deactivation switch (SCDS). Four of the eleven gaskets were found to have the same compressive stiffness as the control (see Figure 33), whereas, the remaining seven gaskets were found to be stiffer than the control gasket (see Figure 34). The composition in each gasket population was evenly split between Likely Good and LBWBF gaskets.
