BARRETT TOWNSHIP VOLUNTEER FIRE COMPANY

FIRE REPORT

Cause & Origin

CAUSE & ORIGIN REPORT

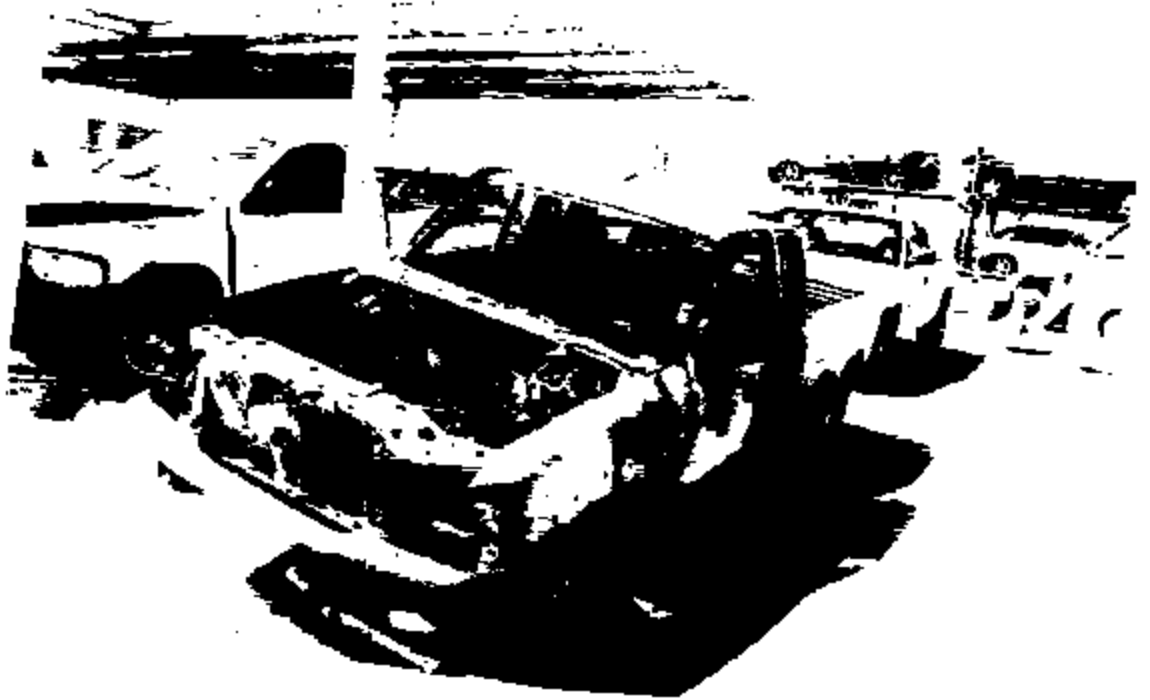
#1

PHOTO #1: Shows an exterior view of the left front portion of the vehicle.

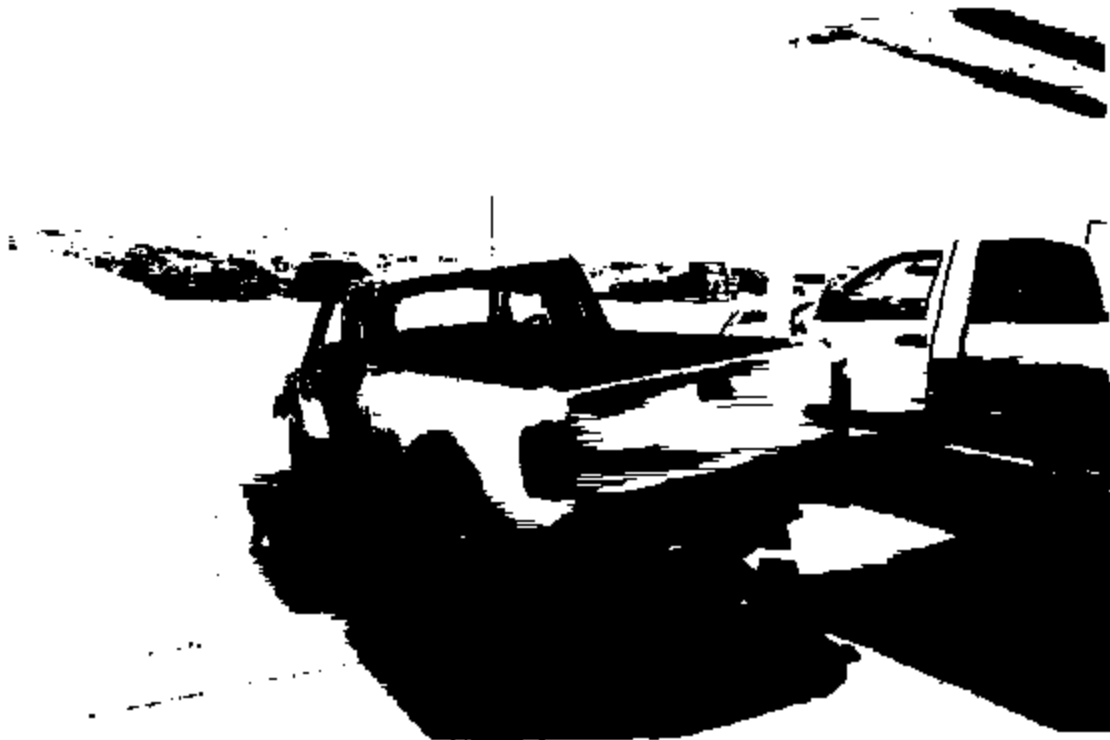
#3

body molding of the vehicle were examined, finding heavy fire damage to the front light assemblies, both of which were collapsed from the vehicle. The rear taillight assemblies, as shown in Photograph #3, were slightly fire damaged but still intact. The body molding in the front portion of the vehicle was consumed and the rear bumper cover appeared to be in relatively good condition. An inspection of the window glass revealed all of the glass was heat fractured and collapsed from the window frames. The burn patterns on the remaining glass fragments indicated that the fire had migrated into the passenger compartment from the engine and undercarriage of the vehicle.

PHOTO #3: Shows an exterior view of the left rear portion of the vehicle.

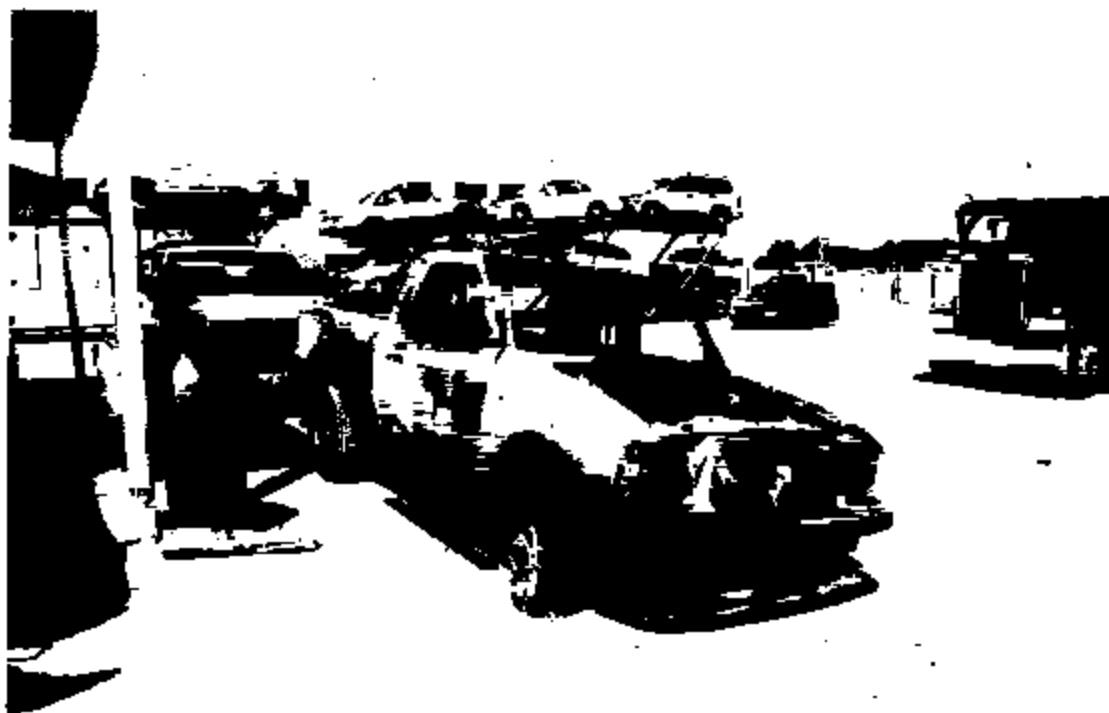
#6

An inspection of the tires and wheels revealed the two front tires were both fire damaged and deflated. The two rear tires of the vehicle were still inflated and no significant fire damage was noted. As shown in Photograph #6, the right front tire appeared to be near totally consumed and the alloy rim was severely melted. It appeared that the greater amount of heat stressing was on the right side of the vehicle.

PHOTO #6: Shows a view of the right front portion of the vehicle. Note there was a greater amount of heat damage to the right side of the vehicle.

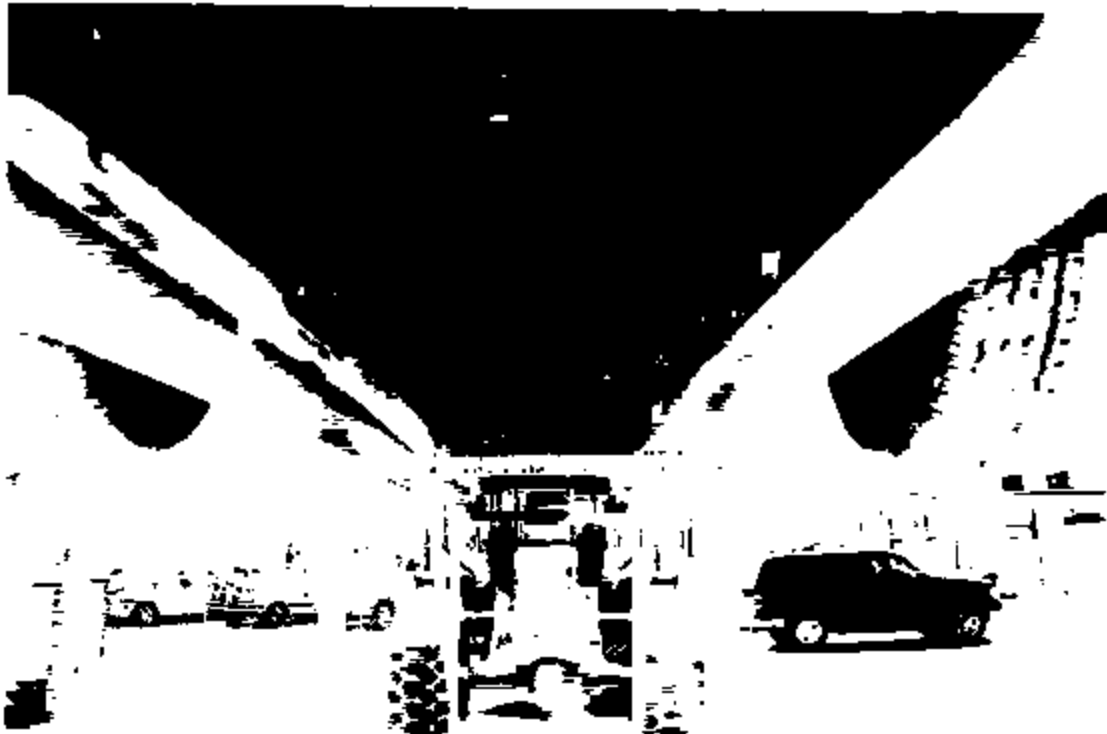
#35

PHOTO #35: Shows a view of the rear axle housing. Note there were oily residue splatters, as well as soot accumulations, on the axle housing.
