Atlantic Claims Service, Inc.

RE: Insured: [REDACTED]
Our Policy #: [REDACTED]
Date of Loss: 02-03-95
Your Customer: [REDACTED]
Insured Vehicle: 1995 Ford 150

DETERMINATION OF CAUSE AND ORIGIN

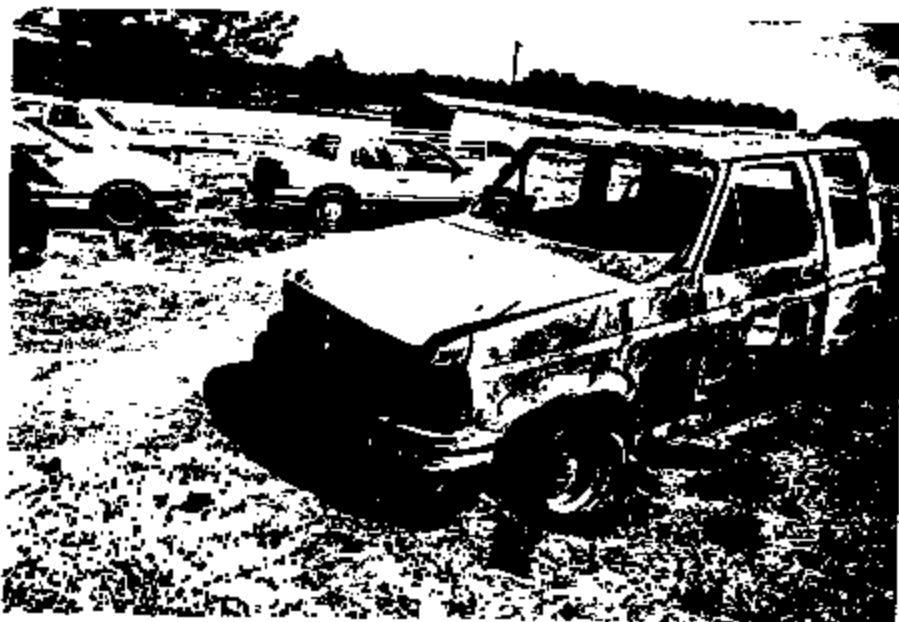
1

- 1-2. Exterior driver's side
3. Exterior showing both gas tank filler doors and caps in place
- 4-5. Exterior passenger side
6. Remains of tool box in tail bed showing personal belongings
7. Underneath portion of the vehicle showing lack of fire damage
8. View of interior damage from over-the hood
- 9-11. Overall damage on the interior
12. Remains of glove box which included owners manual
13. Remains of fuse box
14. Intact remains of dashboard wiring
15. Overall engine compartment
16. Remains of 12V battery
17. Close-up of fuel lines
18. Close-up of fuel injection remains
19. Close-up of wiring from engine side of fire wall
20. Close-up of battery terminals showing no unusual conditions

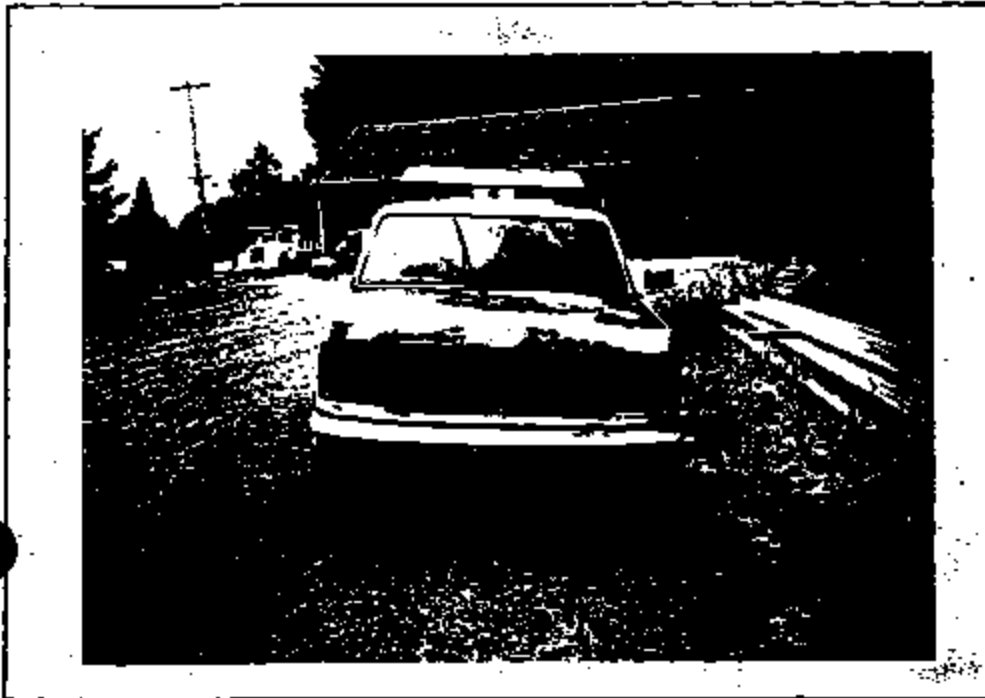
PICTURE NO. ①

DESCRIPTION
Front view
of insured veh.

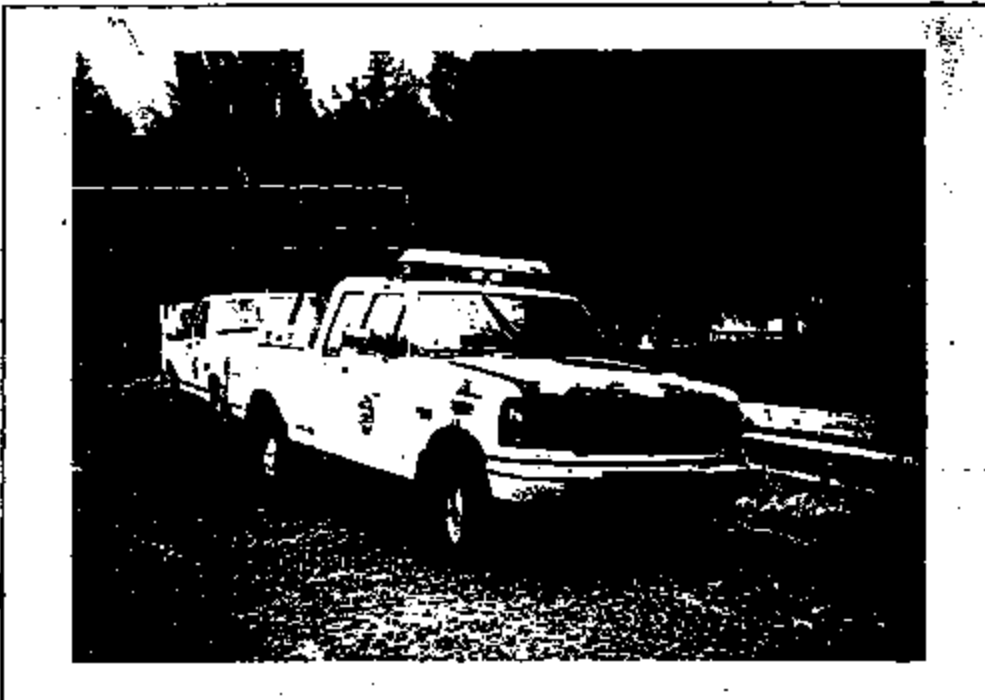
PICTURE NO. ②

DESCRIPTION
Right front
view.

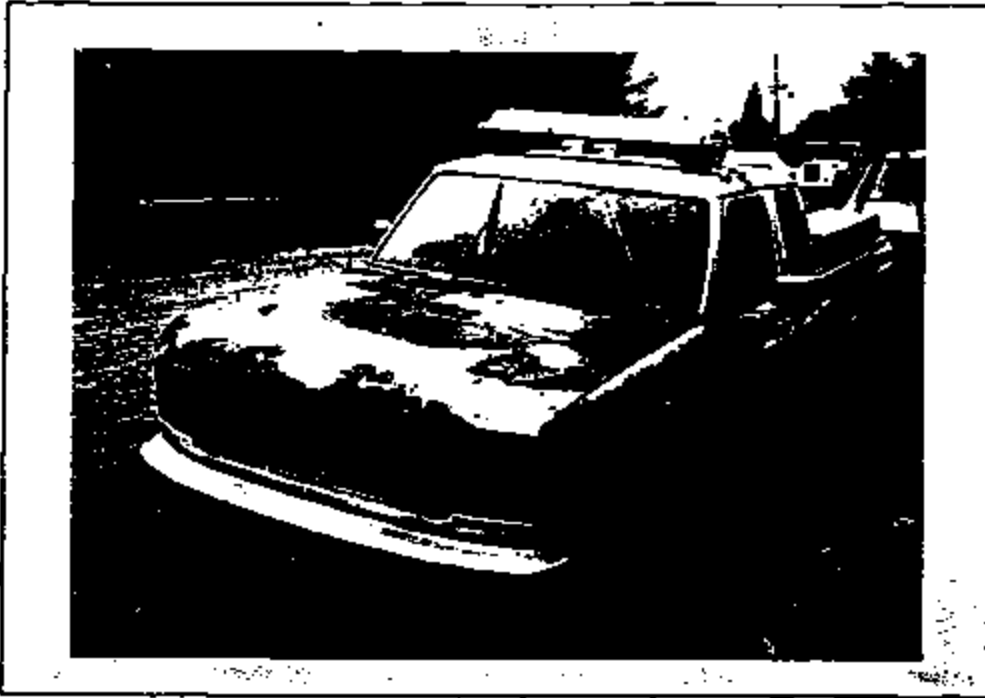
PICTURE NO. **(3)**

DESCRIPTION
Left front view.

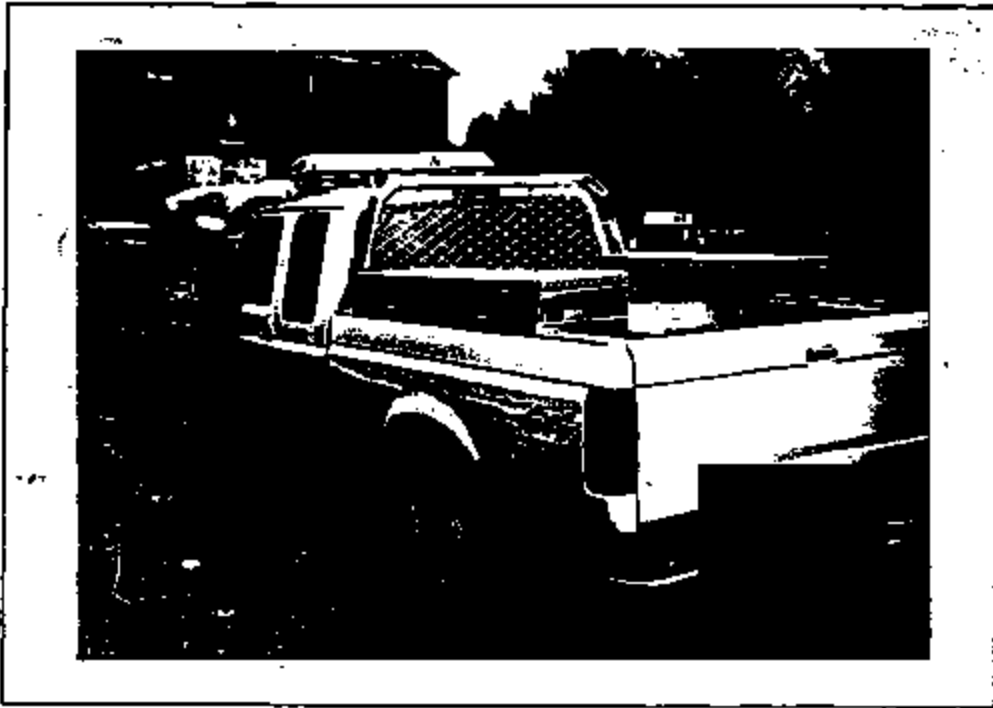
PICTURE NO. **(4)**

DESCRIPTION
Left near view.

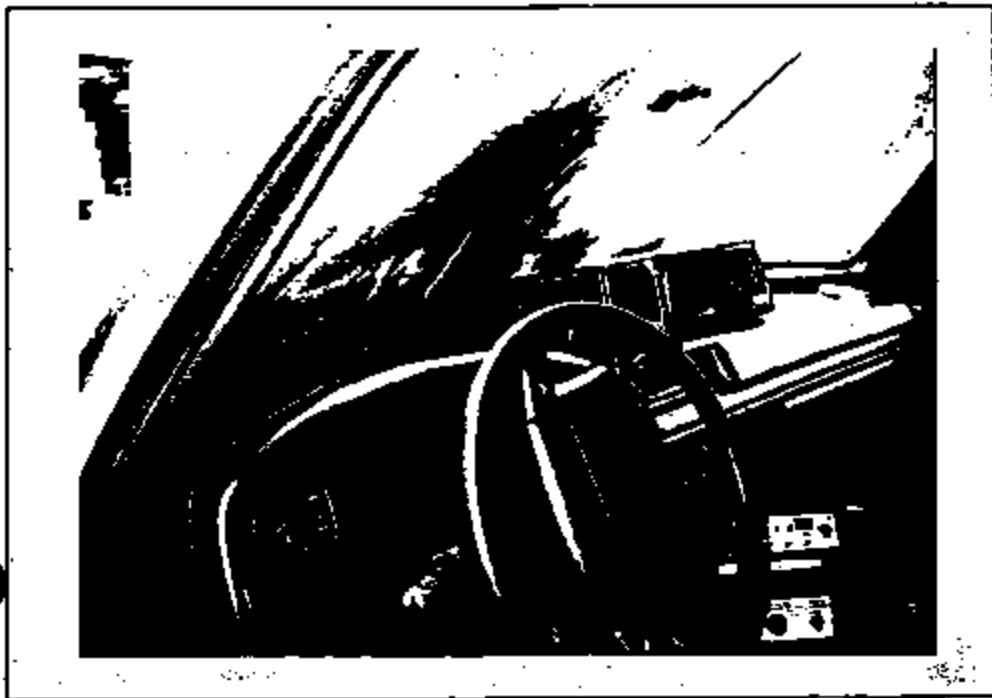
(6)

Inside dash
board.

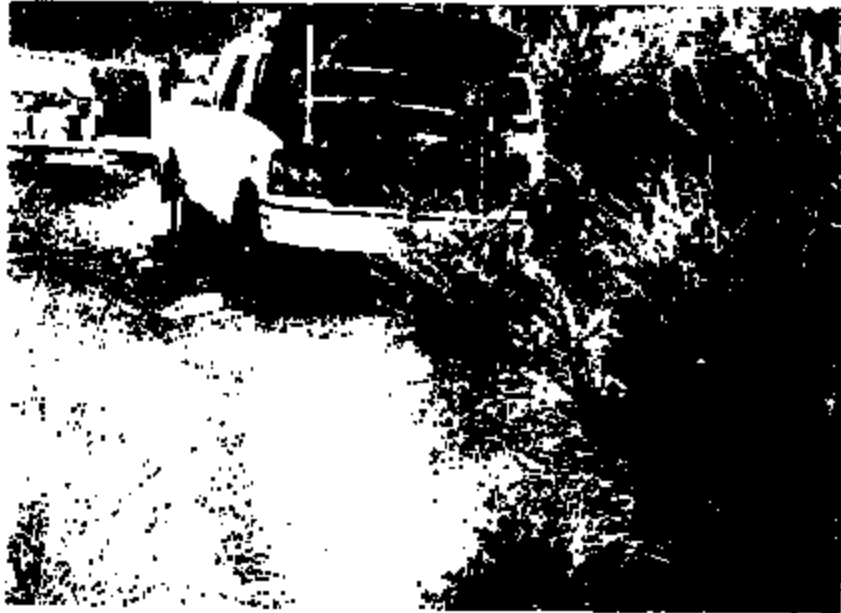
FIGURE 1

- a. The vehicle had been parked on the edge of a Christmas tree farm (fig. 1). Burnable debris on the ground included a small amount of grass and tree trimmings (fig. 2, rear of truck; fig. 3, front of truck; and fig. 4). Also, the truck had been parked on a small tree. The tree had been bent over by the truck's frame and was resting against the muffler (fig. 5).
