RE: Fire Loss Of 1995 Ford F150

I represent [redacted] in regard to its subrogation claim resulting from a fire loss to a 1995 Ford F150 pickup truck. The fire occurred on May 12, 1995, and at that time the vehicle was owned by [redacted] and was insured through Kentucky Farm Bureau Mutual Insurance Company.

The pickup truck was destroyed when gasoline that had leaked from the vehicle ignited resulting in a total loss to the truck. Also enclosed for your consideration is the report of Mr. Frederick F. Franklin with Professional Analytical & Consulting Engineers, Inc., who was retained by Kentucky Farm Bureau to investigate the fire and determine its cause. You will note that the report also includes information obtained from [redacted] regarding the specific facts as to how the vehicle caught fire, and also the problems that he had been having prior to the fire with gas fumes from the truck. Mr. Franklin concludes that a leaking fuel line was the cause of the fire.

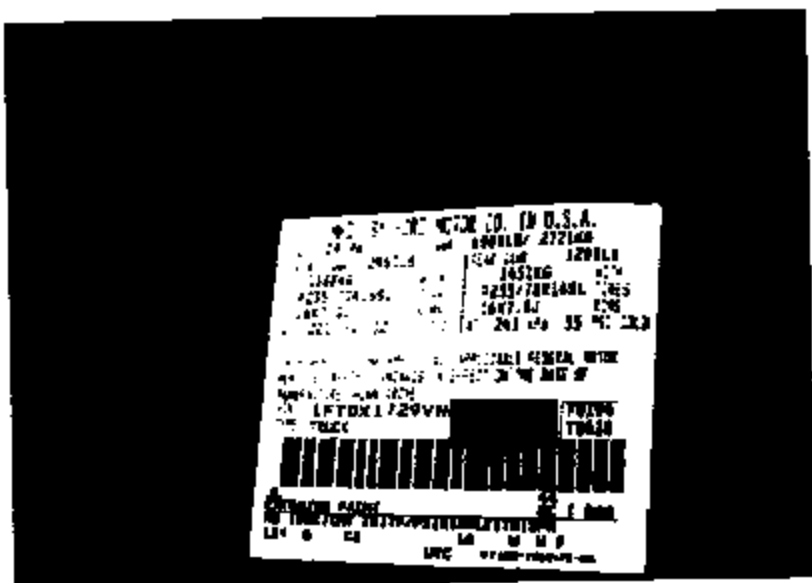
PHOTO #1

Photo #1 shows the vehicle door mounted Vehicle Identification Number 1PTDX1729V [REDACTED] and the date of manufacture of 09/96.

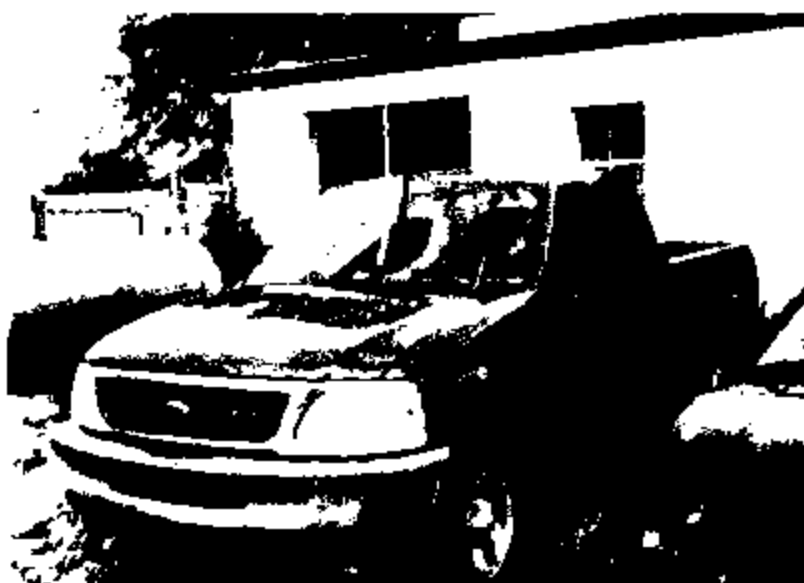
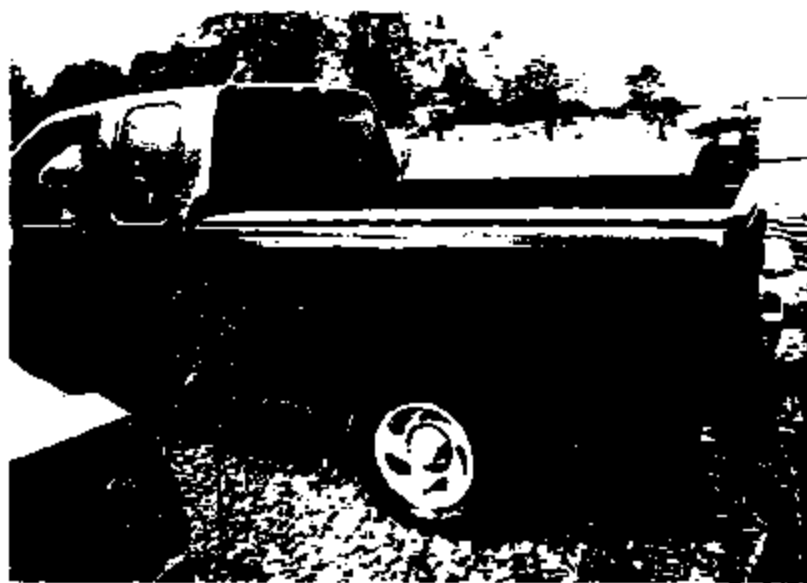
Photos #3 and #4 show the driver's side of the subject vehicle. No heat or fire damage was noted to the driver's side of the vehicle.

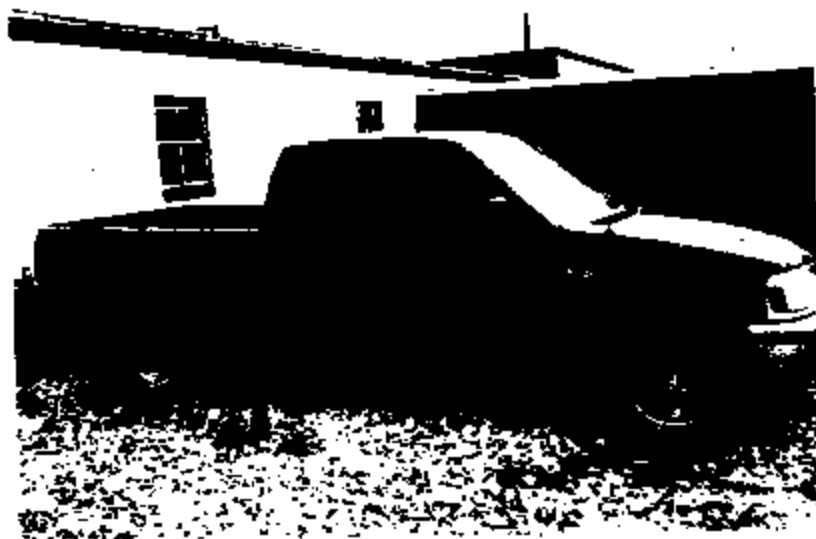
PHOTO #5

Photo #5 shows the passenger side of the subject vehicle. No fire damage was noted to this area of the vehicle.

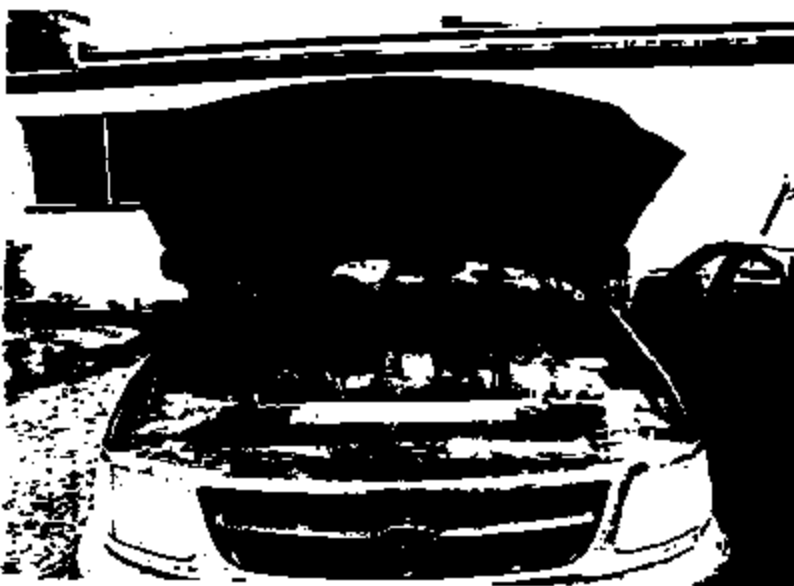
PHOTO #26

Photo #26 shows the open vehicle hood viewed from the front of the vehicle. No heat or fire damage was noted to the vehicle engine compartment.

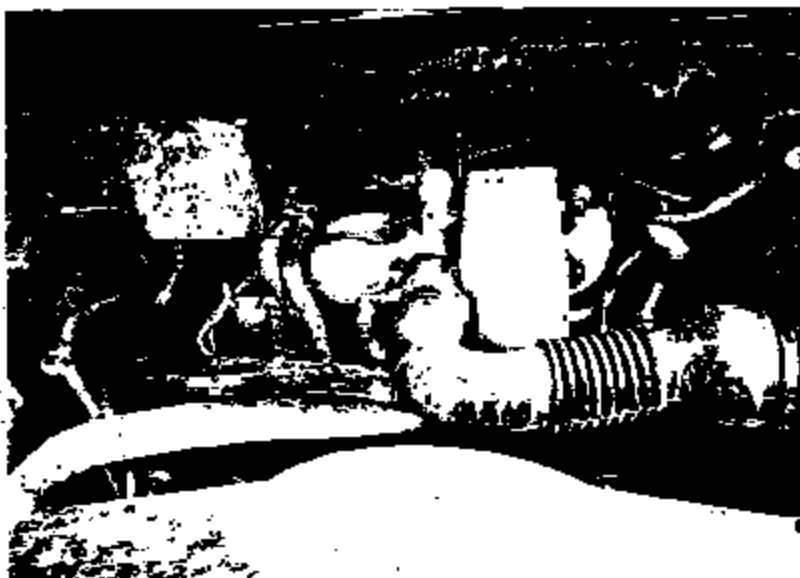
PHOTO #27

Photo #27 shows the vehicle engine assembly viewed from the front of the vehicle. Inspection of the vehicle engine compartment found it to be free of heat and fire damage. This clearly shows the fire did not originate in the engine compartment.

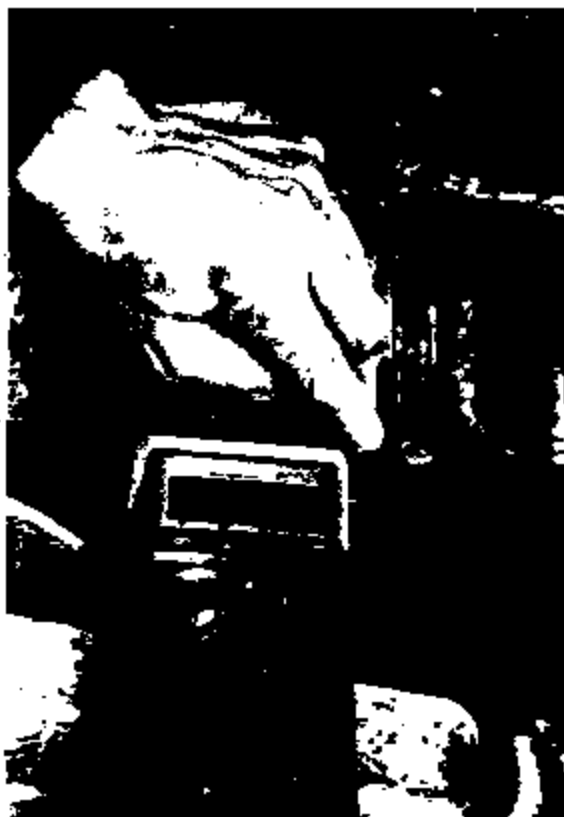
PHOTO #32

Photo #32 shows this investigator testing the vehicle battery with the use of a digital volt meter. A reading of 12.77 volts clearly shows the vehicle battery was not internally shorted.
