Unified
Investigations & Sciences, Inc.

**PRIVILEGED AND CONFIDENTIAL
REPORT NUMBER-ONE & FINAL**

ASSIGNMENT

Assignment received September 8, 2004, to conduct a vehicle fire examination of a 1998 Ford Explorer bearing a vehicle identification number of 1FMZU34E5WU [REDACTED] AND a Tennessee license plate of [REDACTED]. The vehicle examination was conducted at Southern Auto Salvage Pool at 3940 Jackson Avenue on September 13.

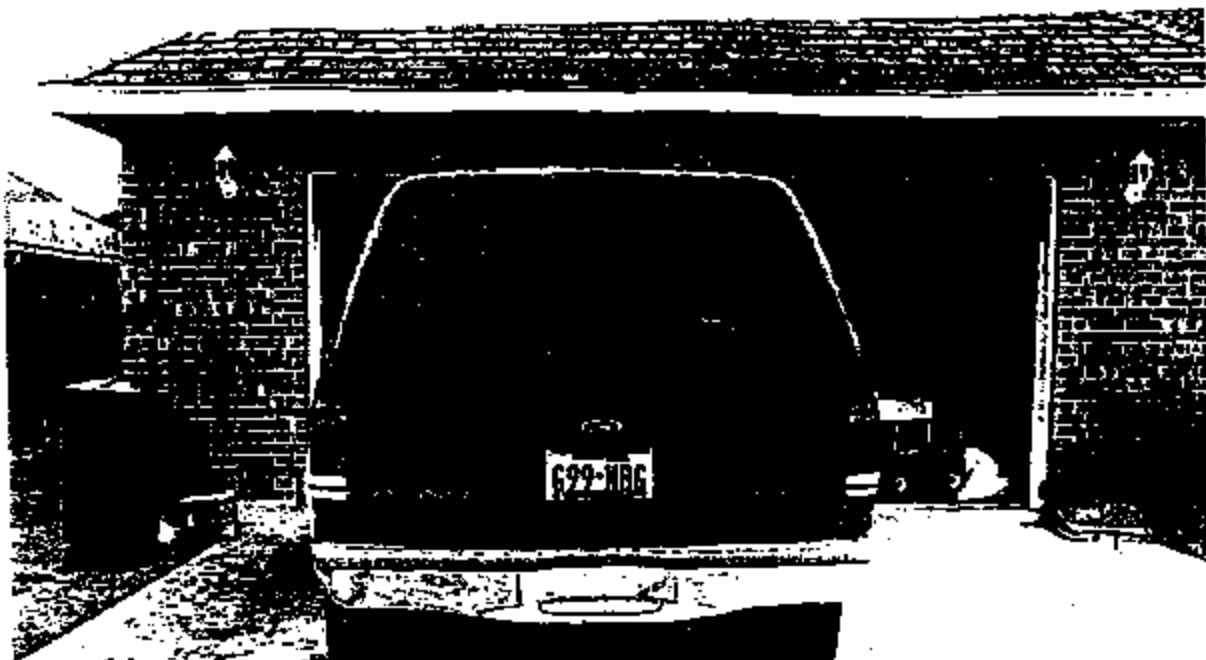
PHOTOGRAPH NO. 18

View of right (driver's side) exterior of the vehicle.

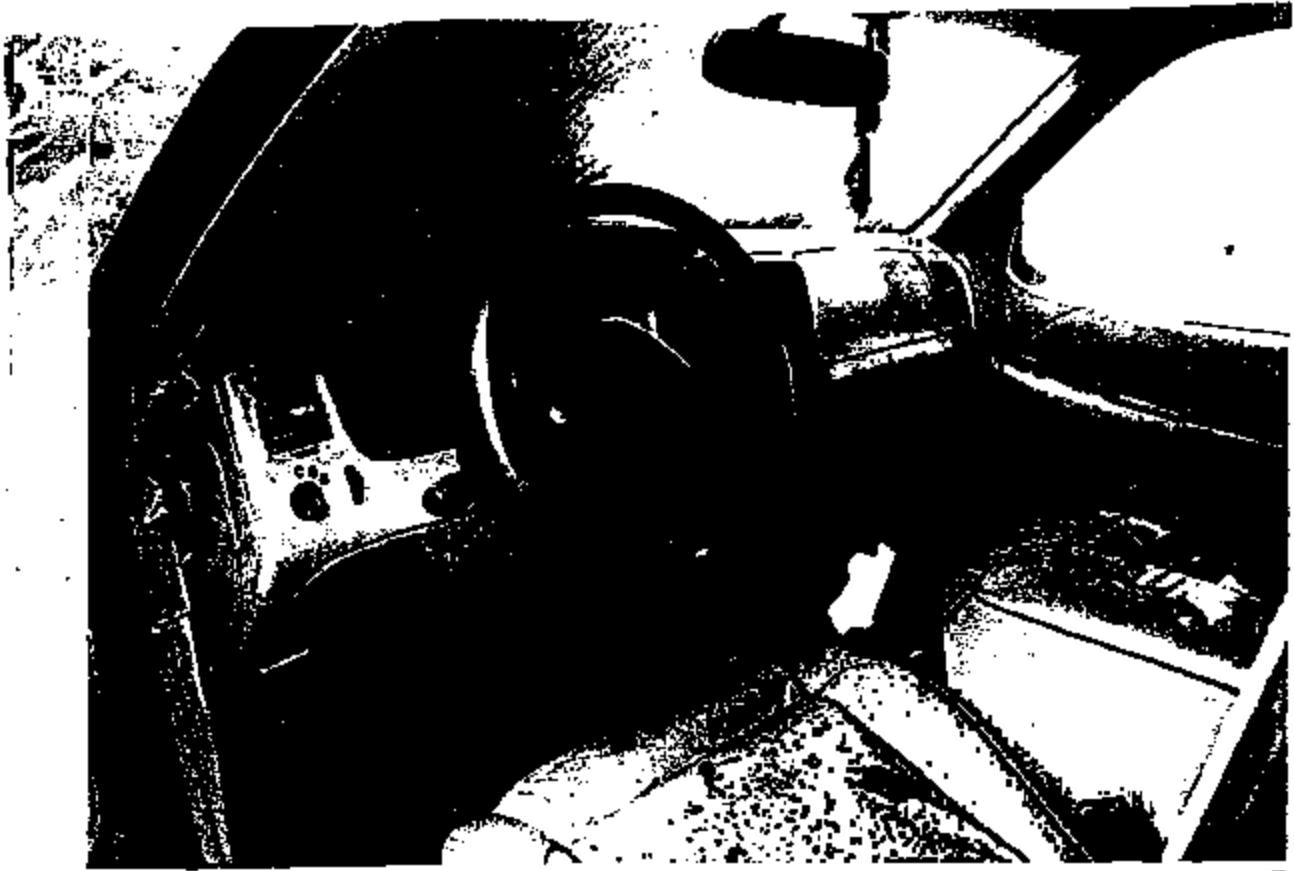
PHOTOGRAPH NO. 20

The next area examined was the engine compartment. Damage noted within the engine compartment was extensive throughout. The most severe damage was noted in the left region. Damage in left area included consumption and melting of plastics, consumption of wiring insulation and rubber insulating material on hoses, and oxidation of metals (RE: Photograph Nos. 20 and 21). It was further noted that the brake fluid reservoir was completely consumed. Slight melting was noted to the master cylinder (RE: Photograph No. 22). The location of the most severe damage was noted at the master cylinder and became progressively less severe in an outward direction from there. The damage noted on the right side of the engine compartment was considerably less severe (RE: Photograph No. 23). Using the evidence mentioned above, it was determined that the fire originated in the left rear region of the engine compartment, which was located in the north central region of the garage at the time of the fire.

View of the left interior of the engine compartment.

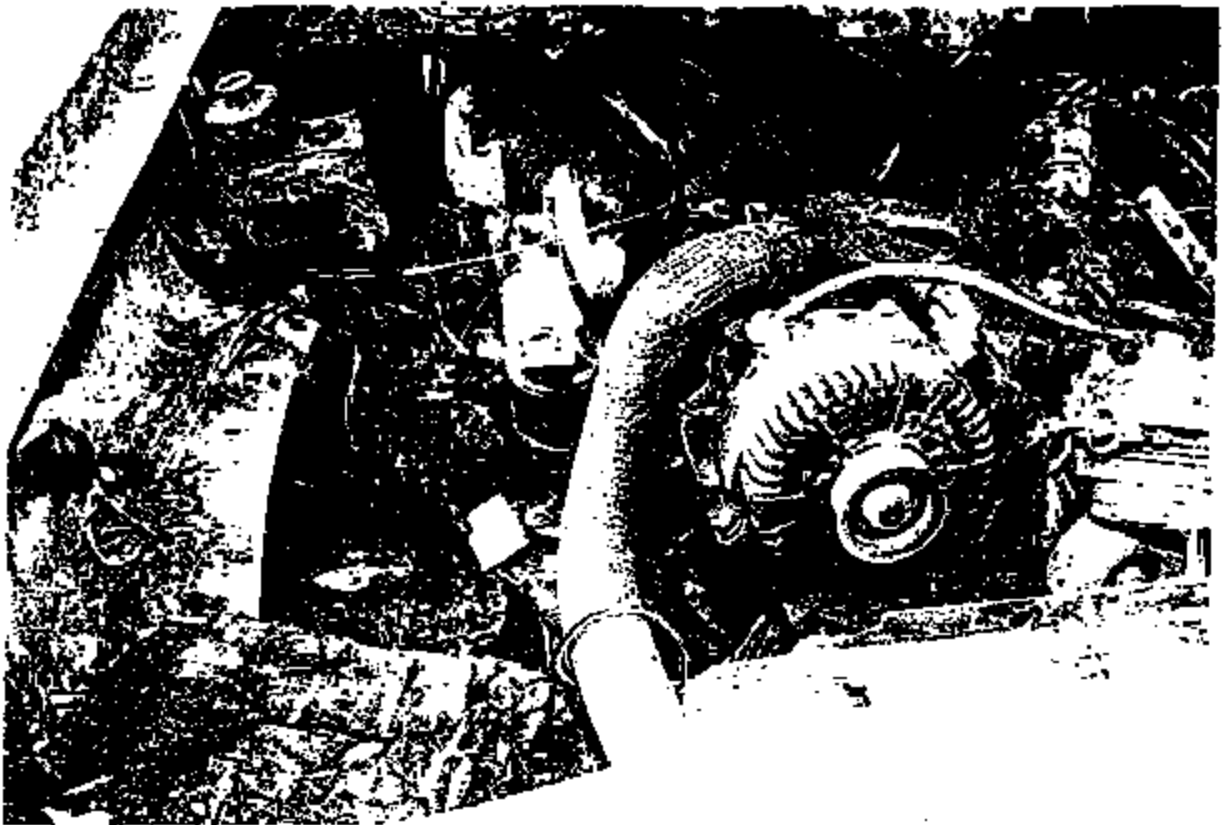
PHOTOGRAPH NO. 24

View of the fuse box. The finger indicates the only "blown" fuse within the box.
