FILE # 430-281183
INSURED [REDACTED]
VEHICLE 1998 Ford F150
VIN 2FTZX1SW5WC [REDACTED]
ODOMETER Unknown - burned
DATE OF LOSS October 24, 2002

Examine the Ford F150 and determine the origin and cause of the fire. Determine the mechanical and cosmetic condition of the vehicle at the time of the loss.

IN RE: Allstate Claim No. [REDACTED]
H&A File No. 04-0883VF
Date Received: May 14, 2004
[REDACTED]

ORIGIN AND CAUSE INVESTIGATION:

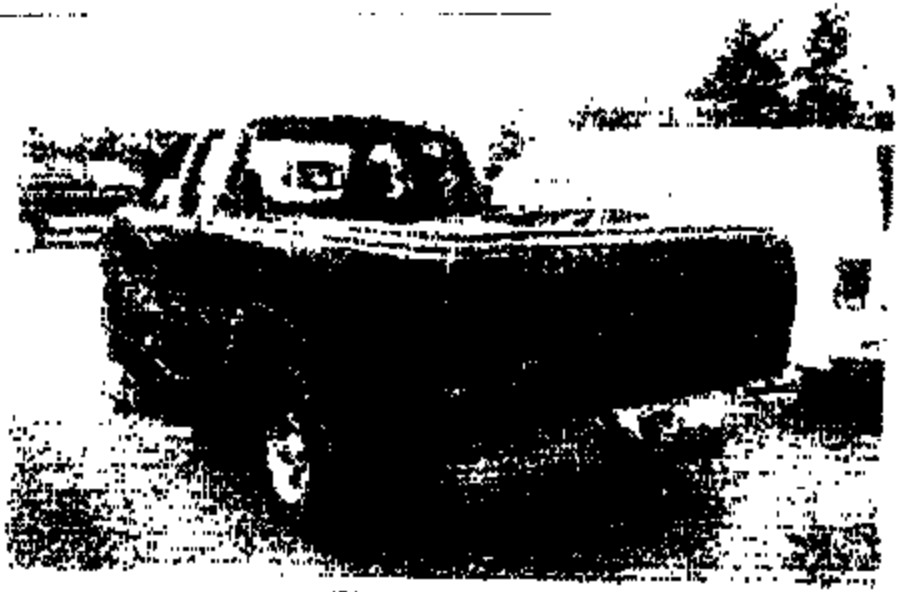
Photograph 4
Left rear view. 7448-03 had been removed

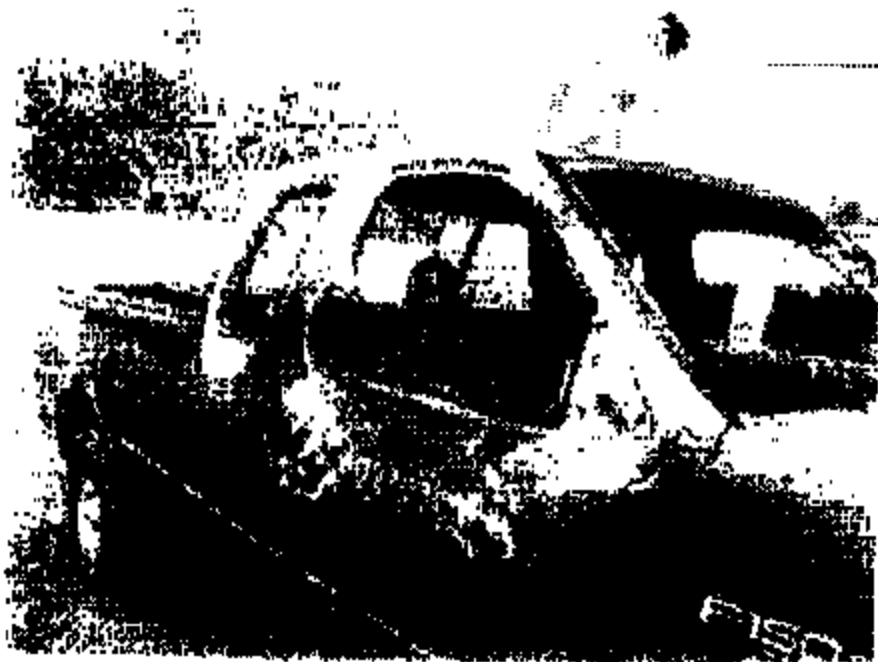
Photograph B
View of driver's position in the right side. The driver was a female.
