PROPERTY INVOLVED:

1995 Ford F150 pickup truck, color black, VIN# 1FTDF15Y05 [REDACTED] This vehicle was equipped with a 4.9 liter 6 cylinder engine, 5 speed manual transmission, and air conditioning. There was no impact damage noted regarding this vehicle. Mileage at the time of loss could not be verified, due to the fire damage and destruction of the dash and instrument panel. The owner insured indicated an estimated mileage of 73,000, and this may be verified through service records at Marshall Ford in Chattanooga, Tennessee. There was no indication that this vehicle had been altered from original factory manufactured specifications, and no installations of after market electrical items were noted. The steering column and the ignition cylinder had not been breached. Tires were Trail Blazer ATP235-75R15 and were in good condition. This vehicle displayed Tennessee tag [REDACTED] registered in Hamilton County.

VEHICLE EXAMINATION:

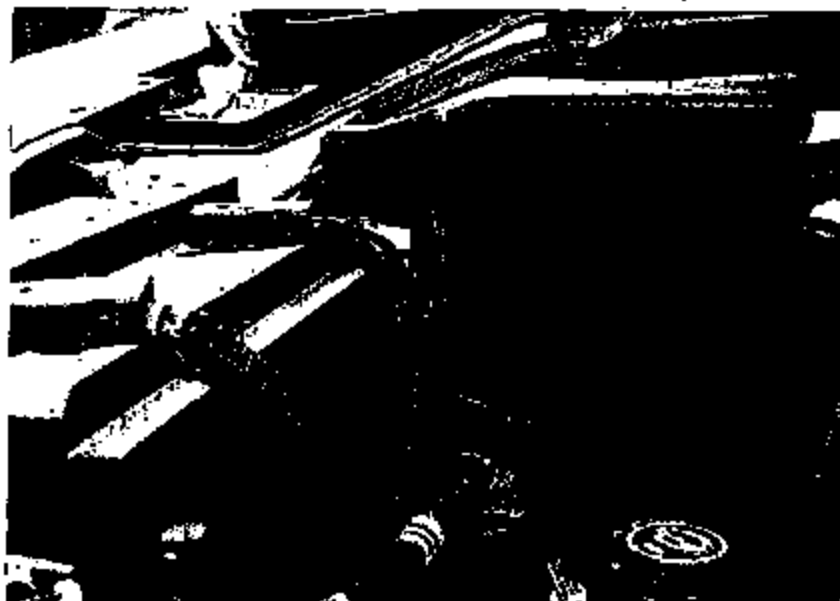
Photo 10 indicates the positive battery cable routing on an exemplar vehicle. Note that the terminal lug is behind a plastic cover and directly above an air conditioner component. On the subject vehicle, a hole was burned into the top of the aluminum air conditioner component, photo 12.

PHOTO 10 View showing the routing of the positive battery cable in an exemplar vehicle.
