MITSUBISHI
4/6/2005
LETTER TO ODI
ATTACHMENT
DOCUMENT NO. 26 - 34
PART 4 OF 4

MMMA ST24/28/41 Melt Headlamp Connector

ST24S Headlamp connector failure mode confirmation

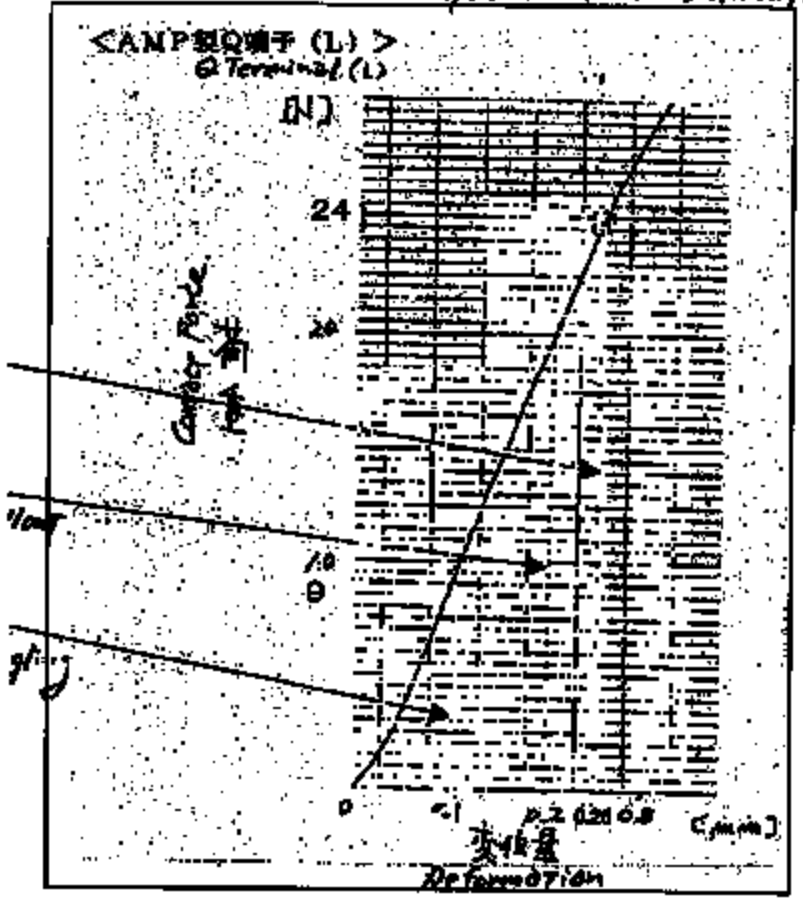
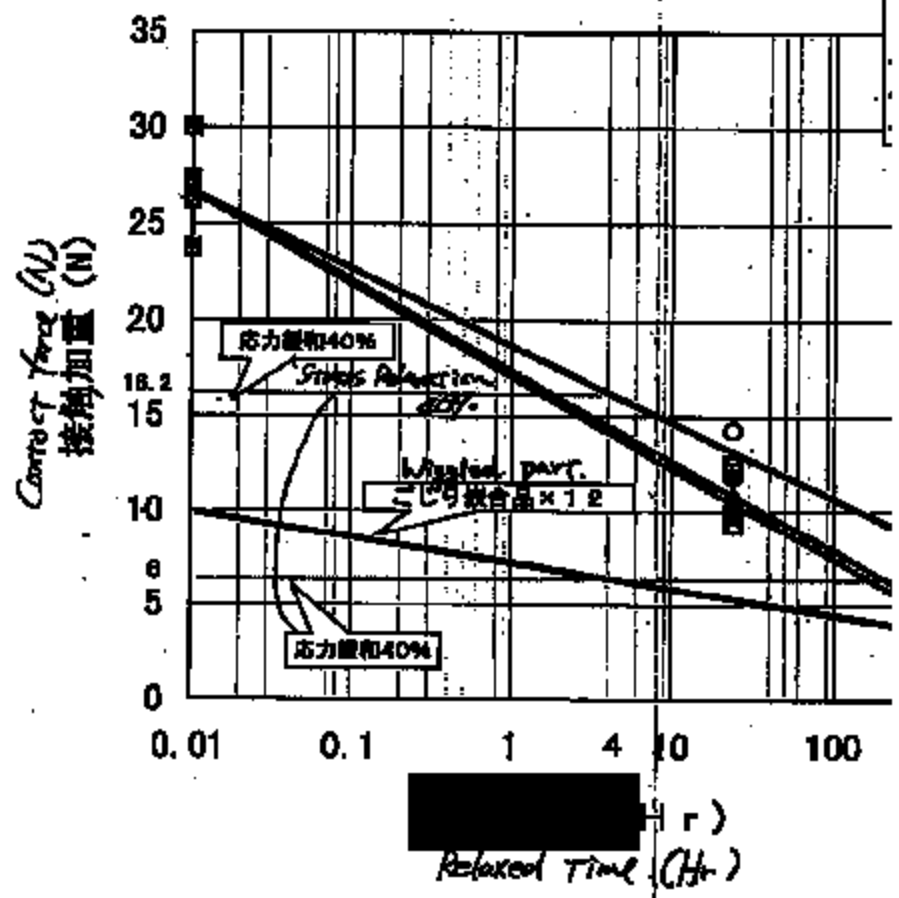
Terminal stress relaxation

The lowest recommended contact force is 6.0N for its stability

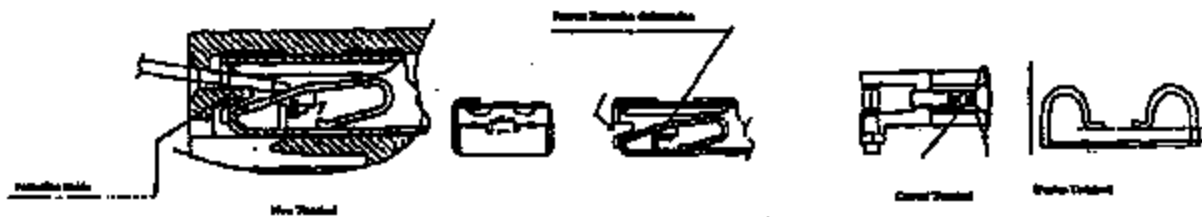
- Terminal Material Change:

From brass (threshold: 120 D.C.) to a Copper alloy (threshold :140 D.C.)

Replace service parts MB943536 with MU800585.

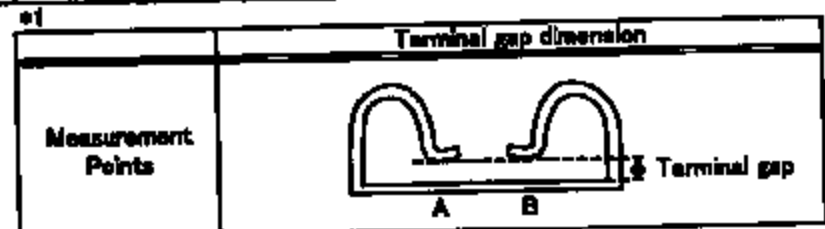
Qualitative analysis	Terminal corroded		Discolored thinning	
	much	Cu, Cu	much	Cu, Sn
	not much	C, O, Zn, Cl	not much	C, S, Zn, Cl
	a little		a little	O

- Contact resistance of the terminals melted are very high although press contact resistance are low.
- Gaps of the terminal melted are wider than the other terminals and the gaps are the same as male terminal thickness or wider than male terminal.
- Appearances of arc marks on the terminal contact surface are similar with the arc mark caused on simulation test.
- From qualitative analysis, Cl which is found on the both of terminal corroded and discolored thinning portions caused by melted wire cover.
