PE05-035
HYUNDAI
8/26/2005
REQUEST NO. 4
PART 3 OF 6

Consumer Assistance Center Case Report

CAUSE & ORIGIN REPORT

REQUEST: The investigation was authorized on October 22, 2004, by Mr. Rick Baisch, a claims representative with State Farm Insurance Company. The purpose of this investigation was to determine the cause and origin of a fire that occurred on September 30, 2004 in a 2003 Kia Sedona.

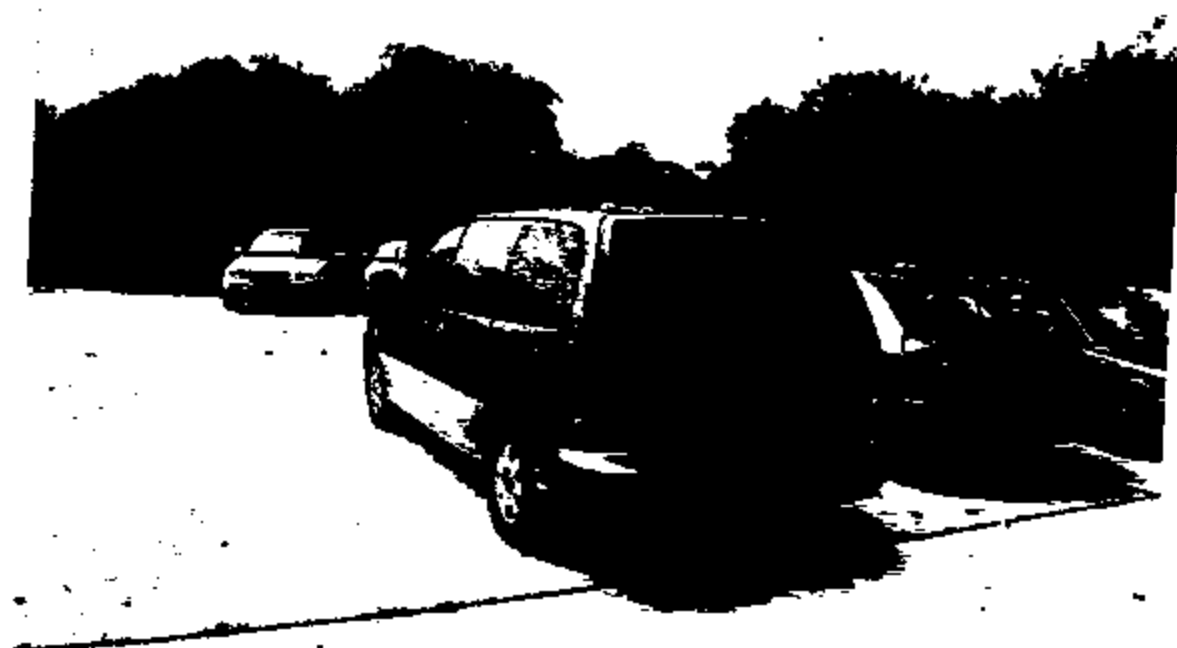
#3

PHOTO #3: Shows an exterior view of the left rear portion of the vehicle.
