- TIRE FORENSICS REPORT -

PN 67722
Purchase Order DTNH22-06-P-08366

SUBJECT: Forensic Evaluation on 9 Toyo Tires.

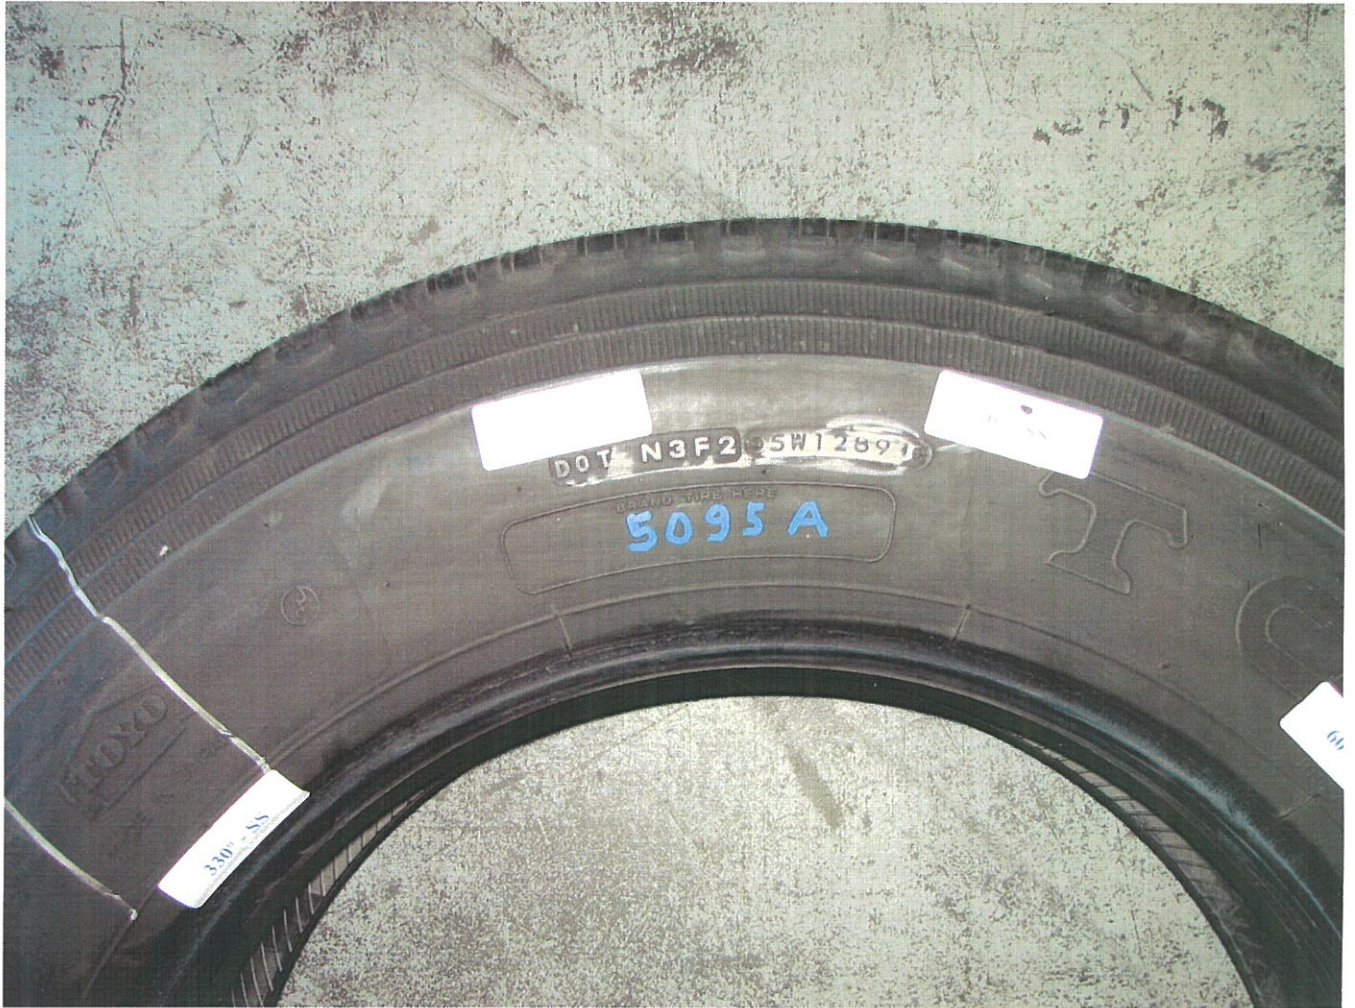
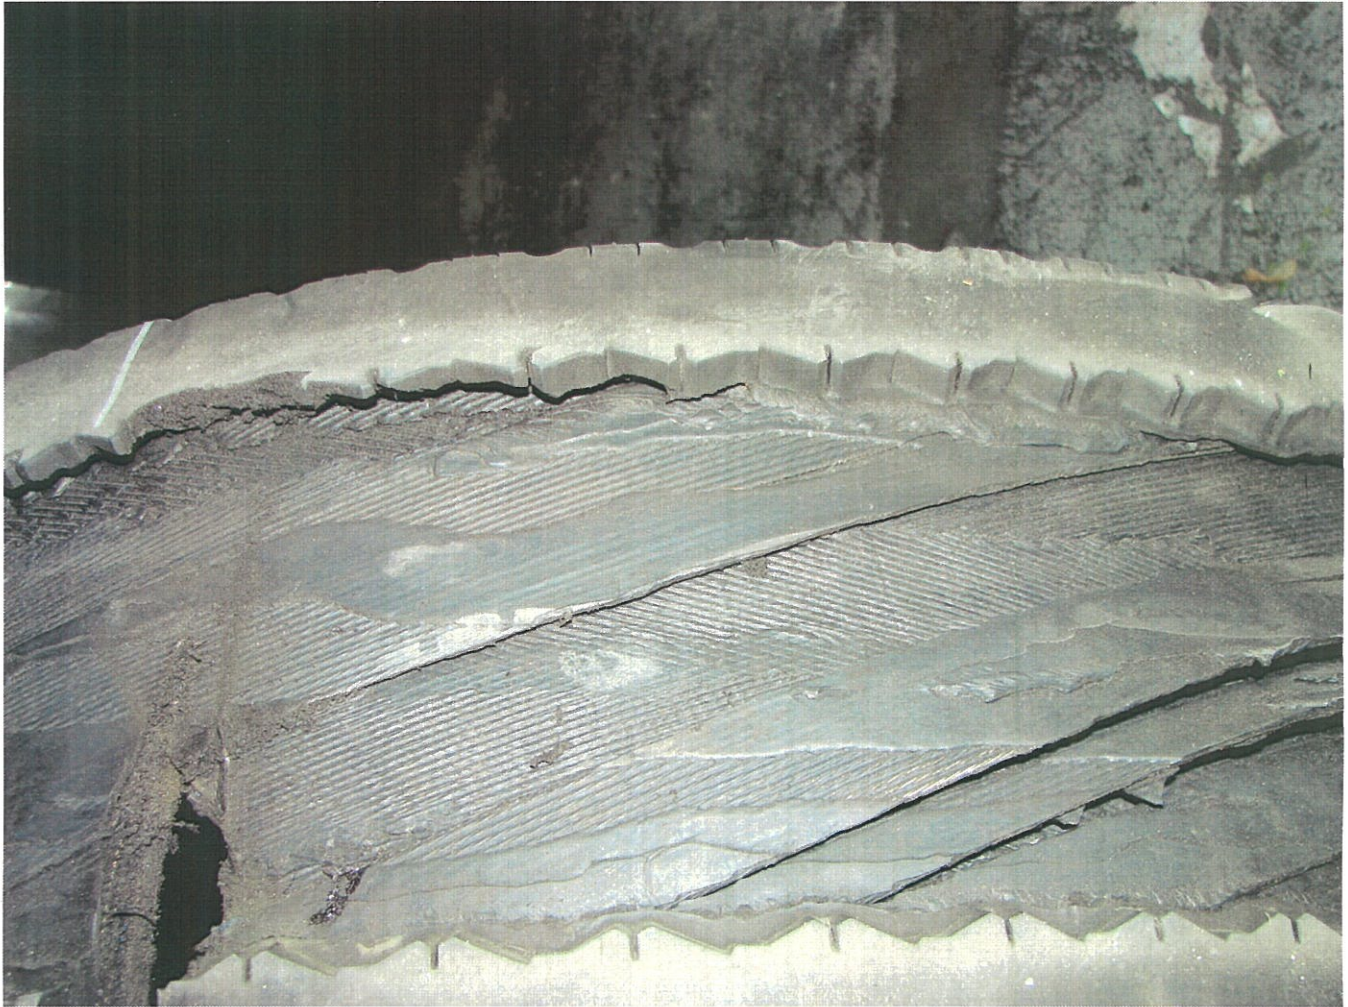
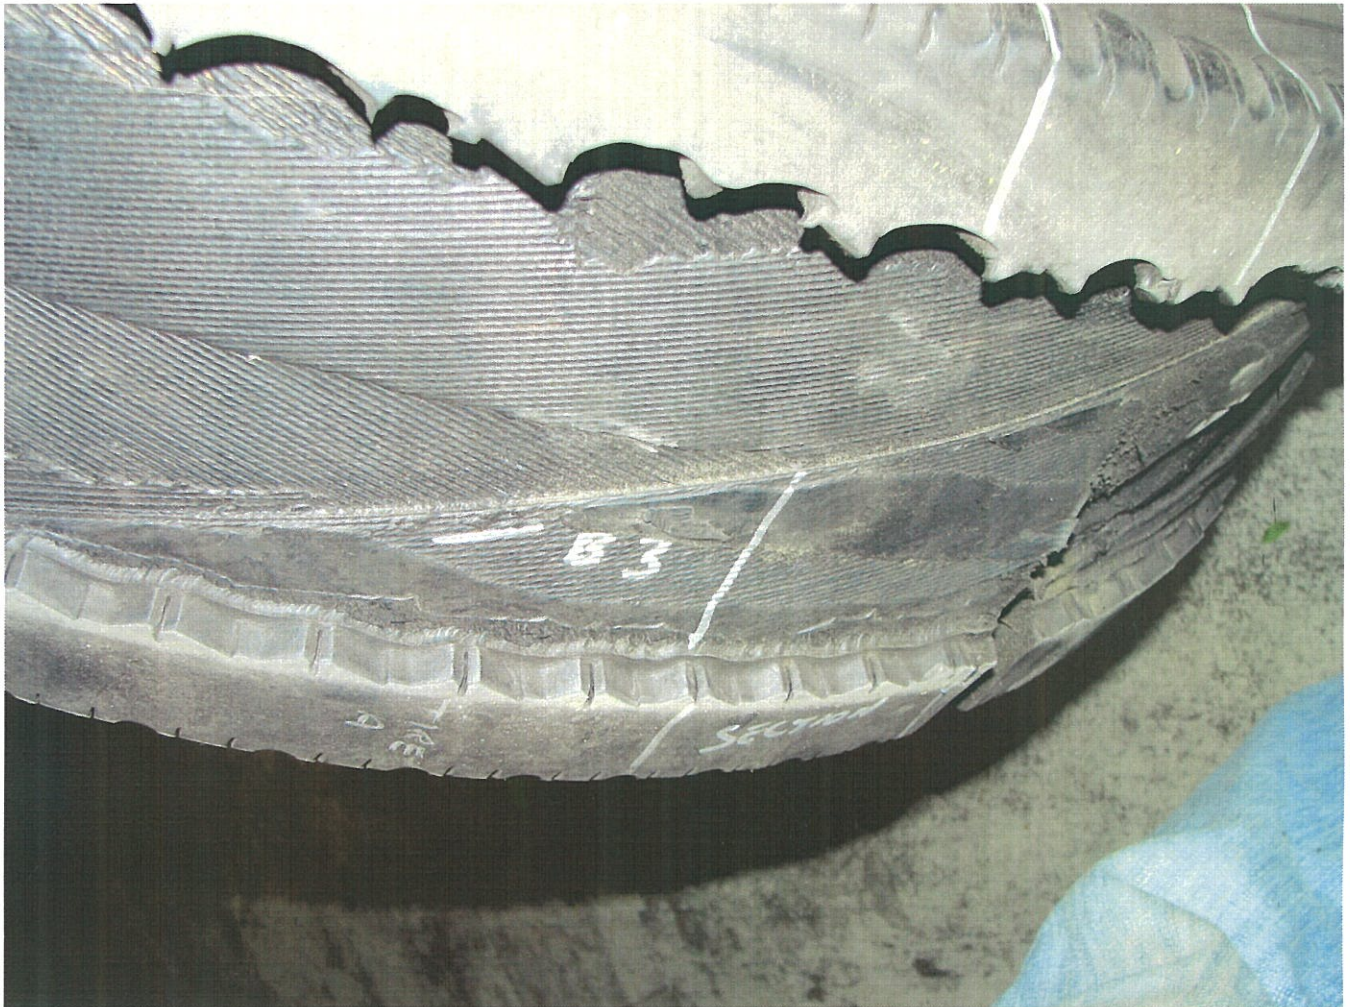
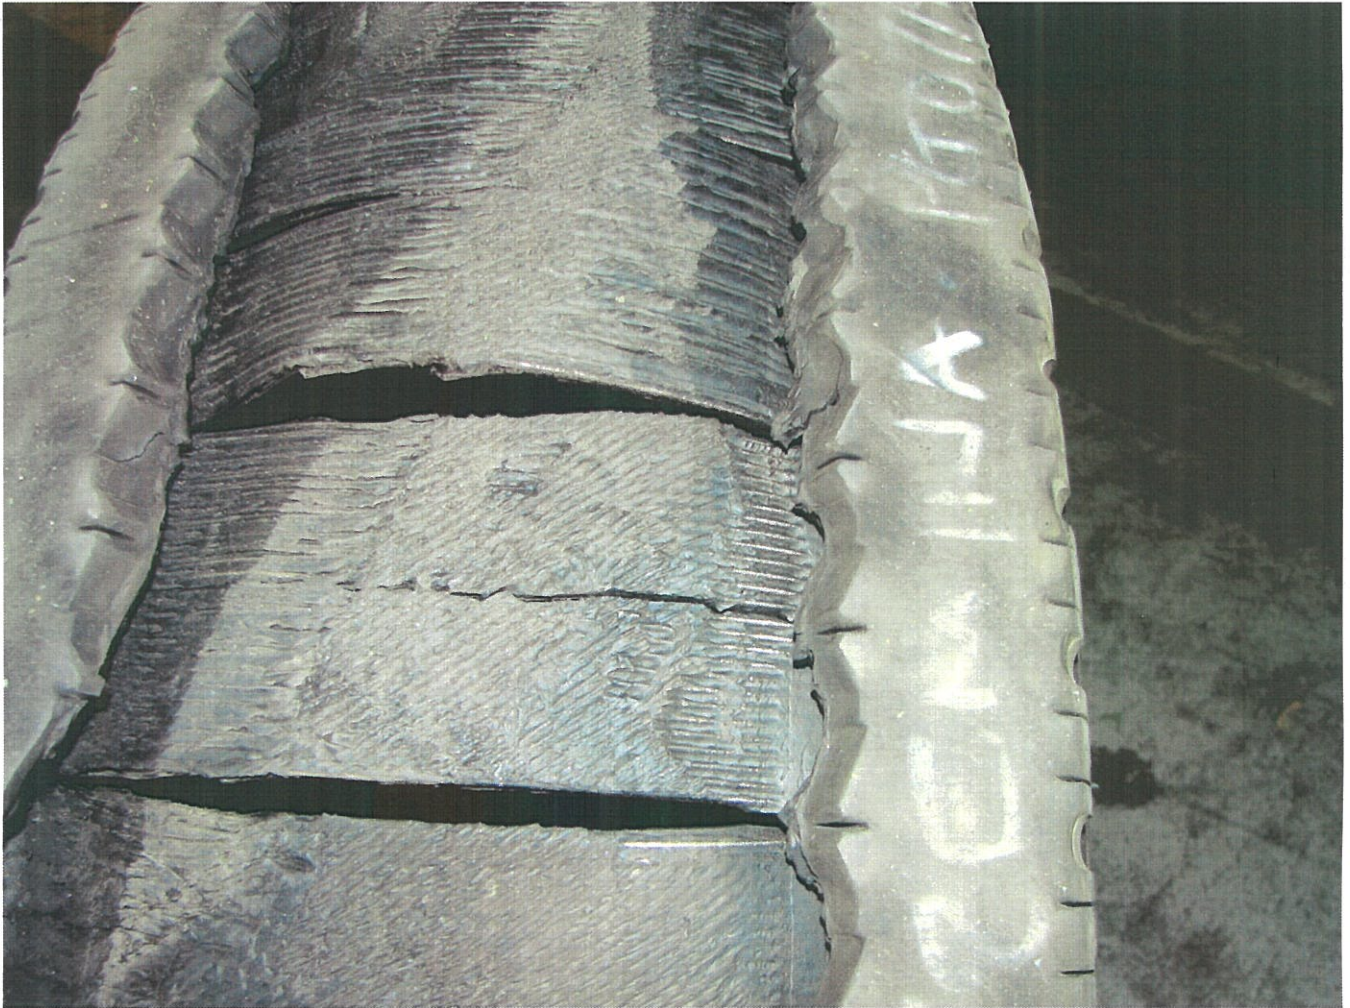
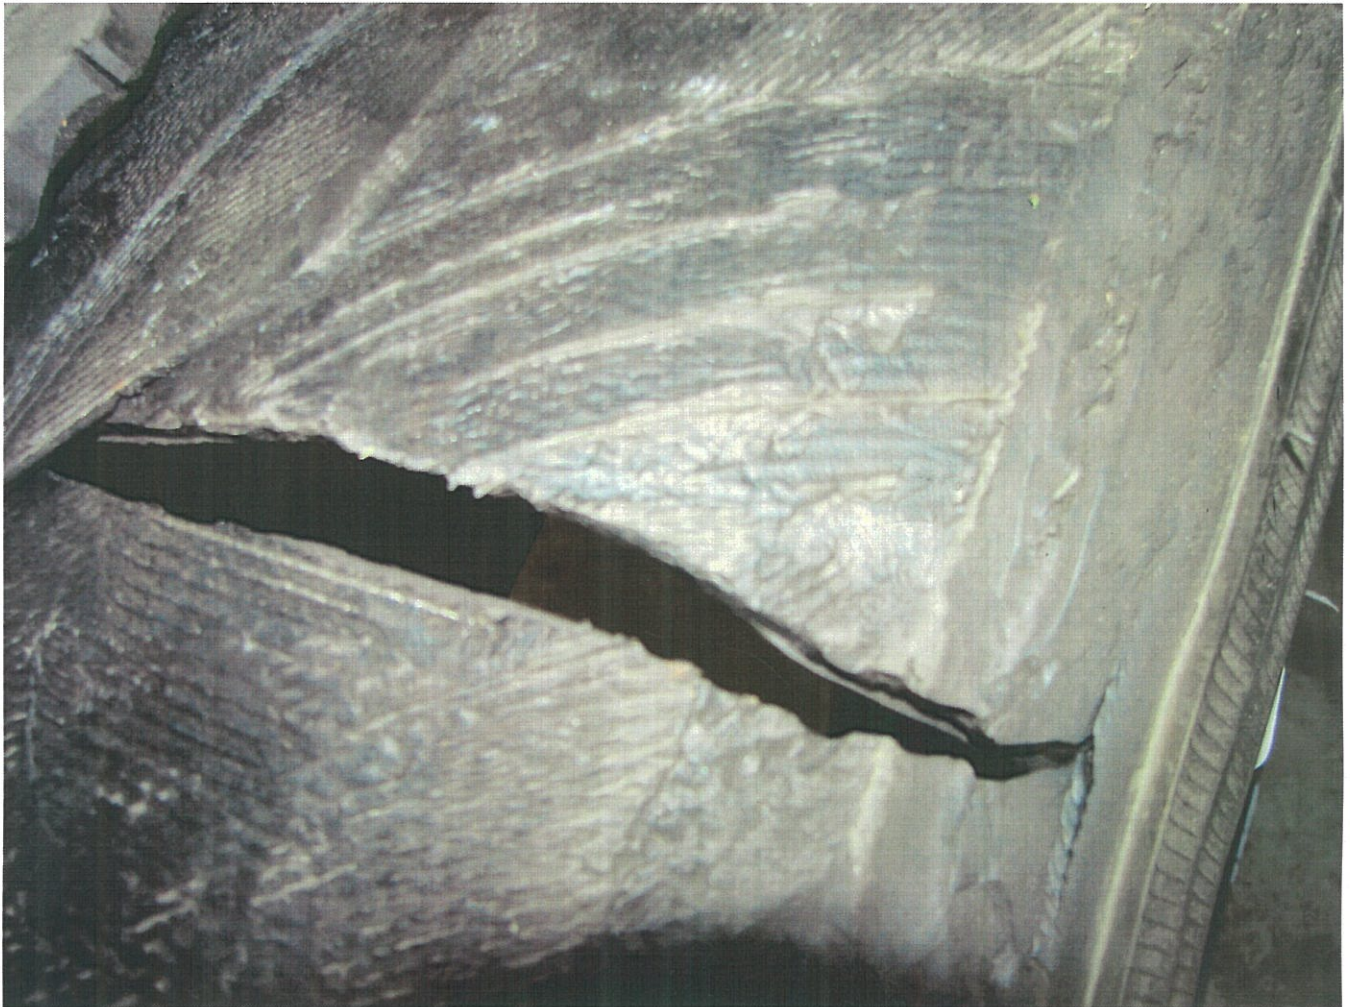
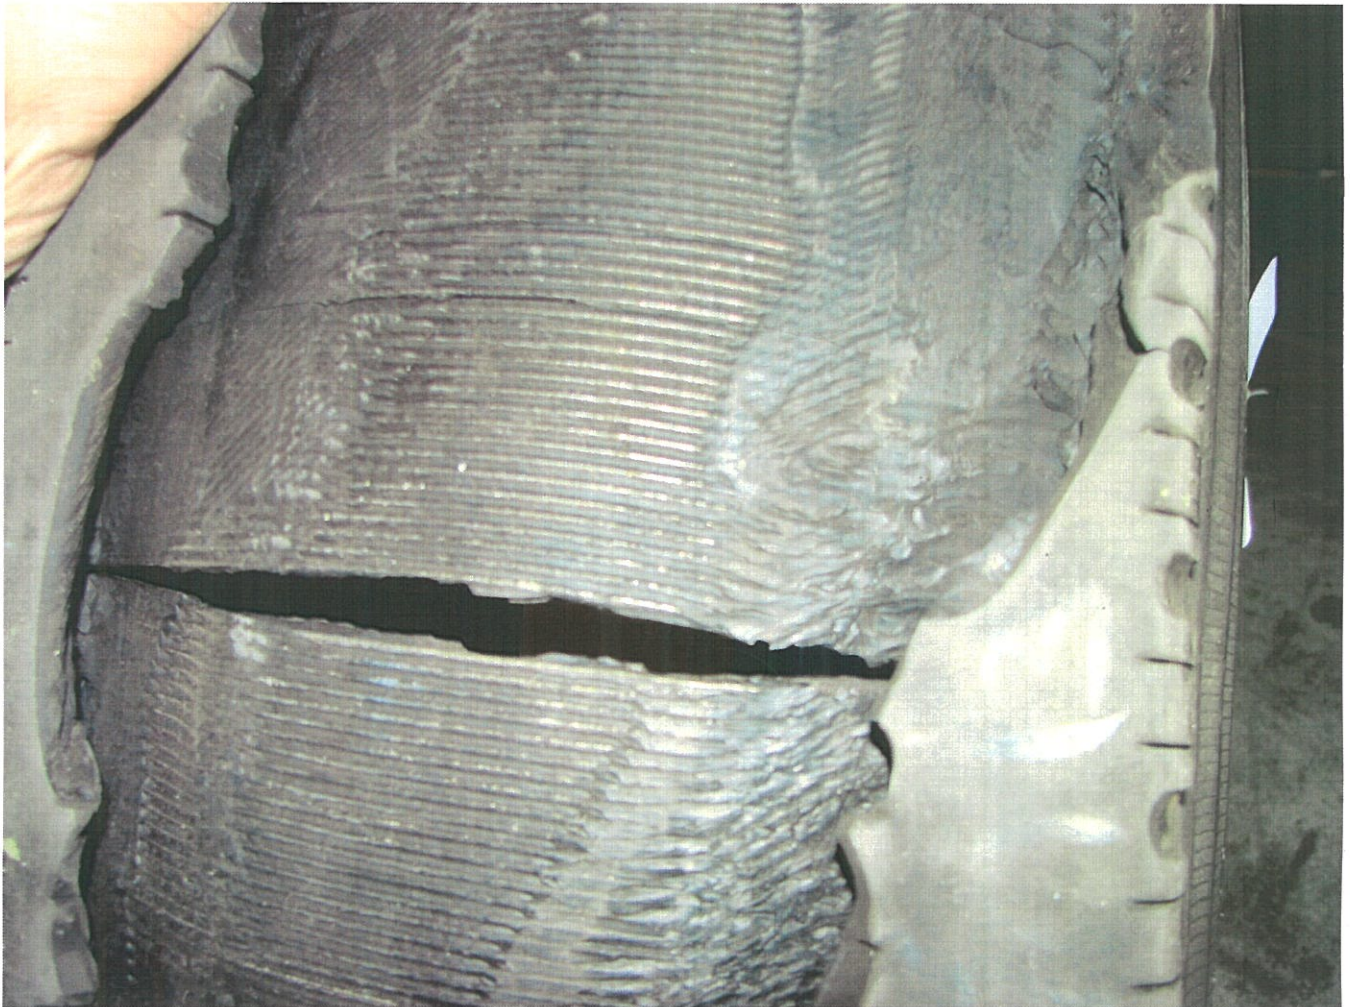
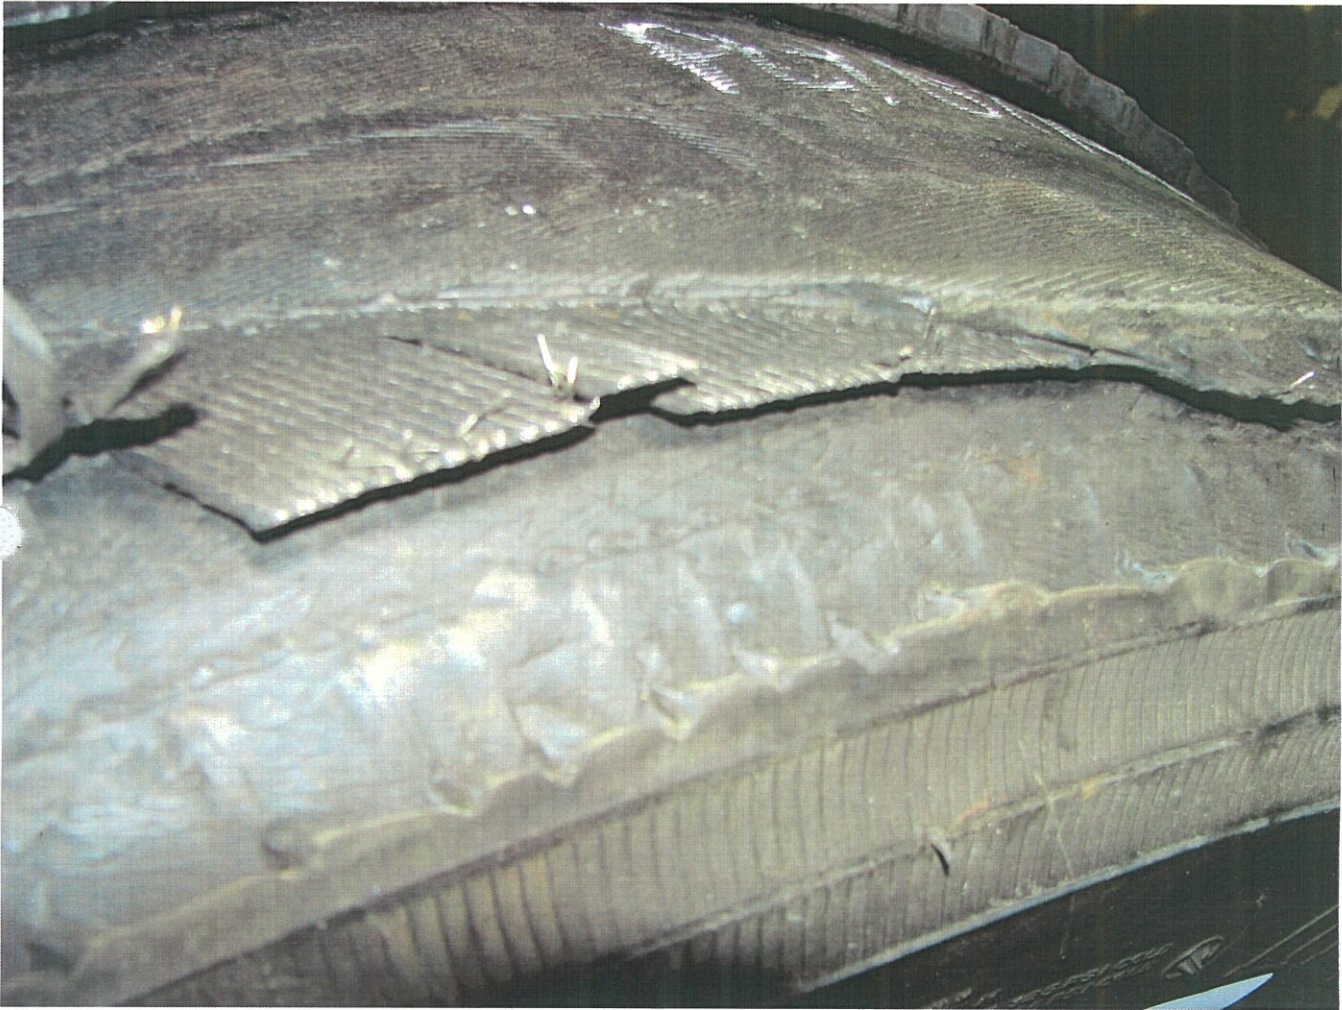
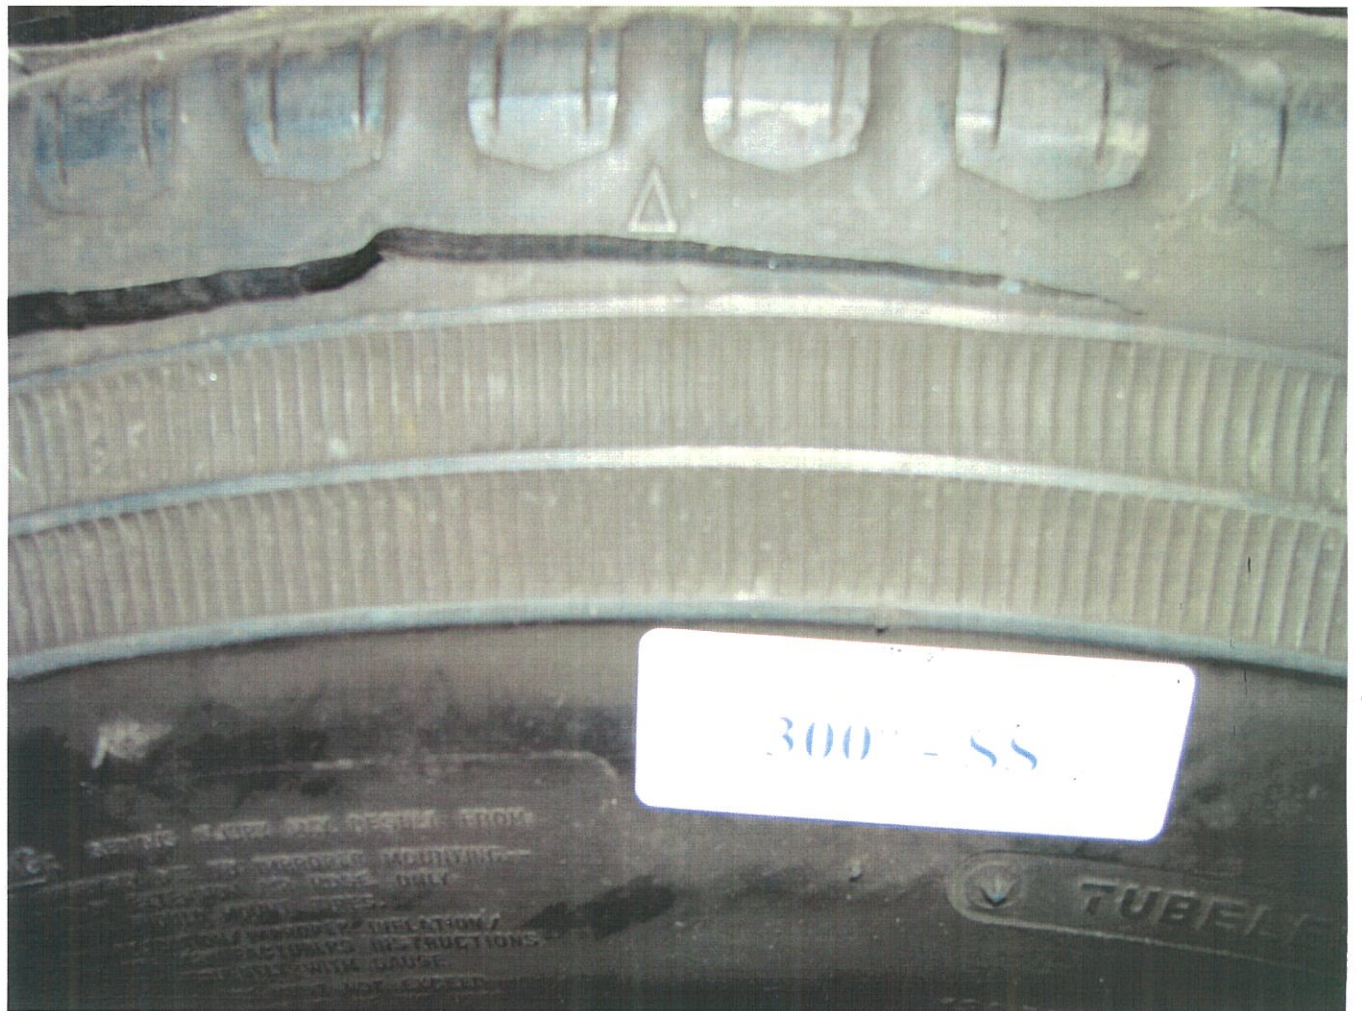
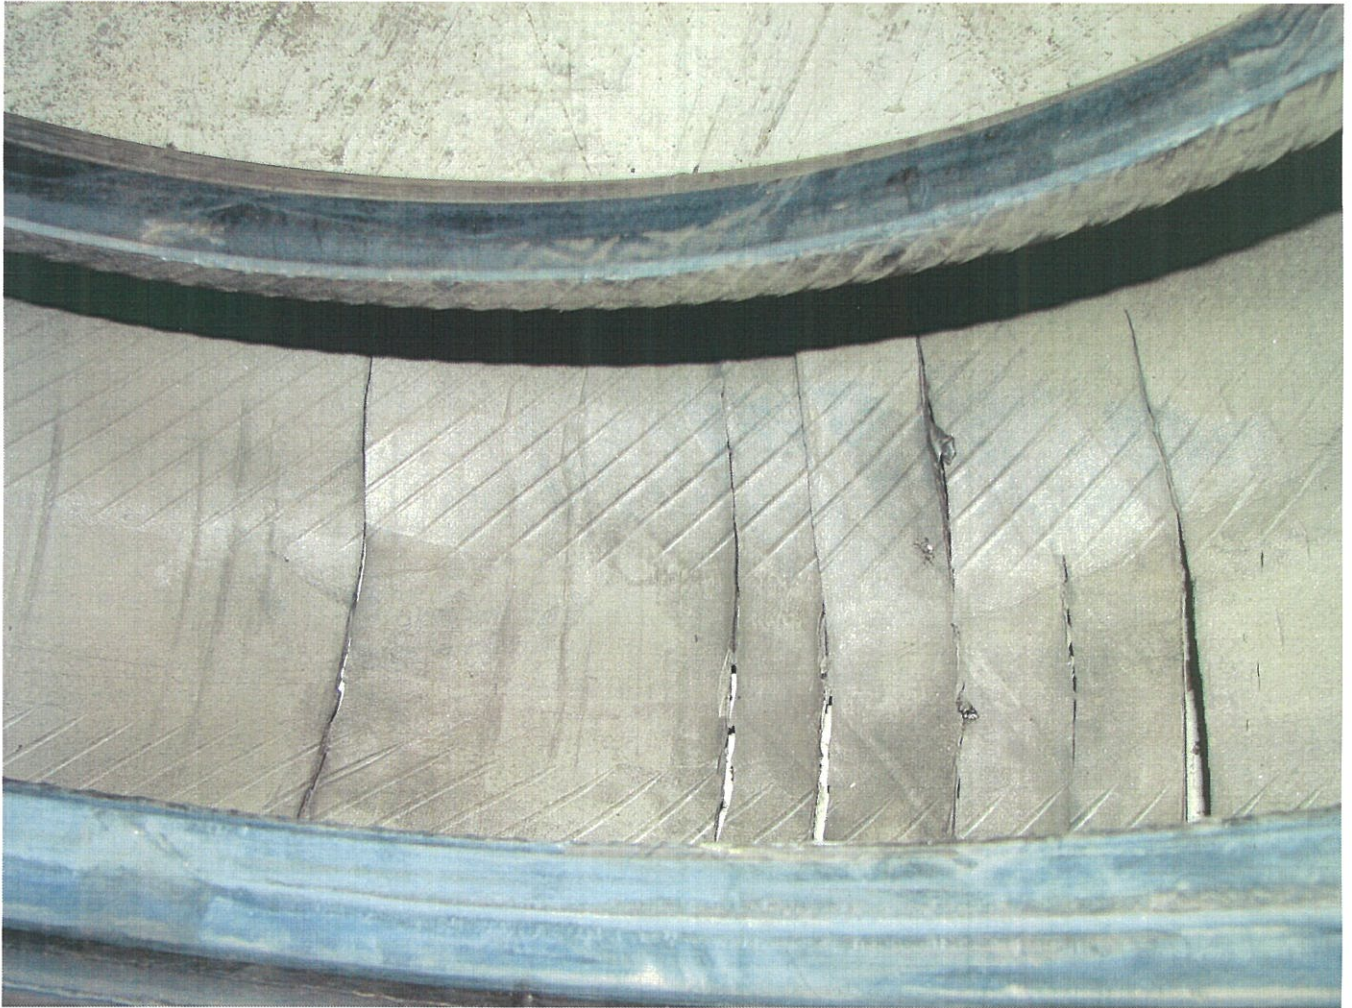
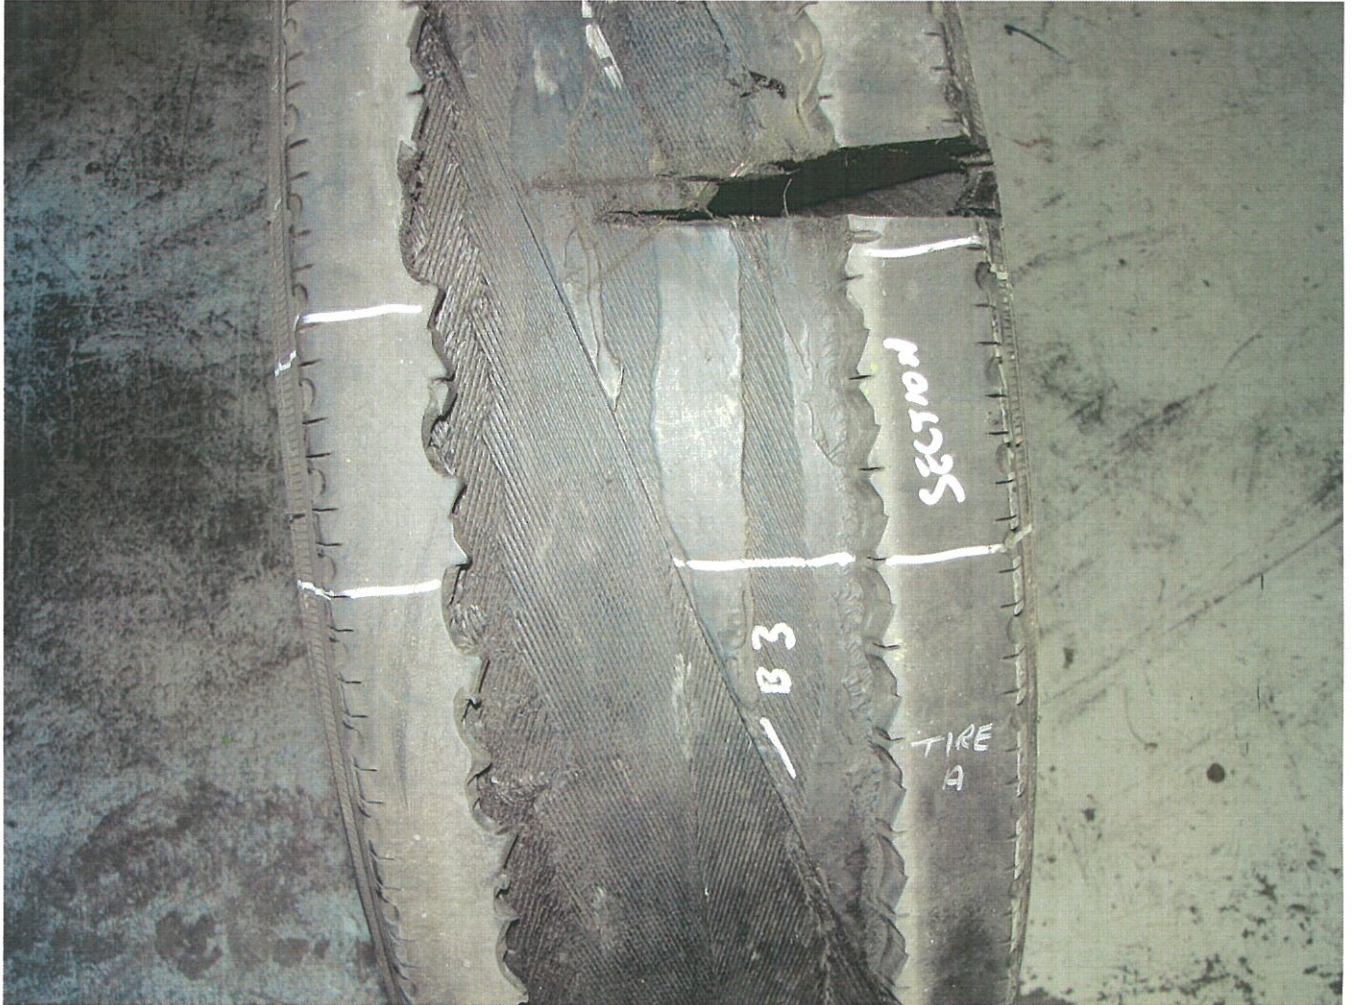
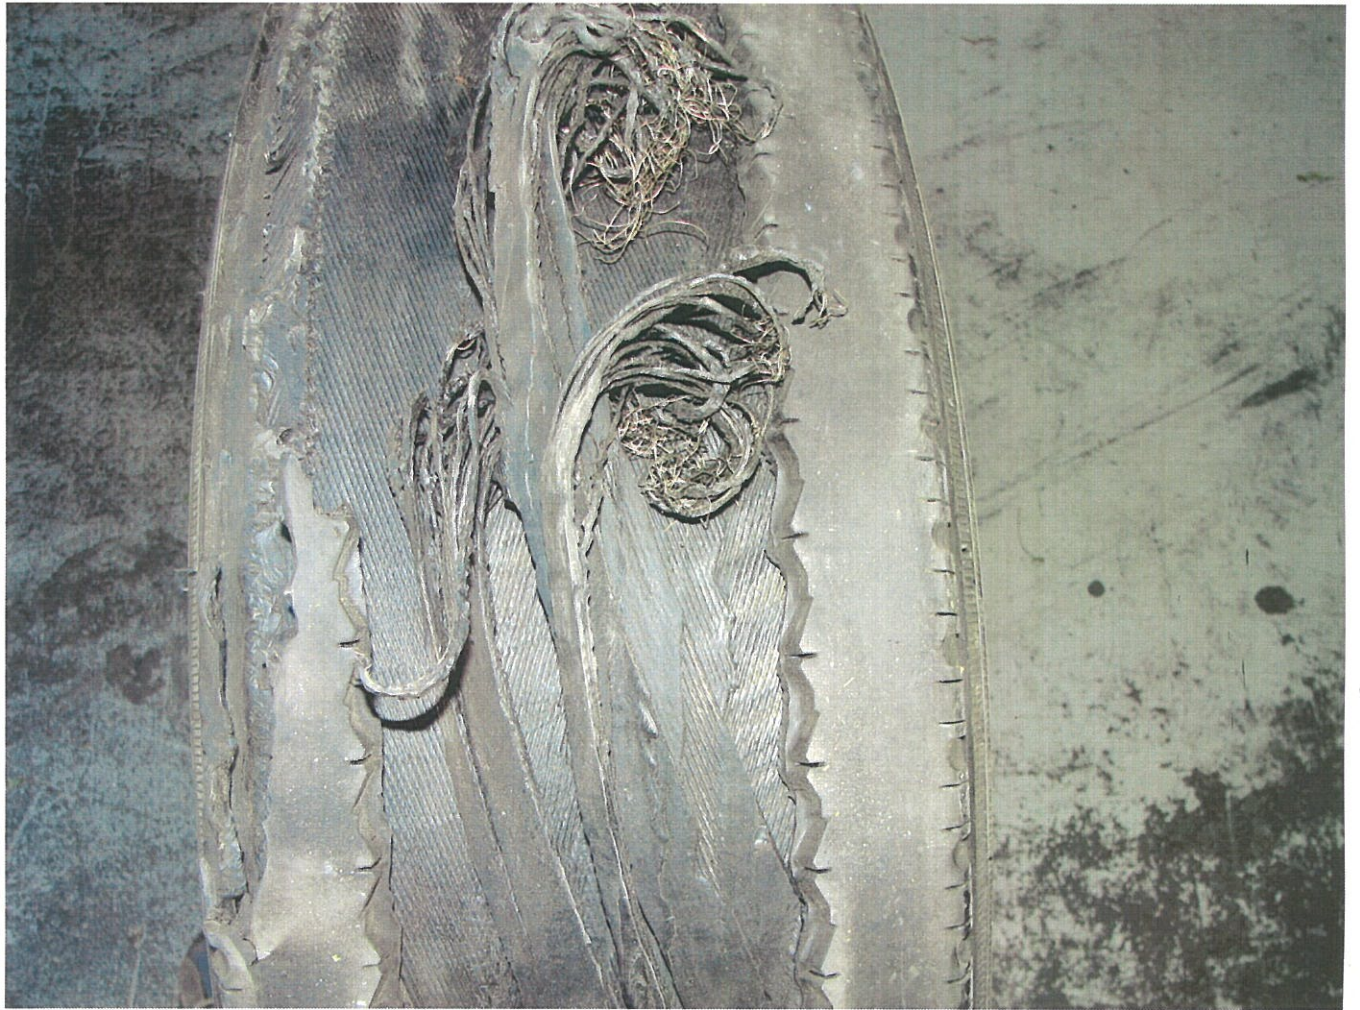
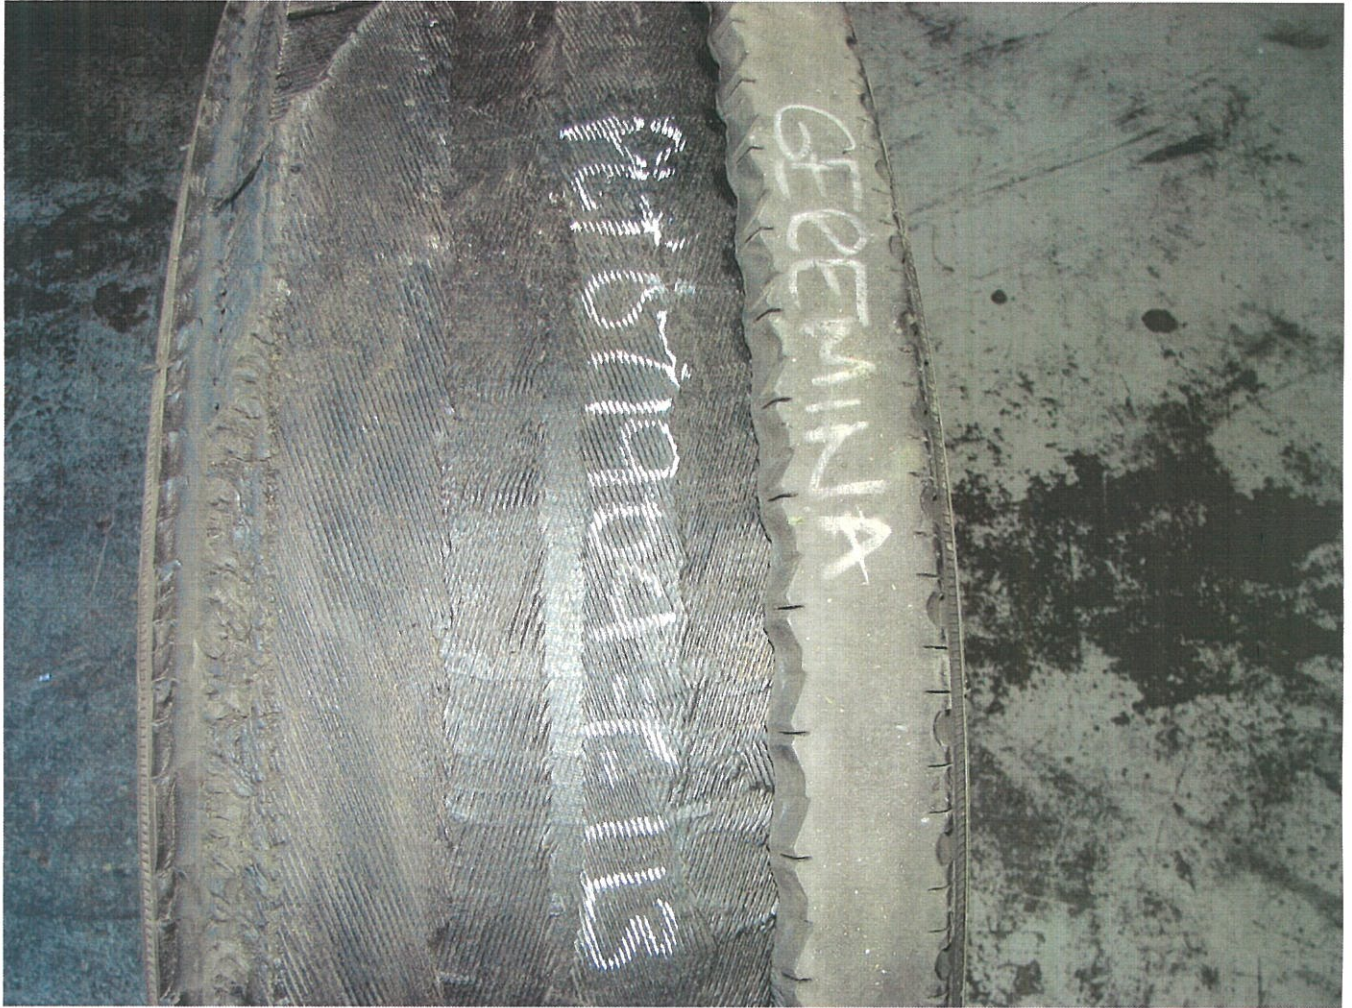
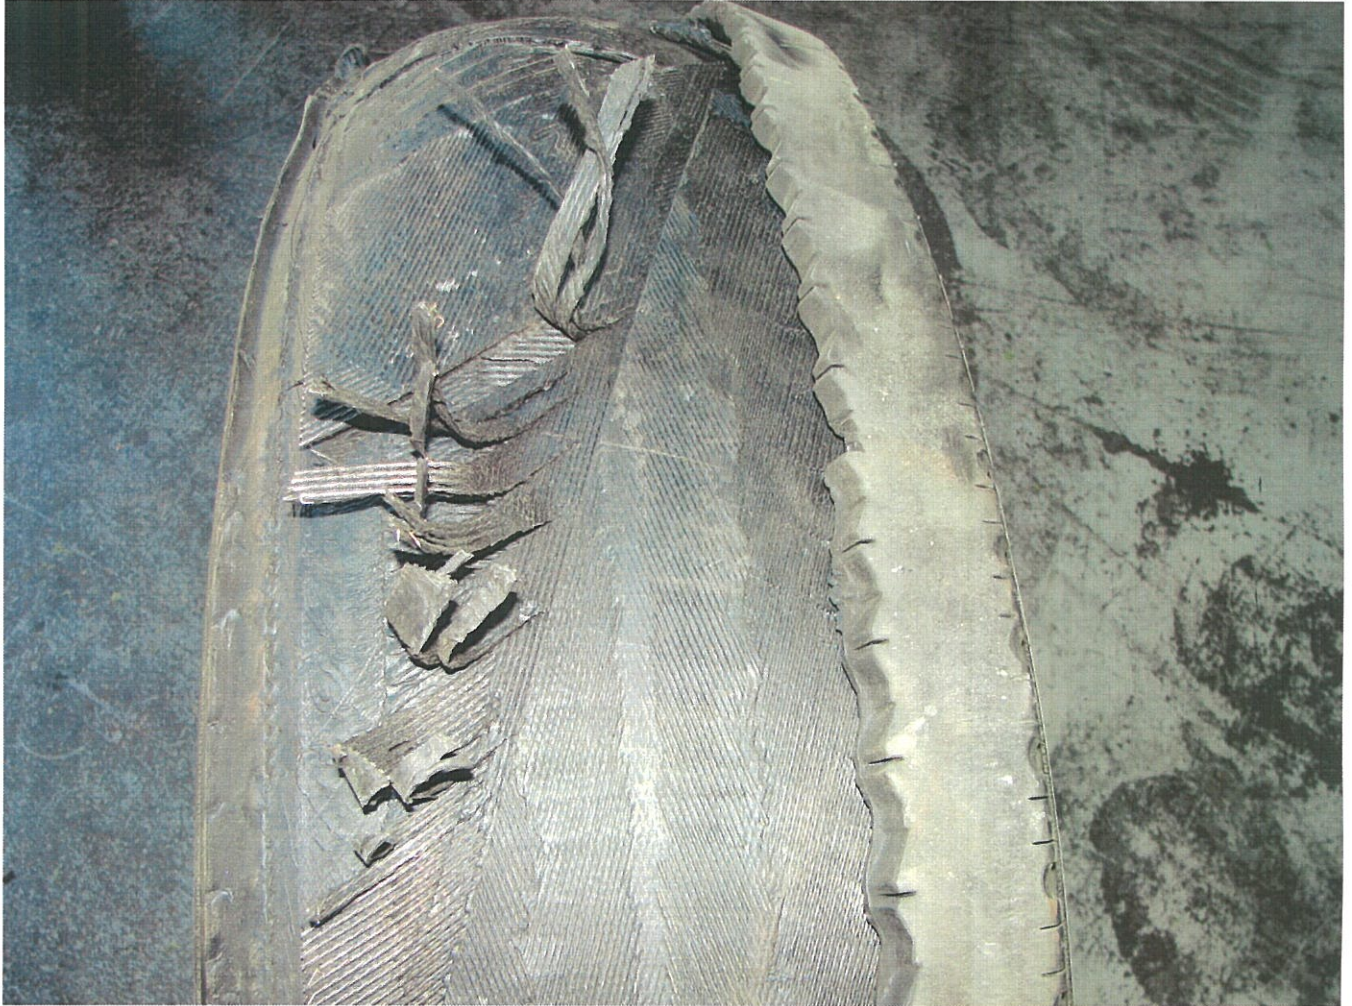
TIRE OBSERVATIONS	0 DEG	30 DEG	60 DEG	90 DEG	120 DEG	150 DEG	180 DEG	210 DEG	240 DEG	270 DEG	300 DEG	330 DEG
Groove 1 nearest to SS												
Groove 2											4MM GOLUGE @320DE G	
Groove 3												
Groove 4												
Tread Block 1 nearest to SS	Visible	Visible	Visible	Visible	Missing	Visible	Visible	Visible	Visible	Visible	Visible	Visible
Tread Block 2	Missing	Missing	Missing	Missing	Missing	Missing	Missing	Missing	Missing	Missing	Missing	Missing
Tread Block 3	Missing	Missing	Missing	Missing	Missing	Missing	Missing	Missing	Missing	Missing	Missing	Missing
Tread Block 4	Missing	Missing	Missing	Missing	Missing	Missing	Missing	Missing	Missing	Missing	Missing	Missing
Tread Block 5	Visible	Visible	Visible	Visible	Visible	Visible	Visible	Visible	Visible	Visible	Visible	Visible
Tread crown area												
Overall Tire												
Steel belt 0 - Radial Plies	Visible	Visible	Visible	Visible	Visible	Visible	Visible	Visible	Visible	Visible	Visible	Visible

Rubber between steel belt 0 and 1	Visible	Visible	Visible	Visible	Visible	Visible	Visible	Visible	Visible	Visible	Visible	Visible
Steel belt 1	Visible	Visible	Missing	Missing	Missing	Visible	Visible	Visible	Visible	Visible	Visible	Visible
Rubber between steel belt 1 and 2	Visible	Visible	Missing	Missing	Missing	Visible	Visible	Visible	Visible	Visible	Visible	Visible
Steel belt 2	Visible	Visible	Missing	Missing	Missing	Missing	Missing	Missing	Missing	Missing	Missing	Visible
Rubber between steel belt 2 and 3	Visible	Visible	Missing	Missing	Missing	Missing	Missing	Missing	Missing	Missing	Missing	Visible
Steel belt 3	Missing	Missing	Missing	Missing	Missing	Missing	Missing	Missing	Missing	Missing	Missing	Visible
Rubber between steel belt 3 and 4	Missing	Missing	Missing	Missing	Missing	Missing	Missing	Missing	Missing	Missing	Missing	Visible
Steel belt 4	Missing	Missing	Missing	Missing	Missing	Missing	Missing	Missing	Missing	Missing	Missing	Visible
