- TIRE FORENSICS REPORT -

PN 67722
Purchase Order DTNH22-06-P-08366

SUBJECT: Forensic Evaluation on 9 Toyo Tires.

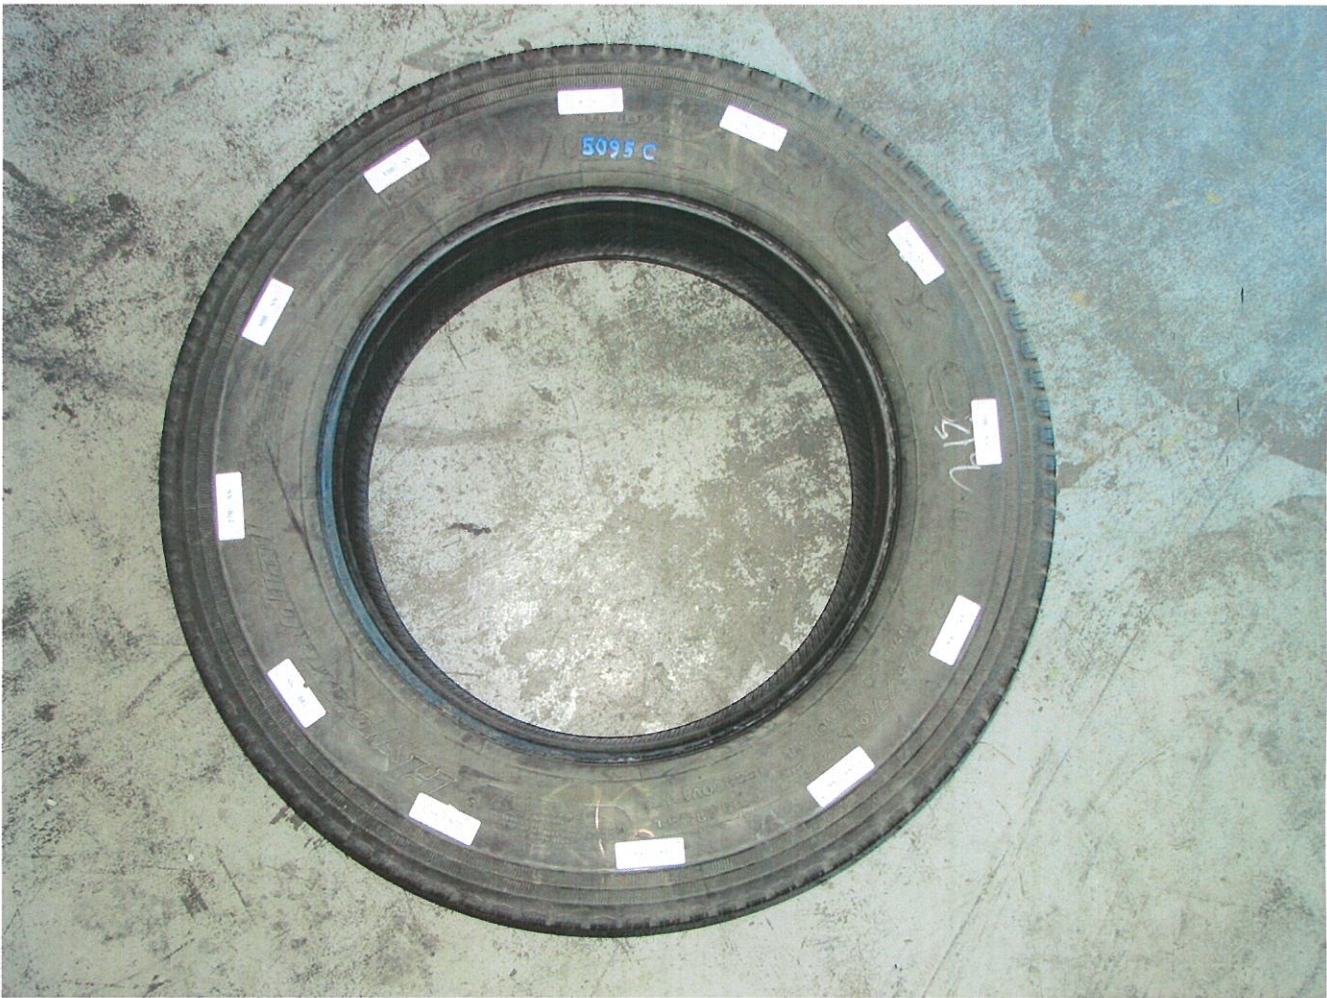
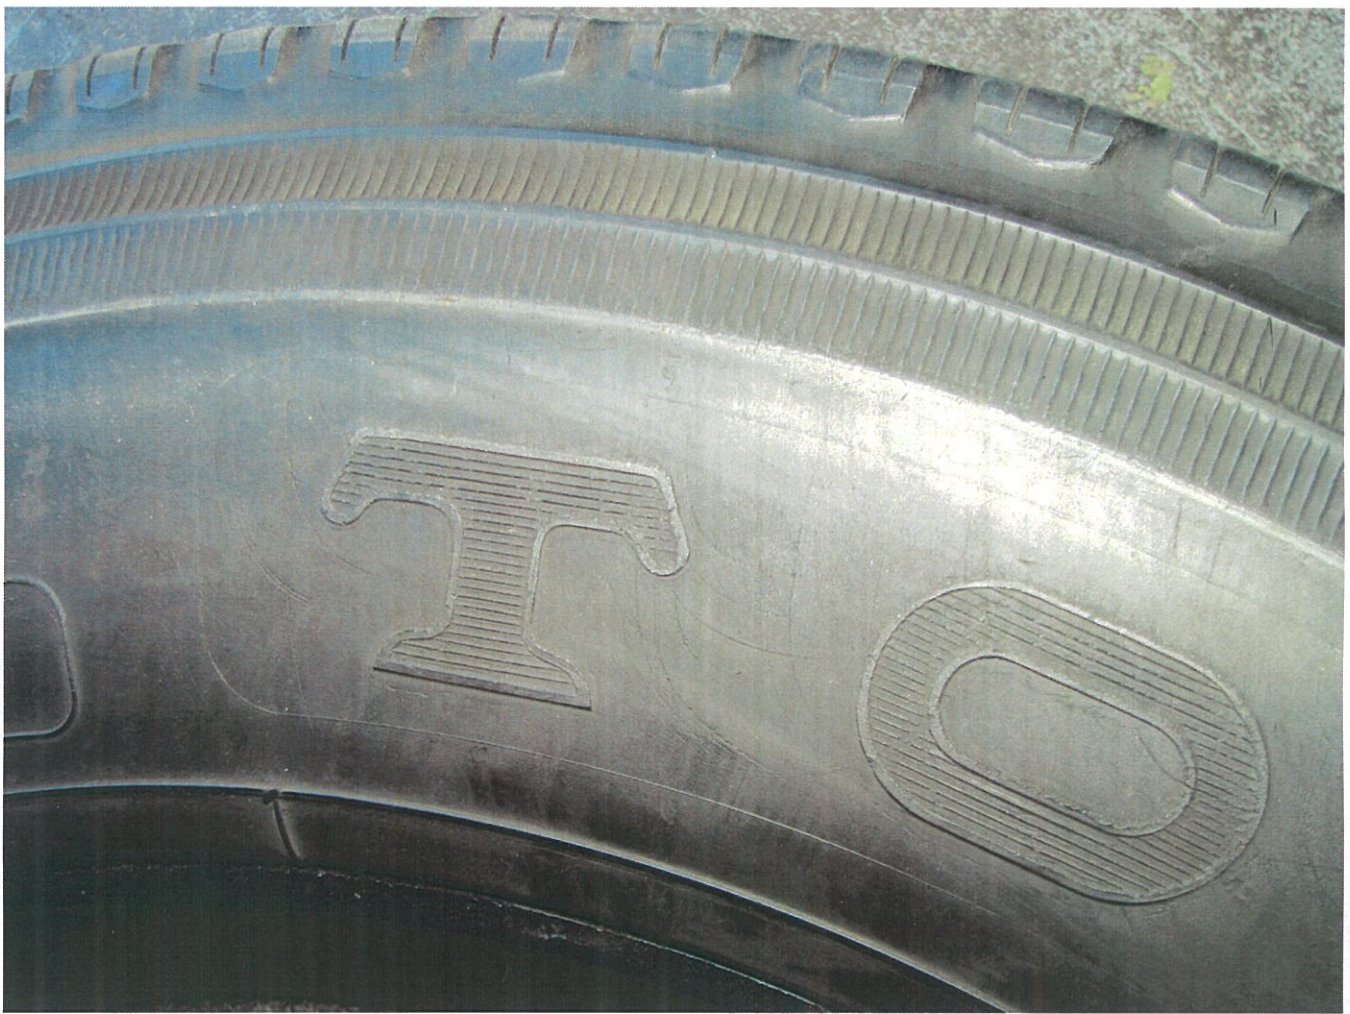
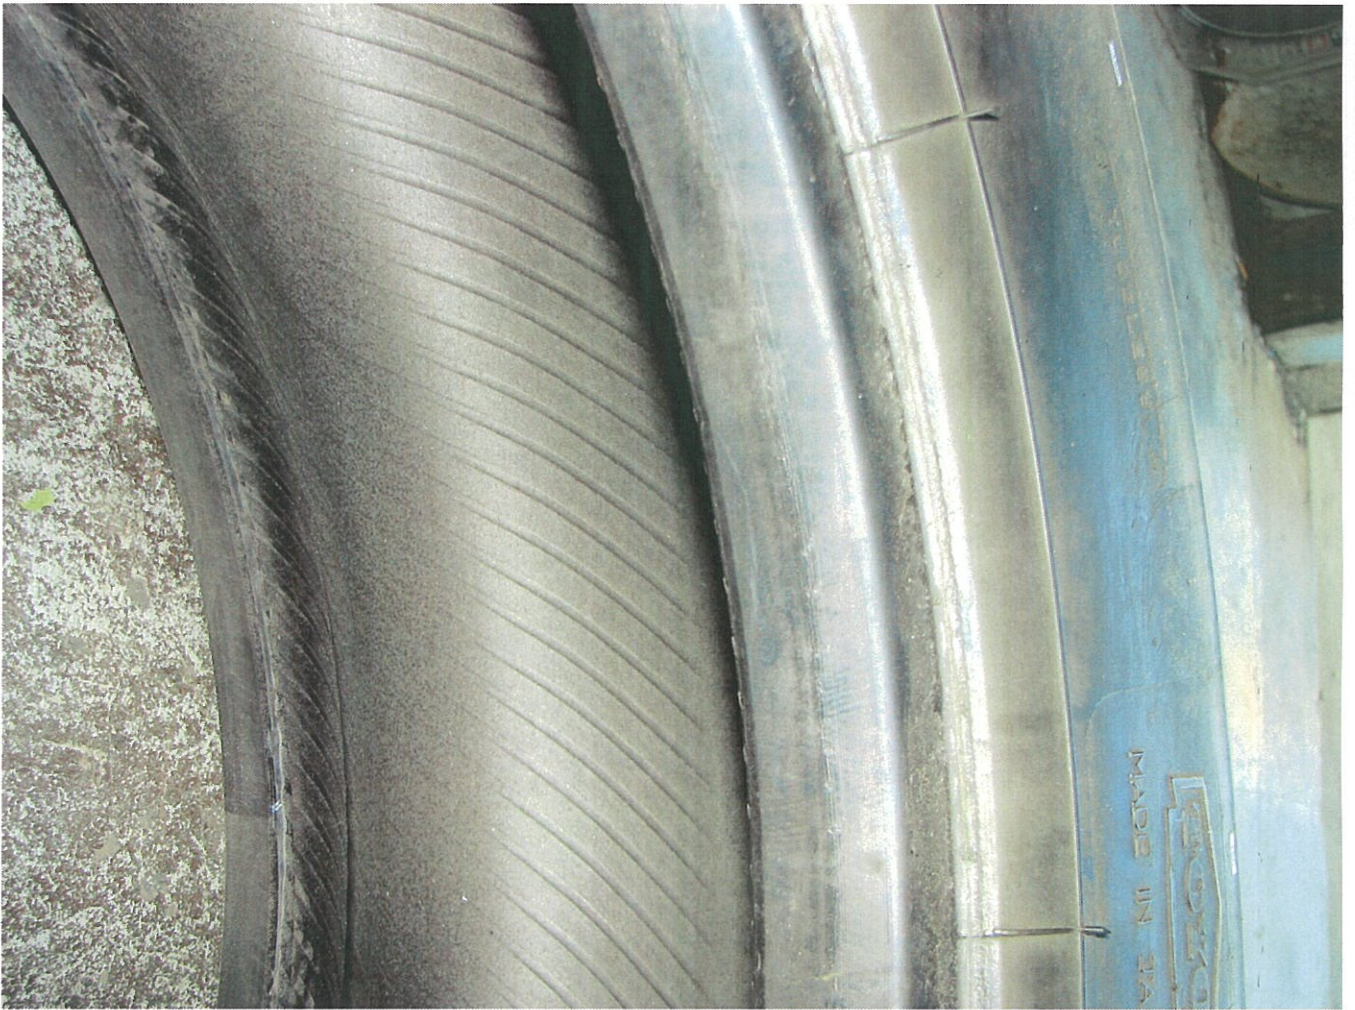
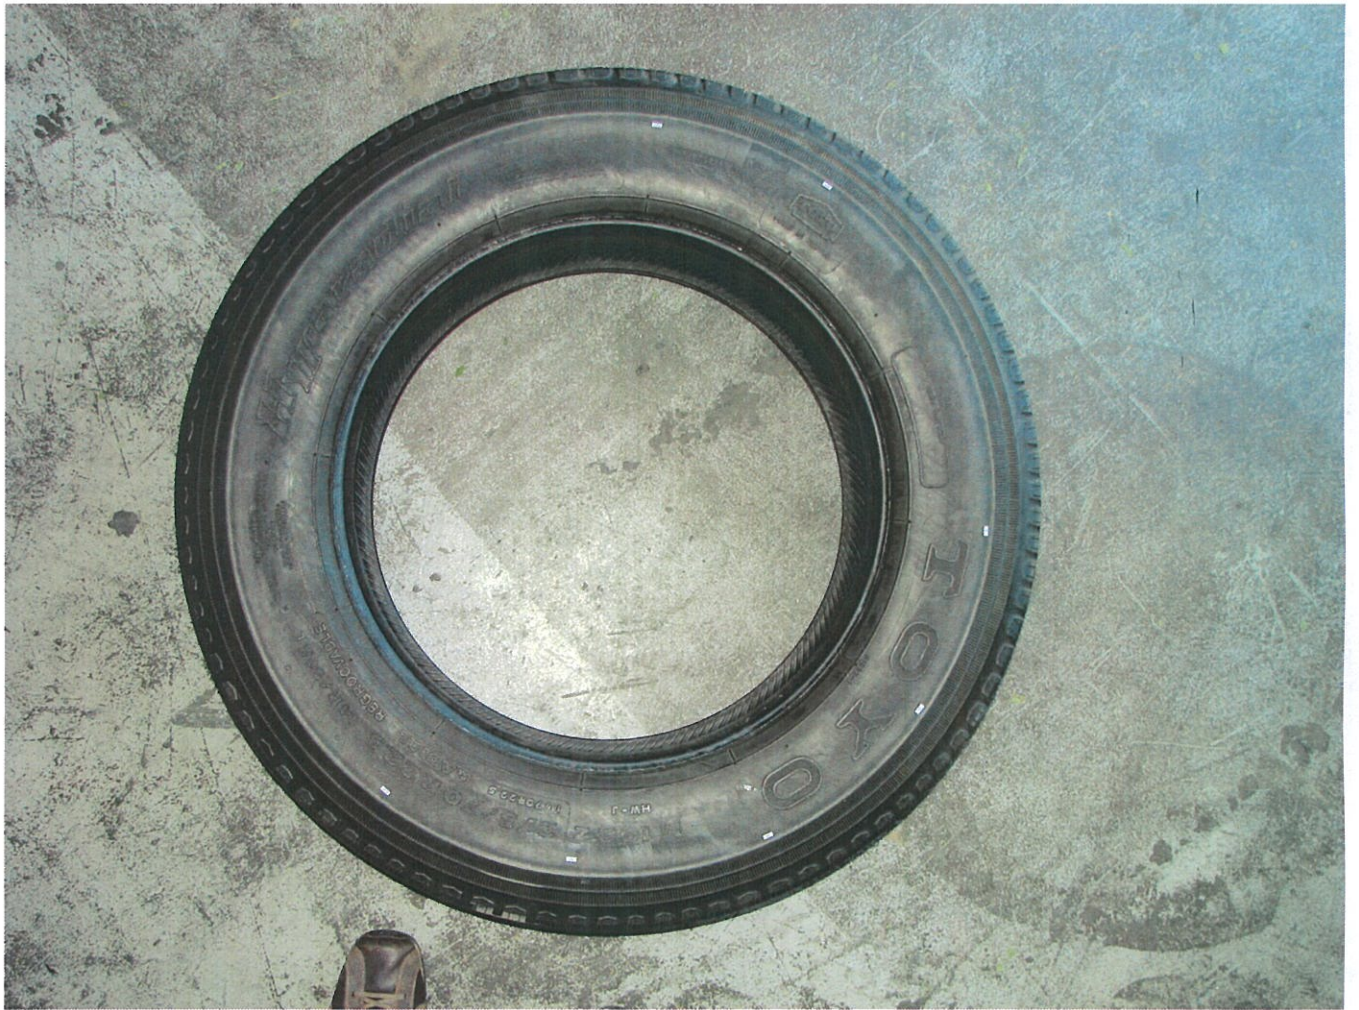
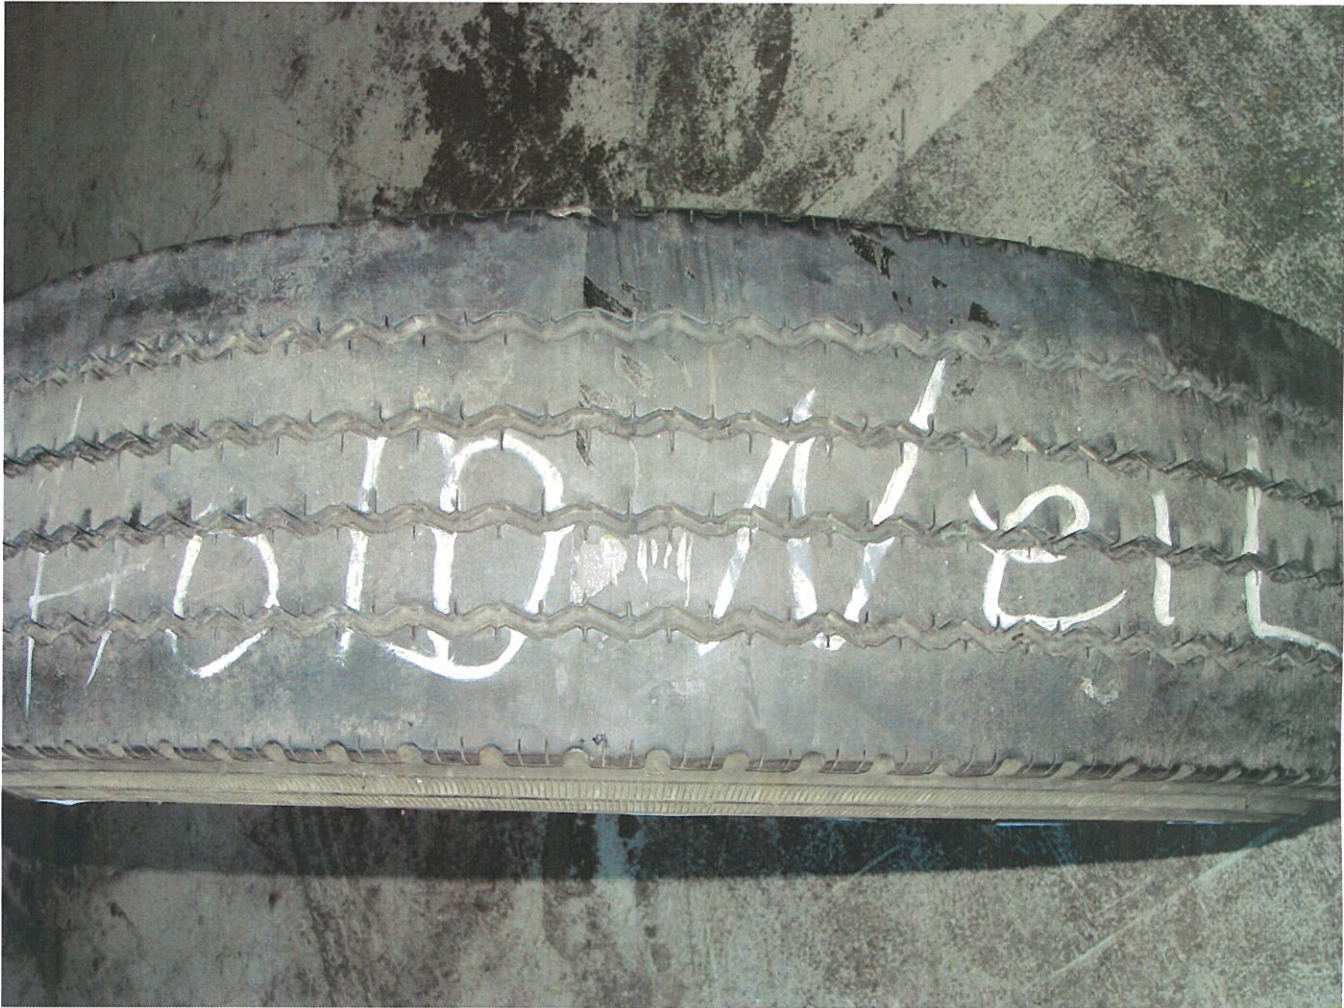
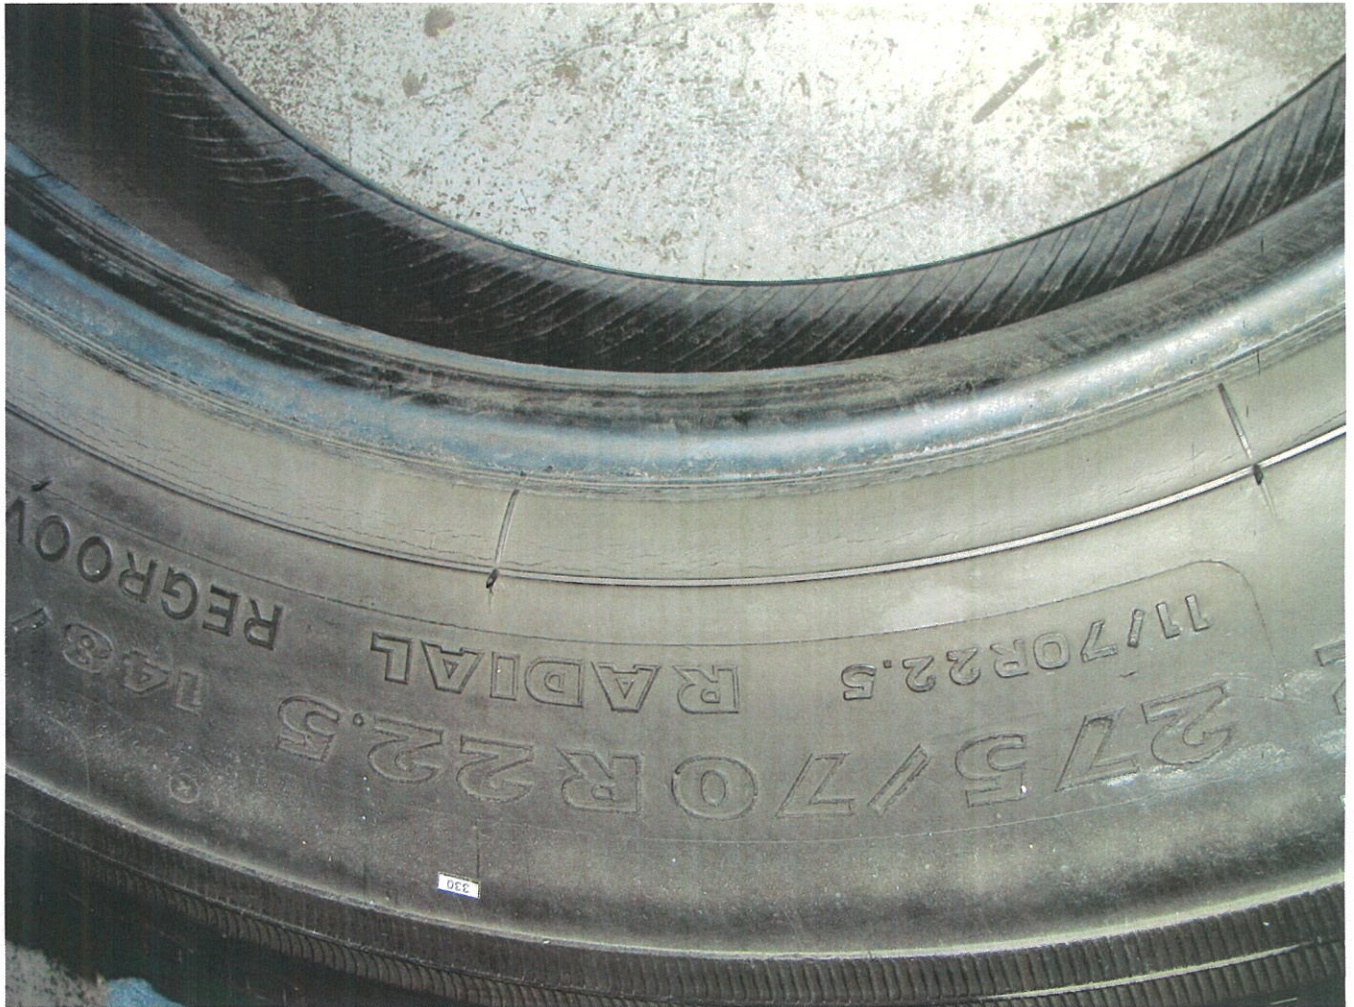
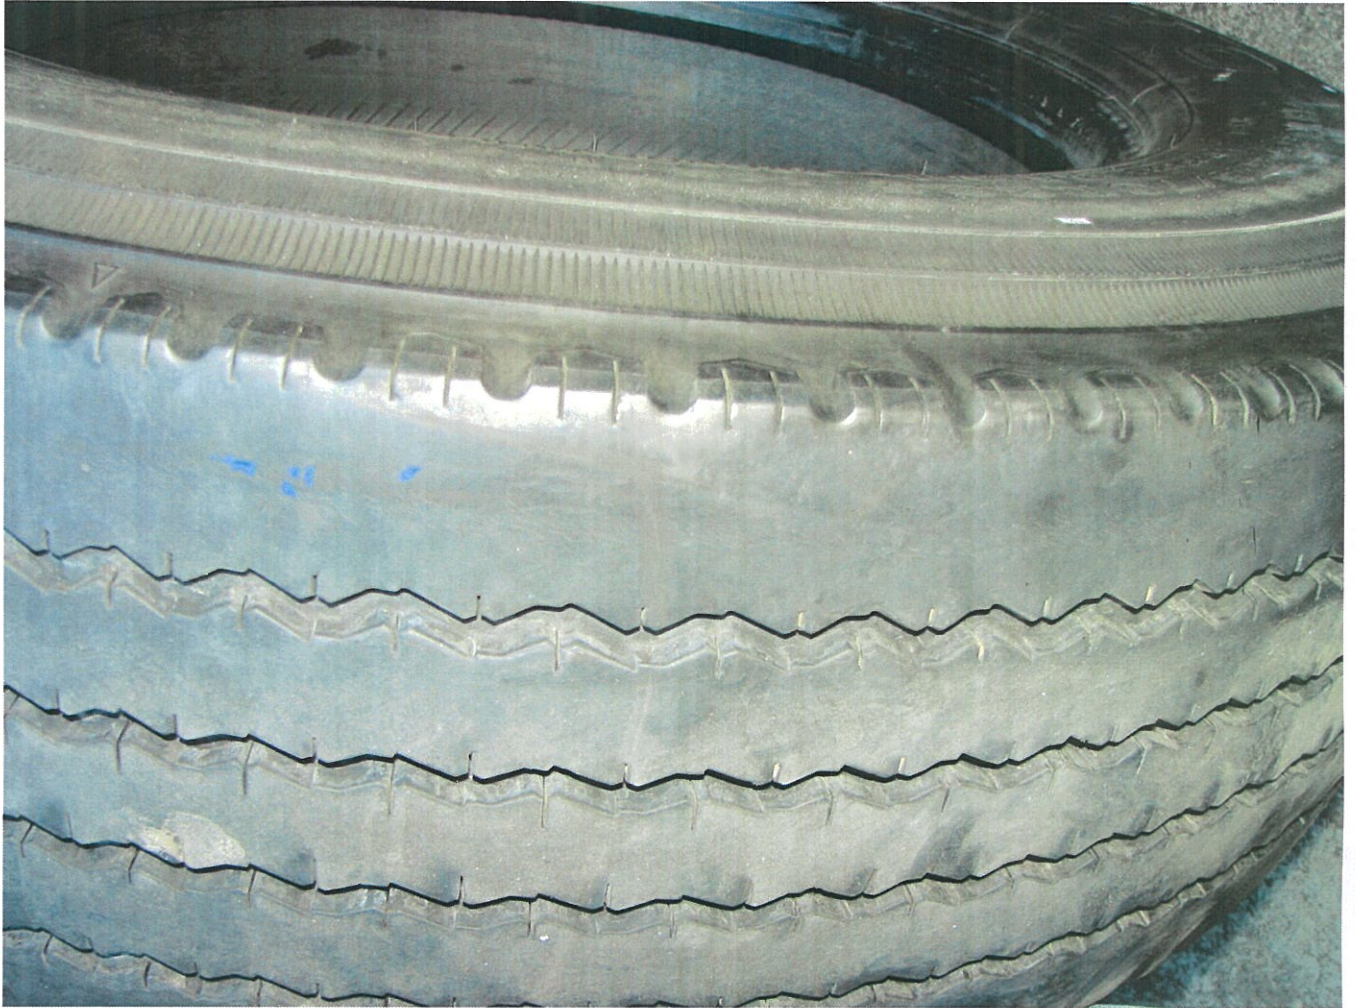
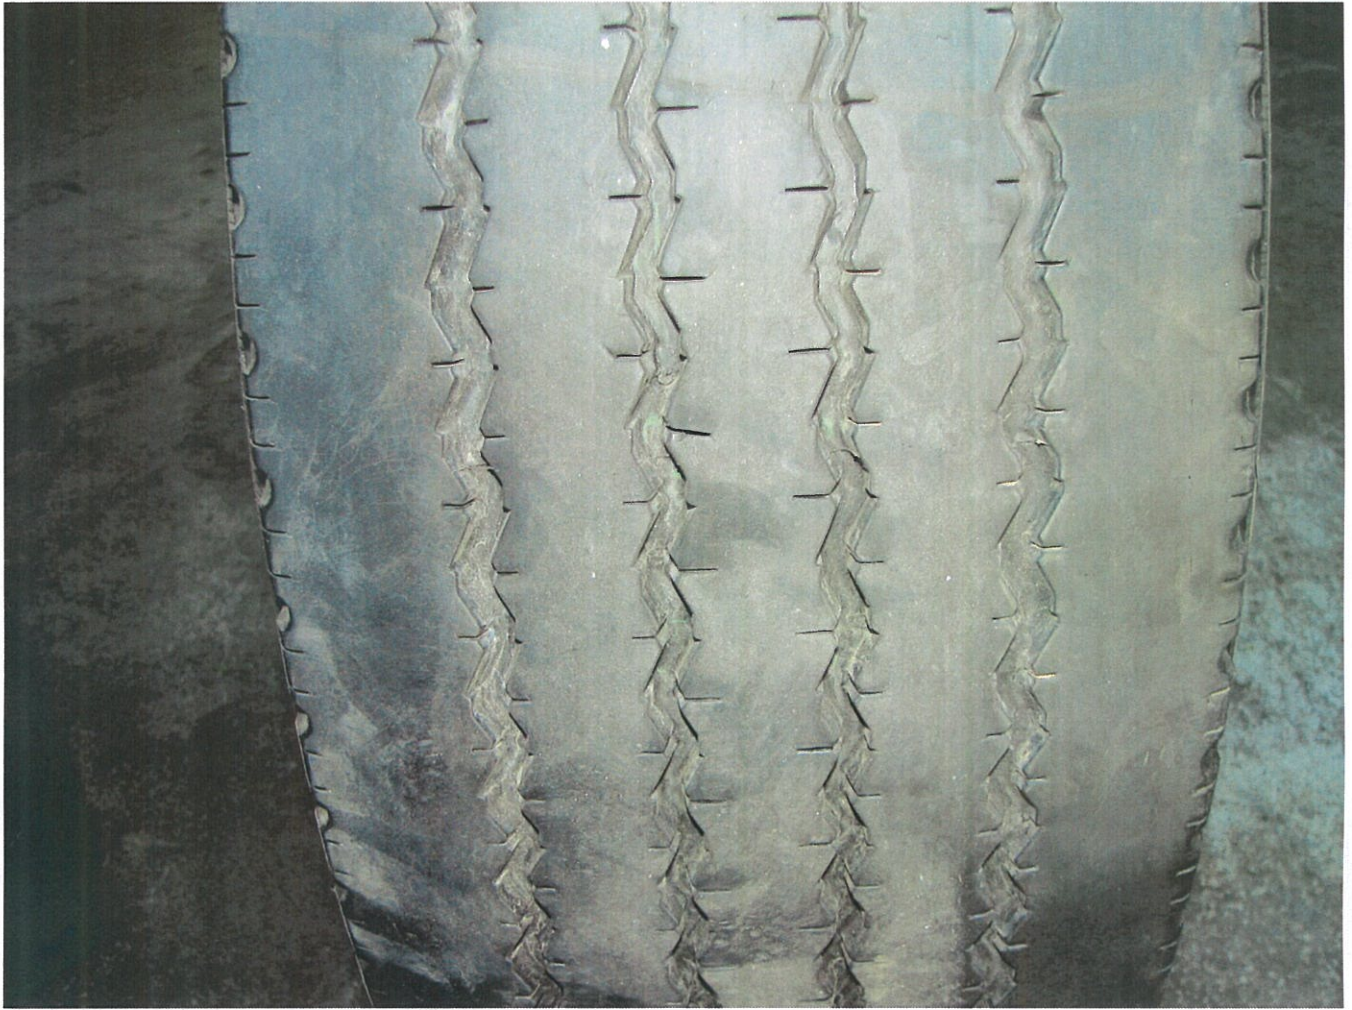
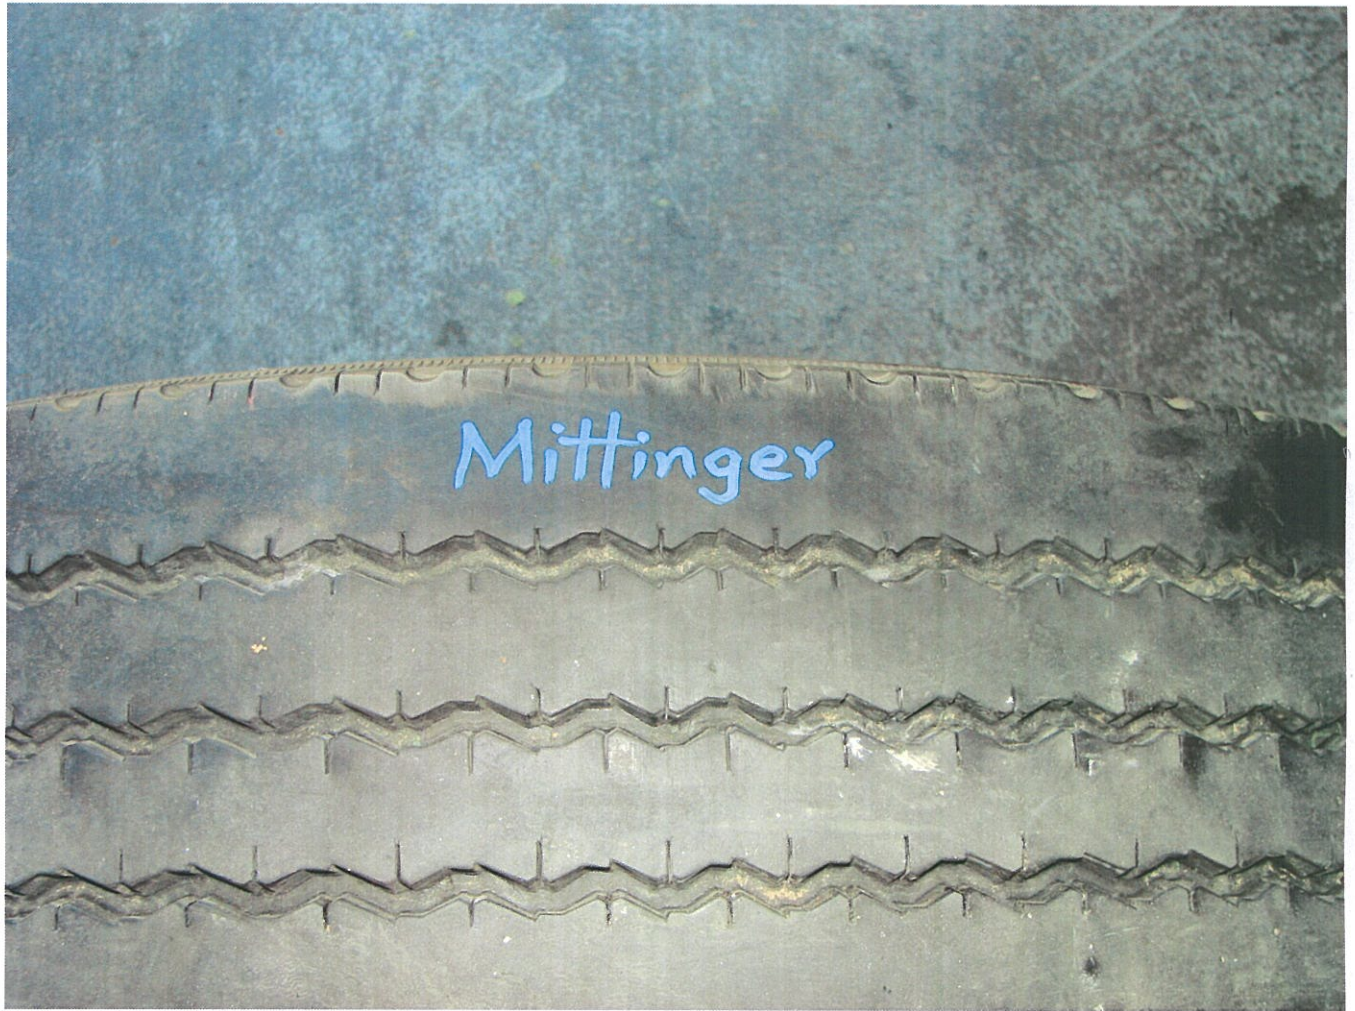
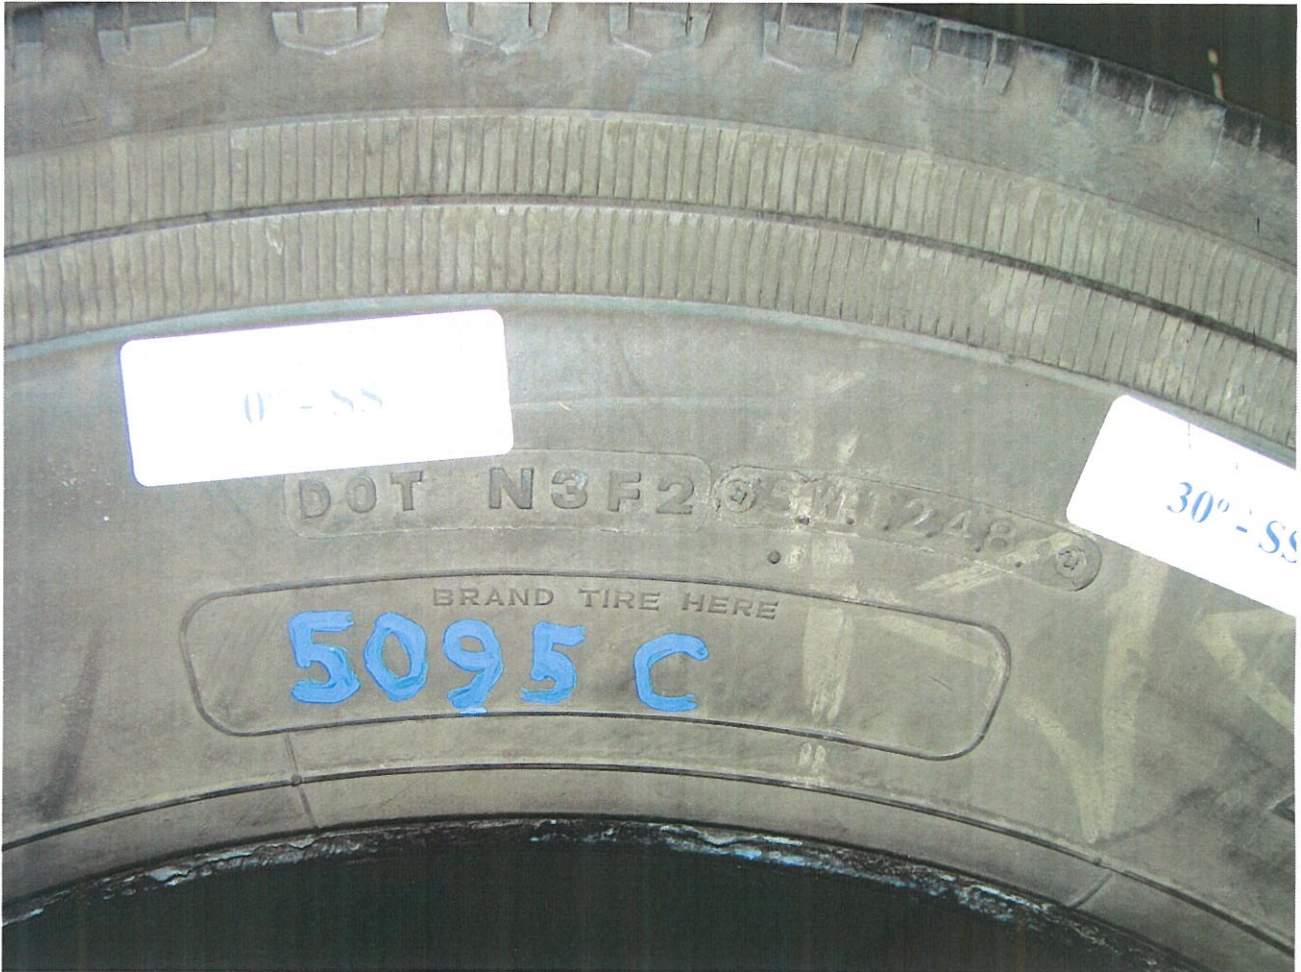
Appendix A - INSPECTION- Tire C – images

TIRE OBSERVATIONS	0 DEG	30 DEG	60 DEG	90 DEG	120 DEG	150 DEG	180 DEG	210 DEG	240 DEG	270 DEG	300 DEG	330 DEG	Overall
TIRE IDENTIFIERS													
Groove 1 nearest to SS													
Groove 2													
Groove 3													
Groove 4													
Tread Block 1 nearest to SS													
Tread Block 2													
Tread Block 3													
Tread Block 4													
Tread Block 5													
Tread crown area								"hold nail marking" @210- 270deg					Blue marking "Mittin ger"
TIRE OBSERVATIONS													
Groove 1 nearest to SS													
Groove 2											4MM GOUGE @320DE G		
Groove 3													
Groove 4													
Tread Block 1 nearest to SS													
Tread Block 2													
Tread Block 3													
Tread Block 4													
Tread Block 5													
Tread crown area													
Overall Tire													
Steel belt 0 - Radial Plies

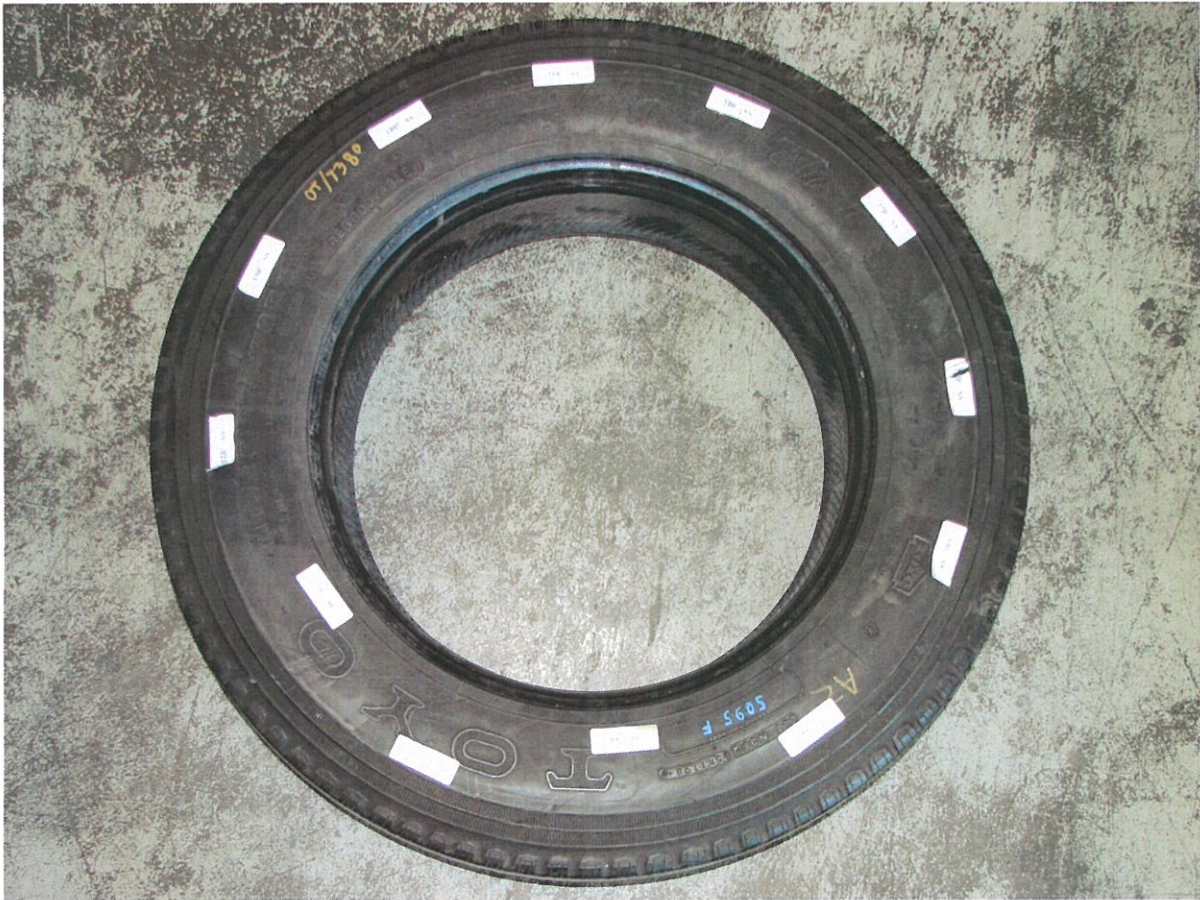
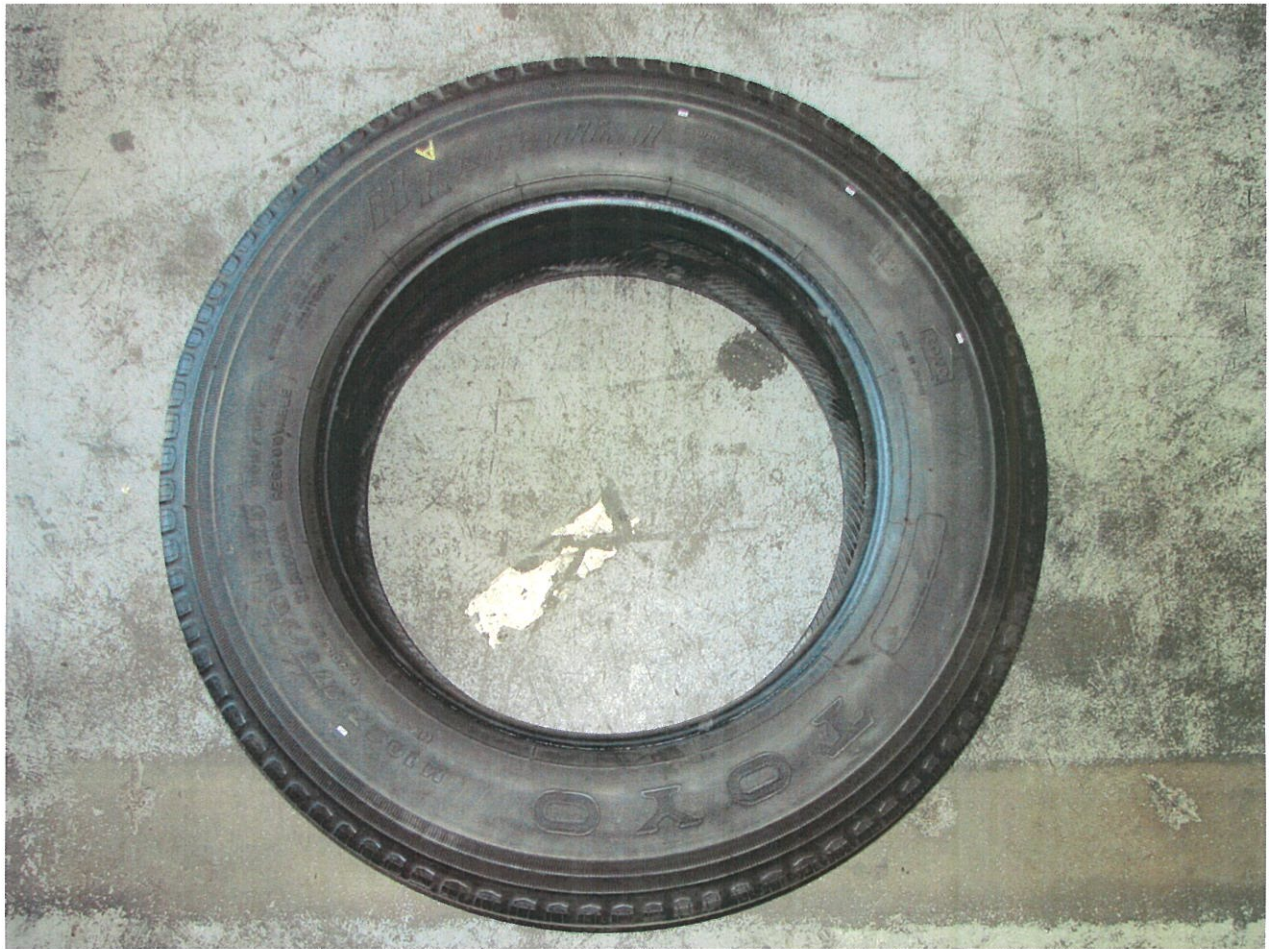
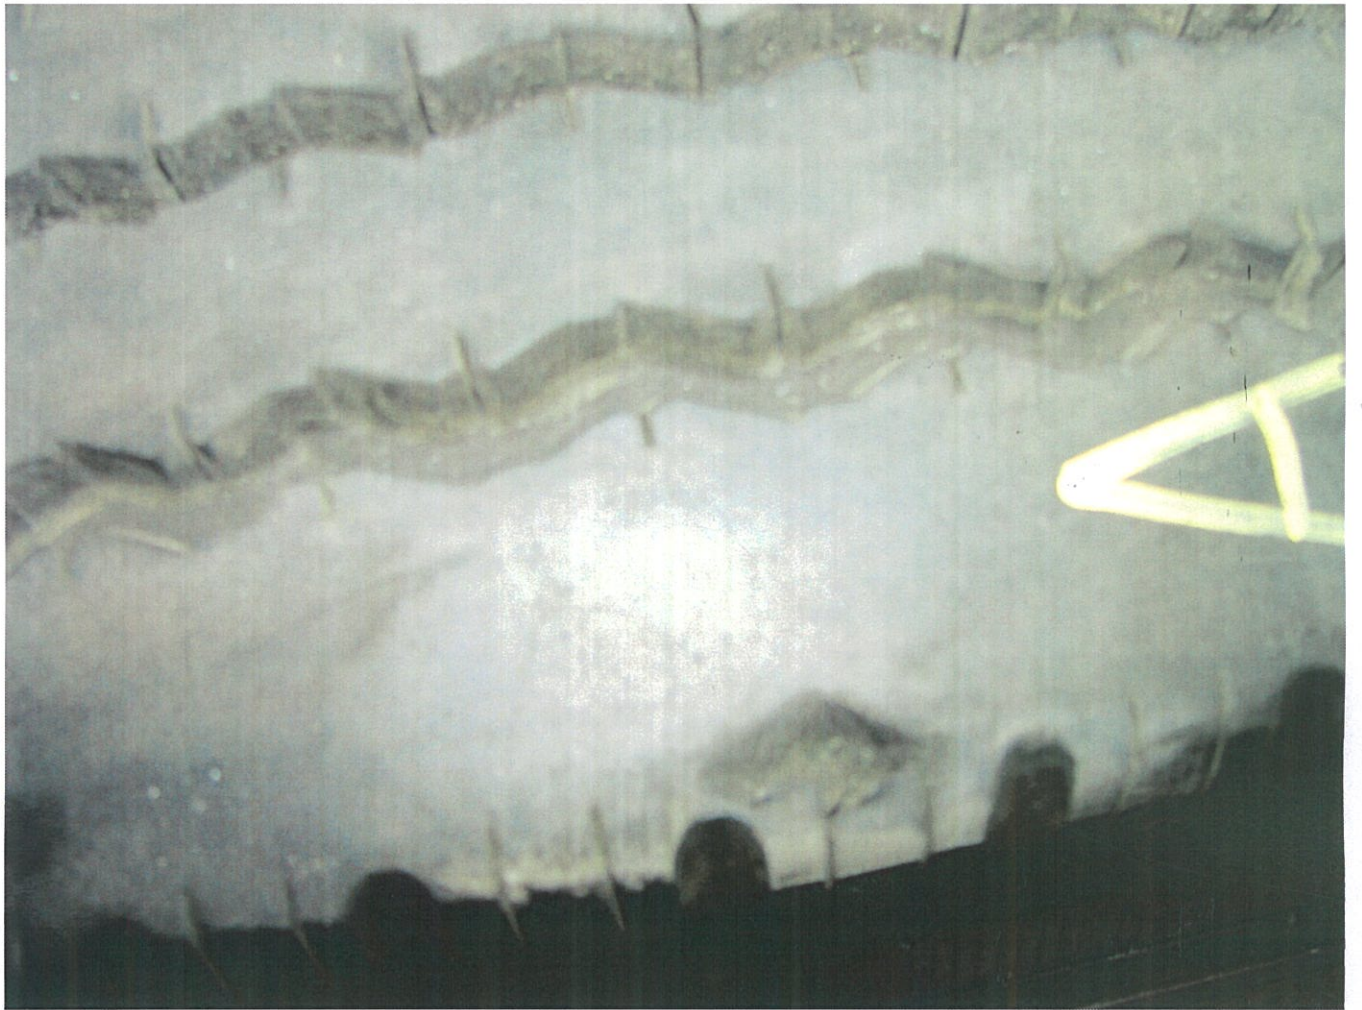
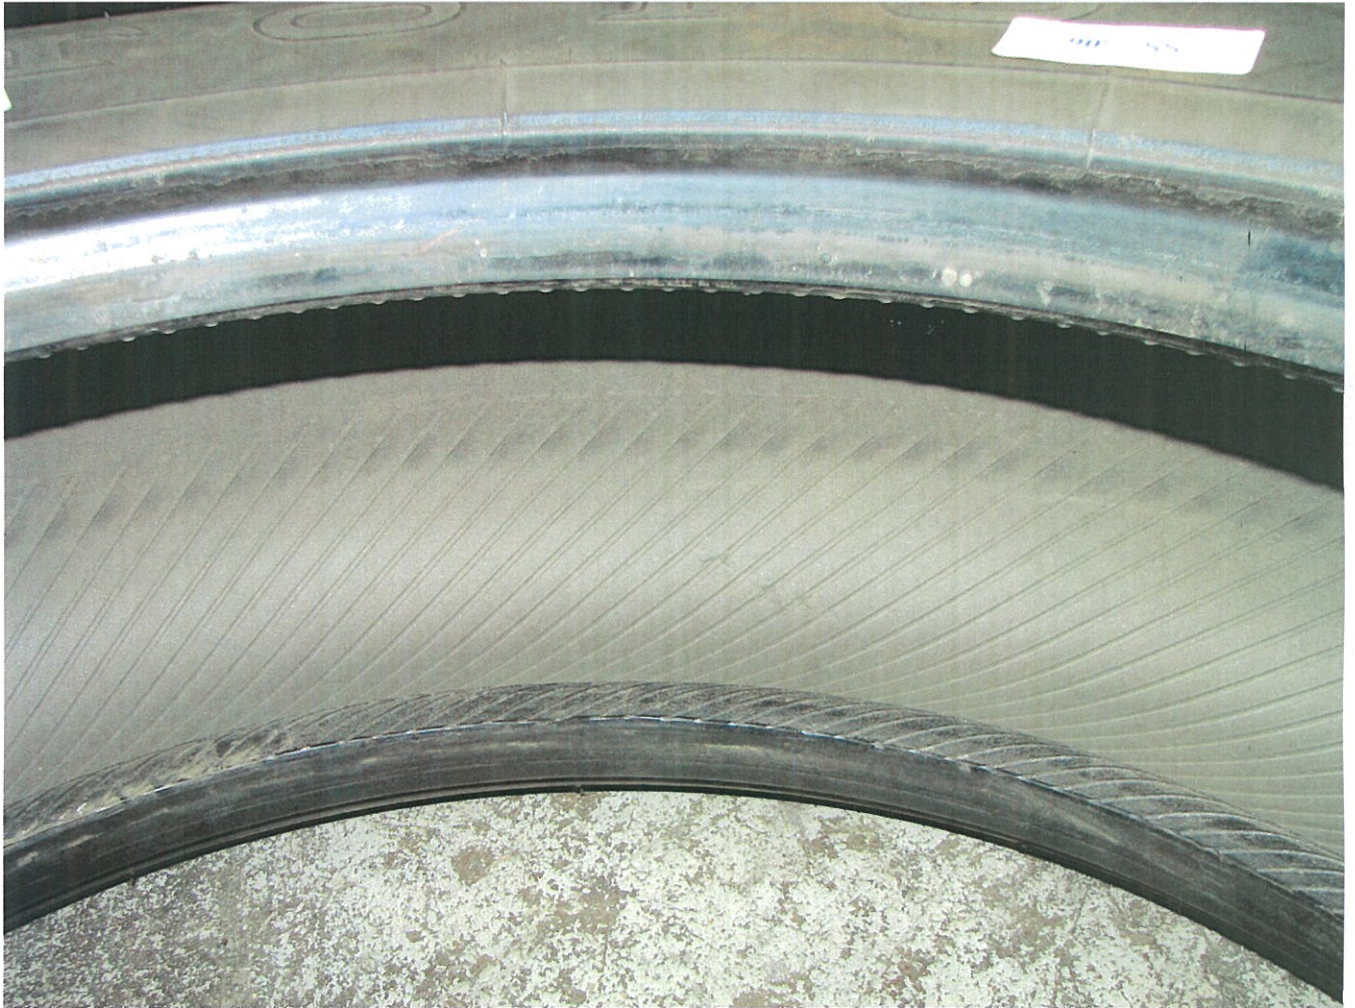
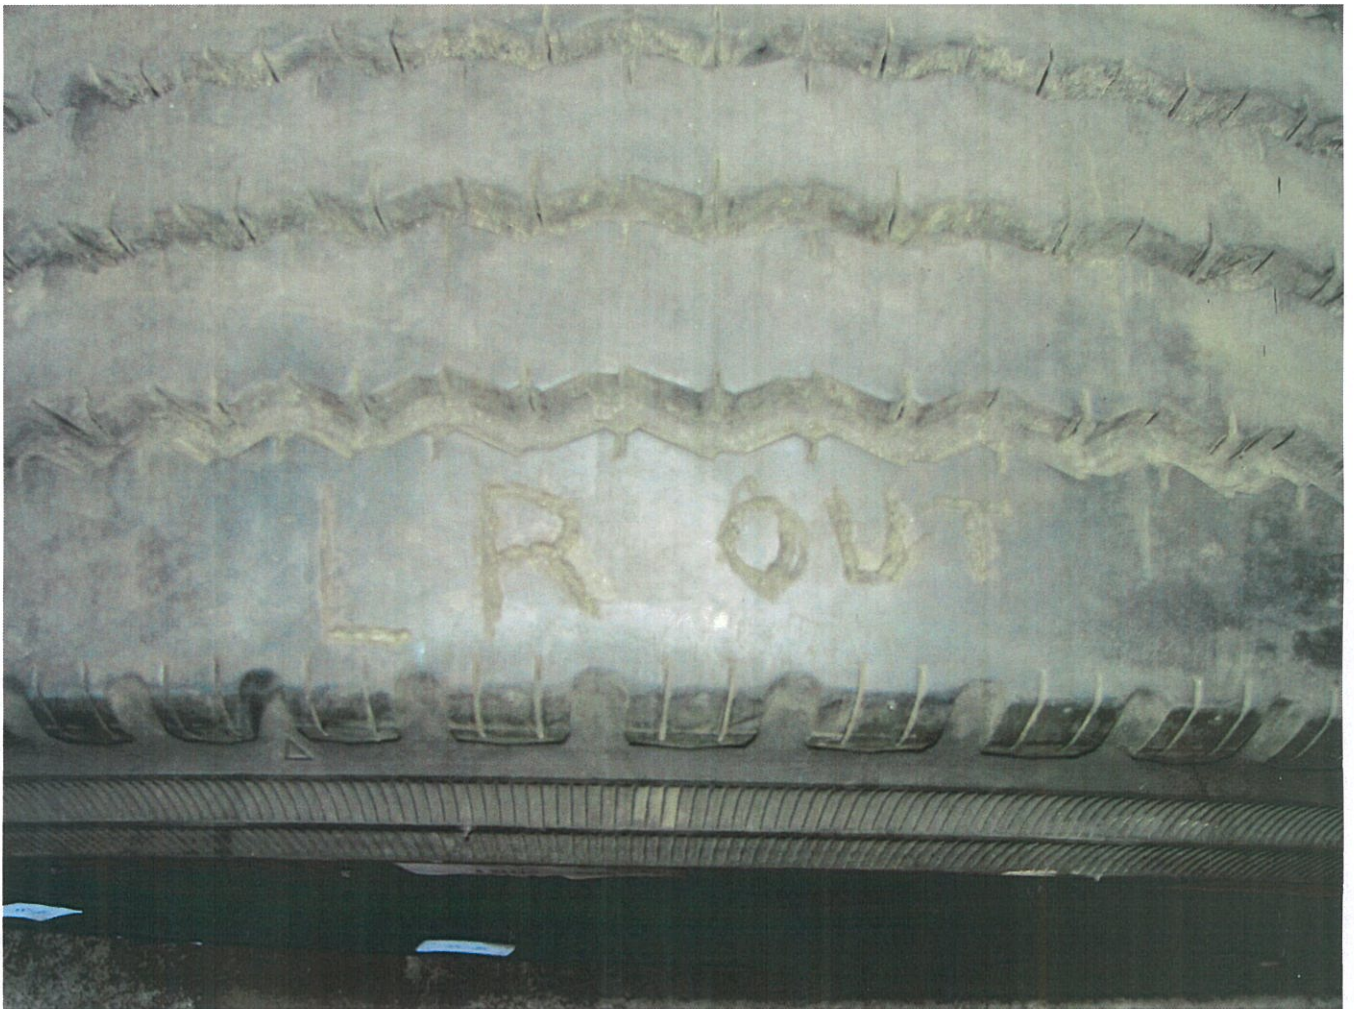
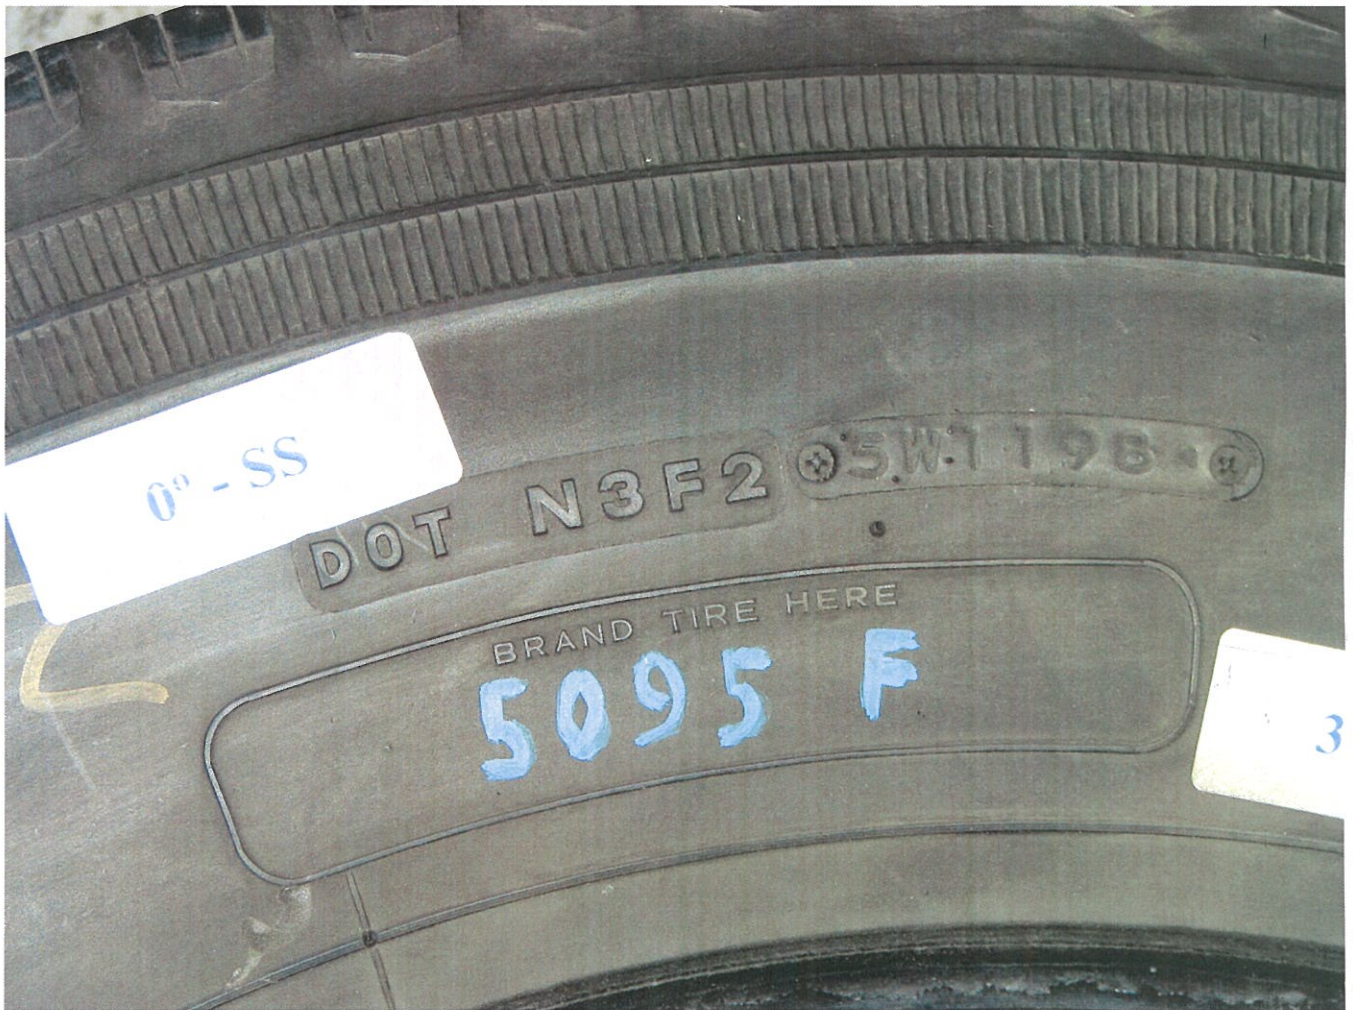
Tire F – OBSERVATIONS AND IMAGES

TIRE OBSERVATIONS	0 DEG	30 DEG	60 DEG	90 DEG	120 DEG	150 DEG	180 DEG	210 DEG	240 DEG	270 DEG	300 DEG	330 DEG	Overall
TIRE IDENTIFIERS													
Groove 1 nearest to SS													
Groove 2													
Groove 3													
Groove 4													
Tread Block 1 nearest to SS							"LR OUT" grooved in						
Tread Block 2													
Tread Block 3													
Tread Block 4													
Tread Block 5													
Tread crown area													
TIRE OBSERVATIONS													
Groove 1 nearest to SS													
Groove 2													
Groove 3													
Groove 4													
Tread Block 1 nearest to SS													
Tread Block 2													
Tread Block 3													
Tread Block 4													
Tread Block 5										Tread chunk 1 inch			
Tread crown area													
Overall Tire
