- TIRE FORENSICS REPORT -

PN 67722
Purchase Order DTNH22-06-P-08366

SUBJECT: Forensic Evaluation on 9 Toyo Tires.

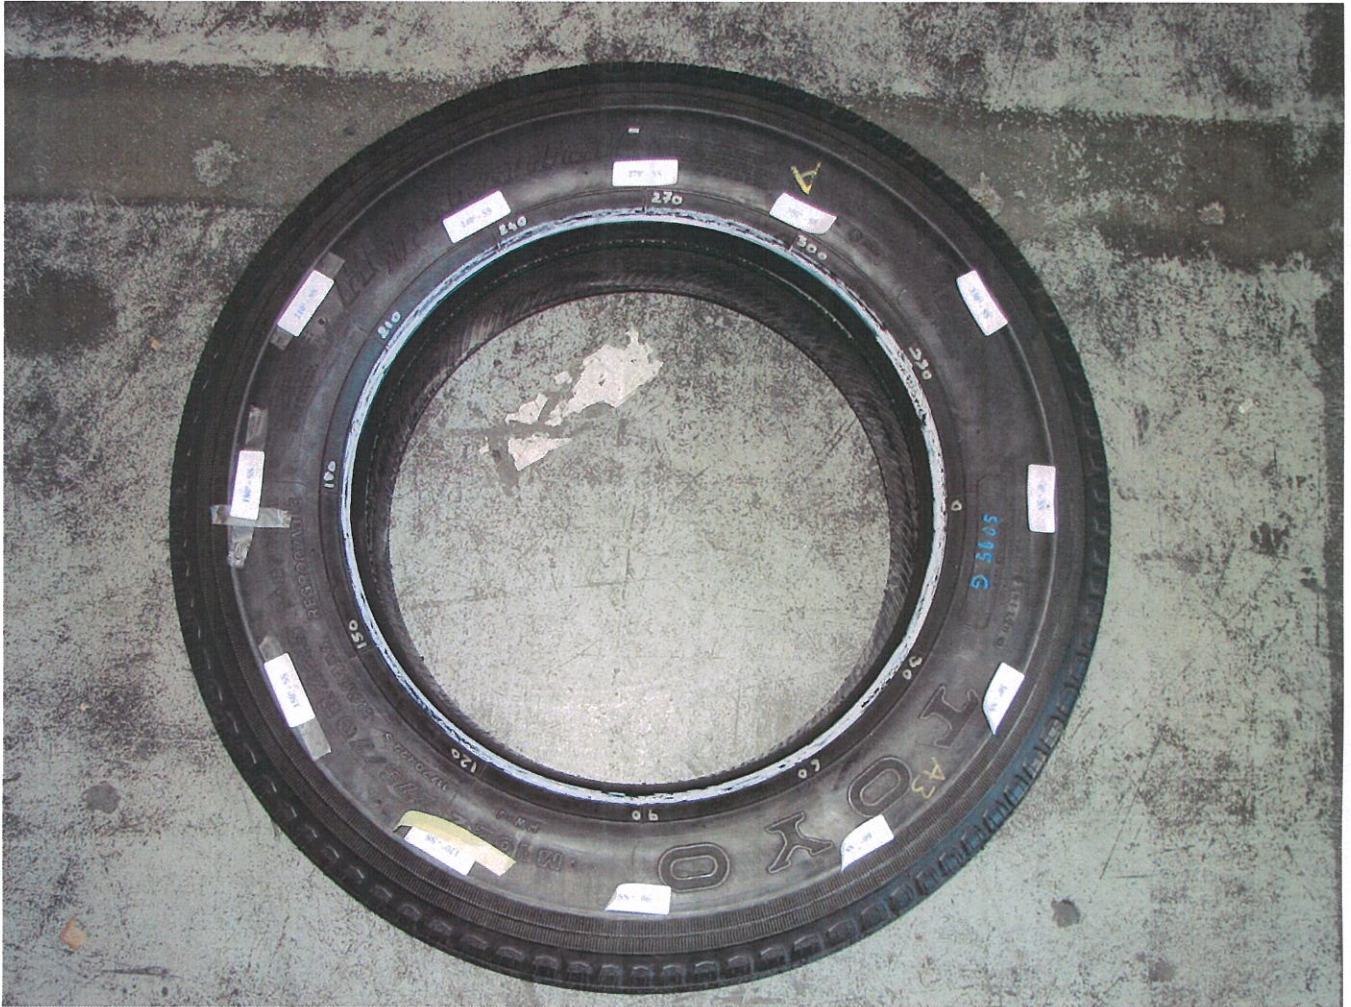
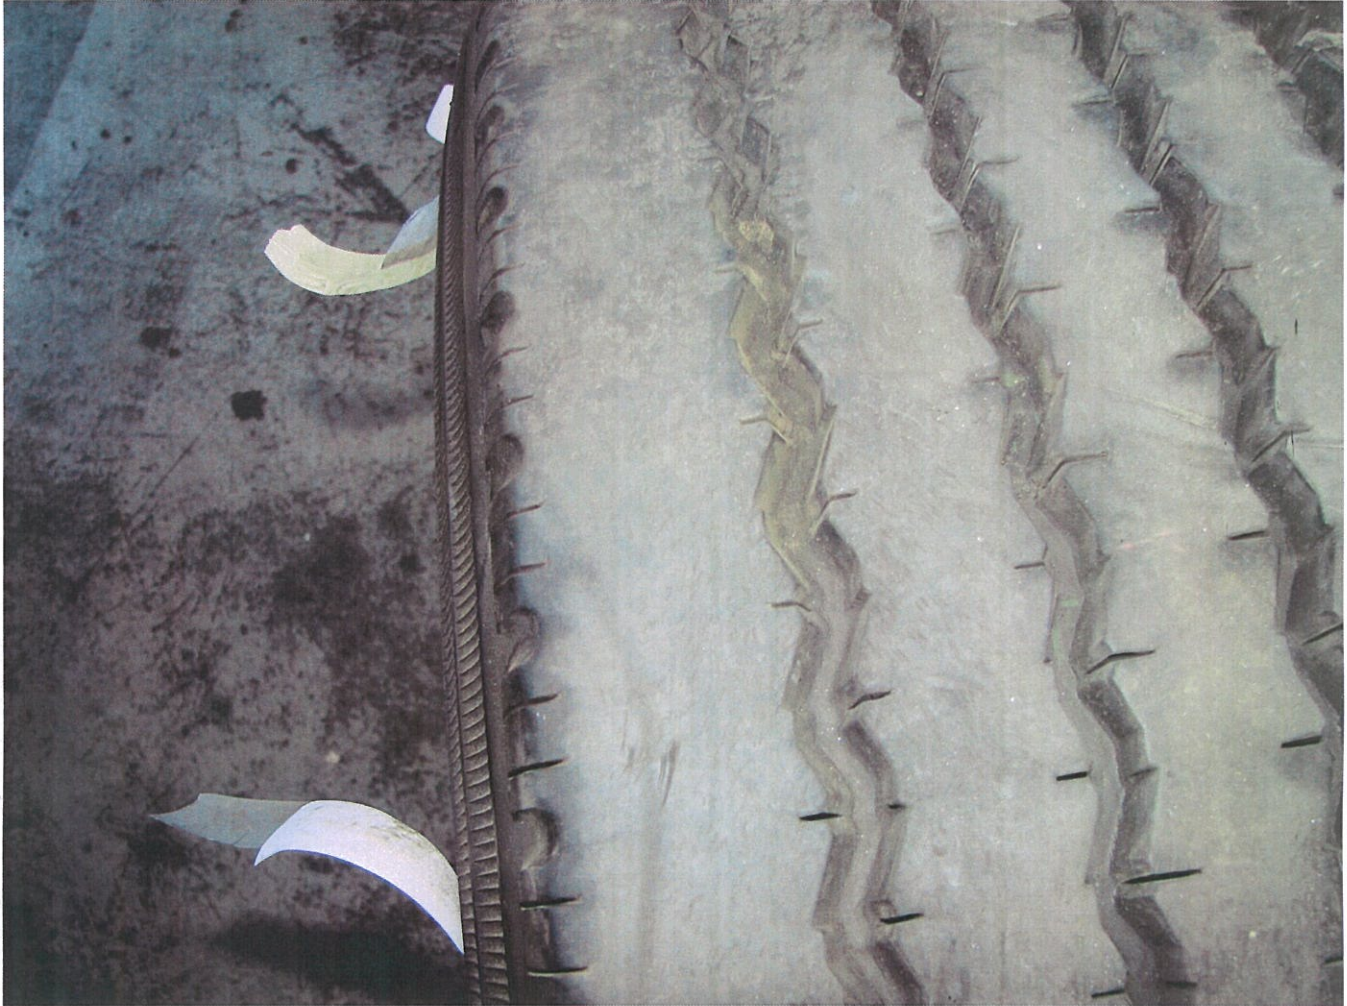
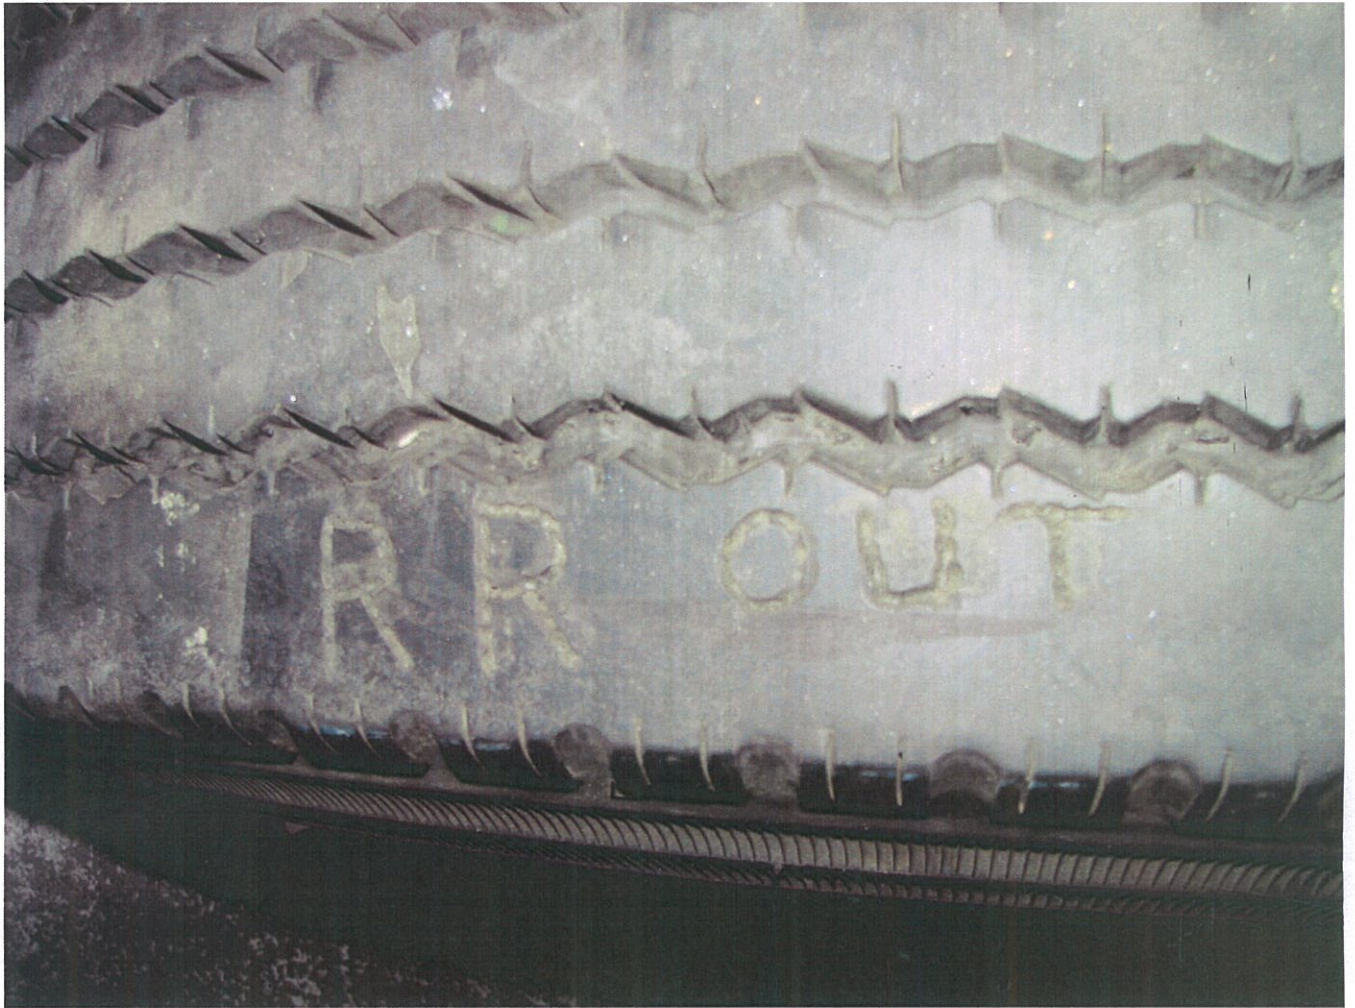
Tire G Pre and Post Endurance Test- OBSERVATIONS AND IMAGES

TIRE OBSERVATIONS	0 DEG	30 DEG	60 DEG	90 DEG	120 DEG	150 DEG	180 DEG	210 DEG	240 DEG	270 DEG	300 DEG	330 DEG	Overall
TIRE IDENTIFIERS													
Groove 1 nearest to SS													
Groove 2													
Groove 3													
Groove 4													
Tread Block 1 nearest to SS													
Tread Block 2													
Tread Block 3													
Tread Block 4													
Tread Block 5													
Tread crown area													
TIRE OBSERVATIONS													
Groove 1 nearest to SS													
Groove 2													
Groove 3													
Groove 4													
Tread Block 1 nearest to SS									"RR OUT" grooved in the tread block				
Tread Block 2													
Tread Block 3													
Tread Block 4													
Tread Block 5													
Tread crown area

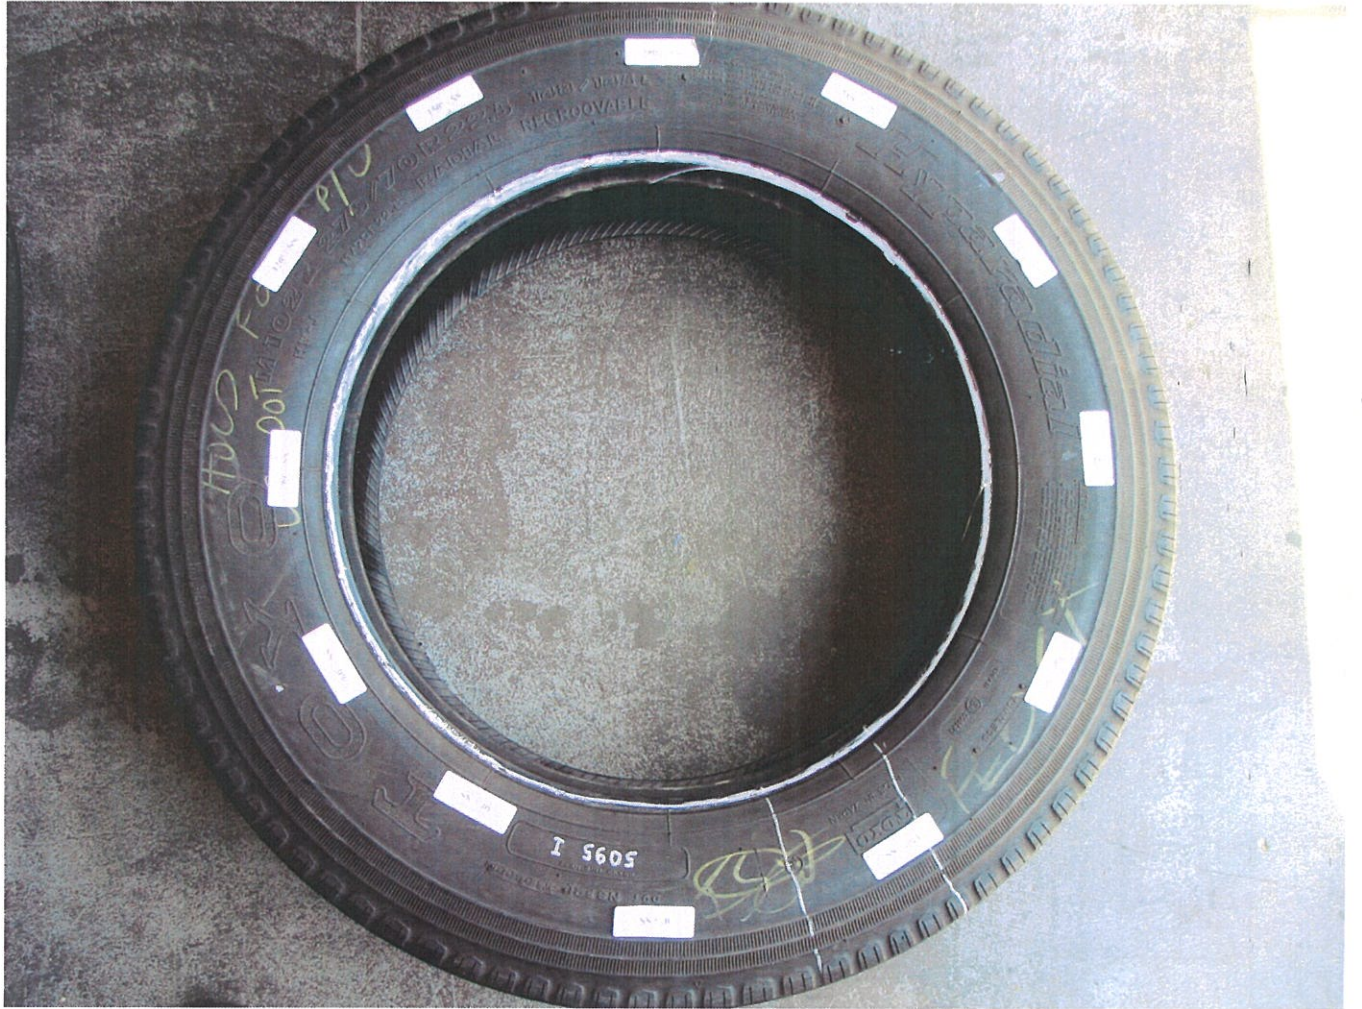
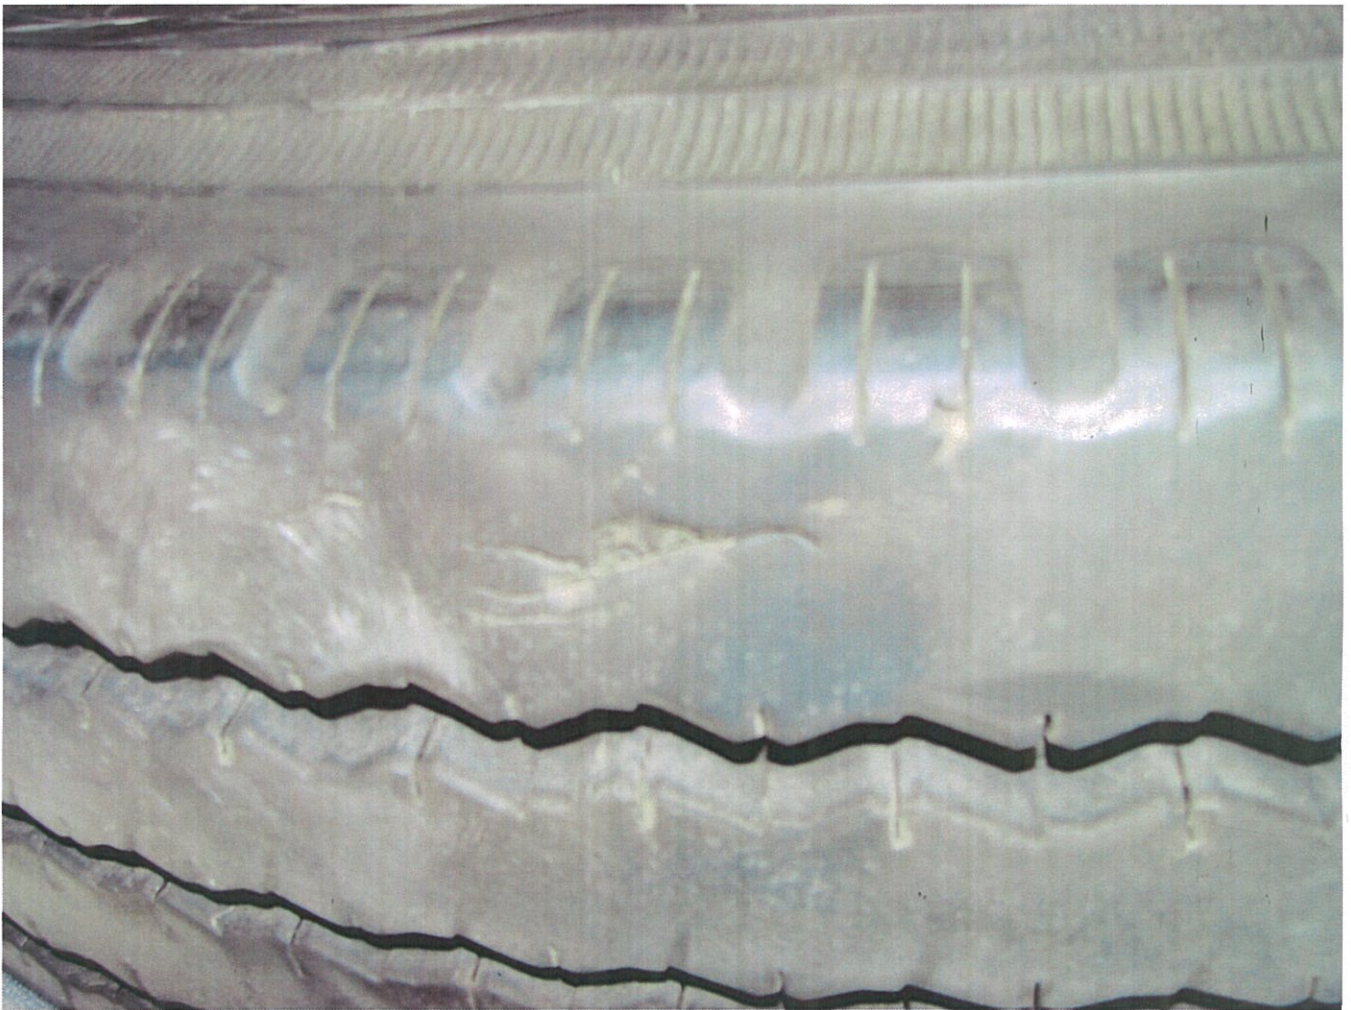
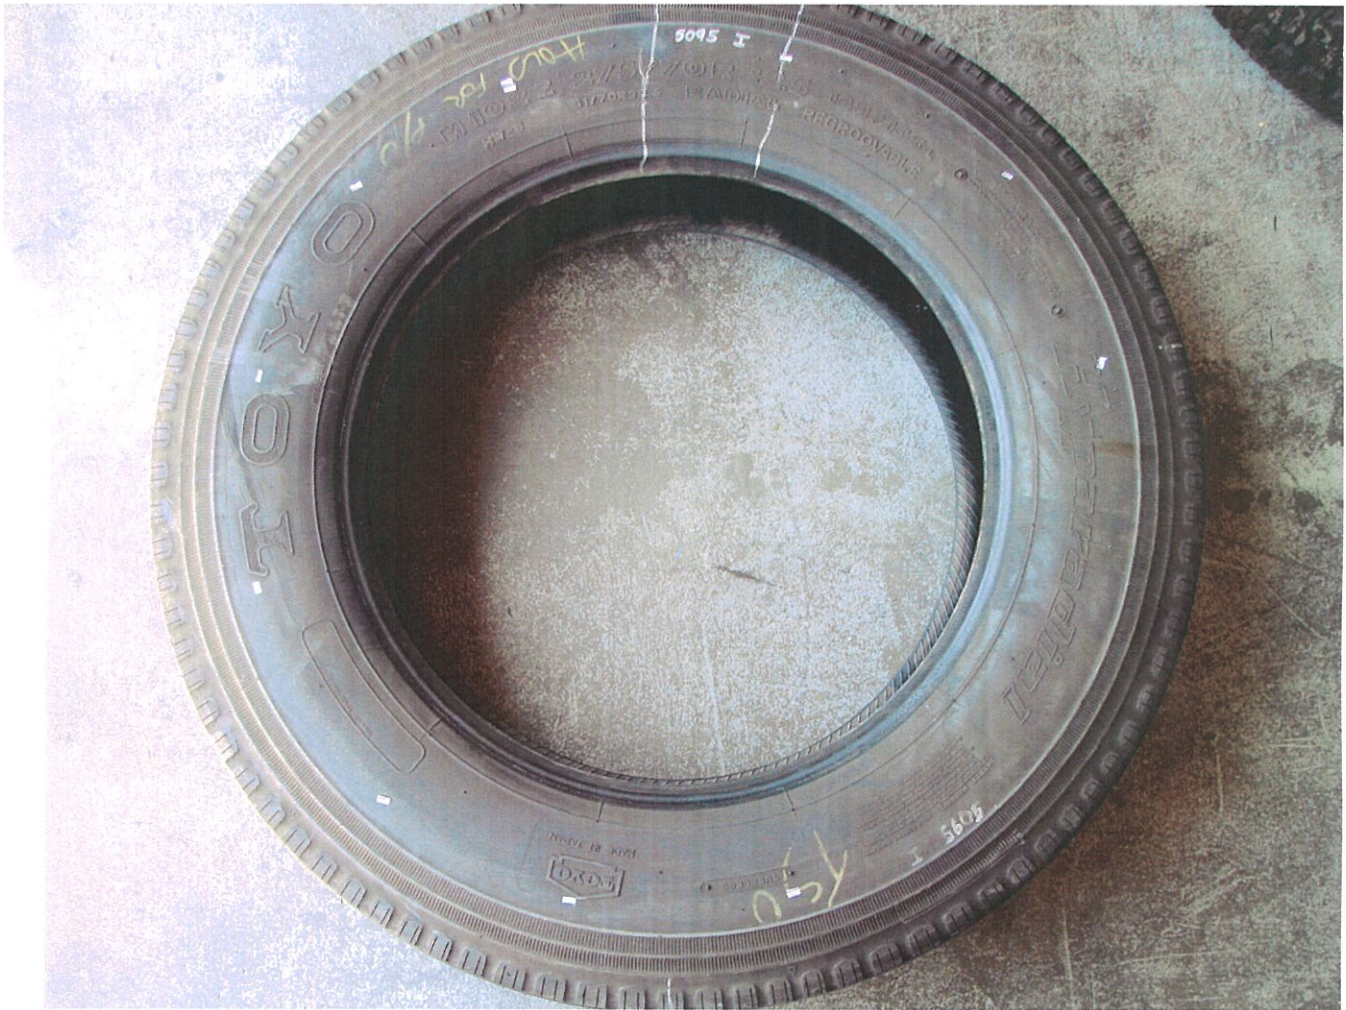
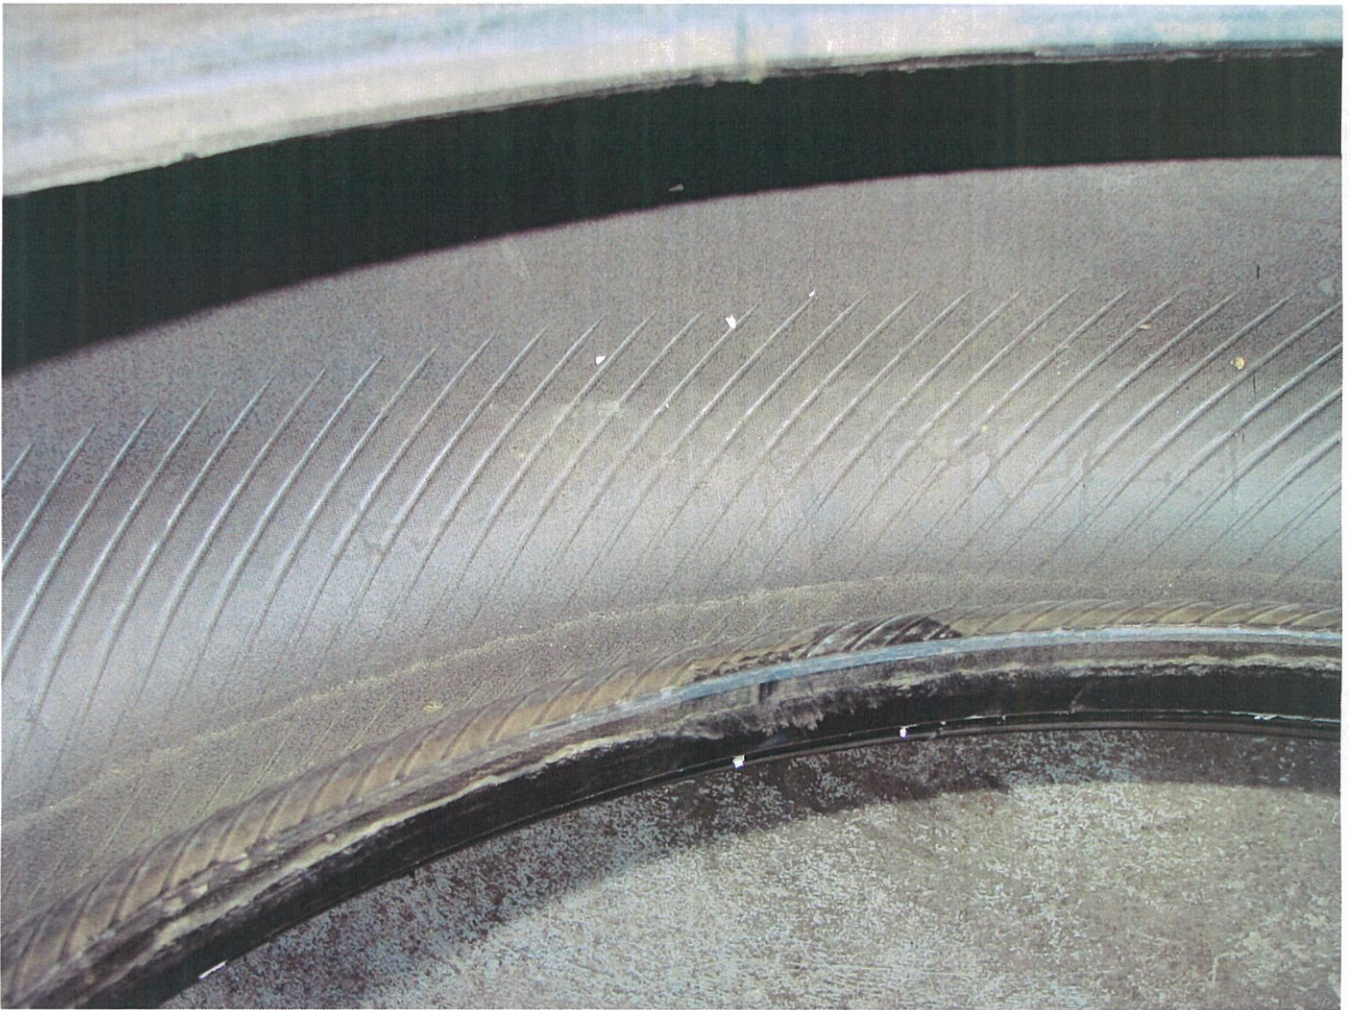
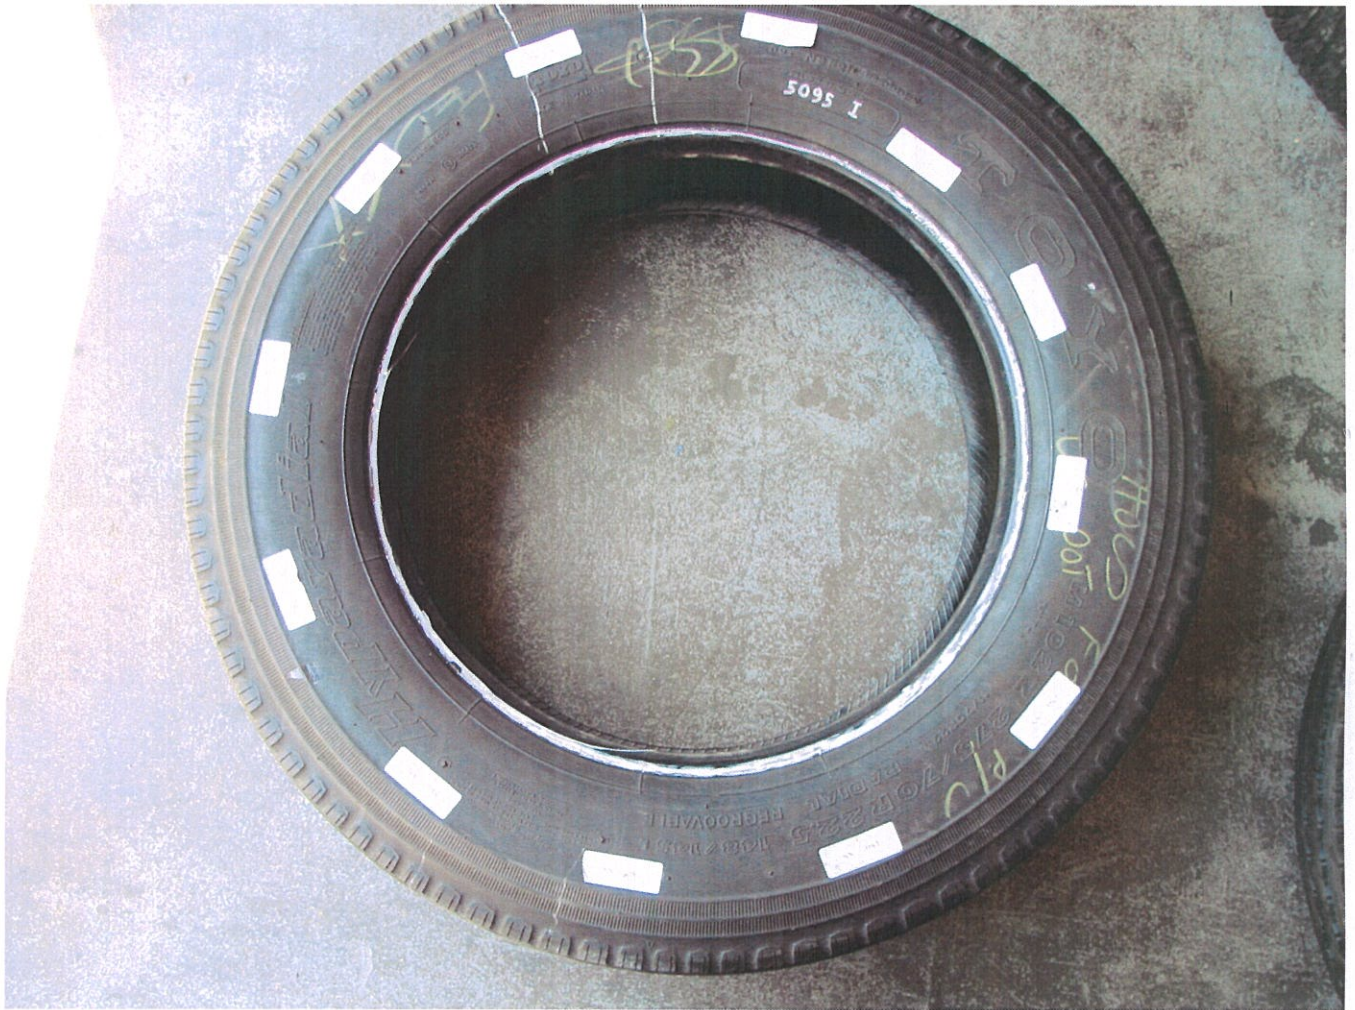
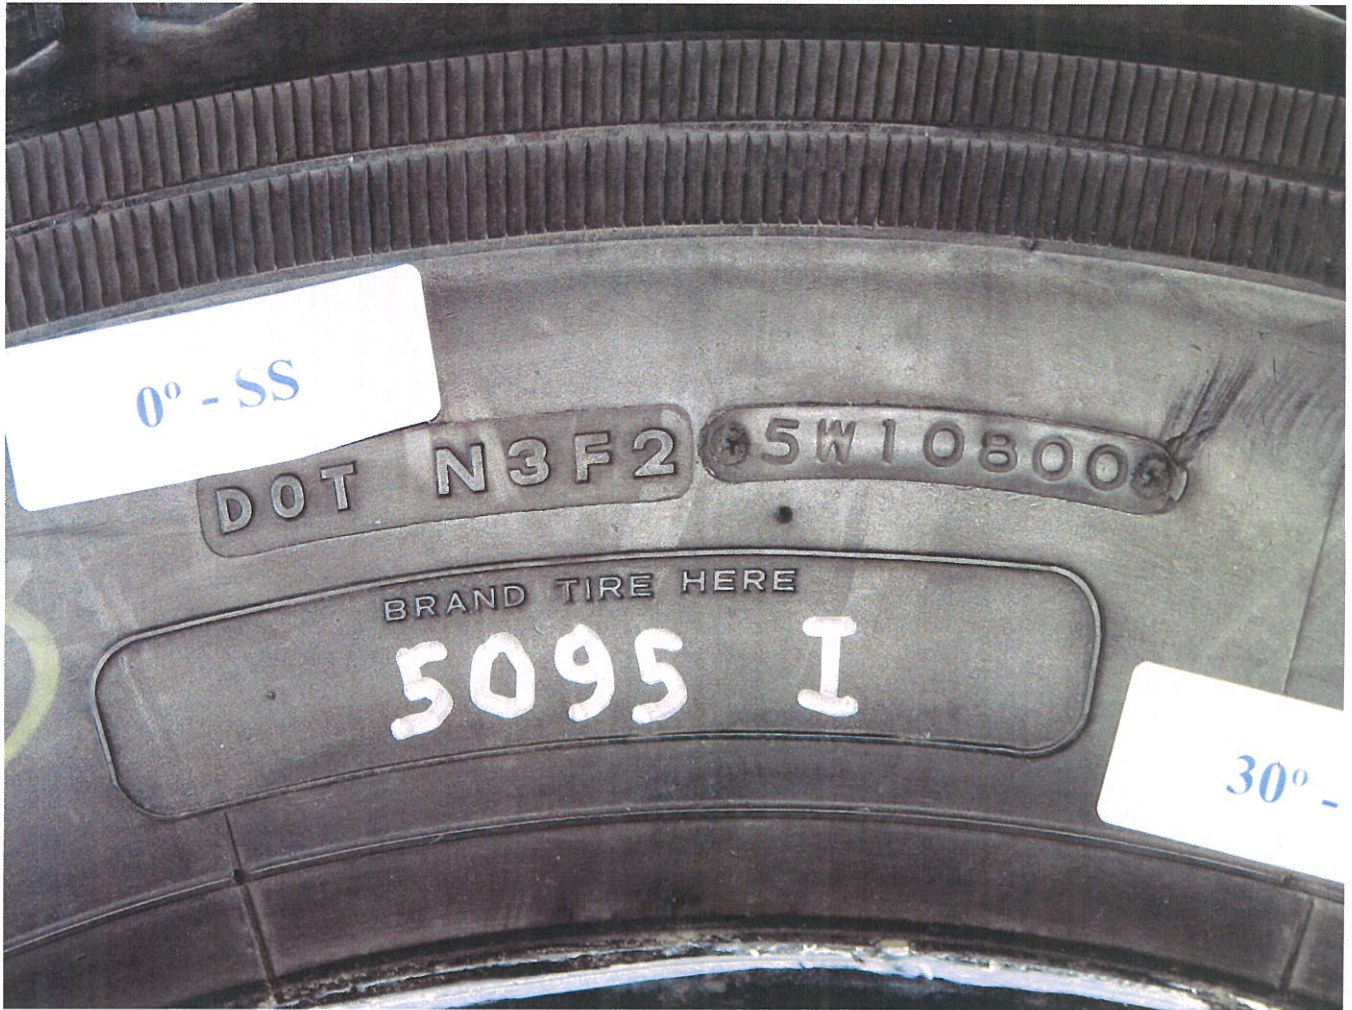
Appendix A - INSPECTION- Tire I – images and observations

TIRE OBSERVATIONS	0 DEG	30 DEG	60 DEG	90 DEG	120 DEG	150 DEG	180 DEG	210 DEG	240 DEG	270 DEG	300 DEG	330 DEG
TIRE IDENTIFIERS												
Groove 1 nearest to SS												
Groove 2												
Groove 3												
Groove 4												
Tread Block 1 nearest to SS												
Tread Block 2												
Tread Block 3												
Tread Block 4												
Tread Block 5												
Tread crown area												
TIRE OBSERVATIONS												
Groove 1 nearest to SS												
Groove 2												
Groove 3												
Groove 4												
Tread Block 1 nearest to SS			1.5 inch cut									
Tread Block 2												
Tread Block 3												
Tread Block 4												
Tread Block 5												
Tread crown area

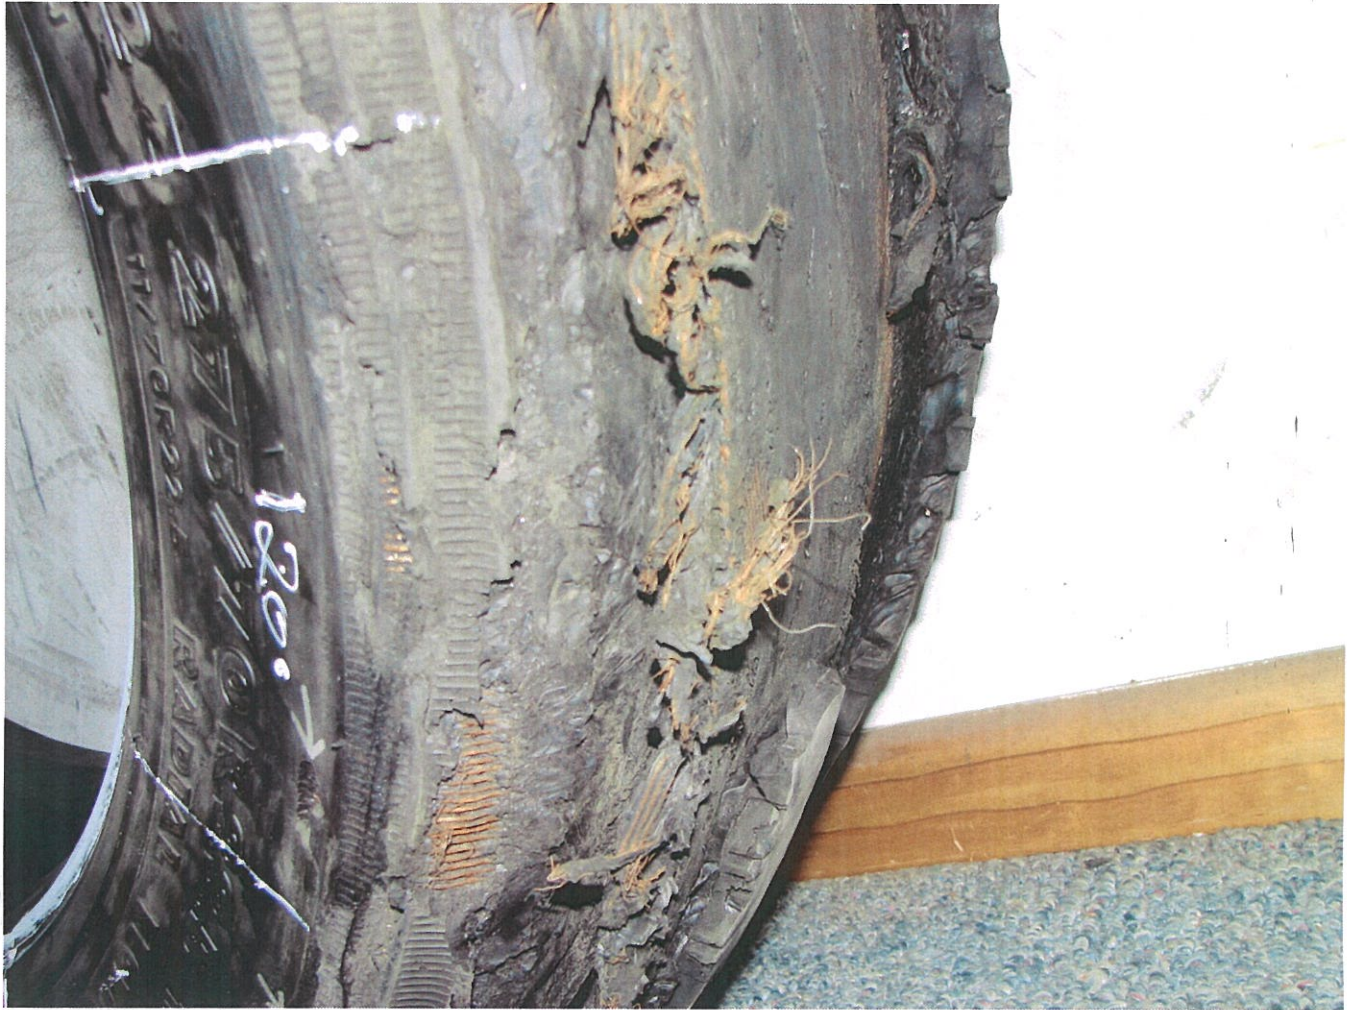
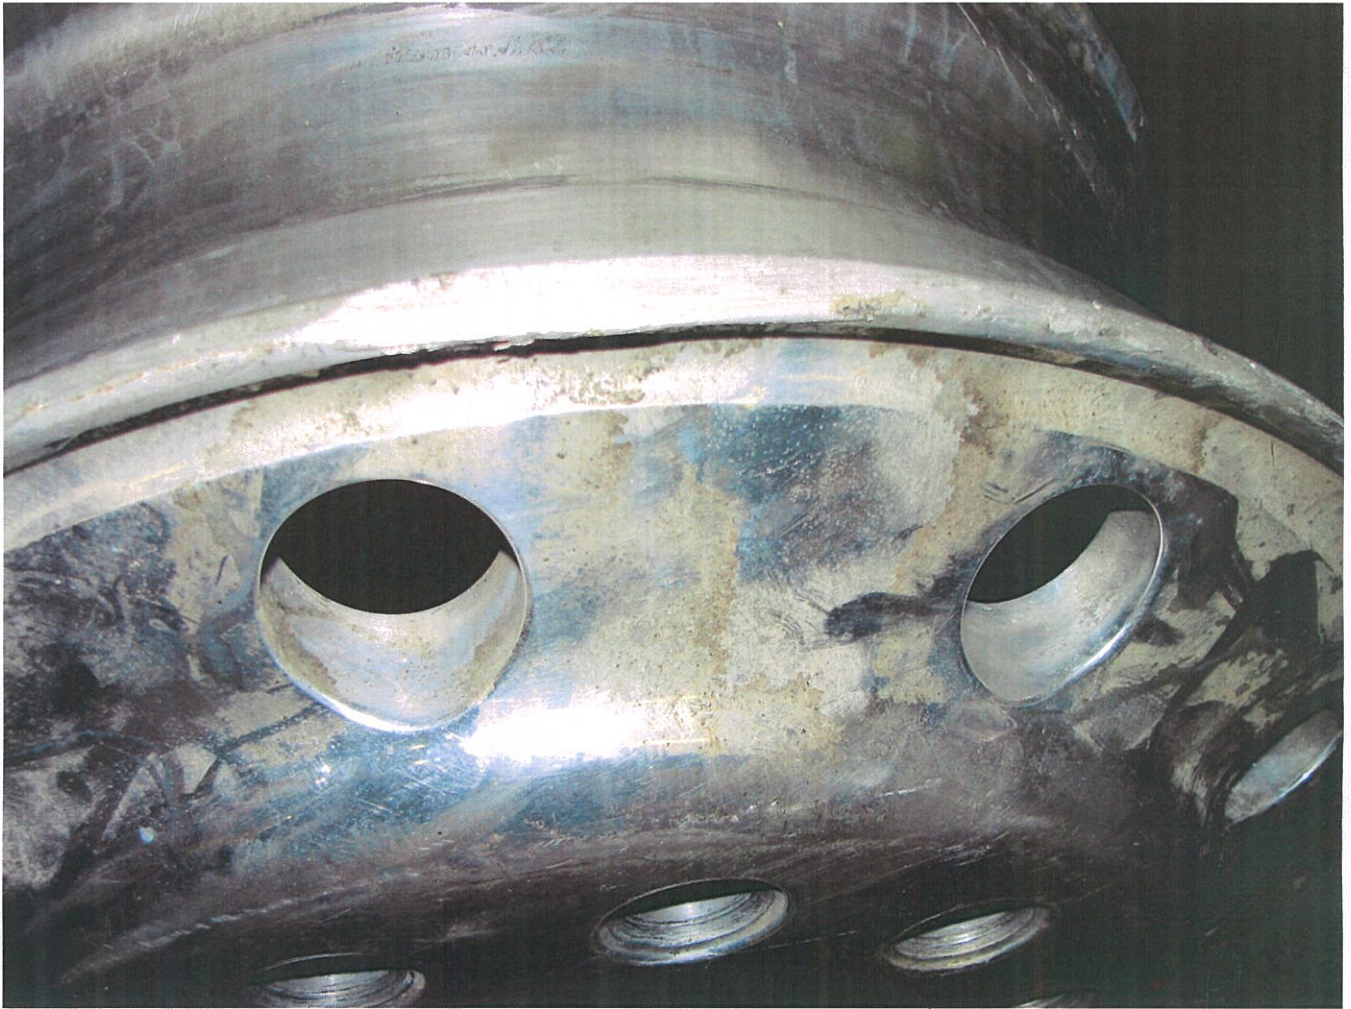
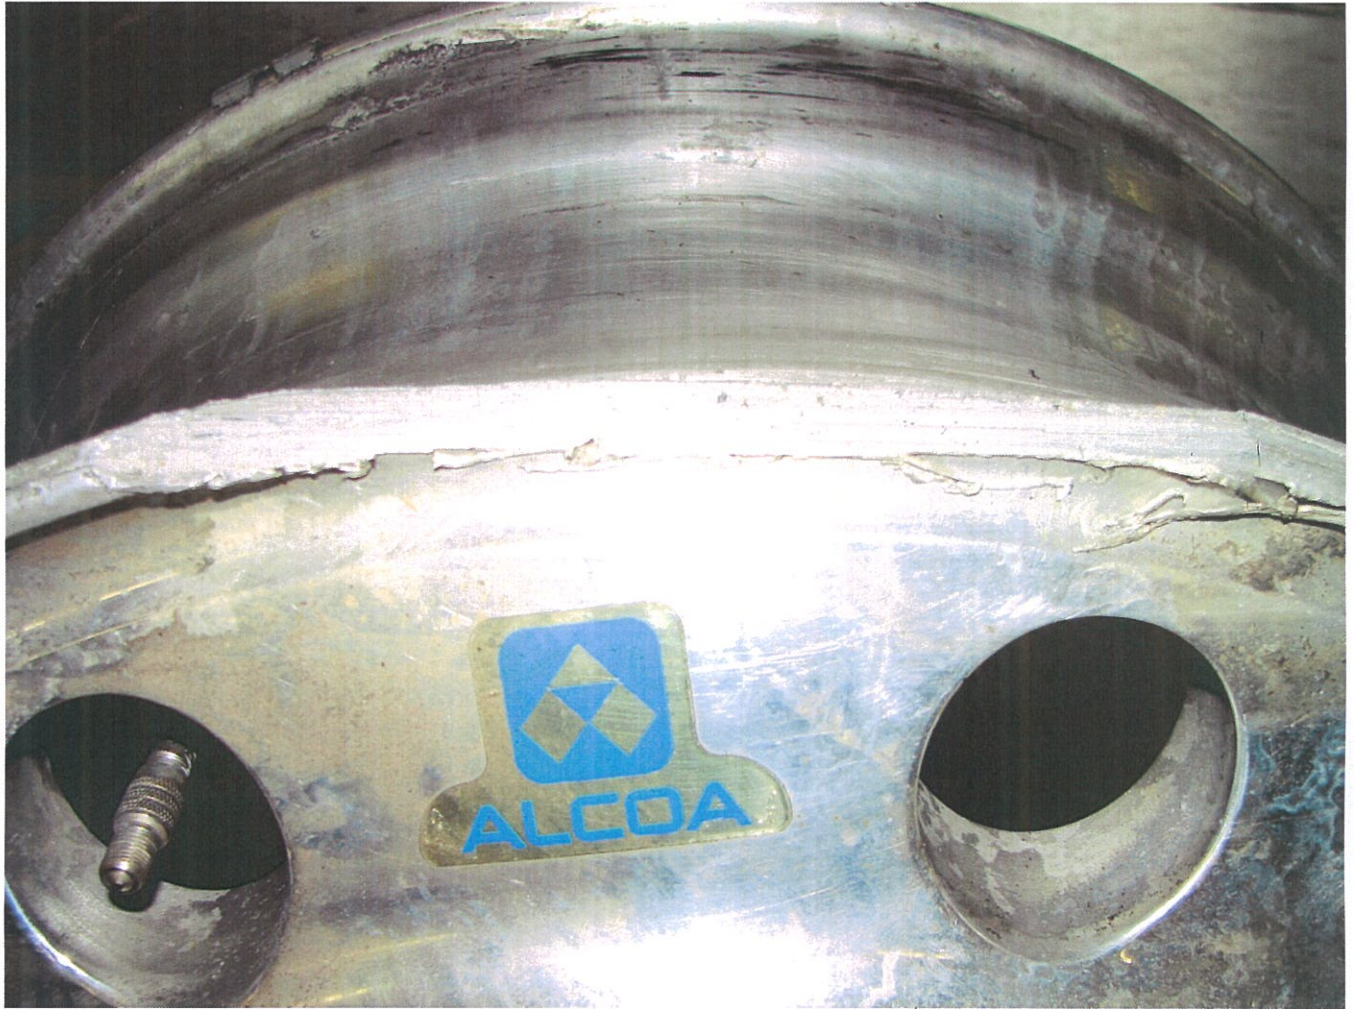
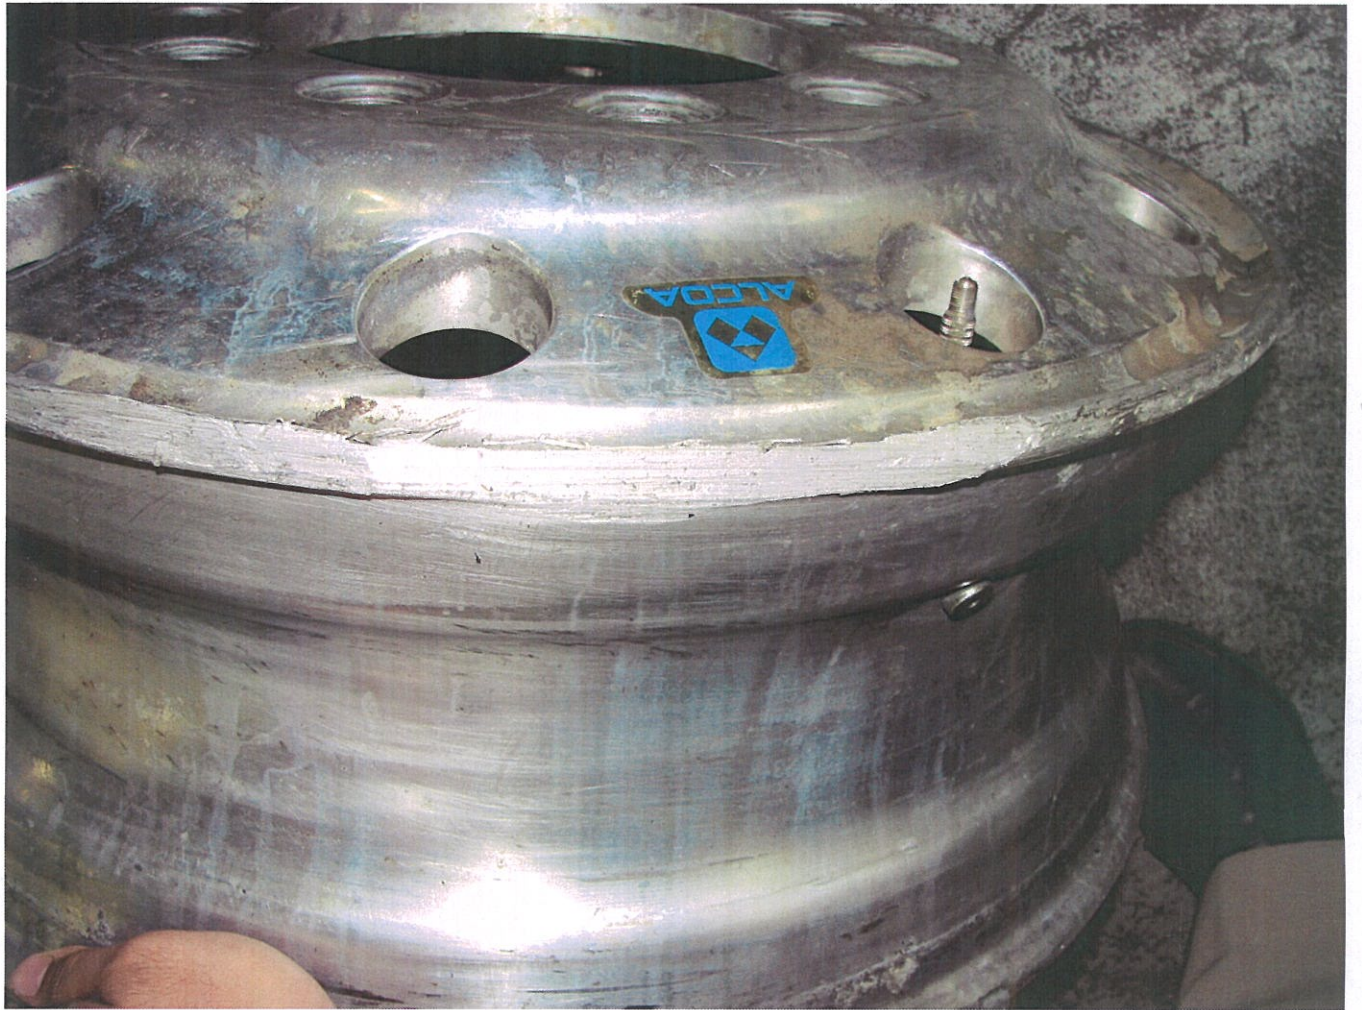
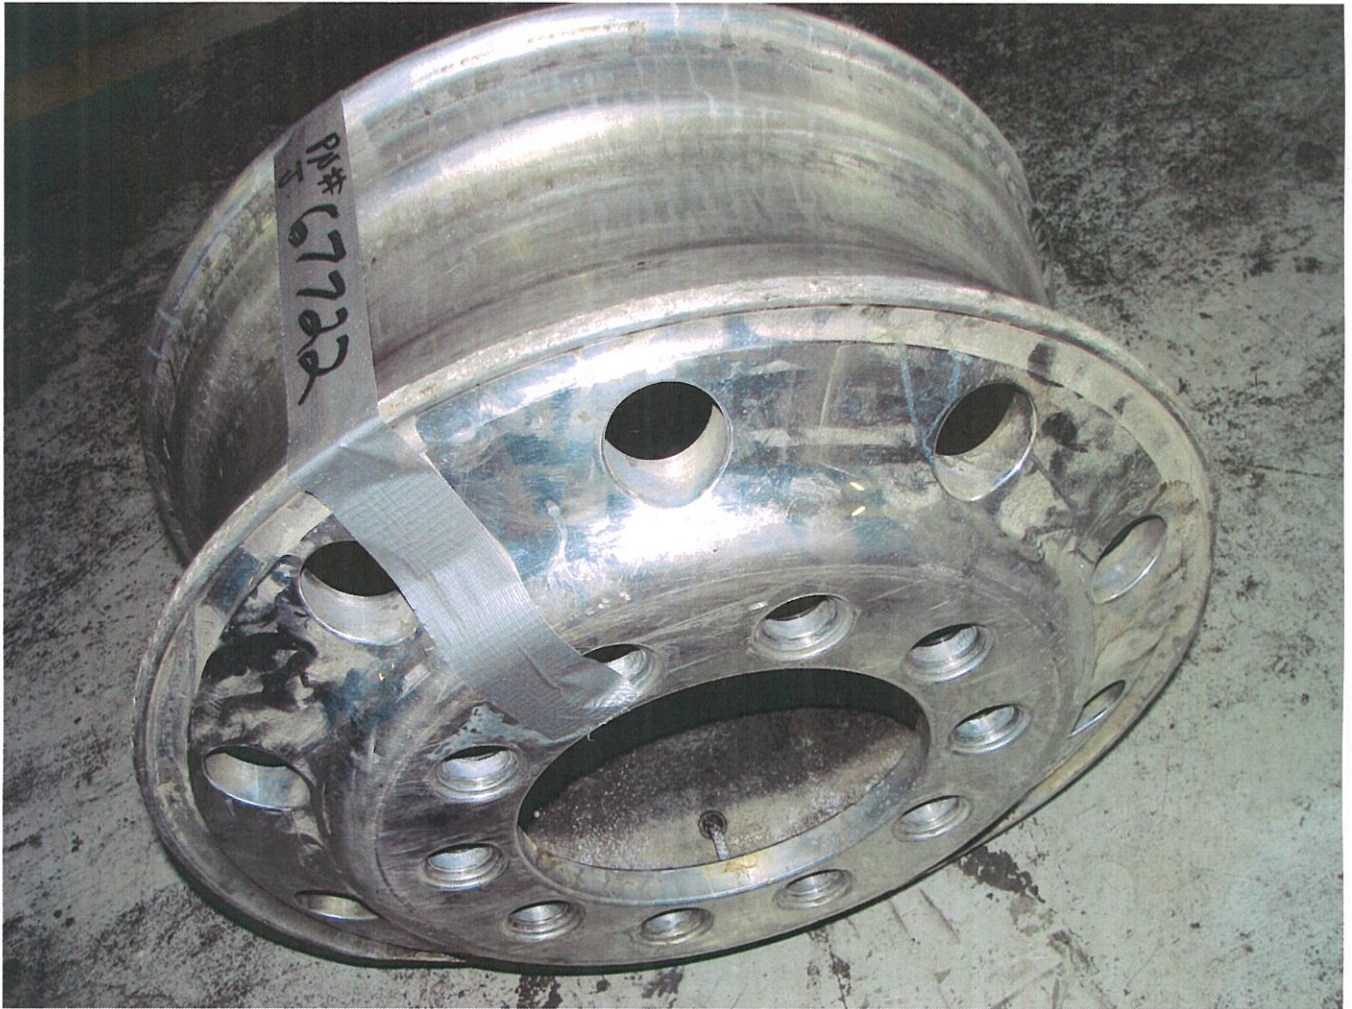
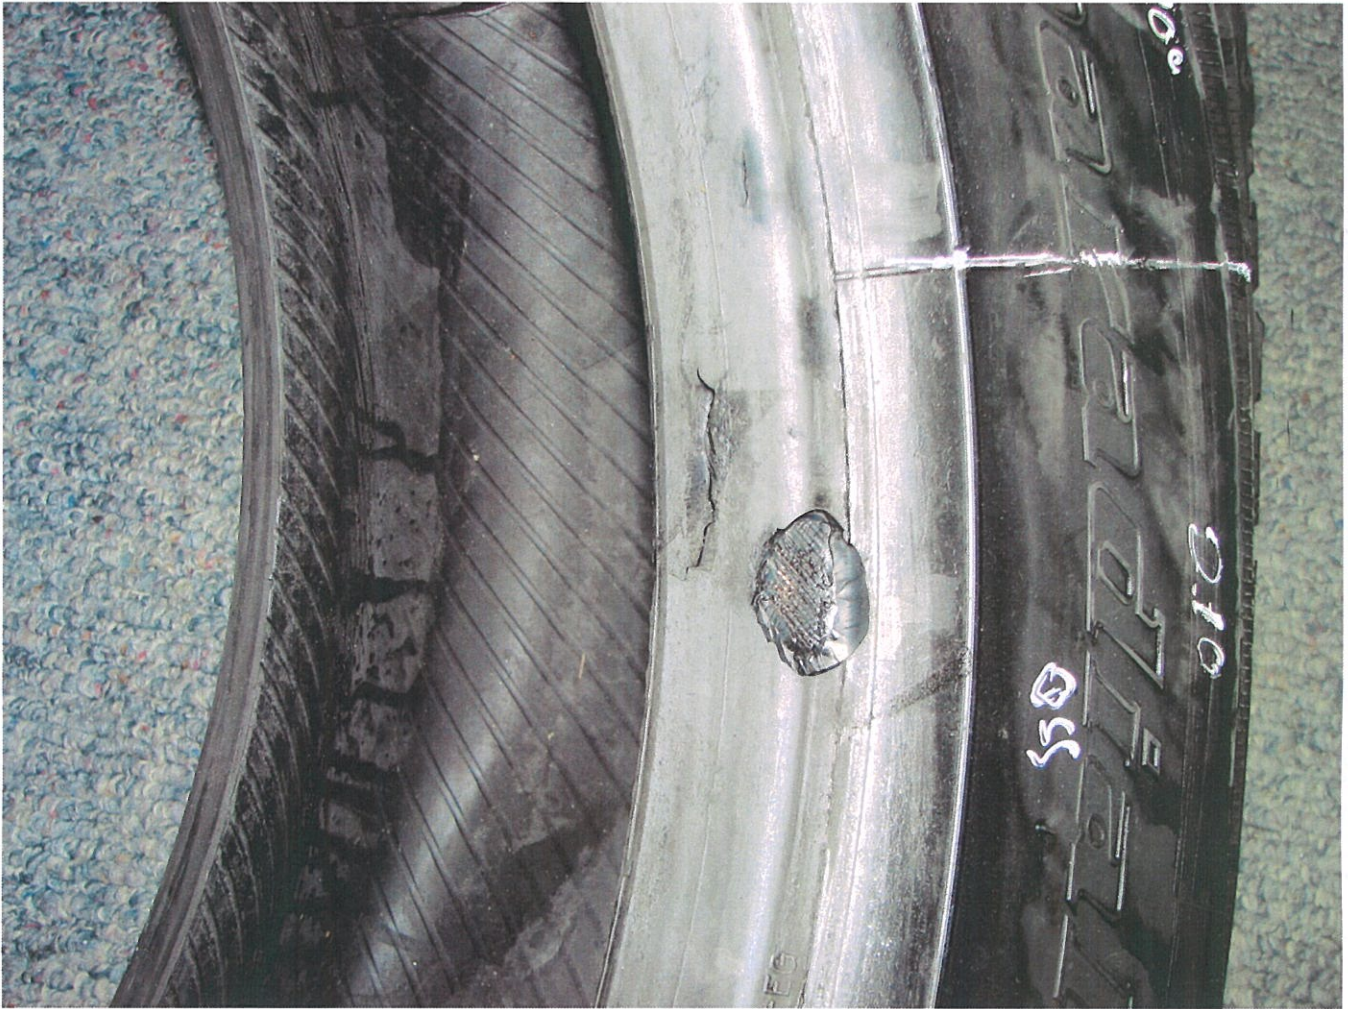
Appendix A - INSPECTION- Tire J – OBSERVATIONS AND IMAGES

VISUAL OBSERVATIONS	0 DEG	30 DEG	60 DEG	90 DEG	120 DEG	150 DEG	180 DEG	210 DEG	240 DEG	270 DEG	300 DEG	330 DEG
Tread Block 1 nearest to SS	Missing	Missing	Missing	Missing	Missing	Missing	Missing	Missing	Missing	Missing	Missing	Missing
Tread Block 2	Missing	Missing	Missing	Missing	Missing	Visible	Visible	Visible	Visible	Visible	Visible	Visible
Tread Block 3	Missing	Missing	Missing	Missing	Missing	Missing	Missing	Missing	Missing	Missing	Missing	Missing
Tread Block 4	Missing	Missing	Missing	Missing	Missing	Missing	Missing	Missing	Missing	Missing	Missing	Missing
Tread Block 5	Missing	Visible	Visible	Visible	Visible	Visible	Visible	Visible	Visible	Visible	Visible	Visible
Tread crown area												
Steel belt 0 - Radial Plies	Visible	Visible	Visible	Visible	Visible	Visible	Visible	Visible	Visible	Visible	Visible	Visible
Rubber between steel belt 0 and 1	Visible	Visible	Visible	Visible	Visible	Visible	Visible	Visible	Visible	Visible	Visible	Visible

Steel belt 1	Missing	Visible	Visible	Visible	Visible	Visible	Visible	Visible	Visible	Visible	Visible	Visible
Rubber between steel belt 1 and 2	Missing	Visible	Visible	Visible	Visible	Visible	Visible	Visible	Visible	Visible	Visible	Visible
Steel belt 2	Missing	Visible	Visible	Visible	Visible	Visible	Visible	Visible	Visible	Visible	Visible	Visible
Rubber between steel belt 2 and 3	Missing	Visible	Visible	Visible	Visible	Visible	Visible	Visible	Visible	Visible	Visible	Visible
Steel belt 3	Missing	Missing	Missing	Missing	Visible	Visible	Visible	Visible	Visible	Visible	Visible	Visible
Rubber between steel belt 3 and 4	Missing	Missing	Missing	Missing	Visible	Visible	Visible	Visible	Visible	Visible	Visible	Visible
Steel belt 4	Missing	Missing	Missing	Missing	Visible	Visible	Visible	Visible	Visible	Visible	Visible	Visible

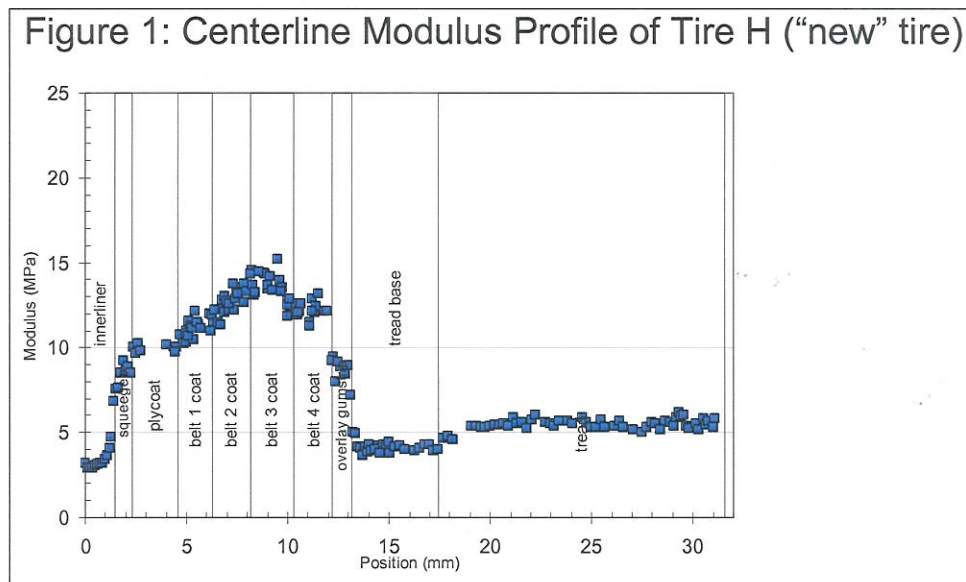
Indentation modulus was measured in the centerline region of tire. The radial scan (modulus profile) was located at the centerline because that region can be a critical (high strain) region in truck tires. Figure 1 shows the centerline modulus profile of Tire H (the “new” tire).

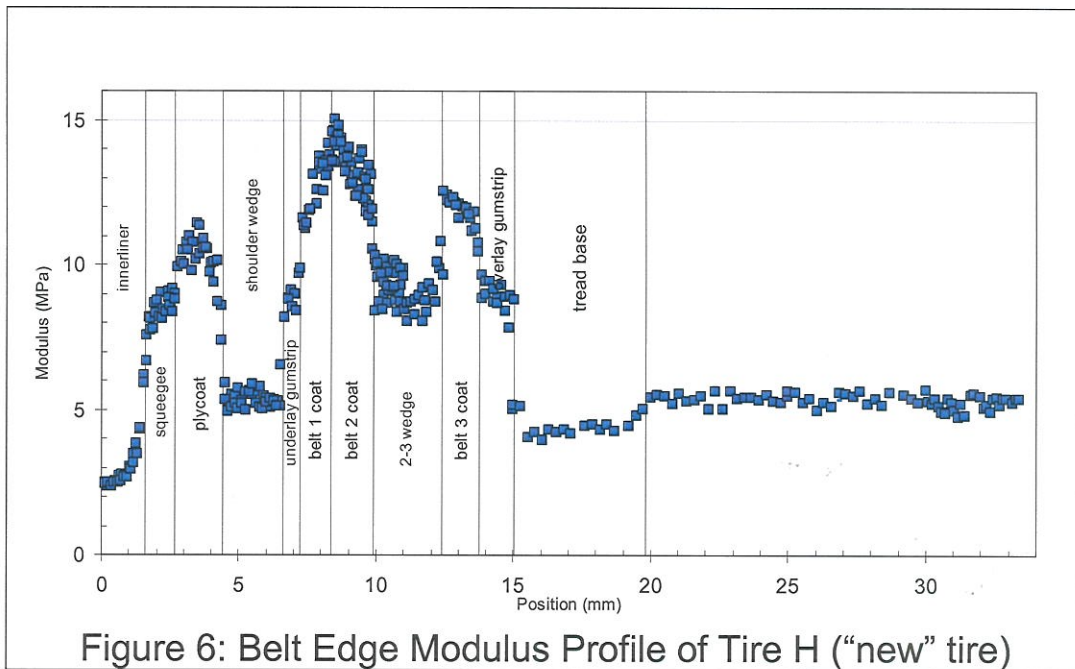
Figure 6: Belt Edge Modulus Profile of Tire H (“new” tire)

Indentation modulus was measured in the shoulder region of tire. The radial scan (modulus profile) was located at the edge of belt 3 because that is the critical (high strain) region of the working belts. Figure 6 shows the centerline modulus profile of Tire H (the “new” tire in the belt edge region).
