- TIRE FORENSICS REPORT -

PN 67722
Purchase Order DTNH22-06-P-08366

SUBJECT: Forensic Evaluation on 9 Toyo Tires.

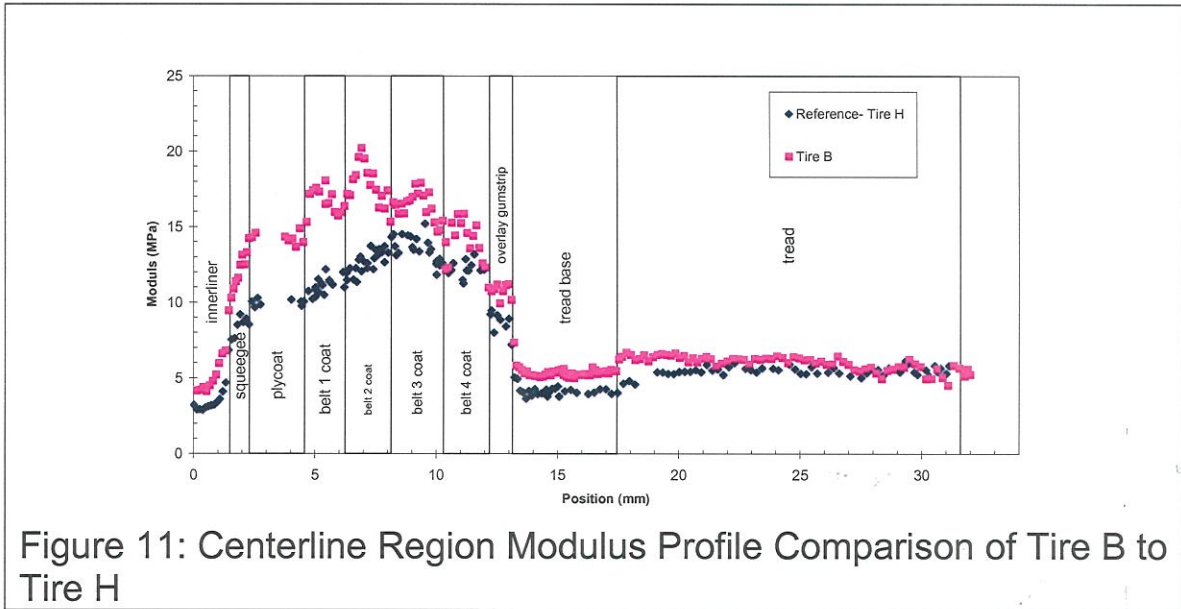
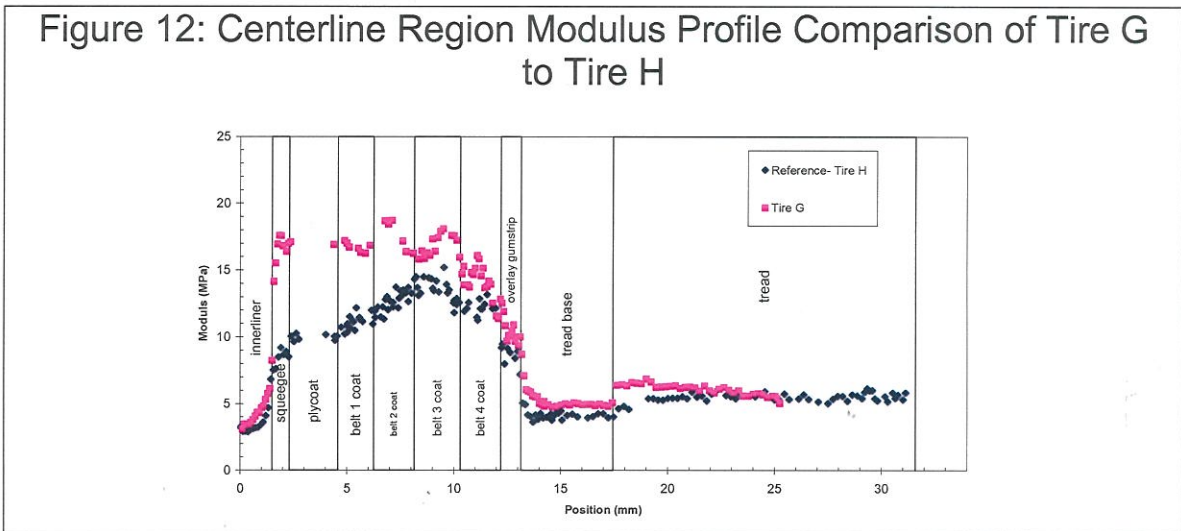
Modulus profiling was performed in the tire centerline region of wheel-tested tires (tires B and G). The modulus increased in each of the components (Figures 11 and 12). The compounds experienced large modulus increases. Presumably, oxidative hardening was significantly affecting these compounds.

The compounds in wheel-tested tires experienced large modulus increases. Presumably, oxidative hardening was significantly affecting these compounds.
