AKRON RUBBER DEVELOPMENT LABORATORY, INC  
ARDL ENGINEERING GROUP  
2851 GILCHRIST ROAD, AKRON, OHIO 44305  
PHONE: 330-7946600 FAX 330-7946623

## - TIRE FORENSICS REPORT -

PN 67722  
Purchase Order DTNH22-06-P-08366

**SUBJECT:** Forensic Evaluation on 9 Toyo Tires.

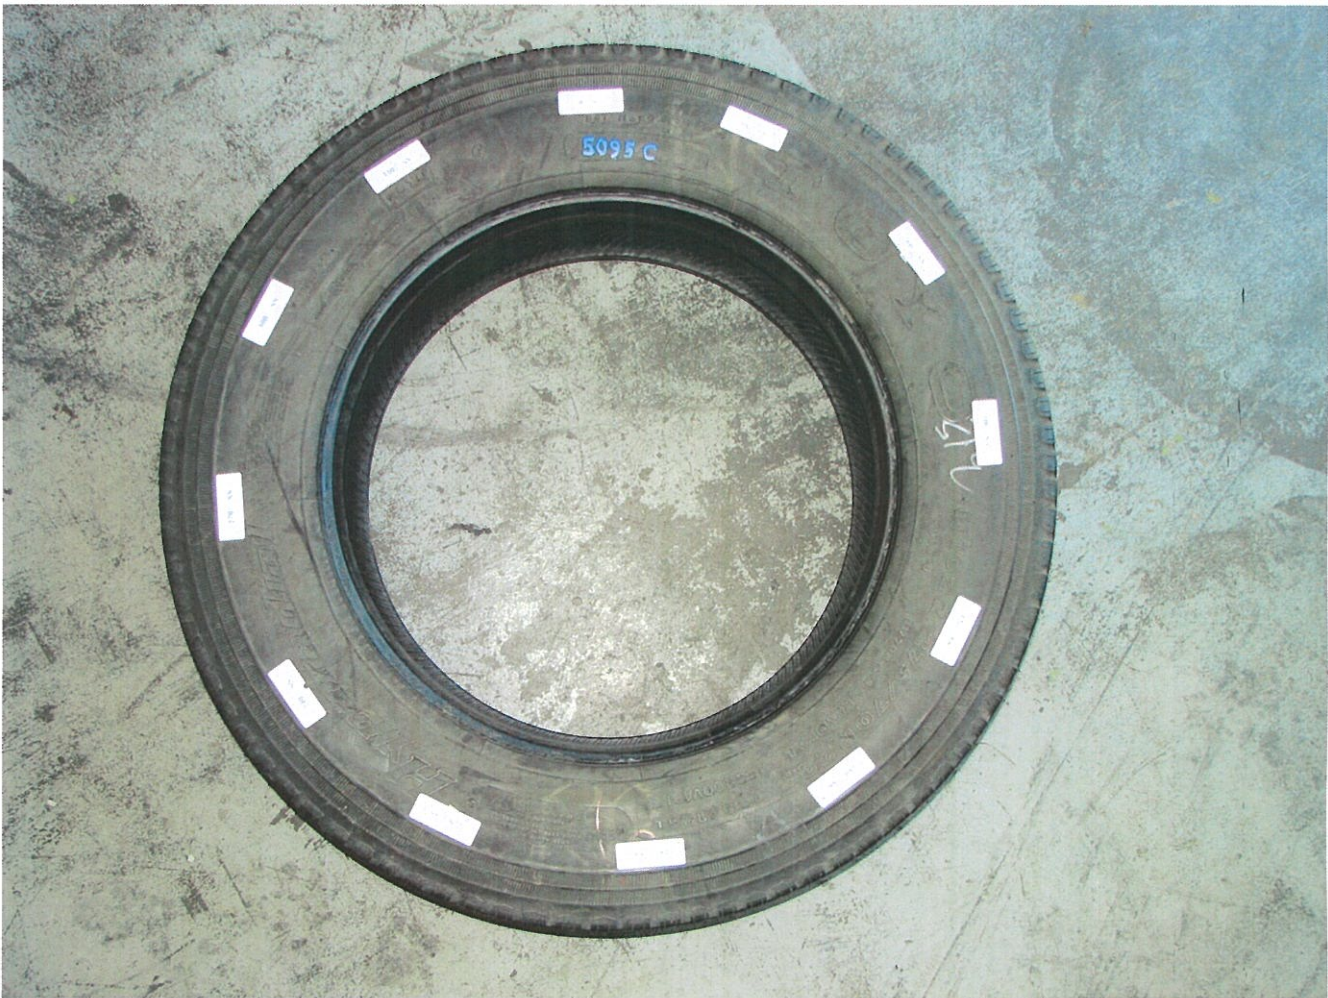
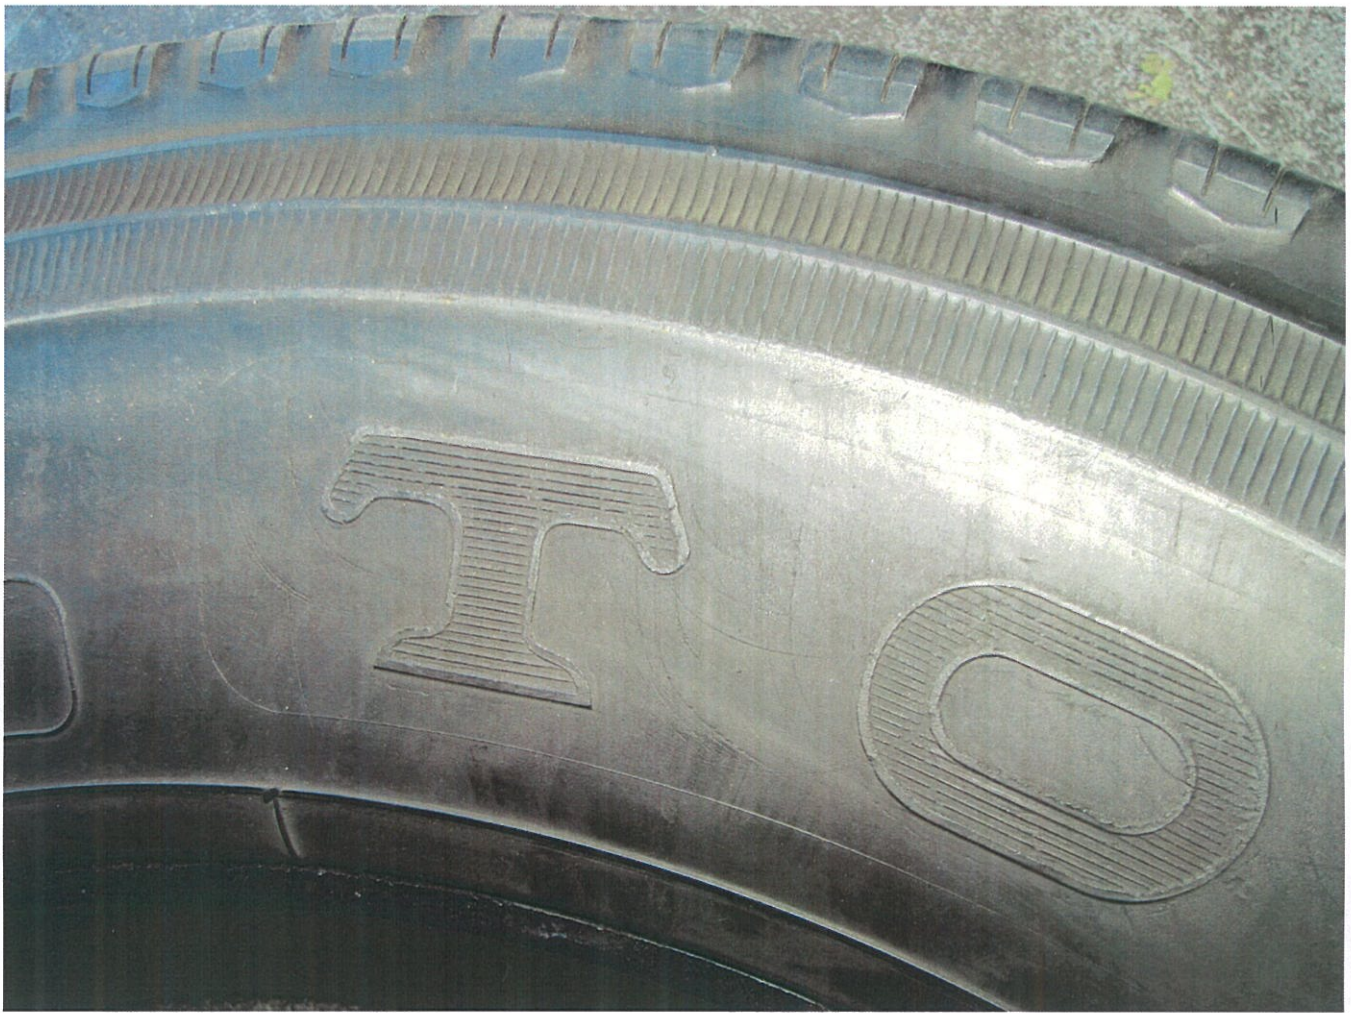
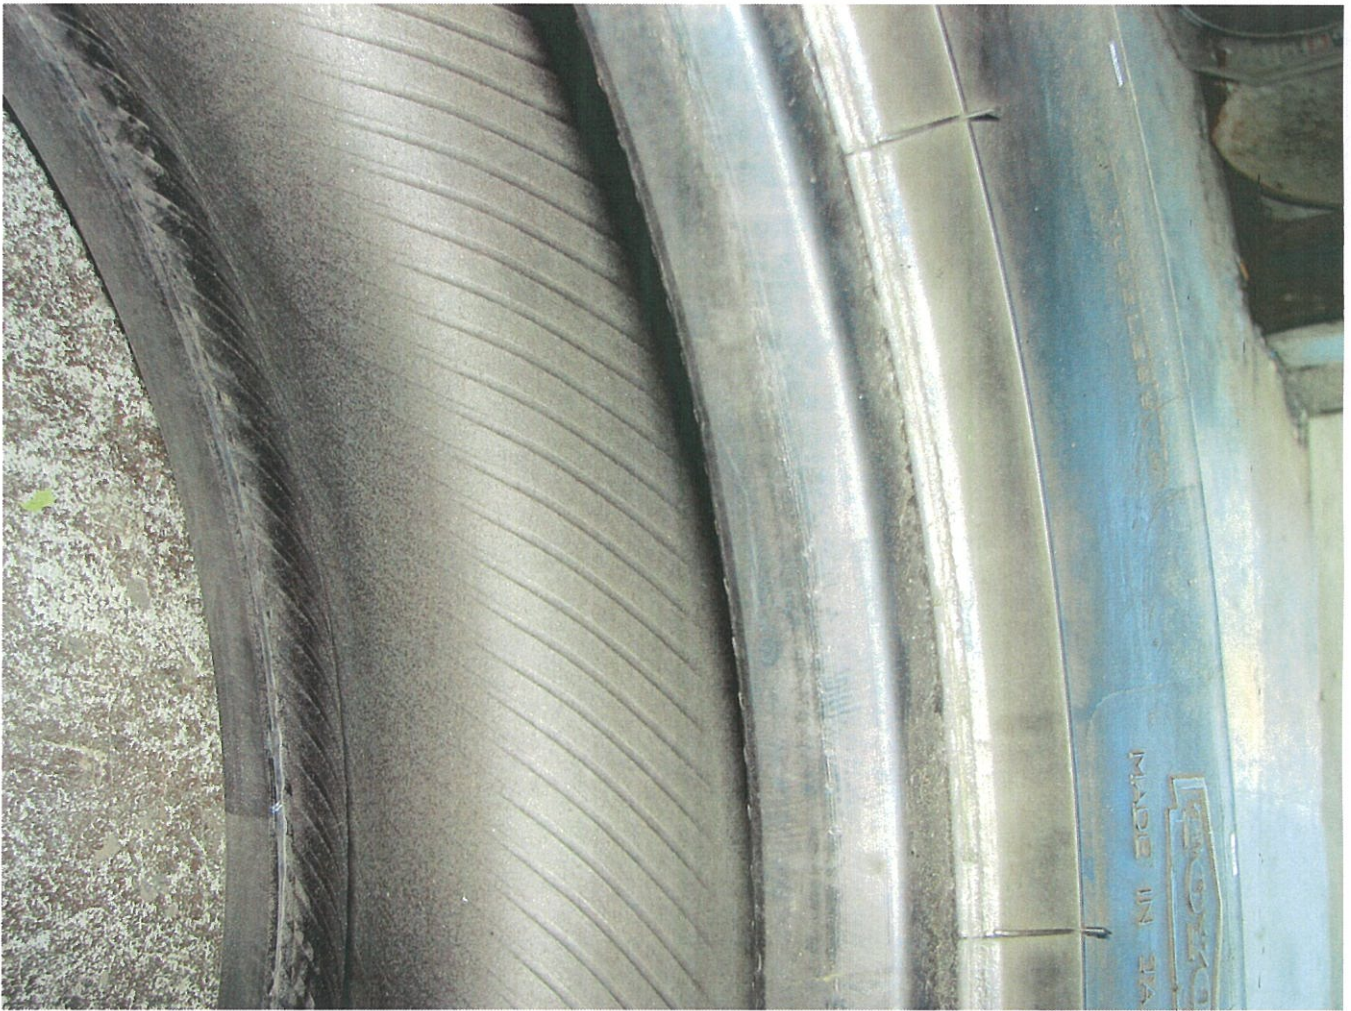
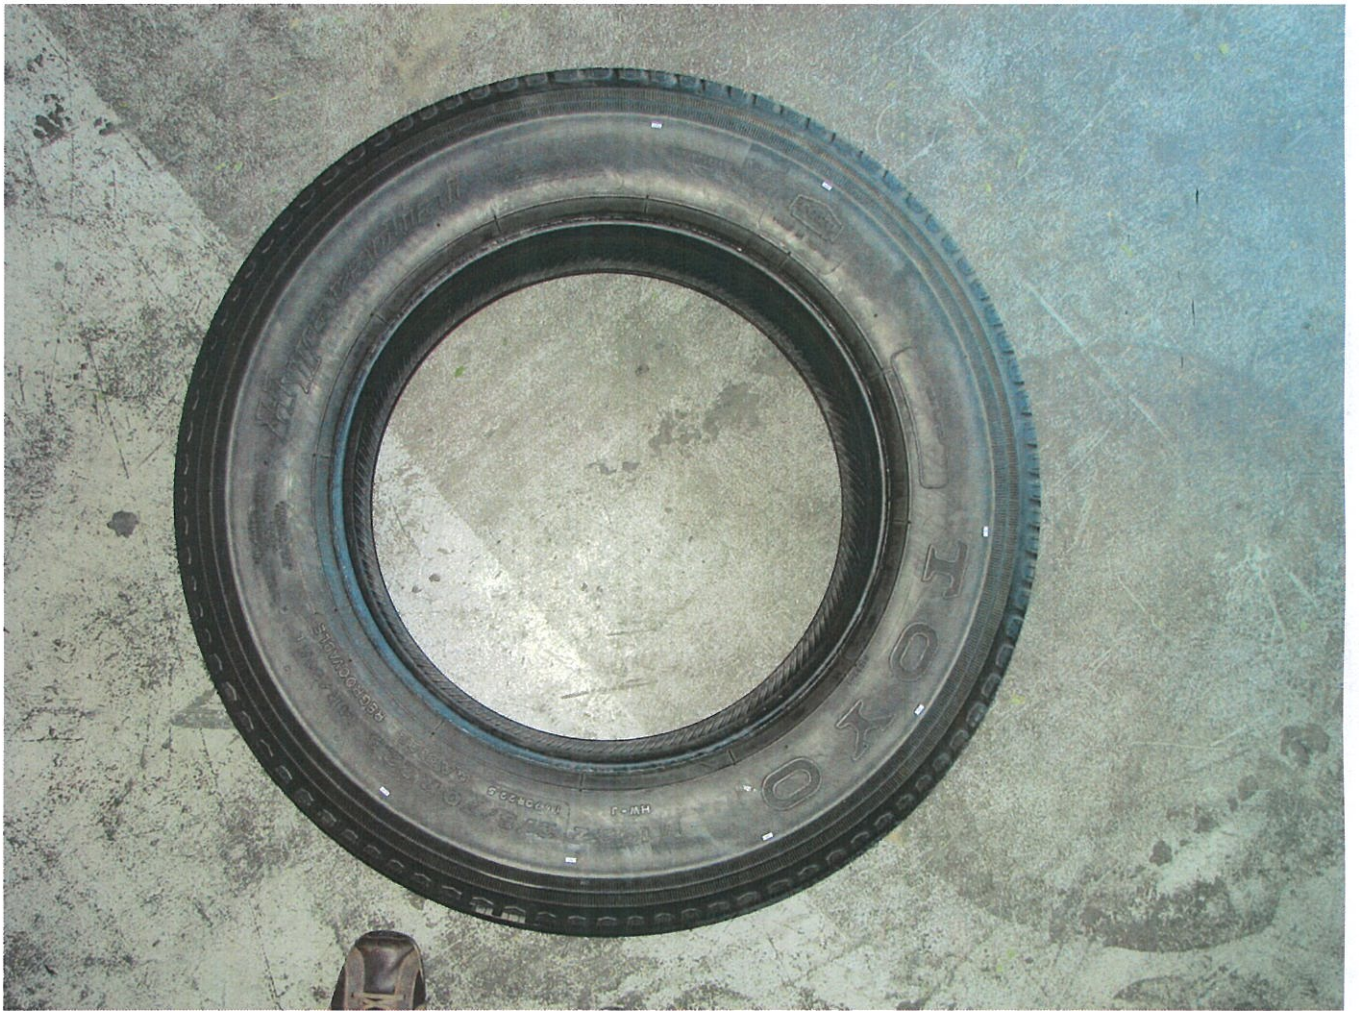
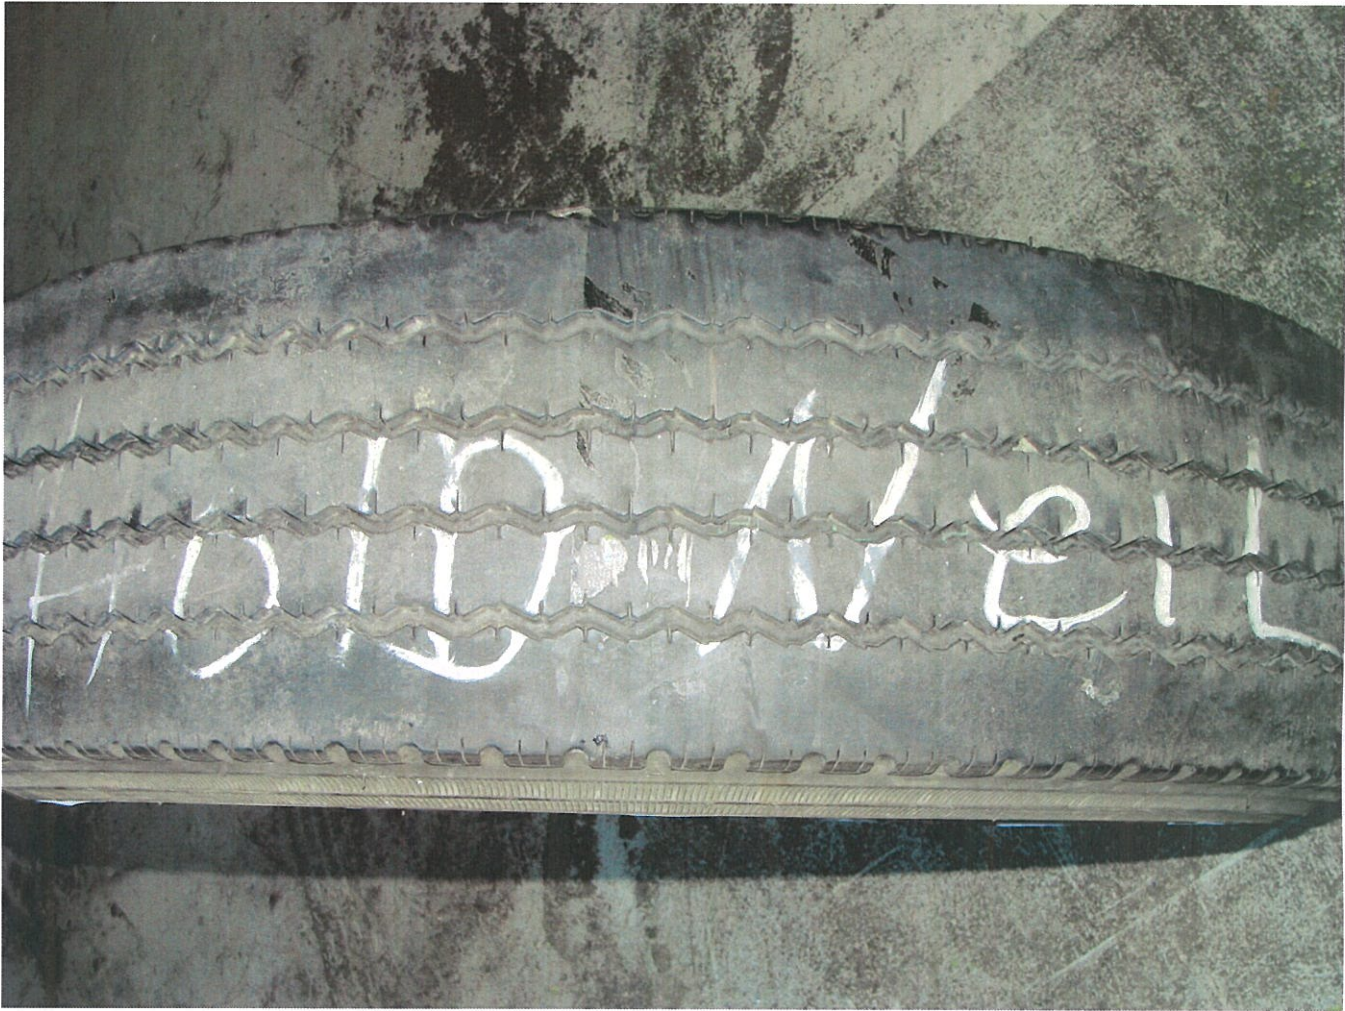
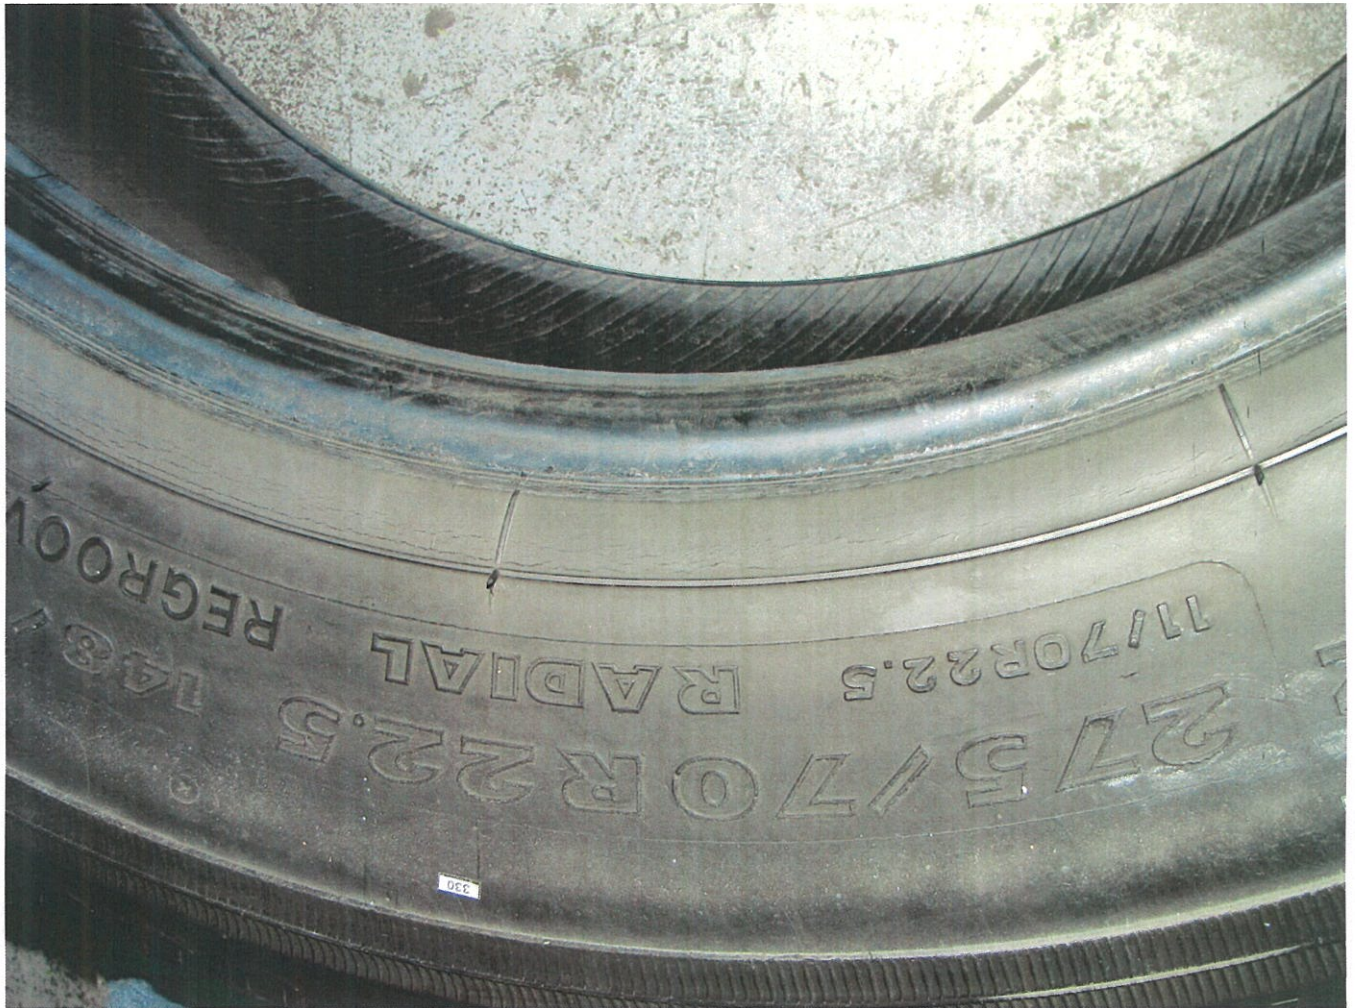
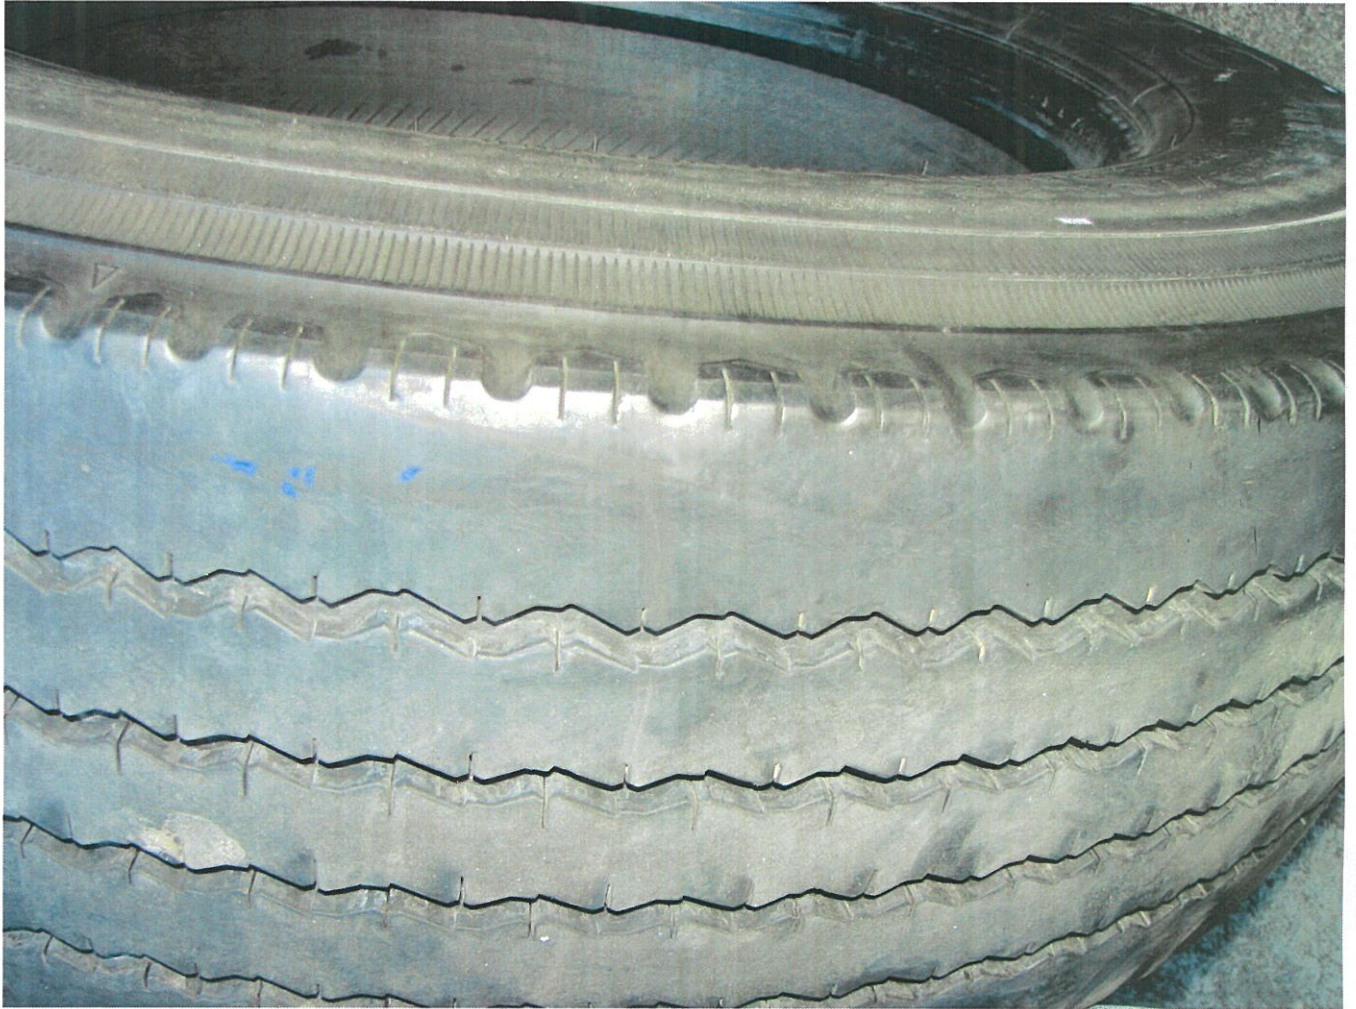
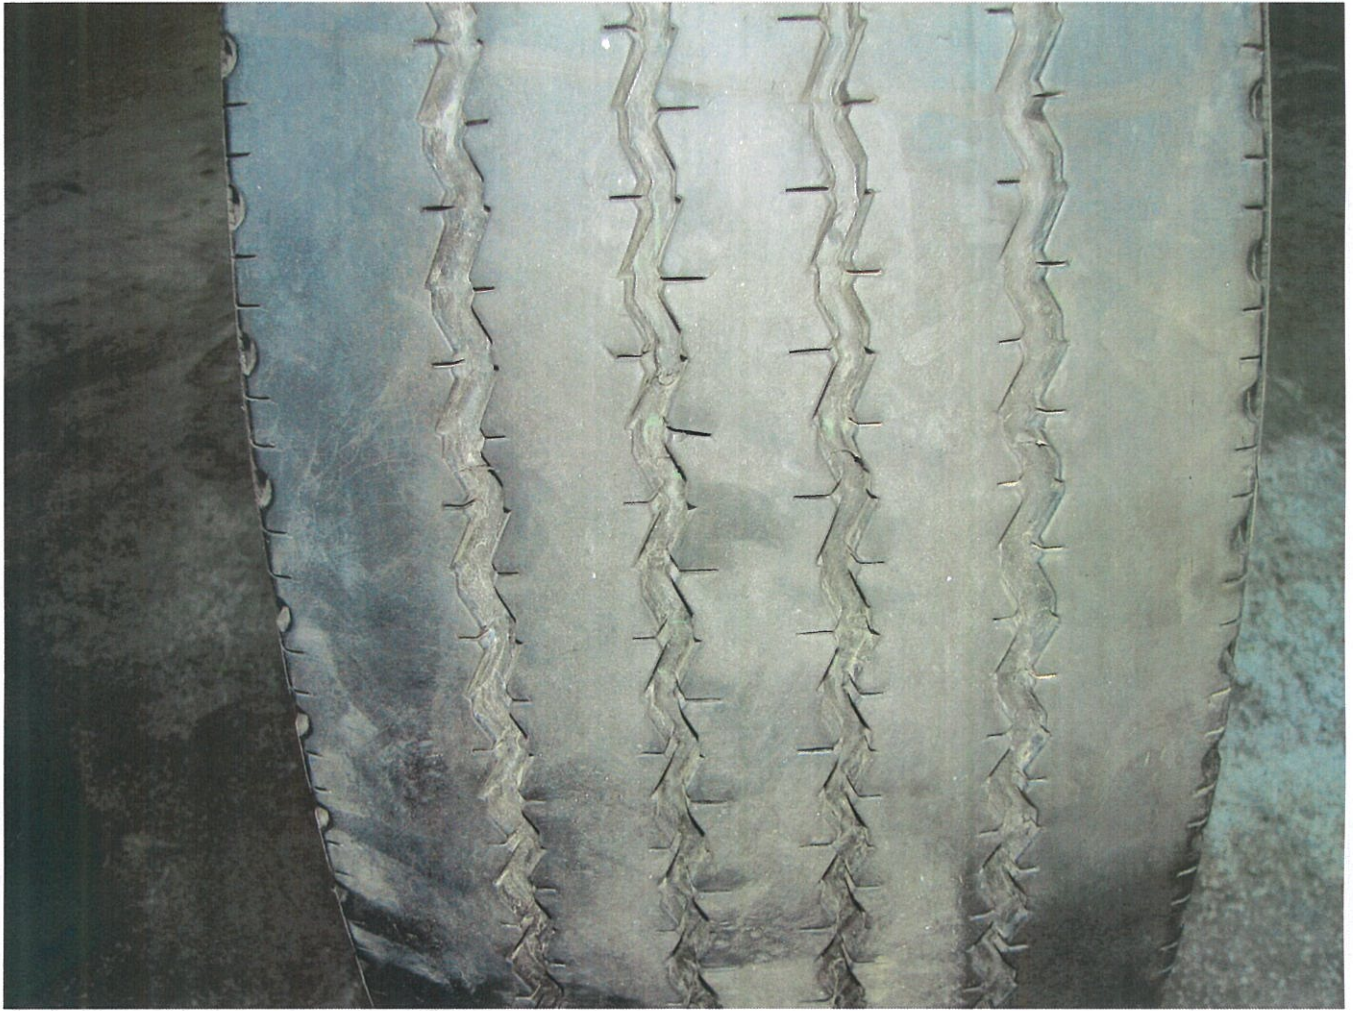
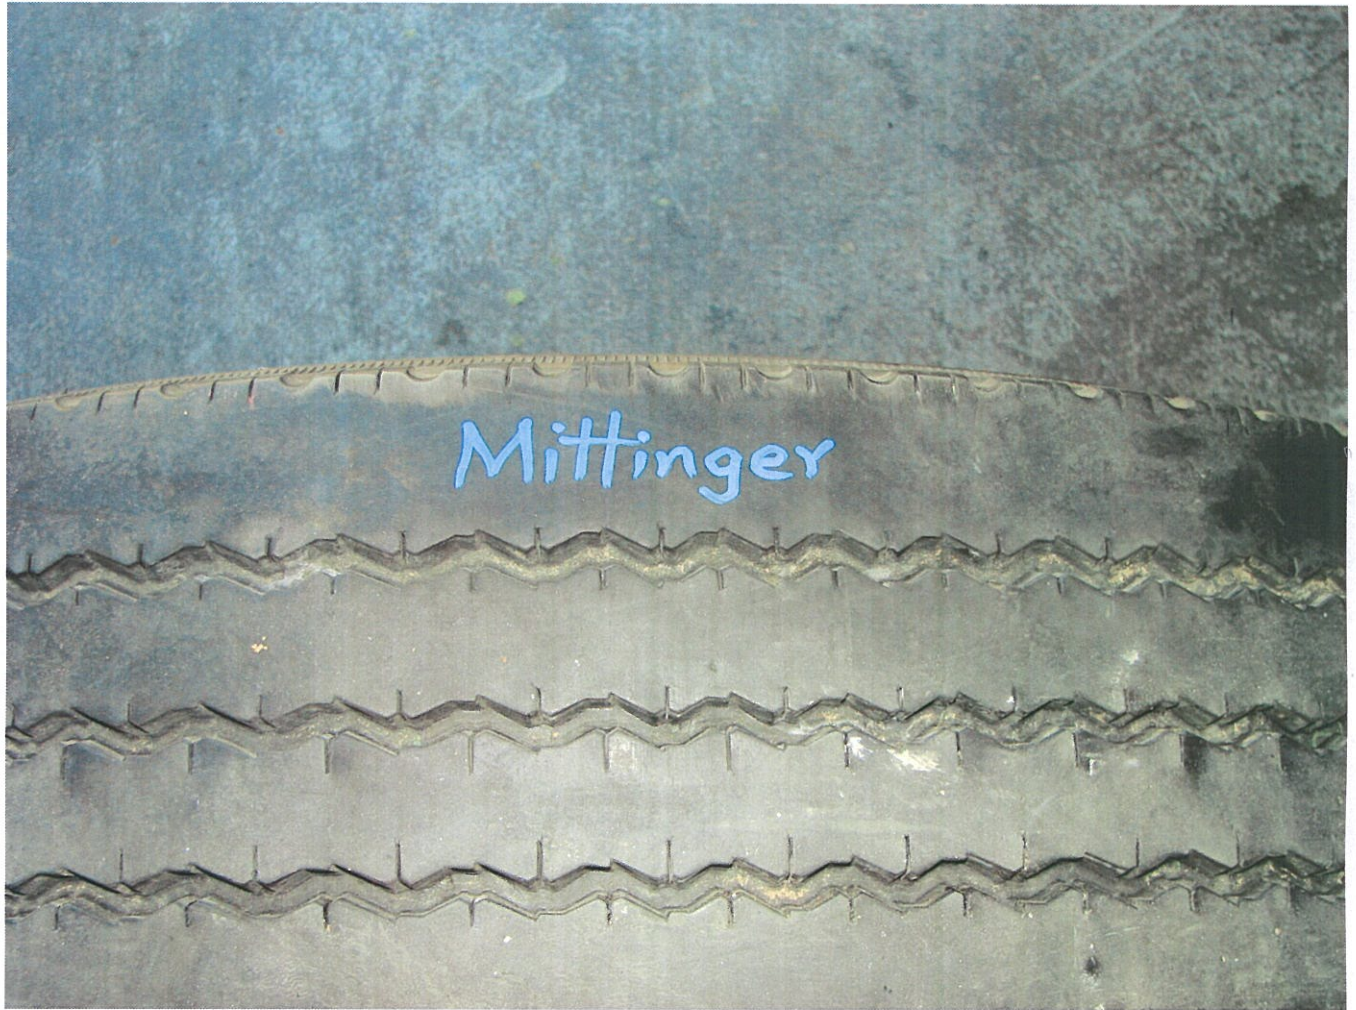
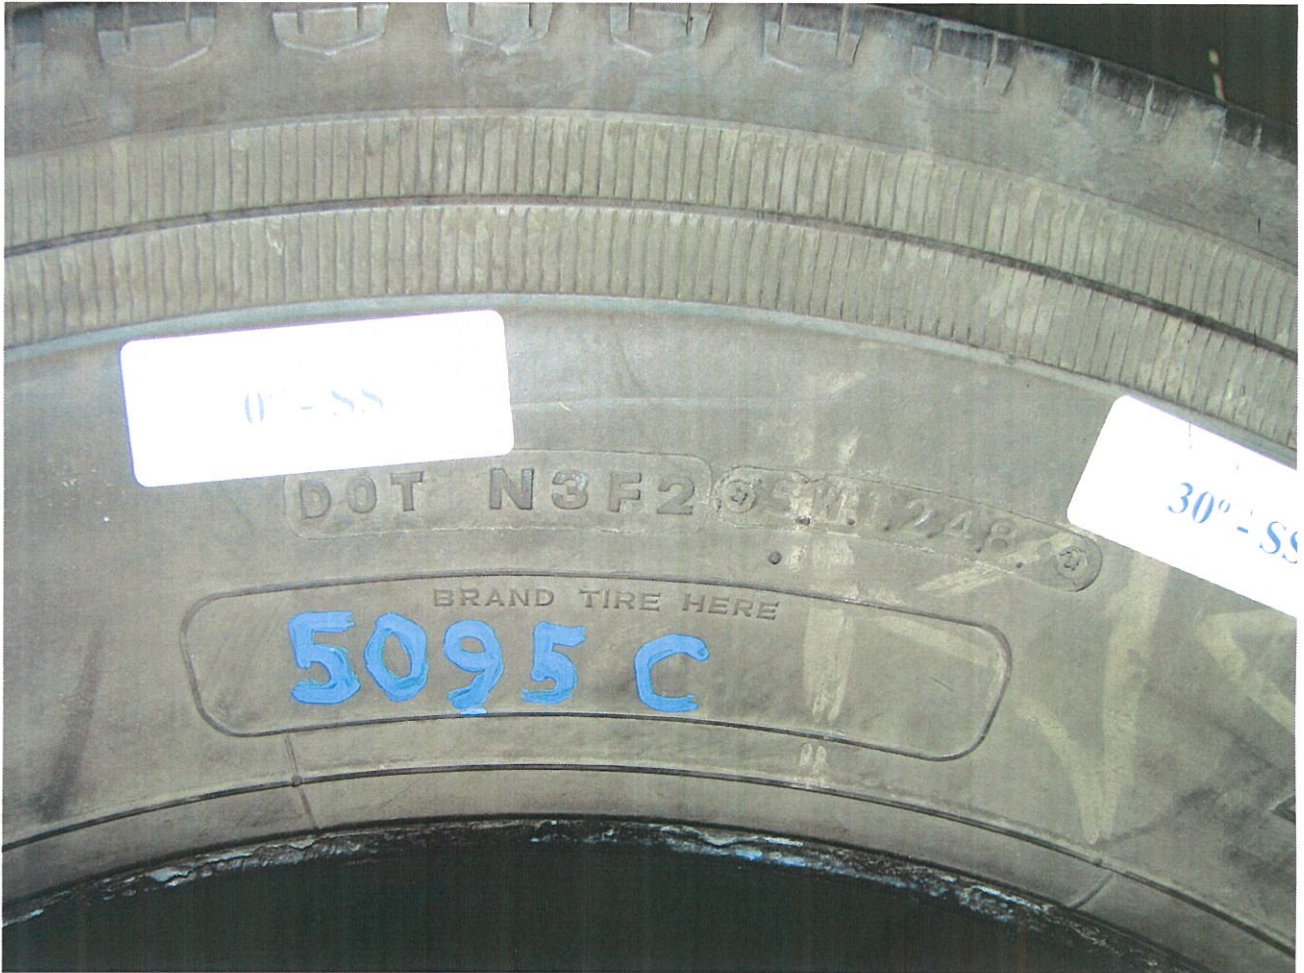
# Appendix A - INSPECTION- Tire C – images

TIRE OBSERVATIONS	0 DEG	30 DEG	60 DEG	90 DEG	120 DEG	150 DEG	180 DEG	210 DEG	240 DEG	270 DEG	300 DEG	330 DEG	Overall
<b>TIRE IDENTIFIERS</b>													
Groove 1 nearest to SS													
Groove 2													
Groove 3													
Groove 4													
Tread Block 1 nearest to SS													
Tread Block 2													
Tread Block 3													
Tread Block 4													
Tread Block 5													
Tread crown area								"hold nail marking" @210- 270deg					Blue marking "Mittin ger"
<b>TIRE OBSERVATIONS</b>													
Groove 1 nearest to SS													
Groove 2											4MM GOUGE @320DE G		
Groove 3													
Groove 4													
Tread Block 1 nearest to SS													
Tread Block 2													
Tread Block 3													
Tread Block 4													
Tread Block 5													
Tread crown area													
Overall Tire													
Steel belt 0 - Radial Plies

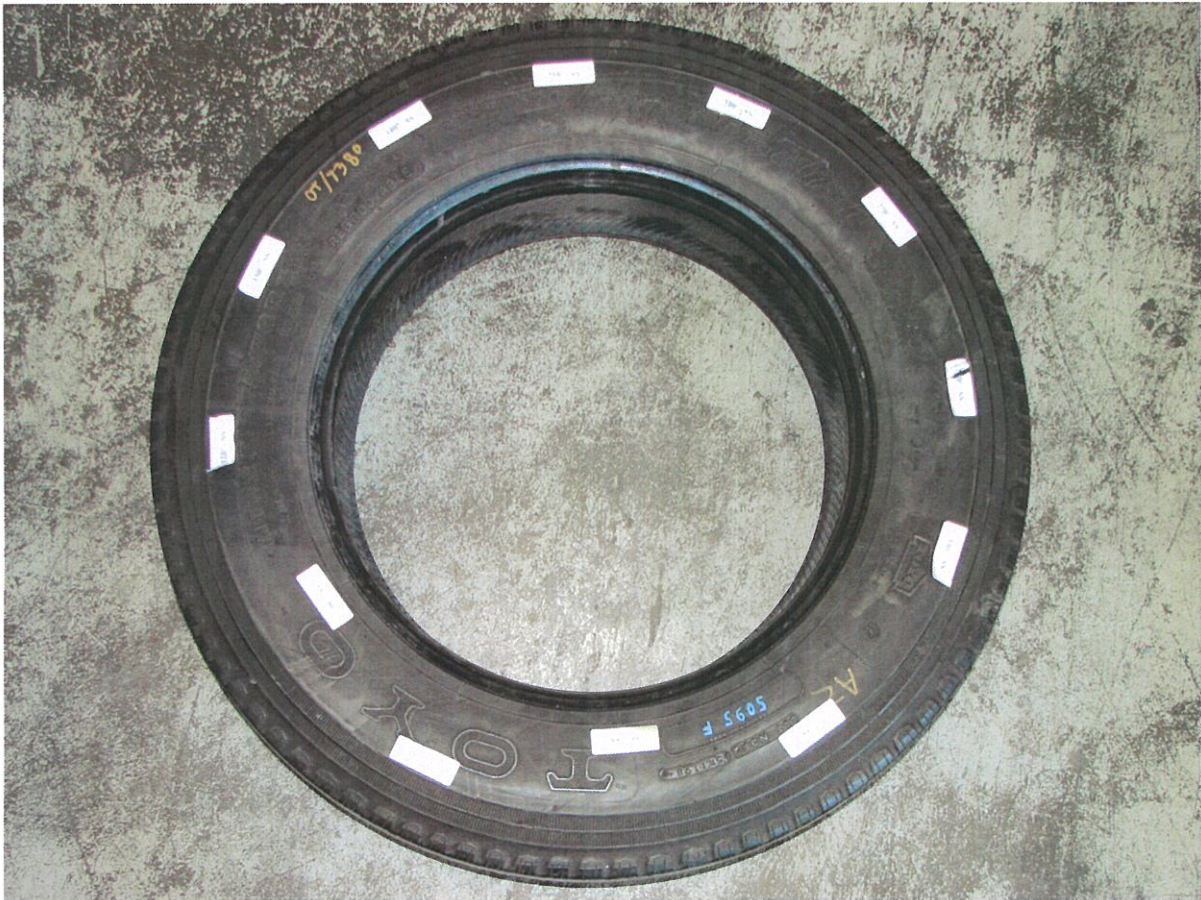
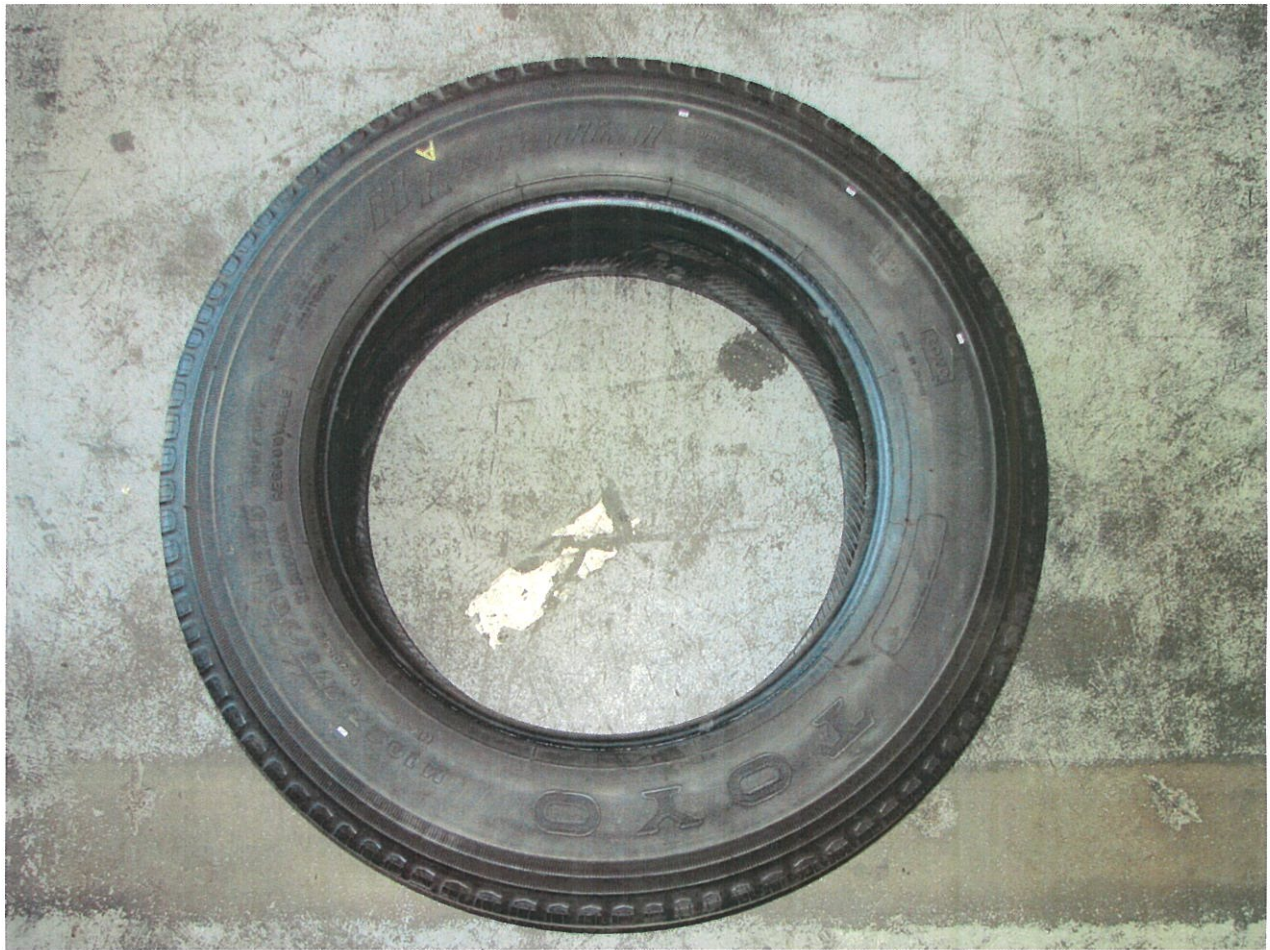
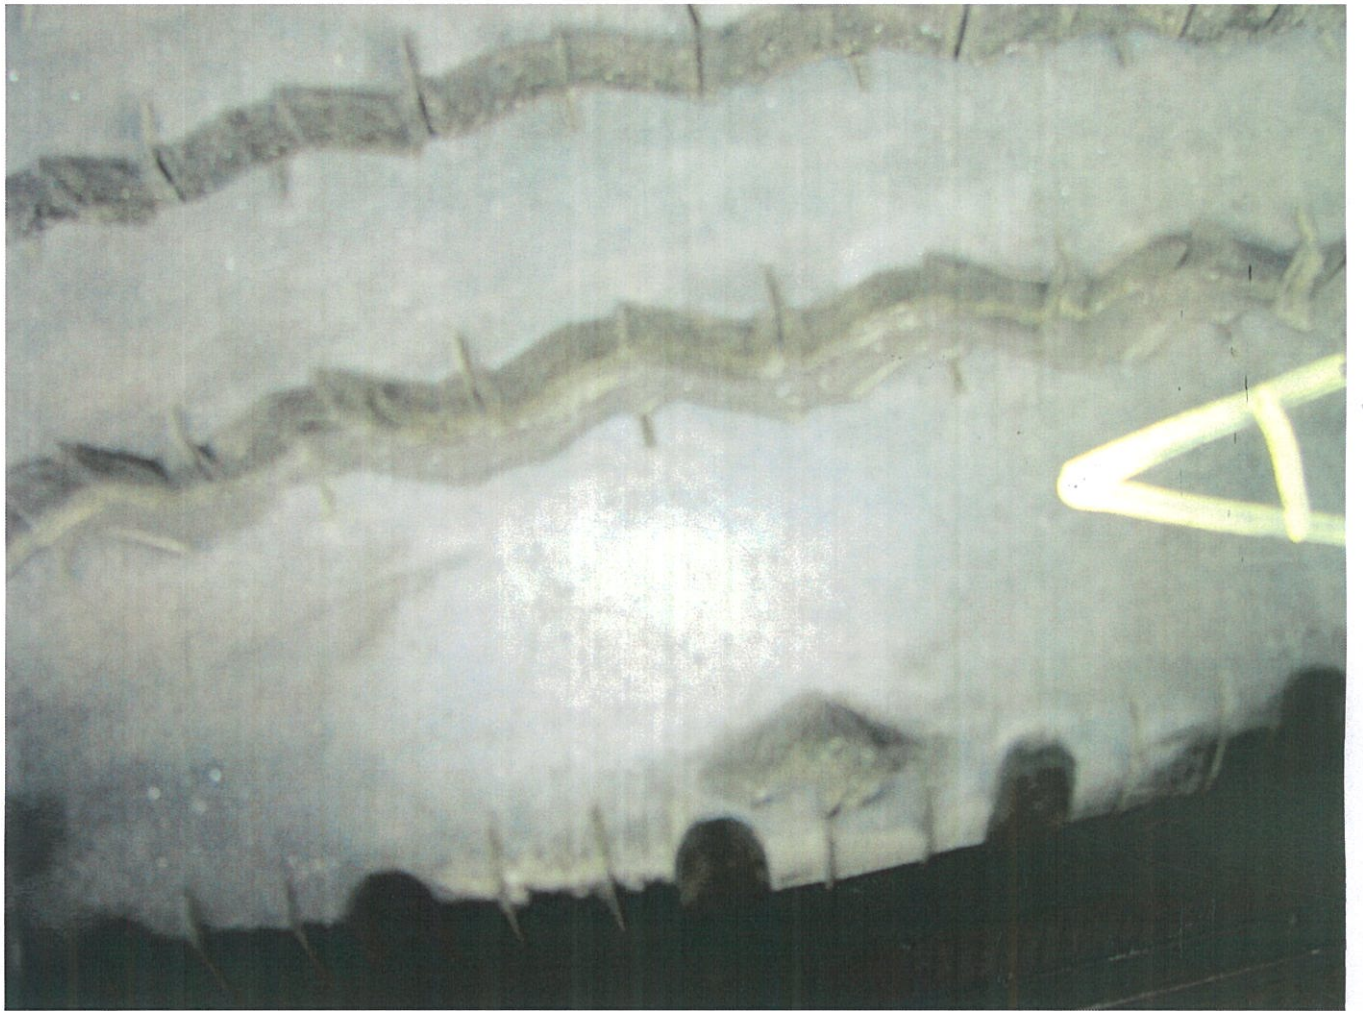
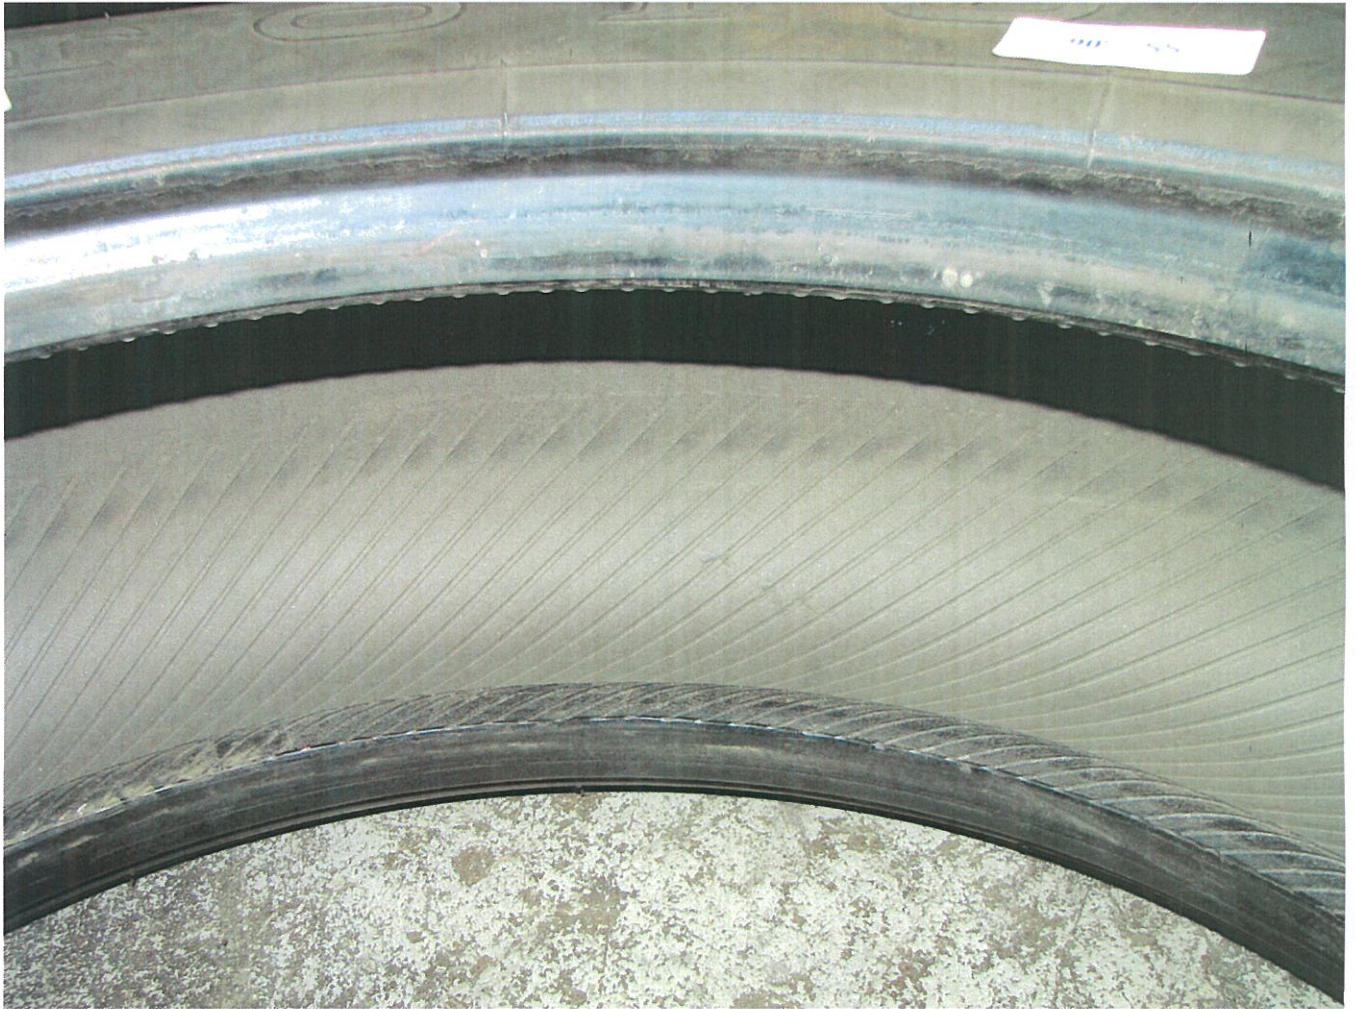
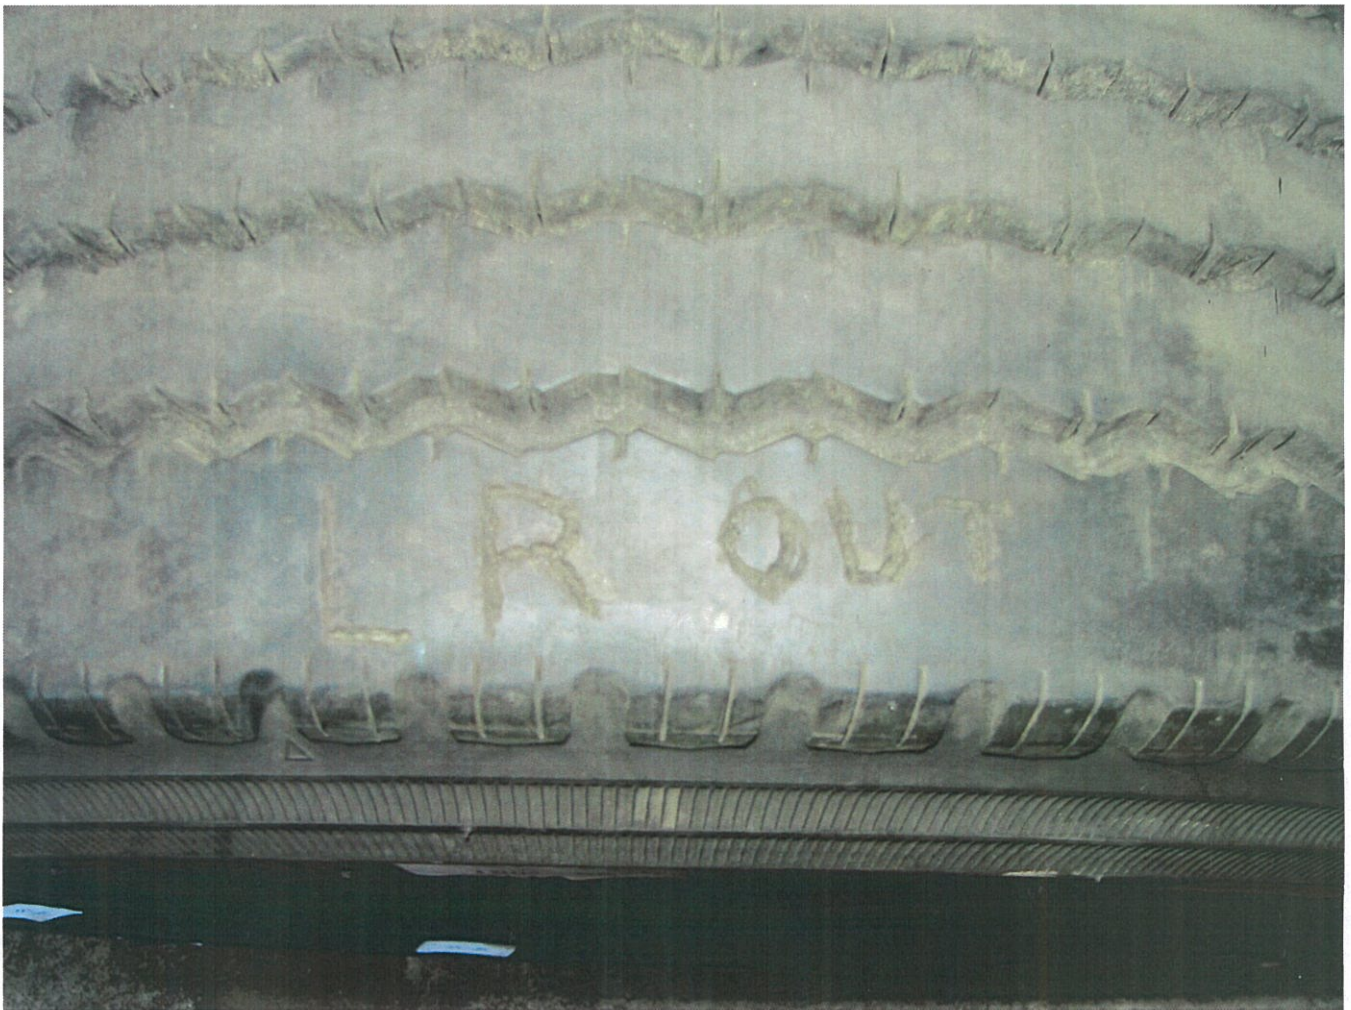
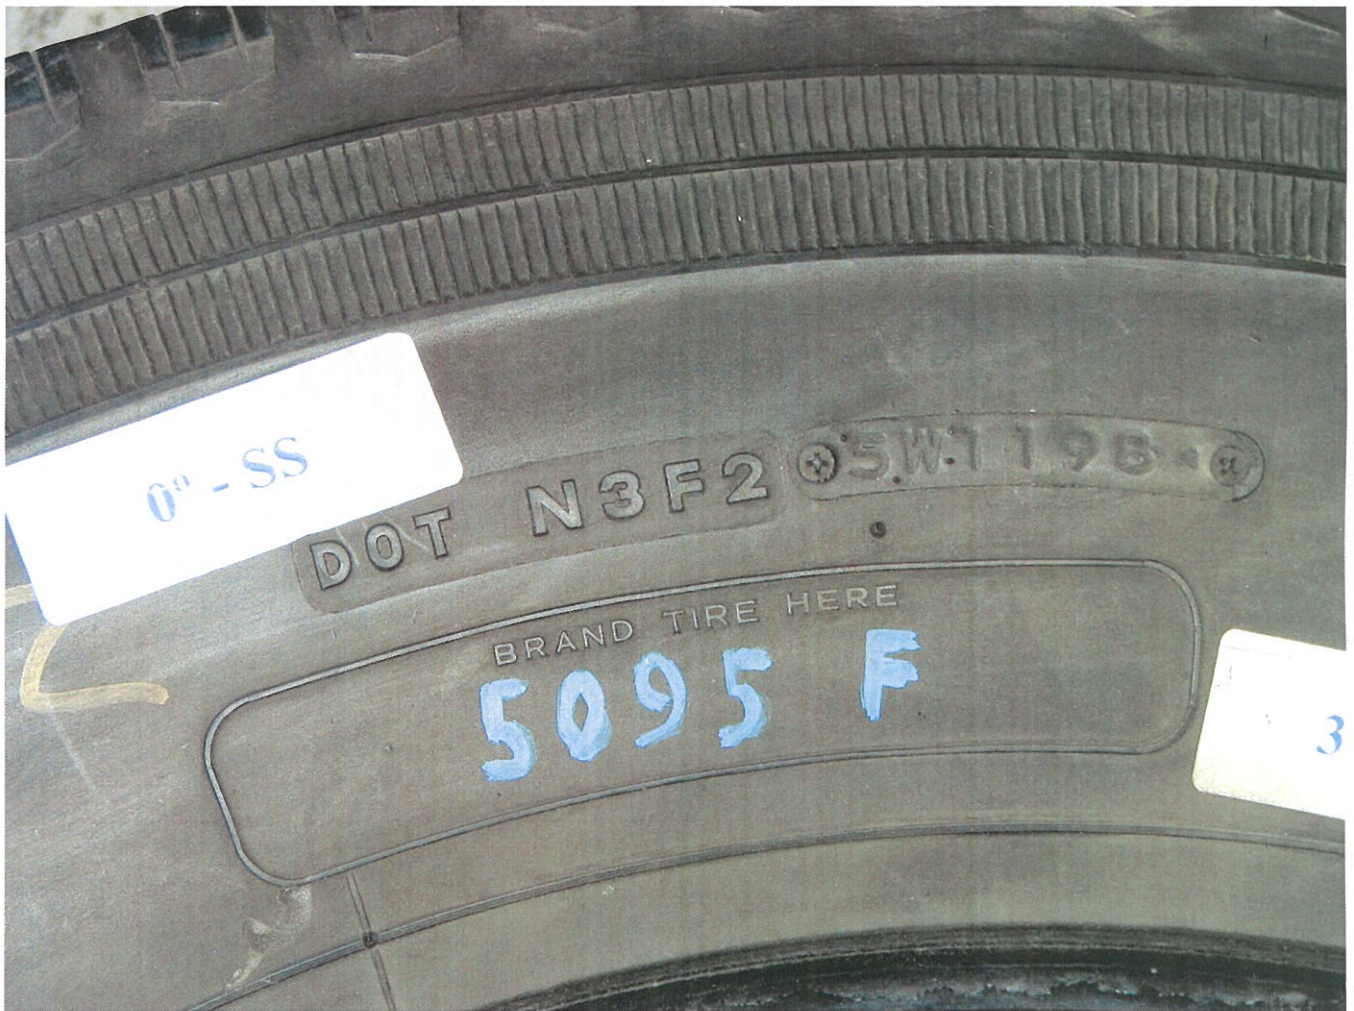
### Tire F – OBSERVATIONS AND IMAGES

TIRE OBSERVATIONS	0 DEG	30 DEG	60 DEG	90 DEG	120 DEG	150 DEG	180 DEG	210 DEG	240 DEG	270 DEG	300 DEG	330 DEG	Overall
<b>TIRE IDENTIFIERS</b>													
Groove 1 nearest to SS													
Groove 2													
Groove 3													
Groove 4													
Tread Block 1 nearest to SS							"LR OUT" grooved in						
Tread Block 2													
Tread Block 3													
Tread Block 4													
Tread Block 5													
Tread crown area													
<b>TIRE OBSERVATIONS</b>													
Groove 1 nearest to SS													
Groove 2													
Groove 3													
Groove 4													
Tread Block 1 nearest to SS													
Tread Block 2													
Tread Block 3													
Tread Block 4													
Tread Block 5										Tread chunk 1 inch			
Tread crown area													
Overall Tire
