AKRON RUBBER DEVELOPMENT LABORATORY, INC  
ARDL ENGINEERING GROUP  
2851 GILCHRIST ROAD, AKRON, OHIO 44305  
PHONE: 330-7946600 FAX 330-7946623

## - TIRE FORENSICS REPORT -

PN 67722  
Purchase Order DTNH22-06-P-08366

**SUBJECT:** Forensic Evaluation on 9 Toyo Tires.

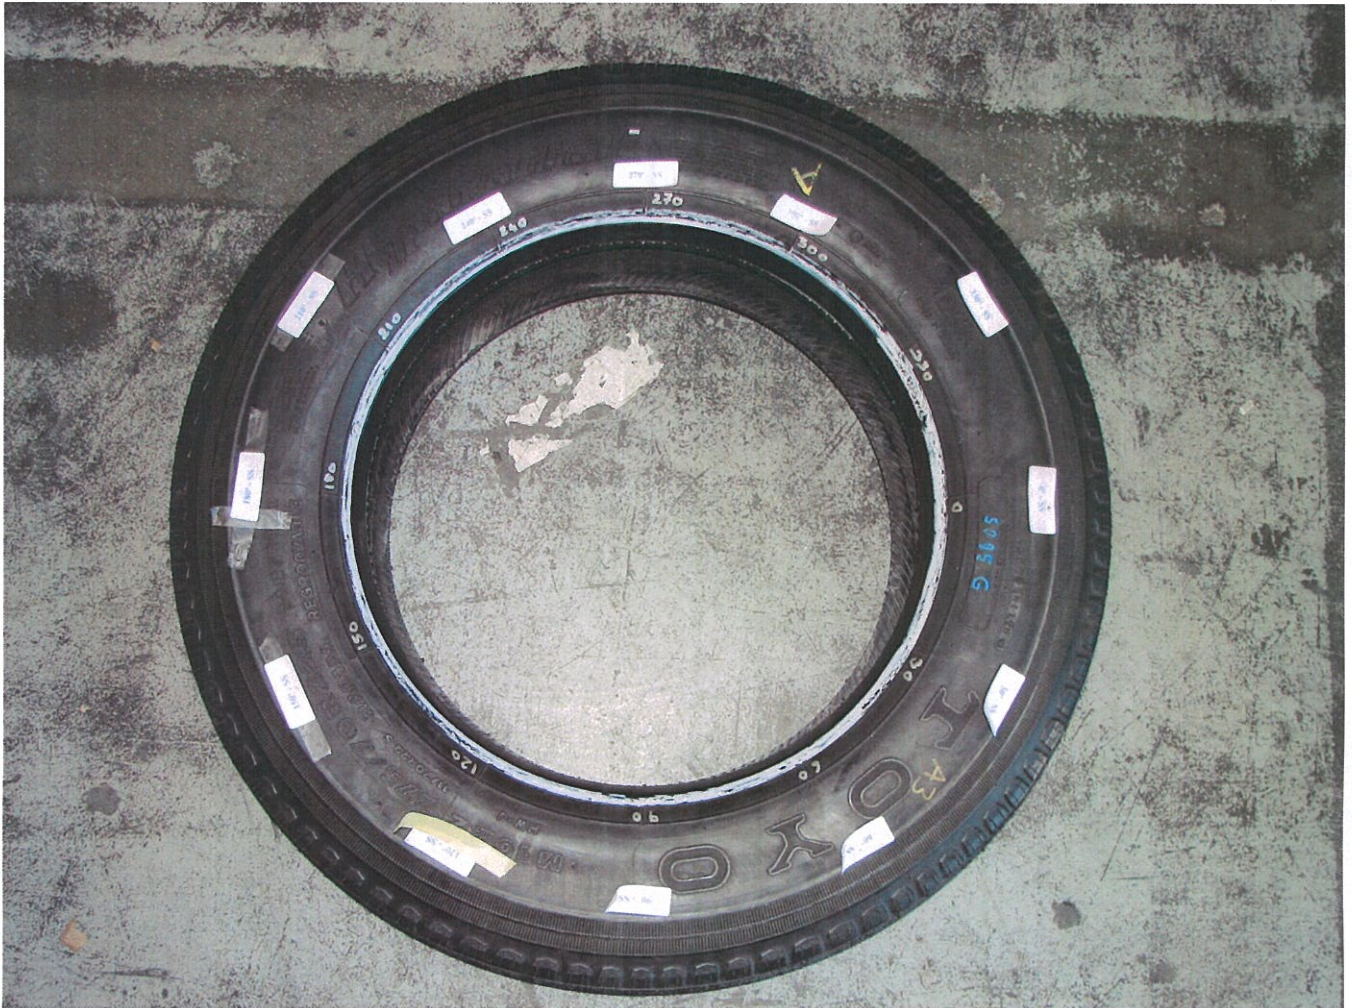
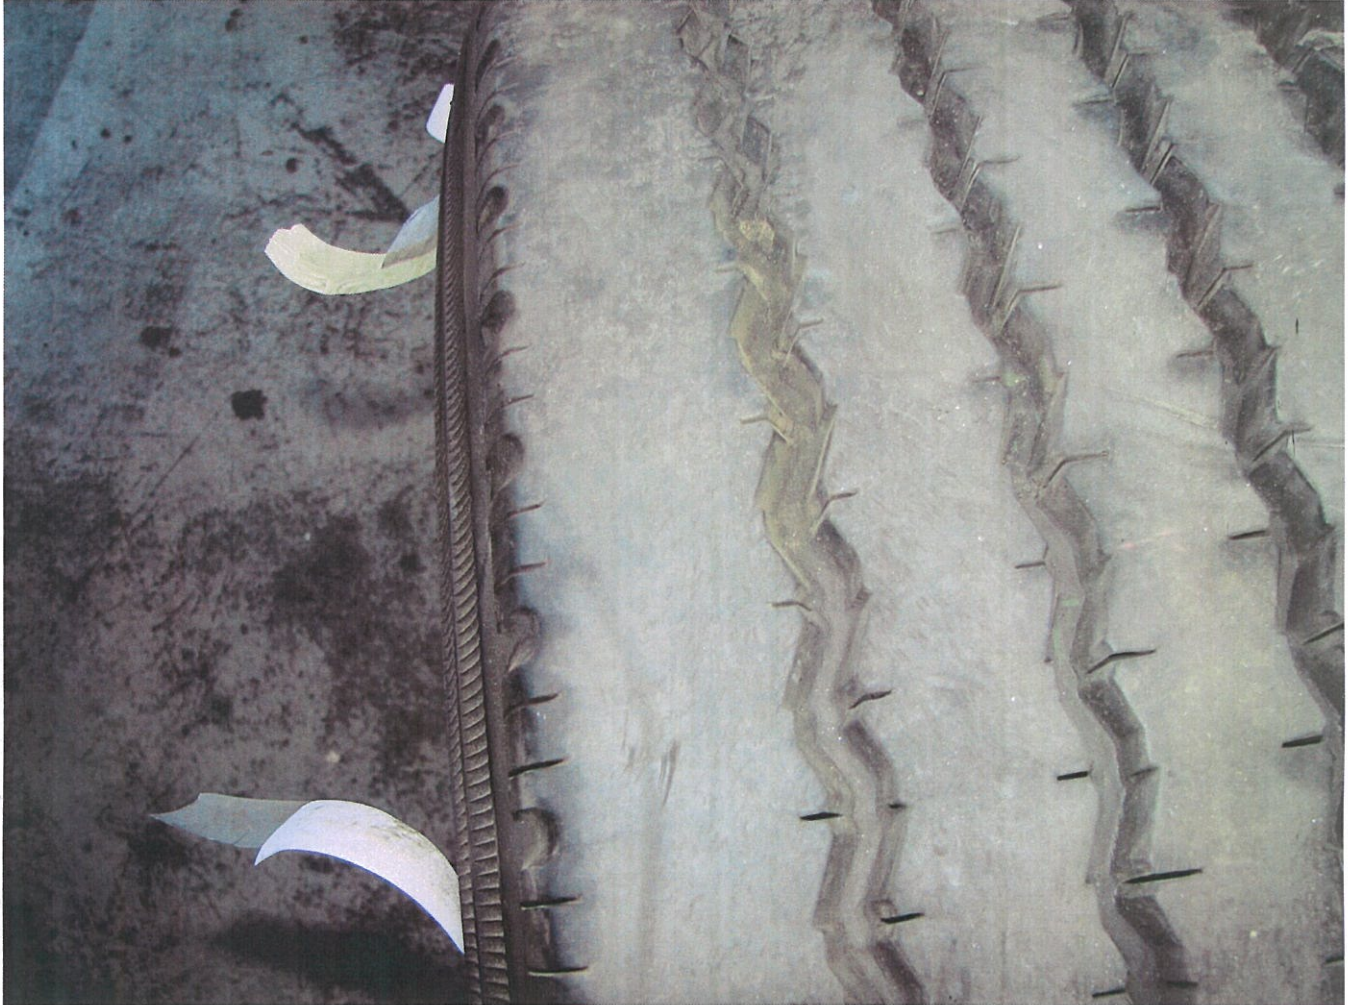
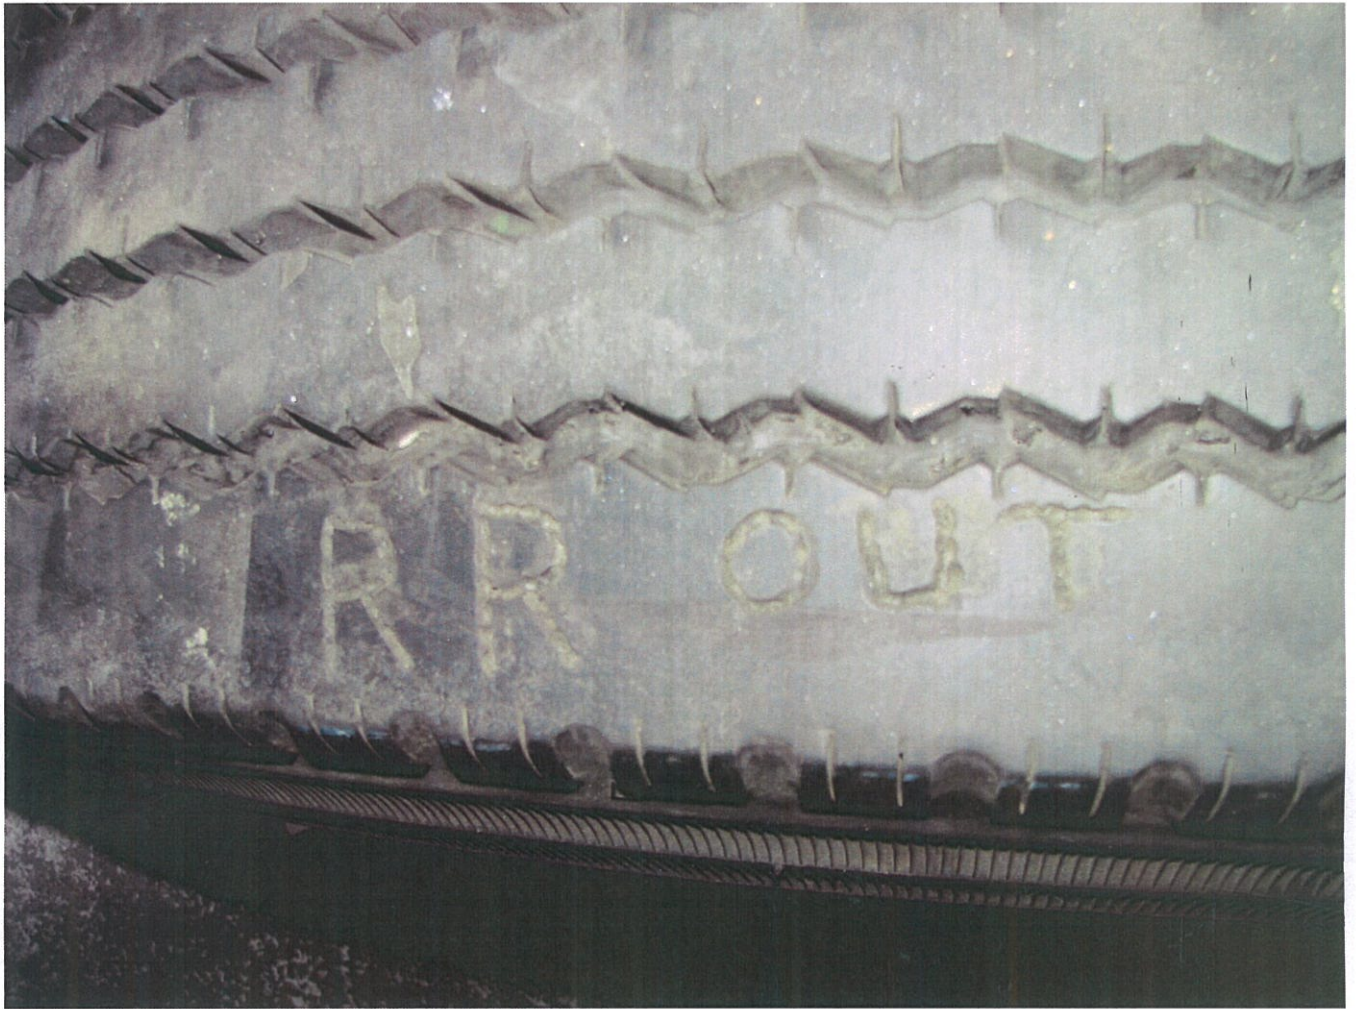
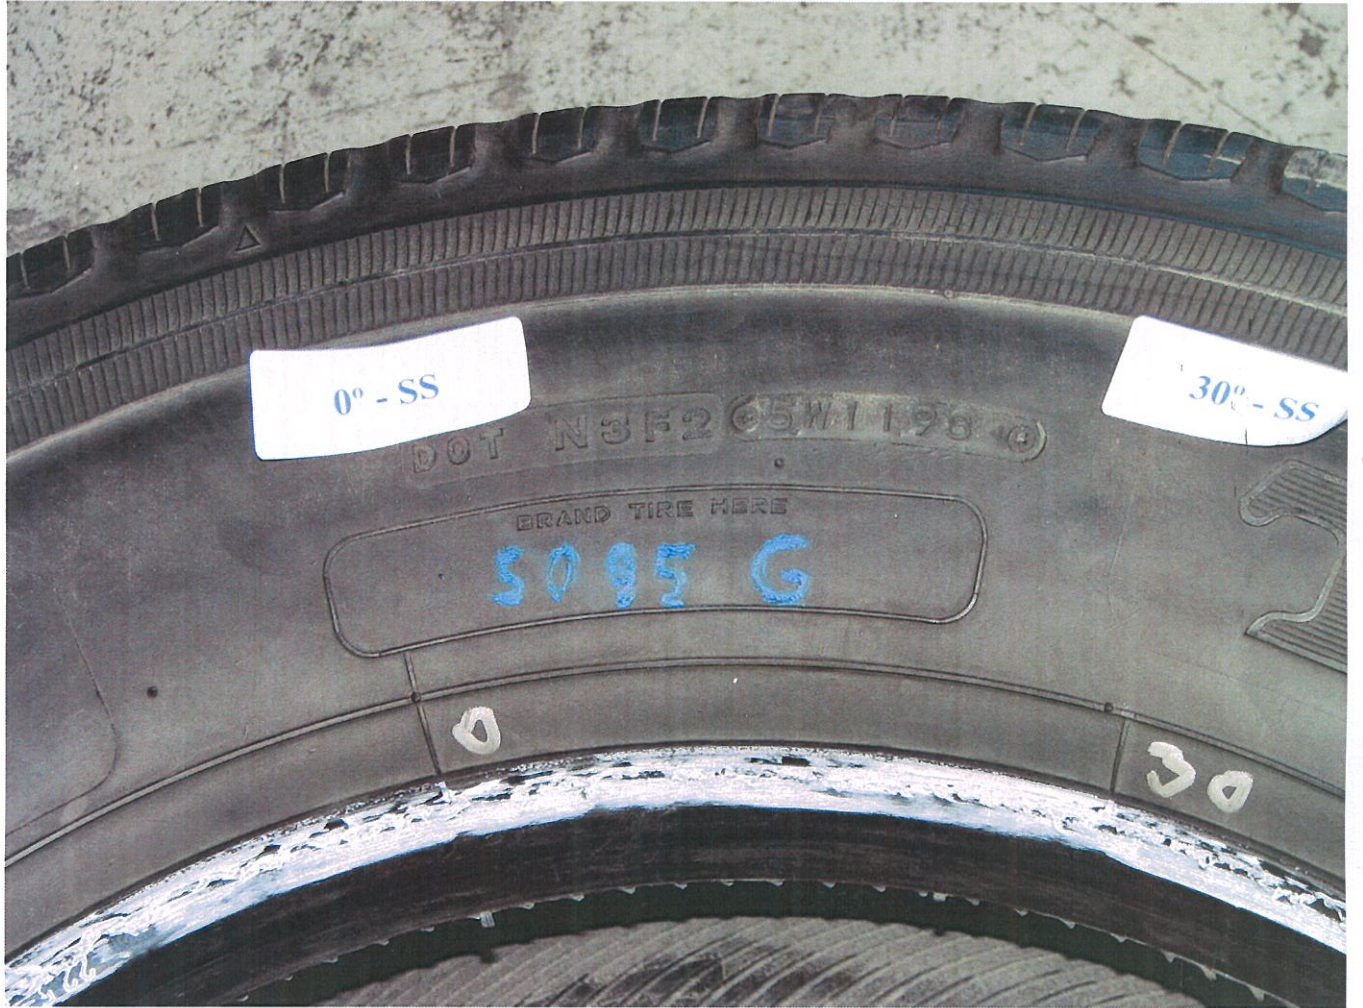
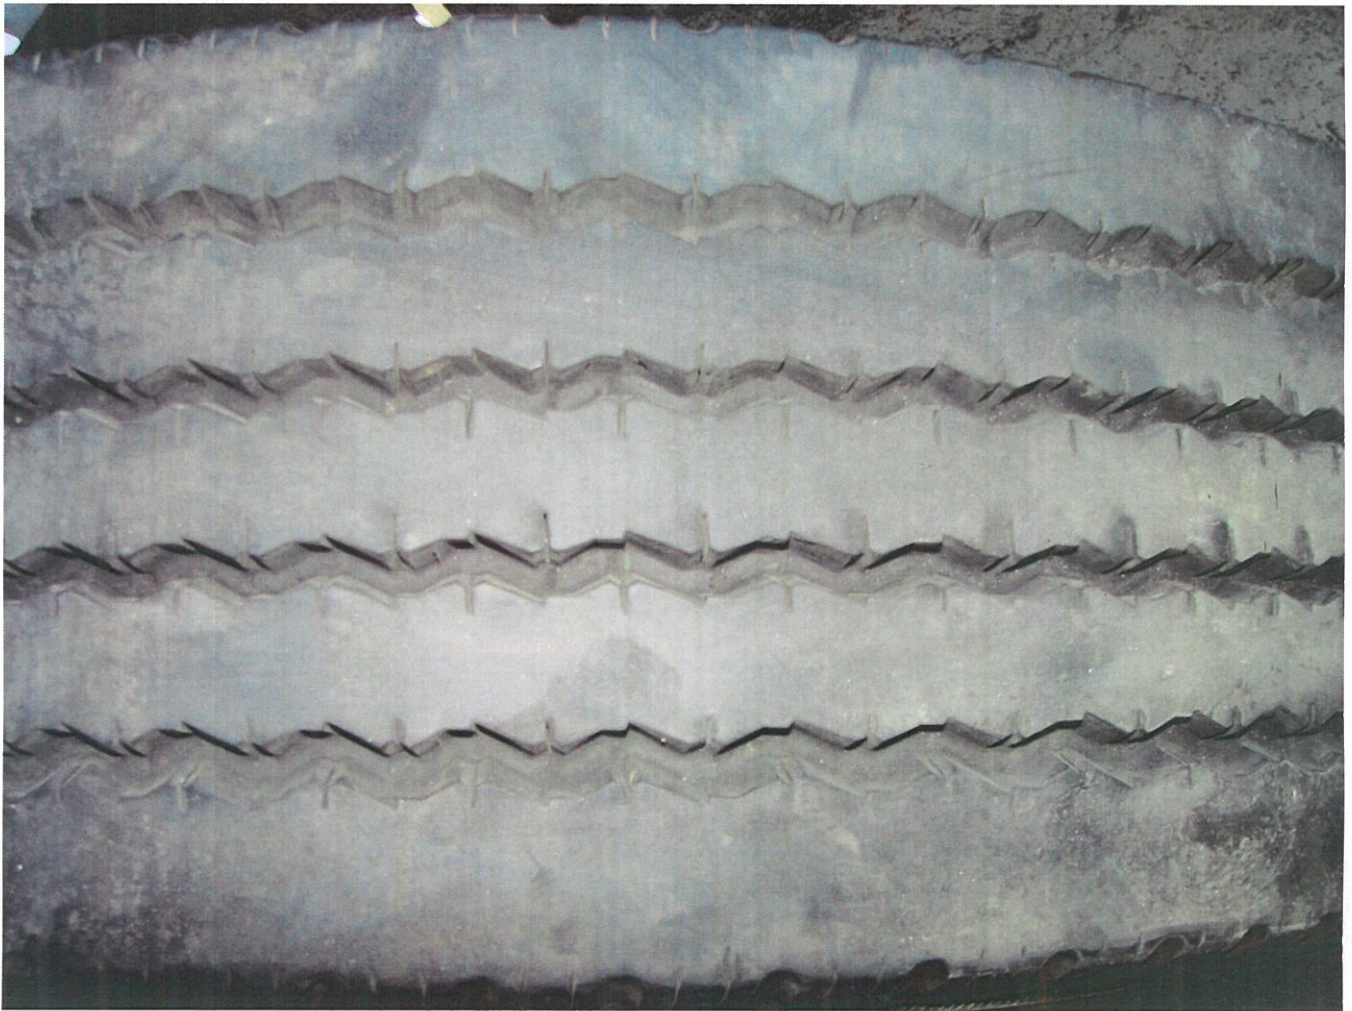
### Tire G Pre and Post Endurance Test- OBSERVATIONS AND IMAGES

TIRE OBSERVATIONS	0 DEG	30 DEG	60 DEG	90 DEG	120 DEG	150 DEG	180 DEG	210 DEG	240 DEG	270 DEG	300 DEG	330 DEG	Overall
<b>TIRE IDENTIFIERS</b>													
Groove 1 nearest to SS													
Groove 2													
Groove 3													
Groove 4													
Tread Block 1 nearest to SS													
Tread Block 2													
Tread Block 3													
Tread Block 4													
Tread Block 5													
Tread crown area													
<b>TIRE OBSERVATIONS</b>													
Groove 1 nearest to SS													
Groove 2													
Groove 3													
Groove 4													
Tread Block 1 nearest to SS										"RR OUT" grooved in the tread block			
Tread Block 2													
Tread Block 3													
Tread Block 4													
Tread Block 5													
Tread crown area

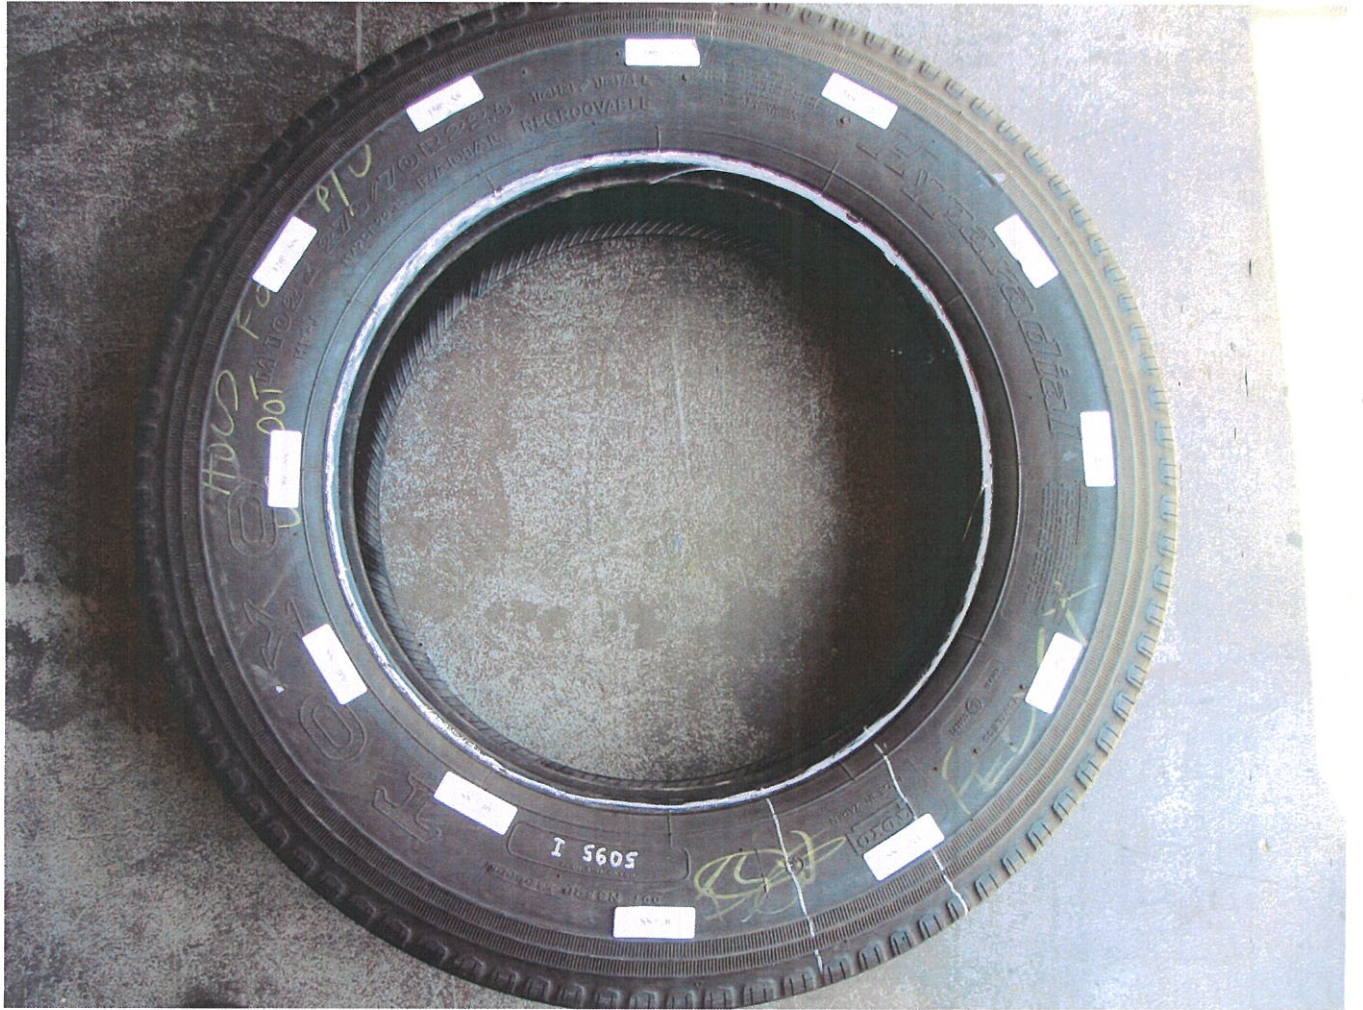
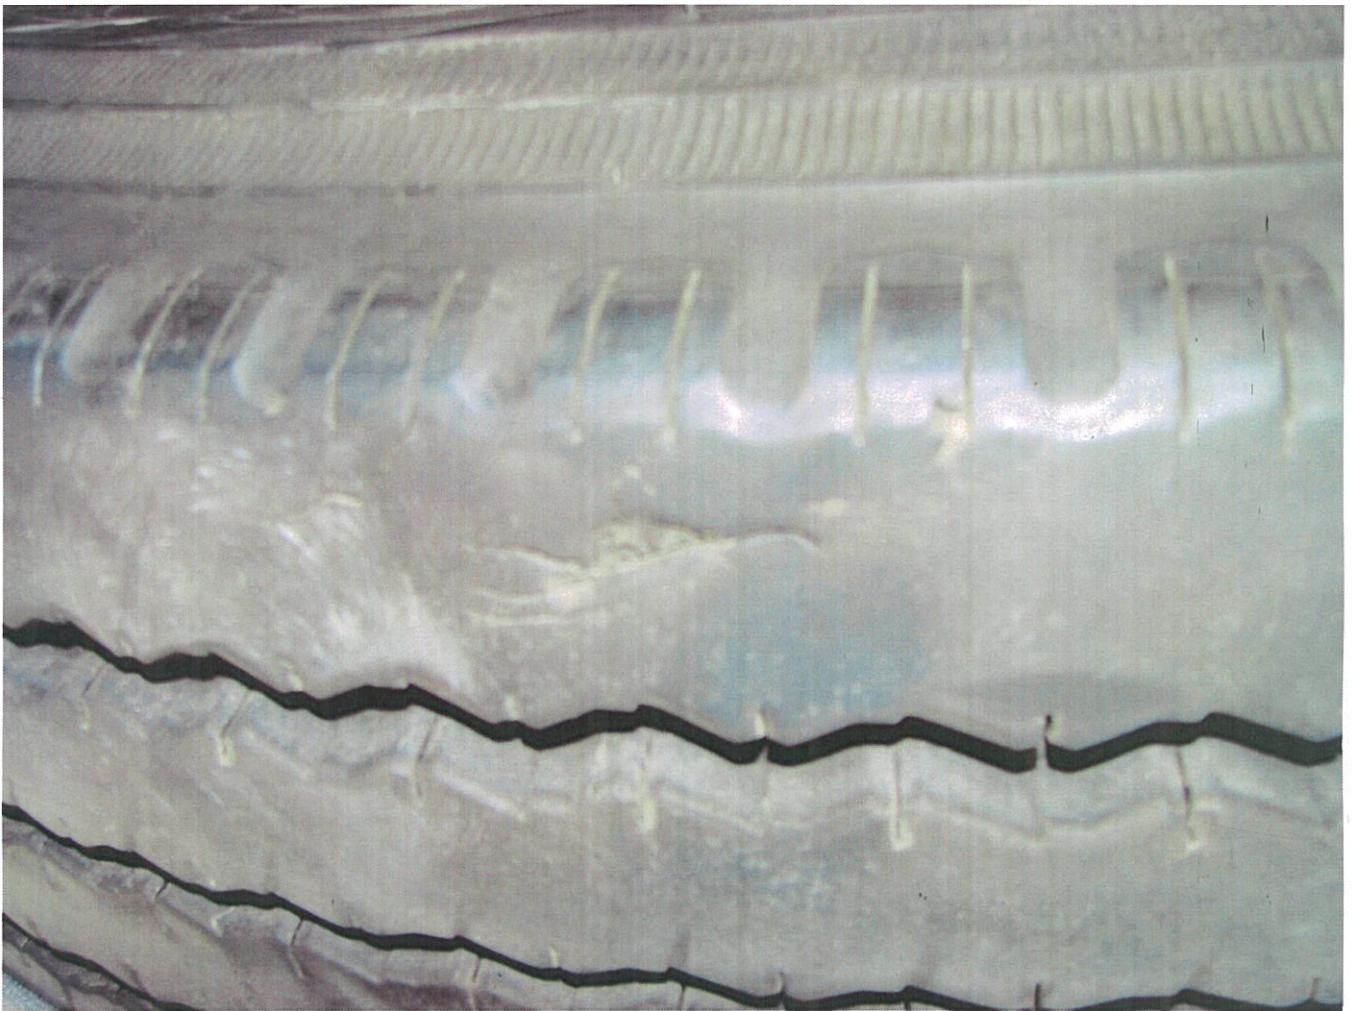
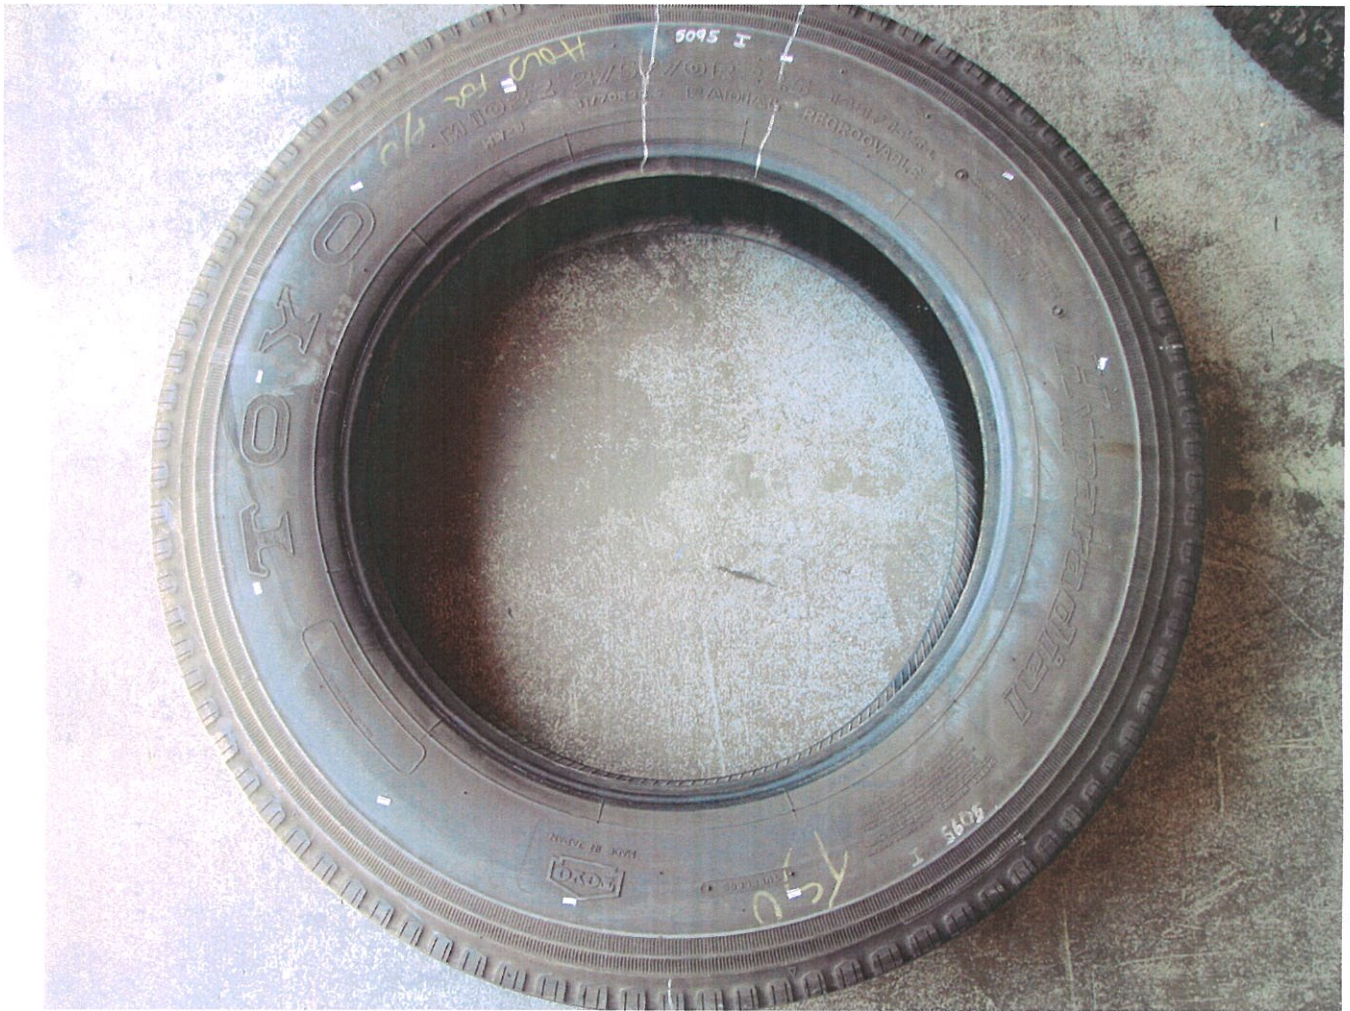
# Appendix A - INSPECTION- Tire I – images and observations

TIRE OBSERVATIONS	0 DEG	30 DEG	60 DEG	90 DEG	120 DEG	150 DEG	180 DEG	210 DEG	240 DEG	270 DEG	300 DEG	330 DEG
TIRE IDENTIFIERS												
Groove 1 nearest to SS												
Groove 2												
Groove 3												
Groove 4												
Tread Block 1 nearest to SS												
Tread Block 2												
Tread Block 3												
Tread Block 4												
Tread Block 5												
Tread crown area												
TIRE OBSERVATIONS												
Groove 1 nearest to SS												
Groove 2												
Groove 3												
Groove 4												
Tread Block 1 nearest to SS			1.5 inch cut									
Tread Block 2												
Tread Block 3												
Tread Block 4												
Tread Block 5												
Tread crown area

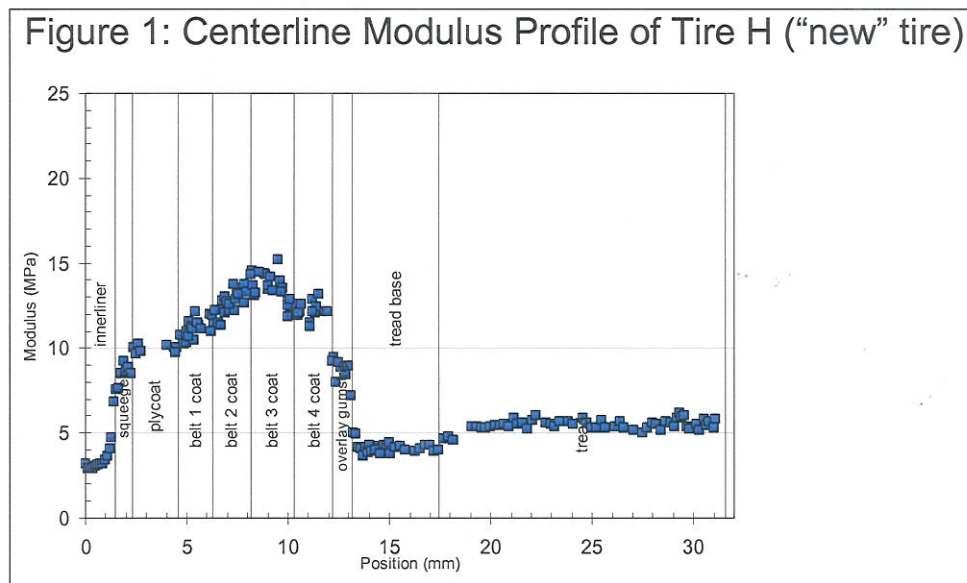
Indentation modulus was measured in the centerline region of tire. The radial scan (modulus profile) was located at the centerline because that region can be a critical (high strain) region in truck tires. Figure 1 shows the centerline modulus profile of Tire H (the “new” tire).

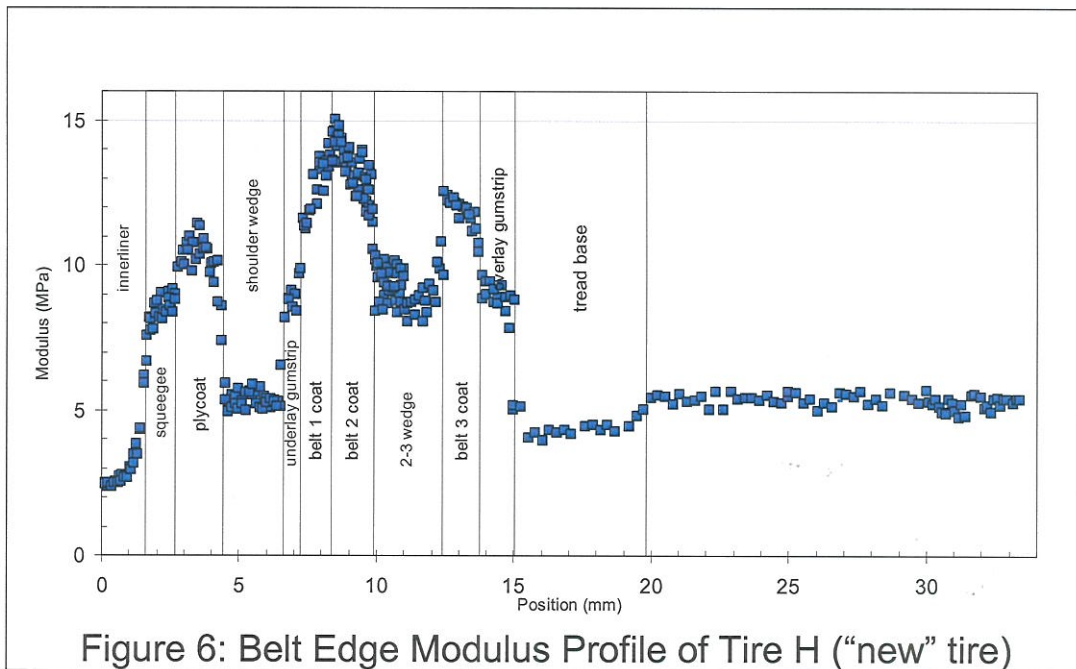
Indentation modulus was measured in the shoulder region of tire. The radial scan (modulus profile) was located at the edge of belt 3 because that is the critical (high strain) region of the working belts. Figure 6 shows the centerline modulus profile of Tire H (the “new” tire in the belt edge region.

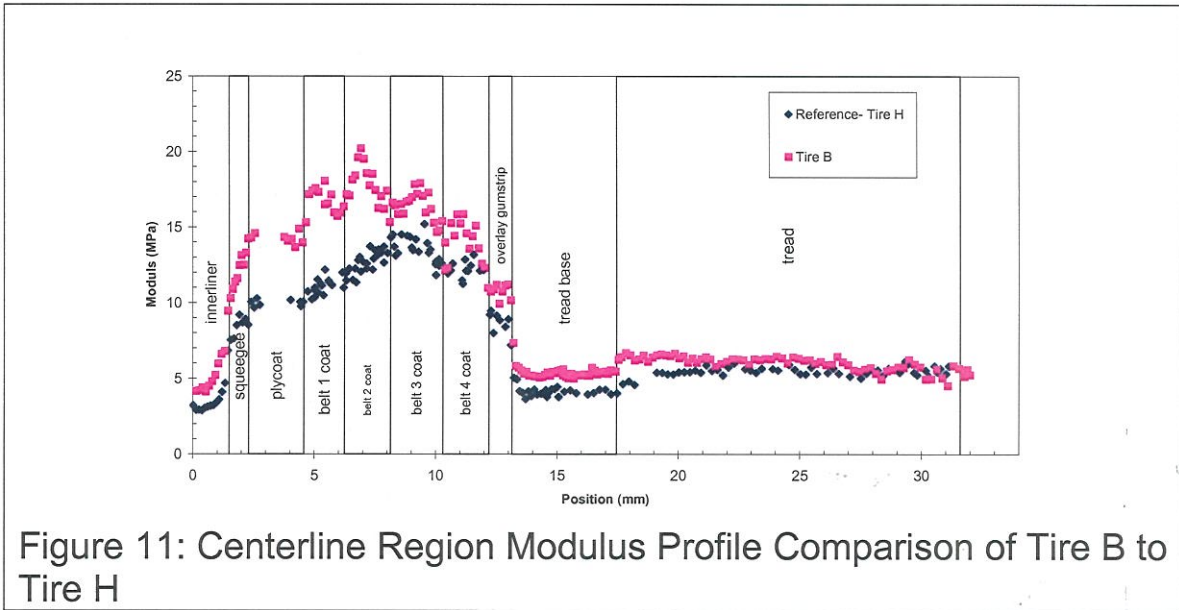
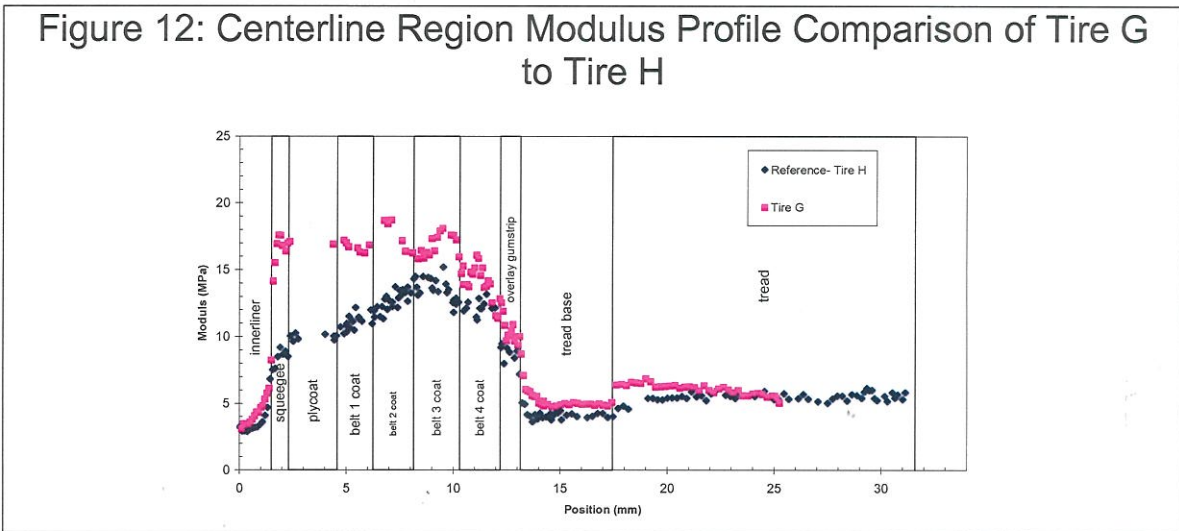
Modulus profiling was performed in the tire centerline region of wheel-tested tires (tires B and G). The modulus increased in each of the components (Figures 11 and 12). The compounds experienced large modulus increases. Presumably, oxidative hardening was significantly affecting these compounds.
